**SUBJECT:** Request for Feedback  
2730 Elgin Mills Road East  
Post Fire Engineering Report

**Property/Building Description:** Christian Heise House, single detached, 1-1/2 storey dwelling constructed c. 1859.

<b>Date:</b>	March 10, 2025	<b>No. of Pages:</b>	7 + Encl.
<b>Project:</b>	Elgin Mills Road House Moving	<b>Project No.:</b>	TE-44712-25
<b>Address:</b>	2730 Elgin Mills Rd E, Markham, Ontario.	<b>Permit No.:</b>	N/A
<b>Client:</b>	Michael Scott Architect Inc.		
<b>Distribution:</b>	Michael Scott	Michael Scott Architect Inc.	mscott@michaelscottarchitect.ca
	Alexander Spasewski	City of Markham	aspasewski@markham.ca

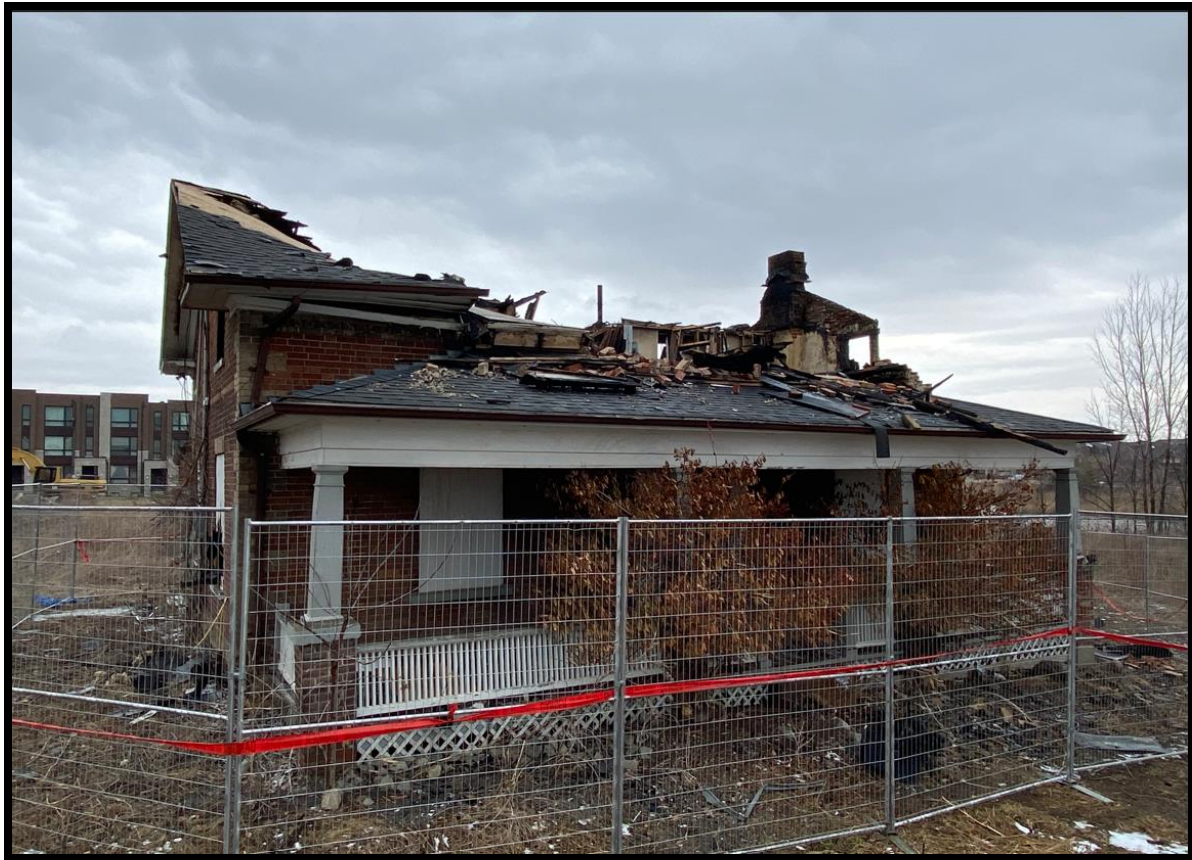
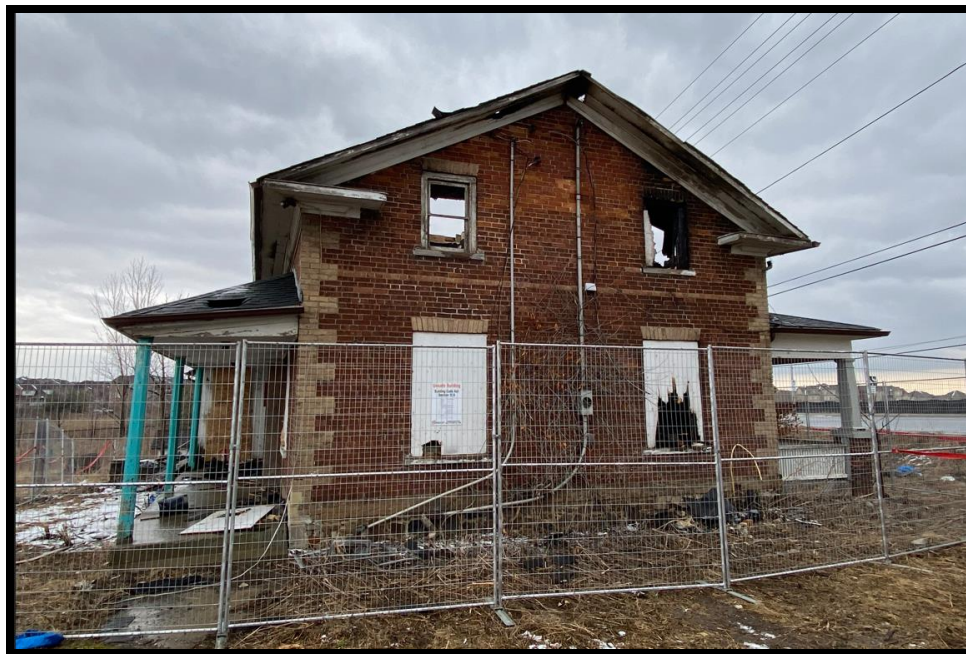
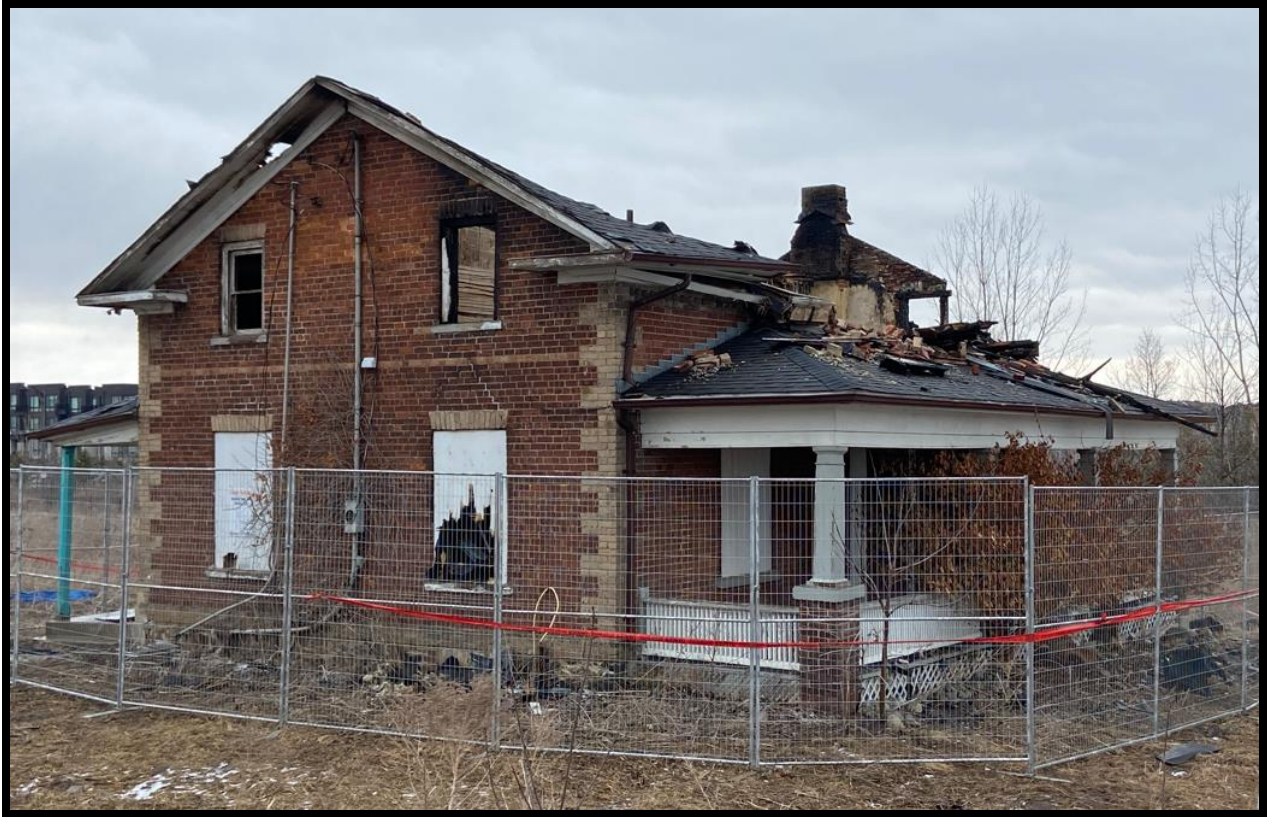
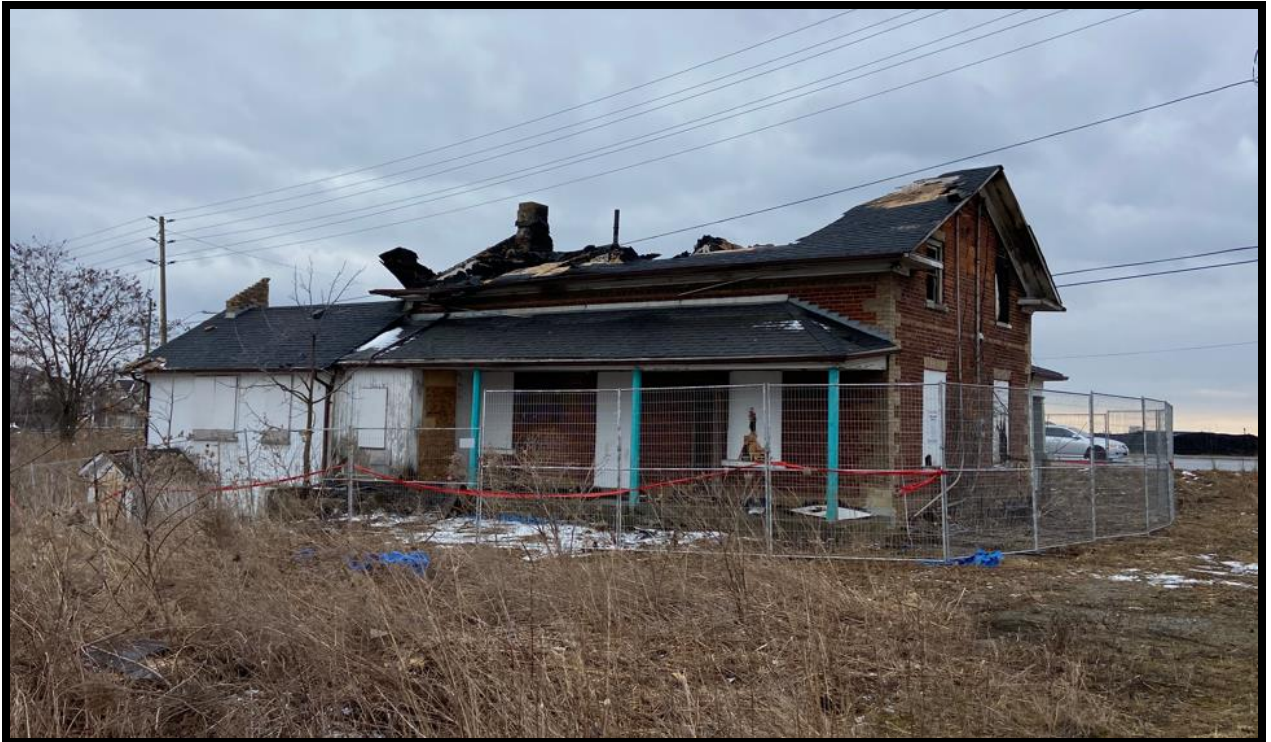
## Post Fire Photographs of the Christian Heise House

- On February 19<sup>th</sup> 2025, a fire caused significant damage to the Christian Heise House including the loss of most of the roof, partial collapse of the east brick gable wall, heat damage to the west gable wall, partial collapse of the second floor adjacent to the west gable wall as well as water damage from the extinguishing of the fire and from the interior being exposed to the winter elements.

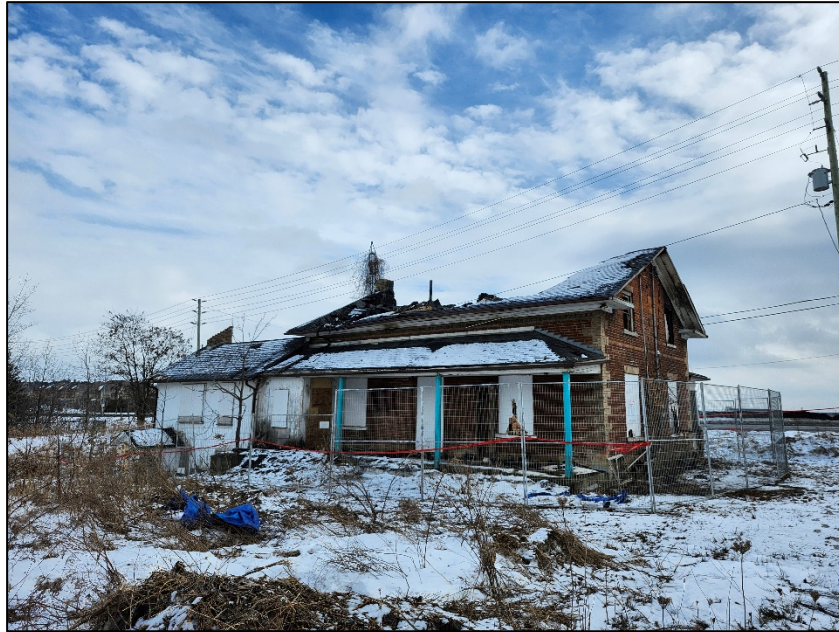
**Photograph 1: North façade**

- The roof has effectively been destroyed (see Photographs 1 and 2 of Appendix A).
- The brick gable end wall on the east side of the house has suffered a partial collapse (see Photographs 4 and 5 of Appendix A).
- The brick gable end wall on the west side of the house is displaying signs of heavy deterioration from heat exposure (see Photograph 6 of Appendix A).
- The second level floor, adjacent to the west gable wall, has collapsed rendering the wall laterally unsupported (see Photographs 7 and 8 of Appendix A).

- a) Review and reinstate any compromised site security fencing.
- b) Install temporary bracing to stabilize the partially collapsed gable wall (east).
- c) Install temporary bracing to stabilize the laterally unsupported and fire damaged gable wall (west).
- d) Remove debris from the first and second story floor.

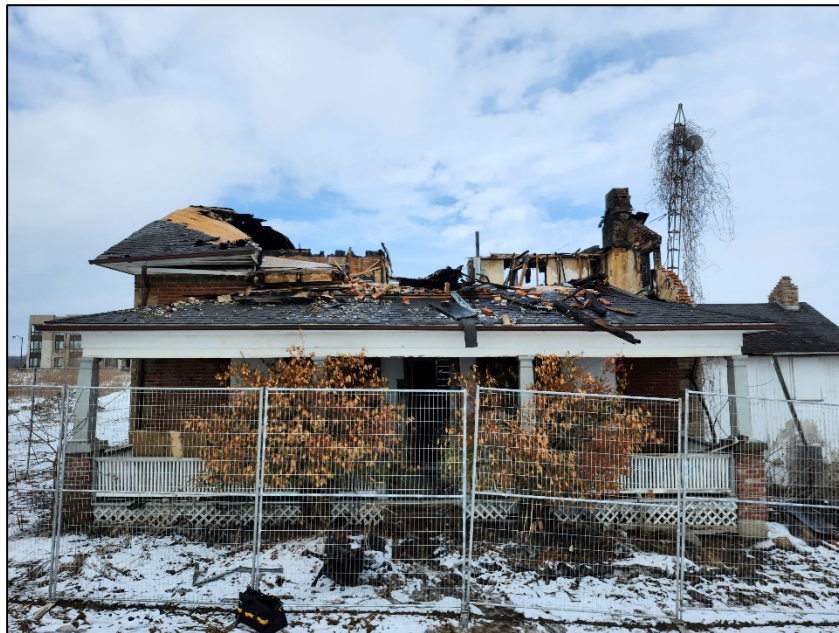
**Photograph 2: South façade**

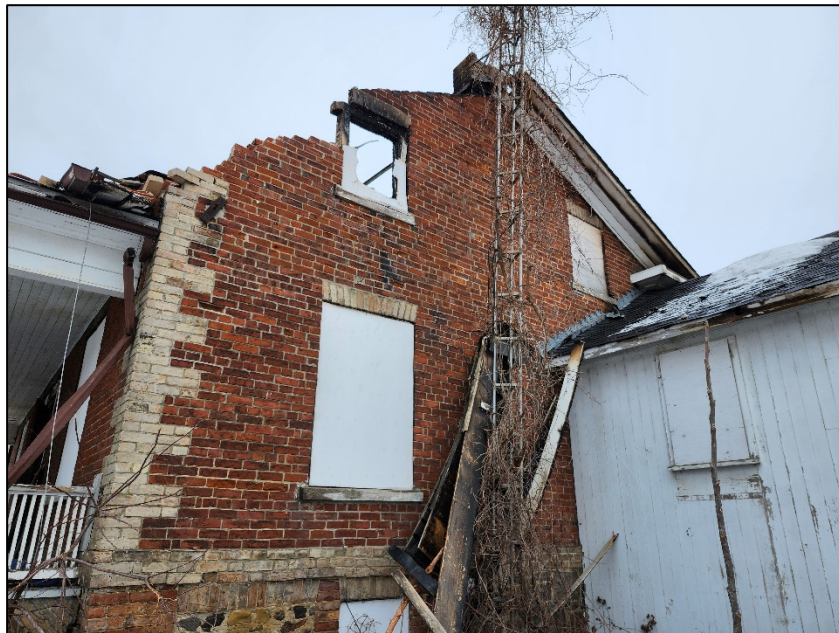
**Photograph 4: East façade**

- a) Reconstruct the collapsed masonry wall at the east gable end and along the top of the south wall.
- b) Localized masonry repairs at fire-damaged locations.
- c) Removal and replacement of all fire-damaged structural members.

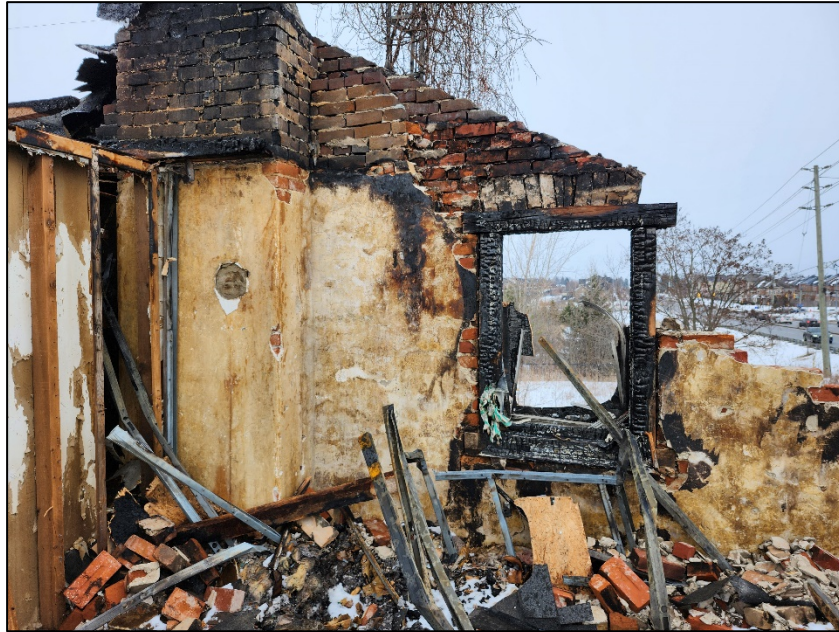
**Photograph 5: Partially collapsed east gable wall**

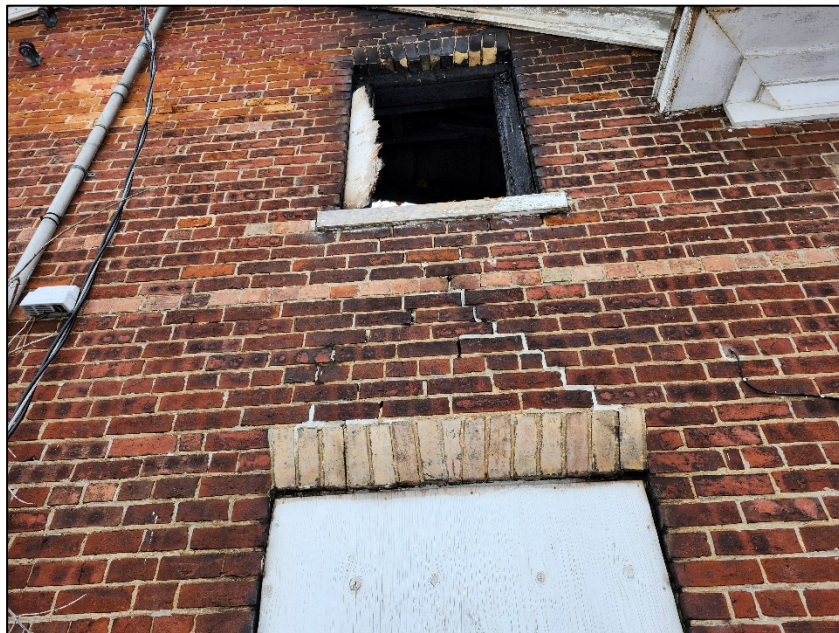
**Photograph 6: Deteriorated masonry on the west gable wall**

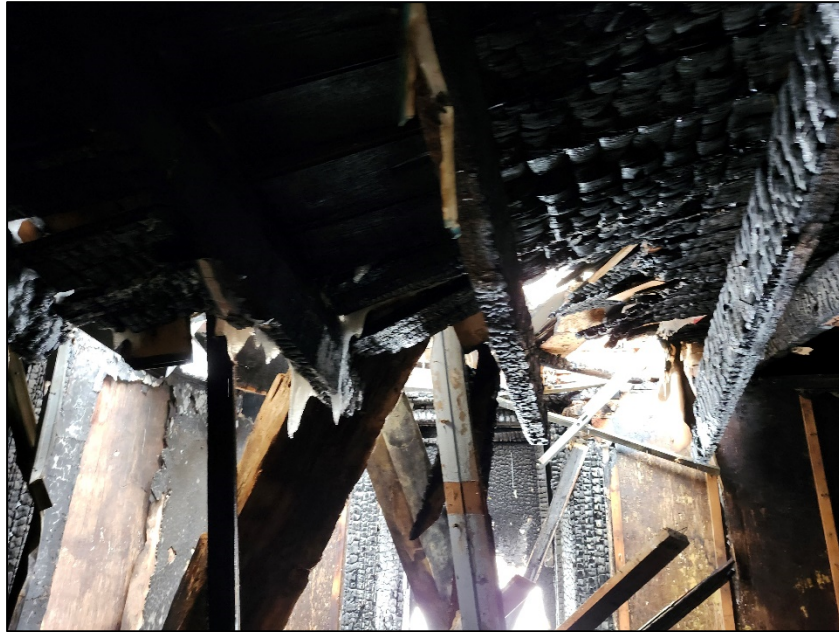
**Photograph 7: Collapsed second level floor**

- e) Reconstruct the collapsed portion of the second story floor.
- f) Reconstruct the roof.
- g) Reinstate the building envelope.

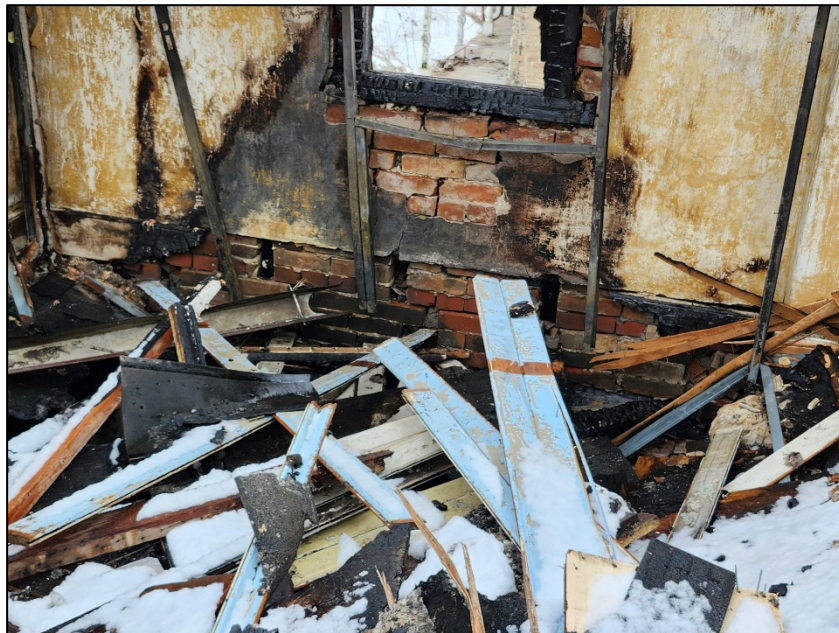
**Photograph 8: Collapsed second level floor**
