**DAHL GROUP**  
ENGINEERING

October 24, 2025  
File No.: DGE25178

**Re: Engineering Assessment – Building Exposed to Fire Loss Event**

Property Owner: Burlew, Edward & Heather  
Property Address: 16 John Street, Thornhill, ON.

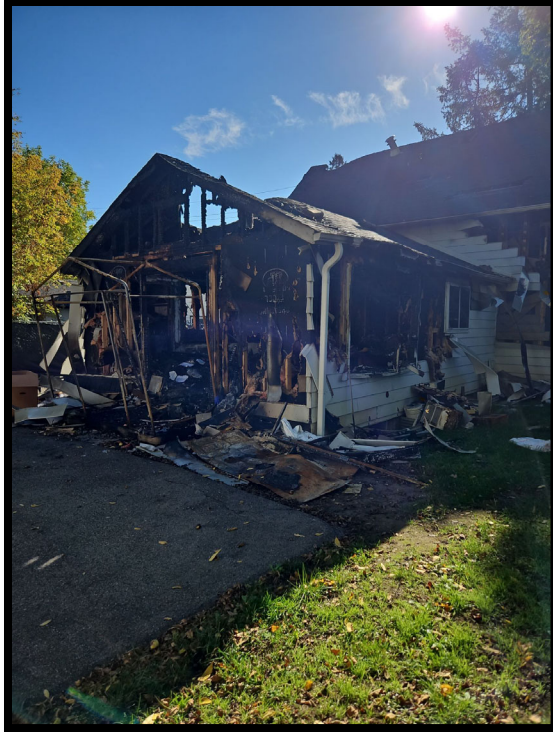
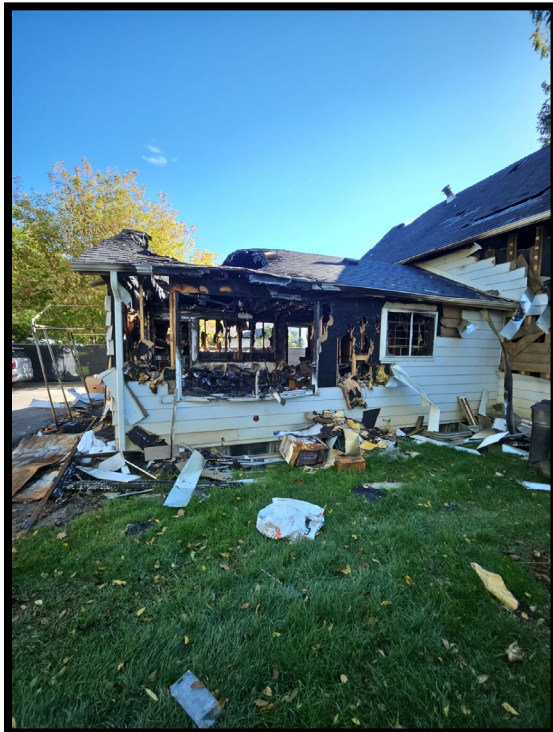
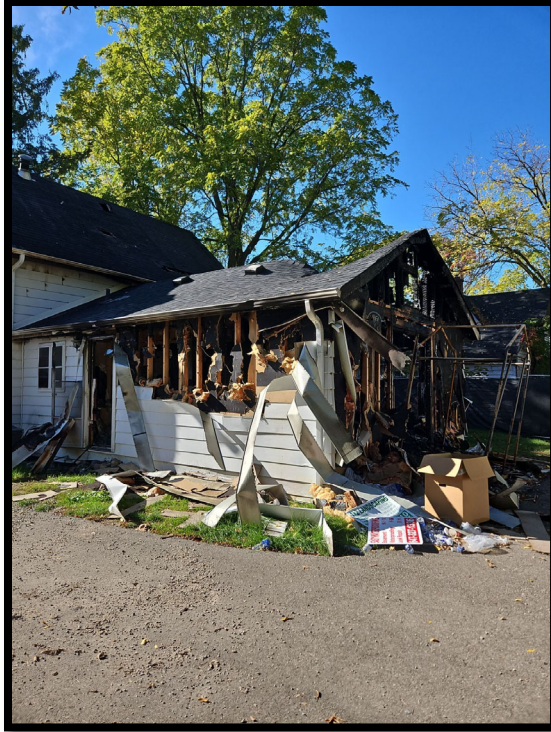
Photographs No. 1 to 3 provide general exterior views of the rear addition portion of the building wherein the fire was reported to have originated. For reference purposes the rear elevation of the addition as shown in Photograph No. 1 faces north towards the rear of the property. The rear addition appeared to have been fully involved resulting in the walls and roof visible in these photographs to have been substantially consumed by the fire.

Due to the extent of damage sustained to this portion of the building, it cannot be relied upon to perform predictably and should be demolished immediately in a controlled manner to prevent risk of unintentional collapse and/or injury.

Based on the discussions presented in the preceding section of this report, it is our opinion that the building is not salvageable as a result of the fire loss event. The rear addition of the building had been largely consumed by the fire event. It is presently unstable and at significant risk of collapse under its own weight, only to be exacerbated by the forthcoming snow season. Complete demolition of the rear addition is required.

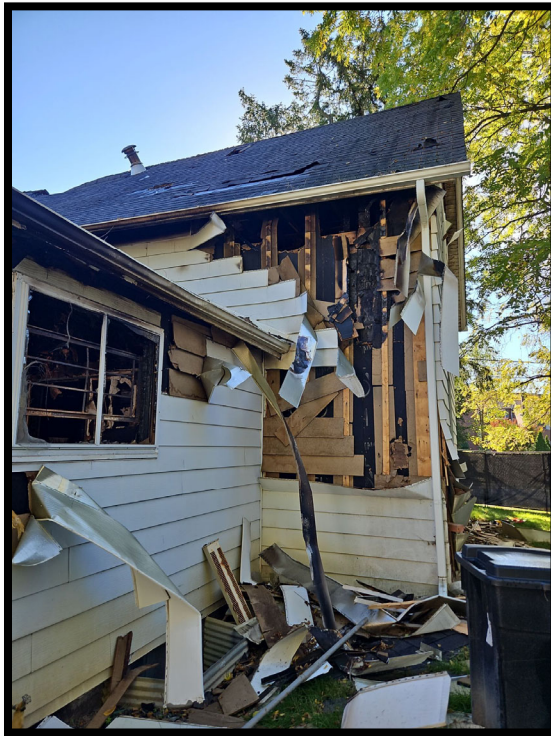
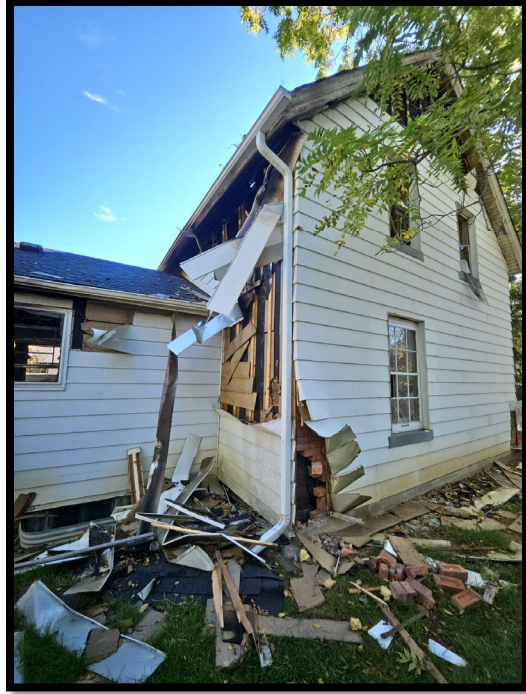
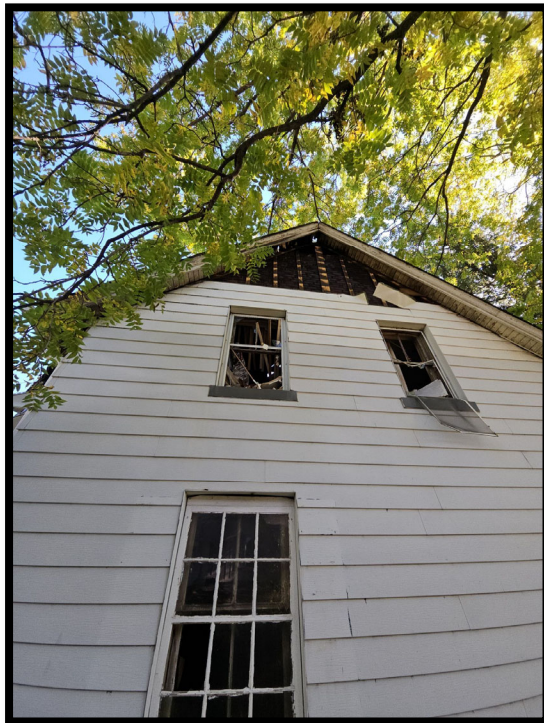
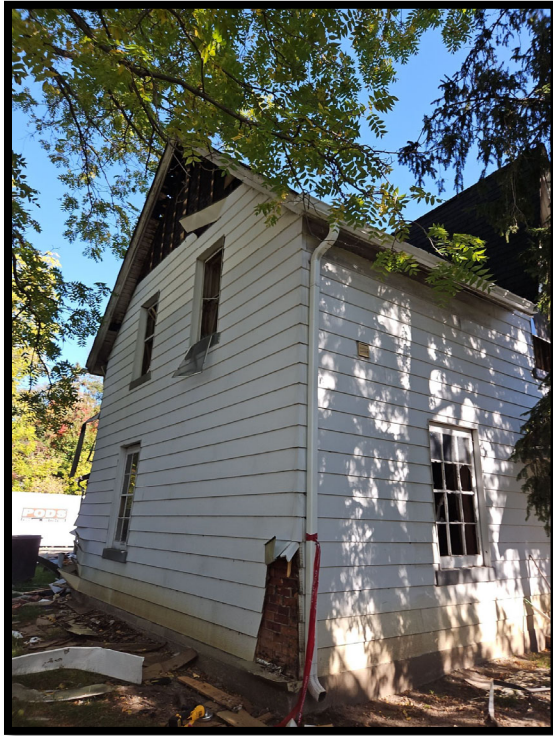
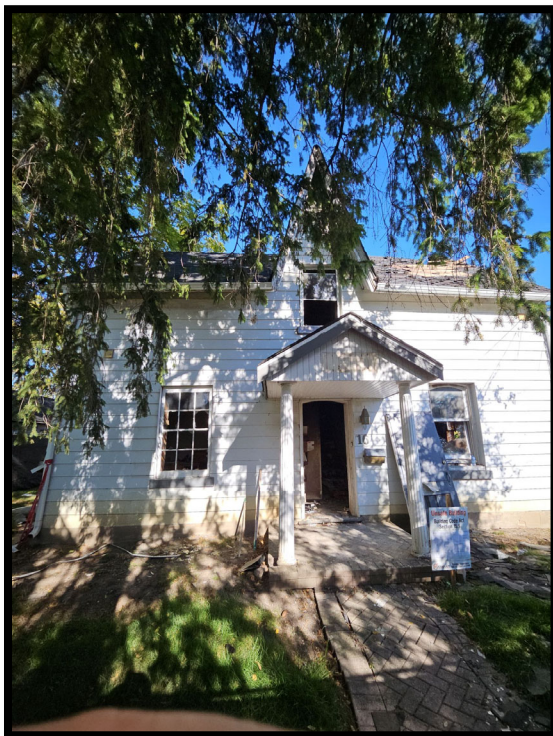
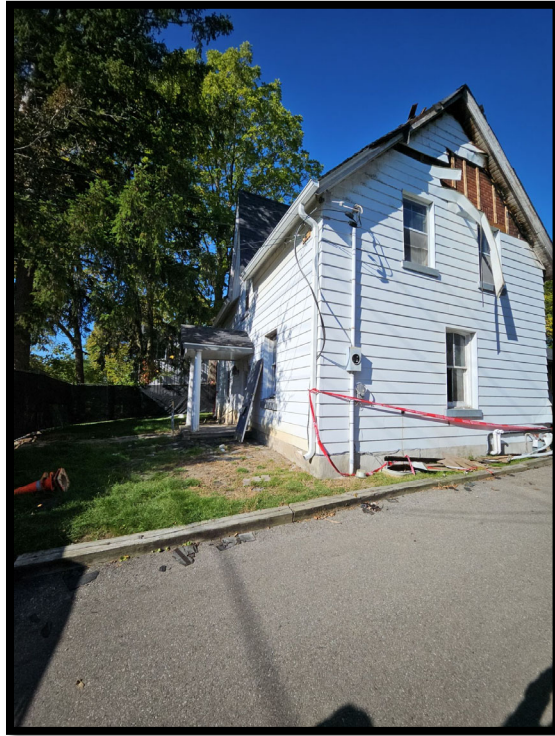
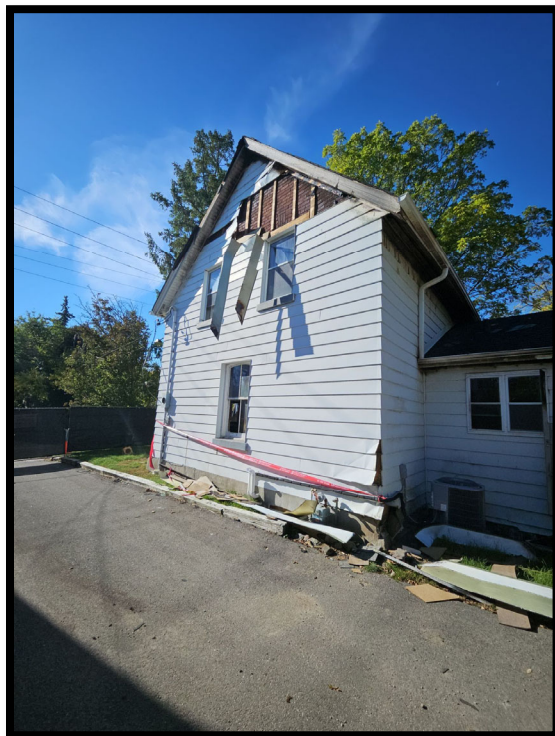
Photographs No. 4 to 10 provide general exterior views of the 'original' portion of the building. The fire appeared to have migrated through the rear (north) exterior wall and into the roof assembly. Several small sections of the exterior aluminum siding had either been dislodged by the fire event or subsequently removed for inspection of the substrate. The condition of the brick has been discussed further within this report.

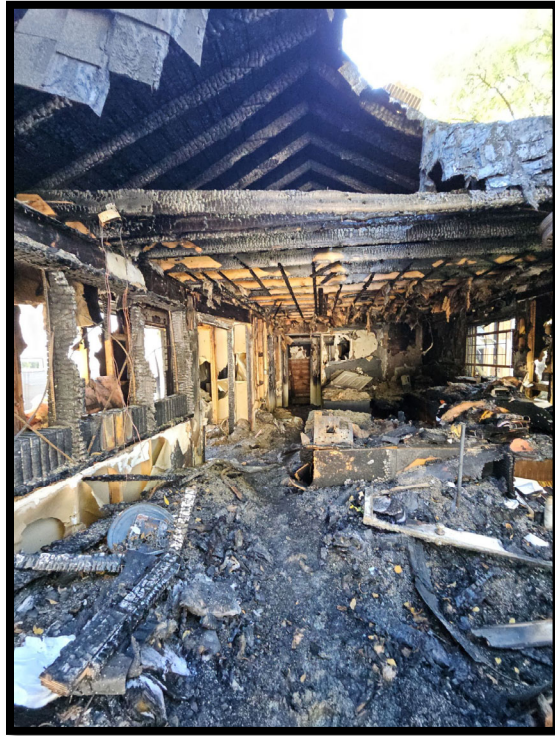
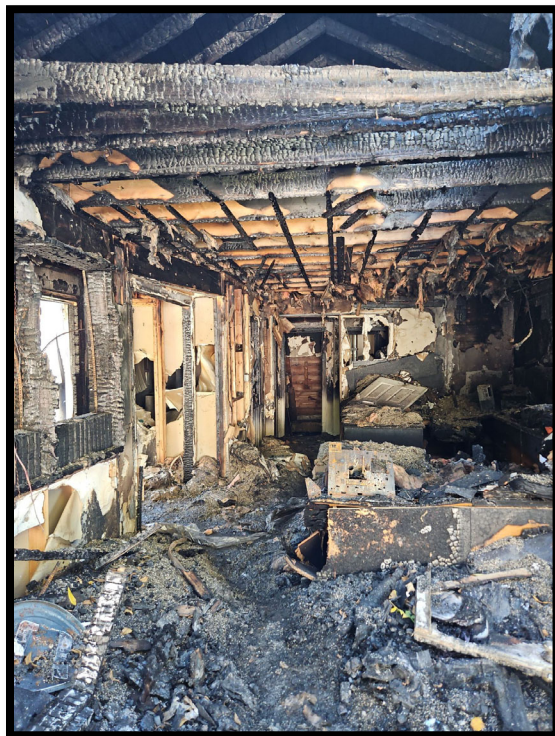
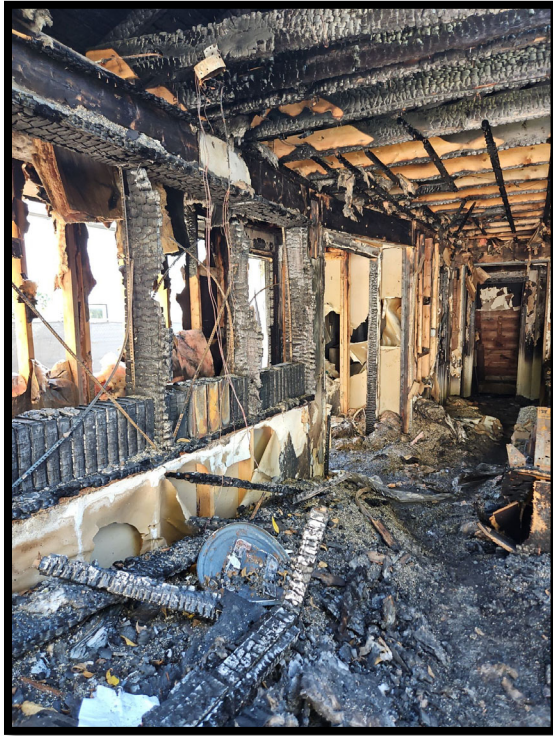
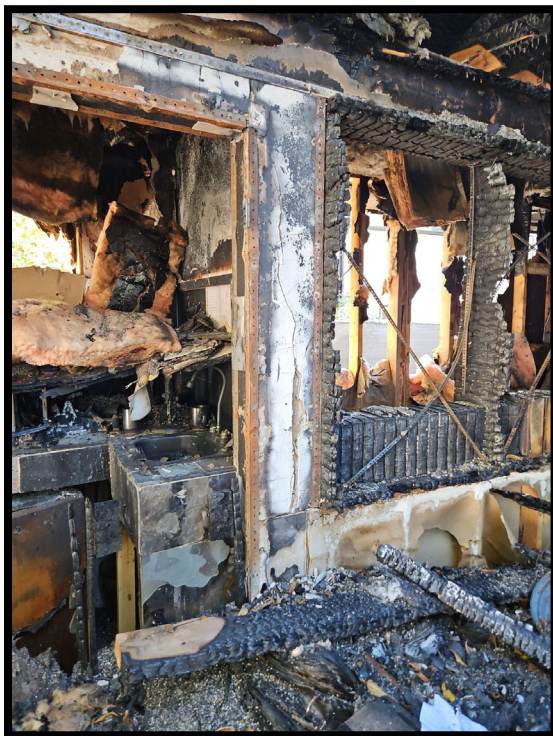
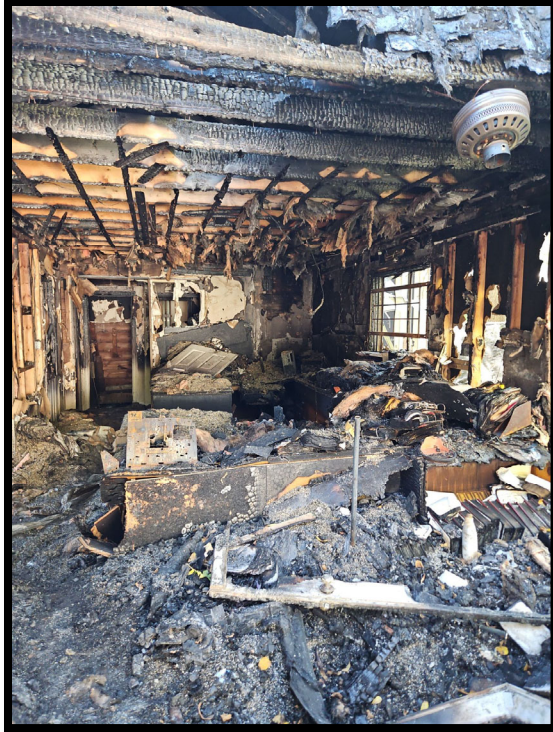
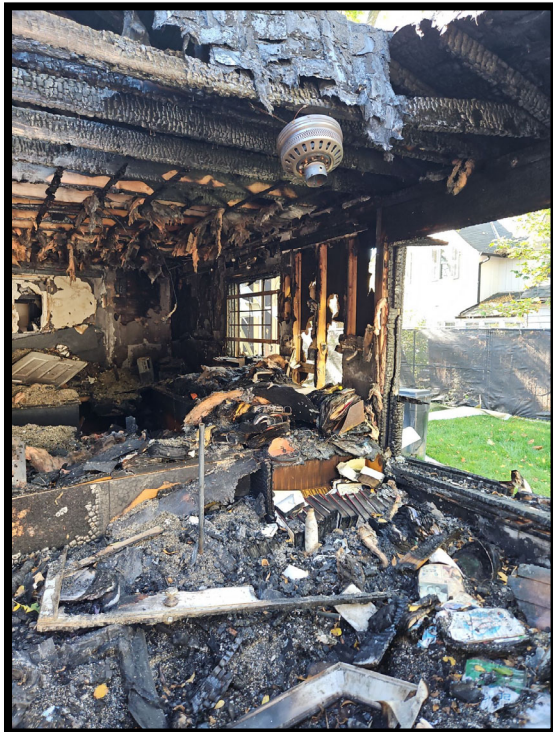
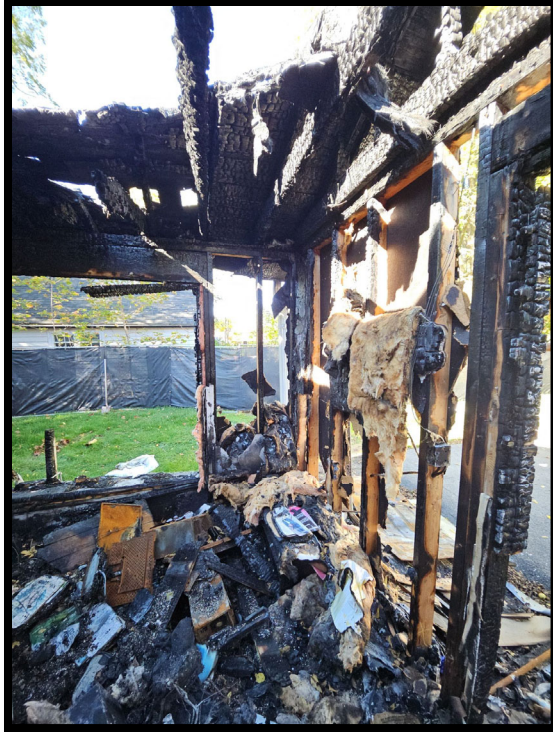
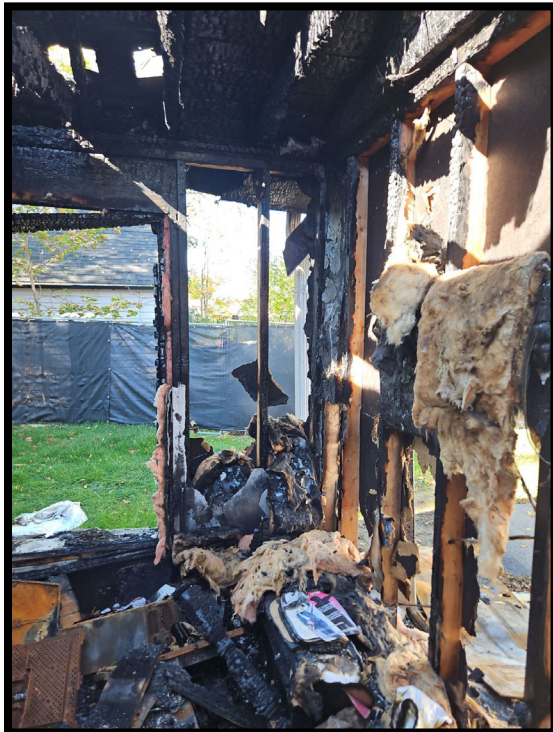
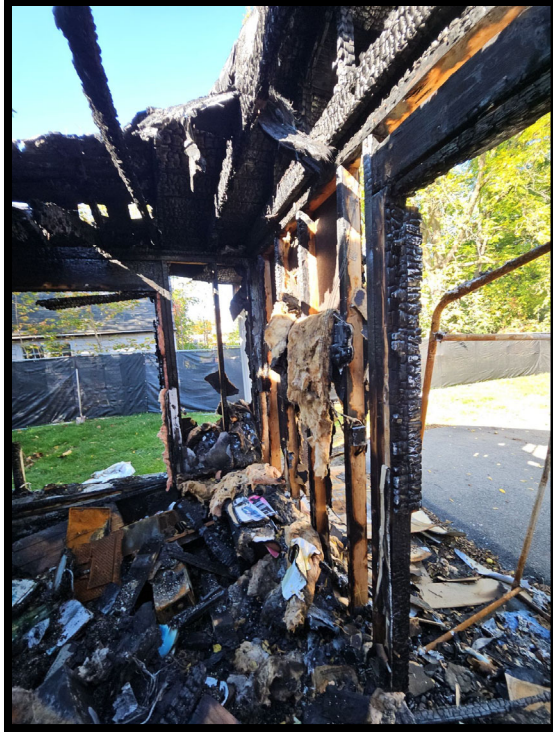
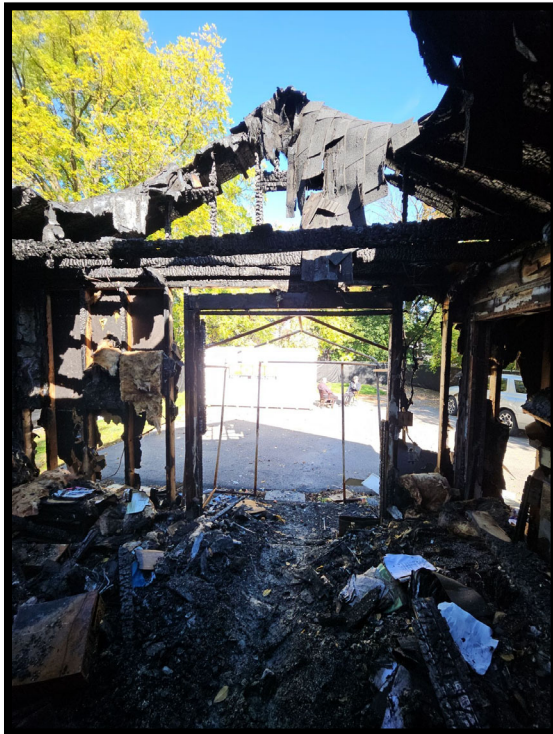
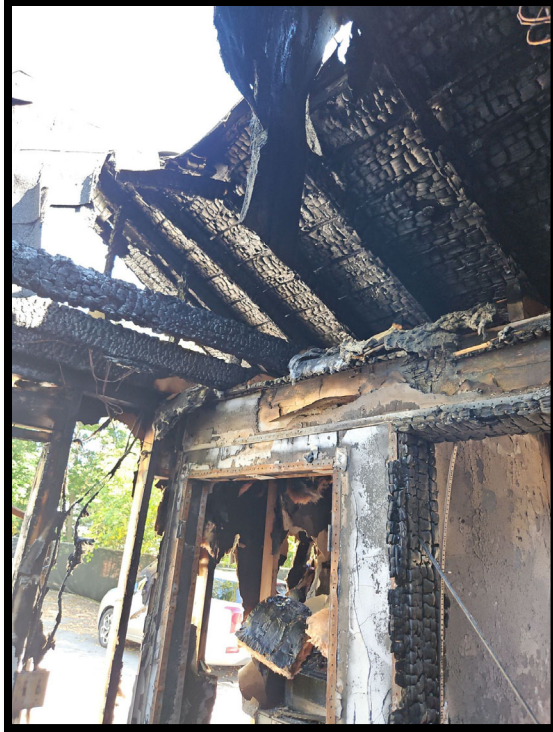
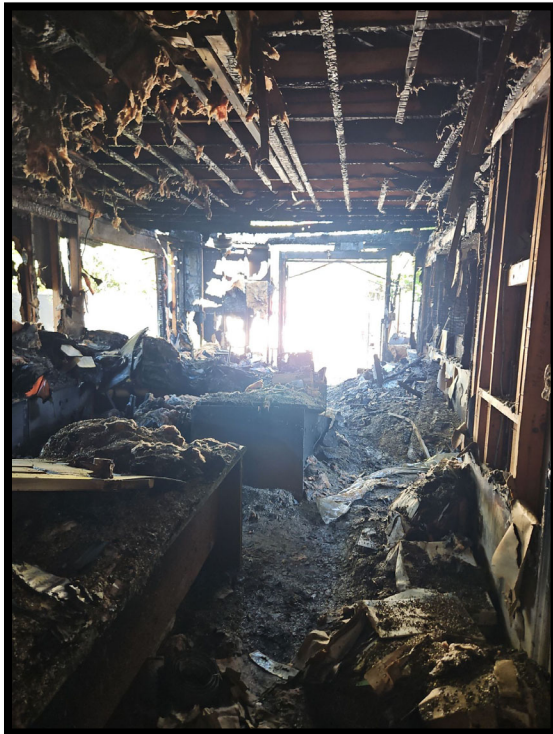
Photographs No. 11 to 22 provide general views of the building from within the rear addition. The framing in this area has been substantially consumed by the fire and requires complete replacement above the main floor level. The condition of the foundation walls could not be confirmed at the time of our inspection due to the presence of interior finishes; however, the exposed main level floor framing and sheathing has sustained significant mould-like growth, as well as water damage and smoke contamination. All interior finishes within the basement have been exposed to significant smoke and water damages necessitating replacement.

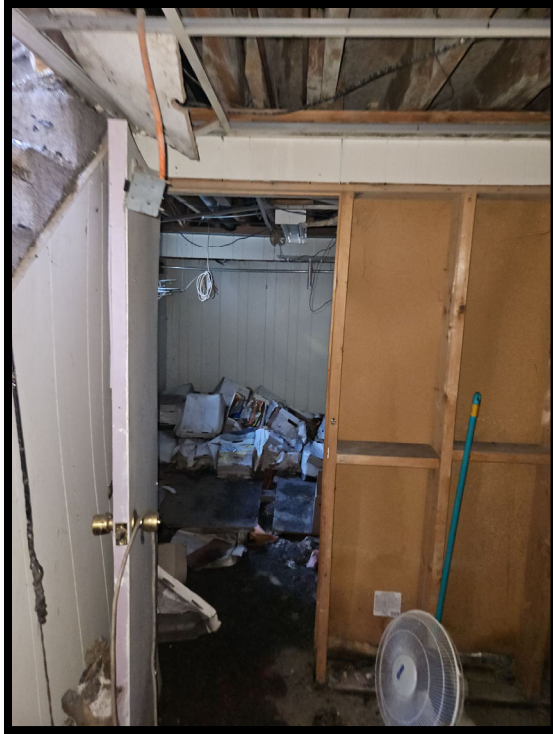
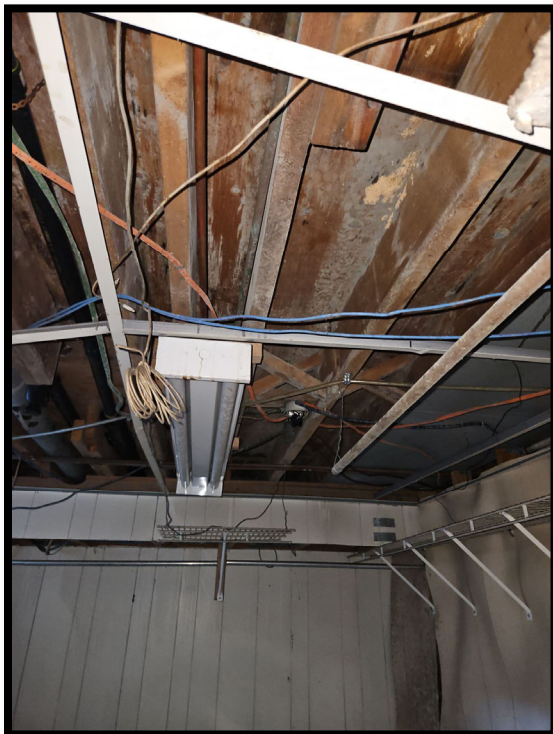
#### Photographs No. 11 to 24: General Views of the Rear Addition

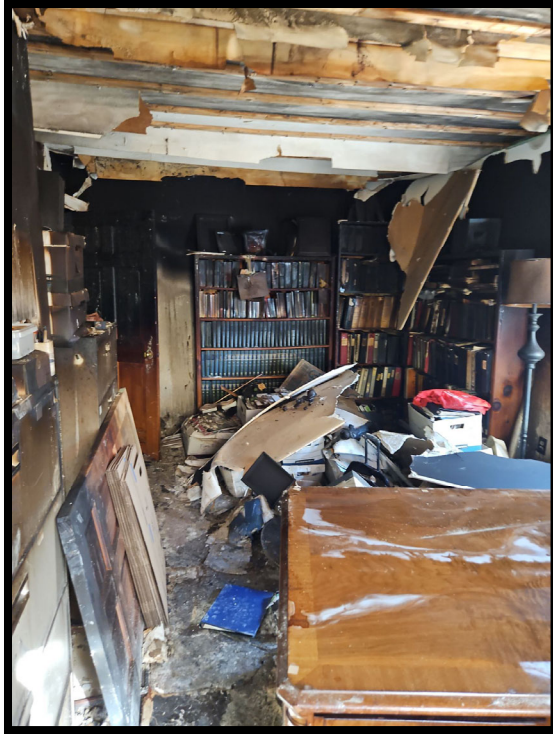
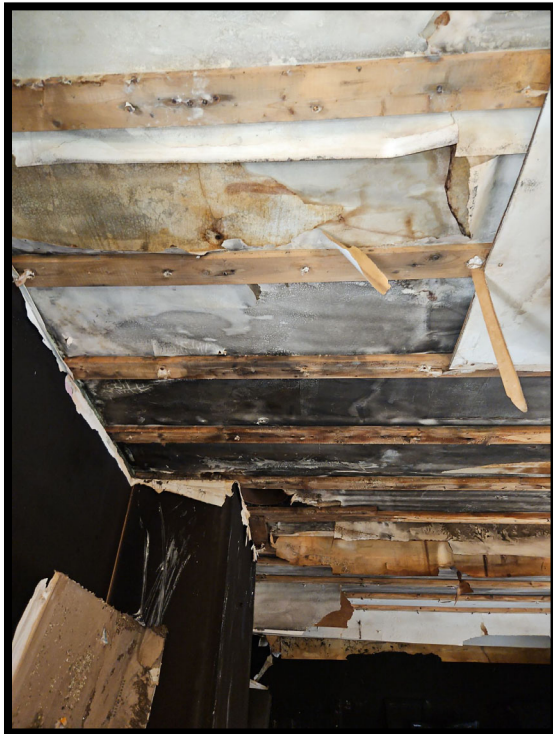
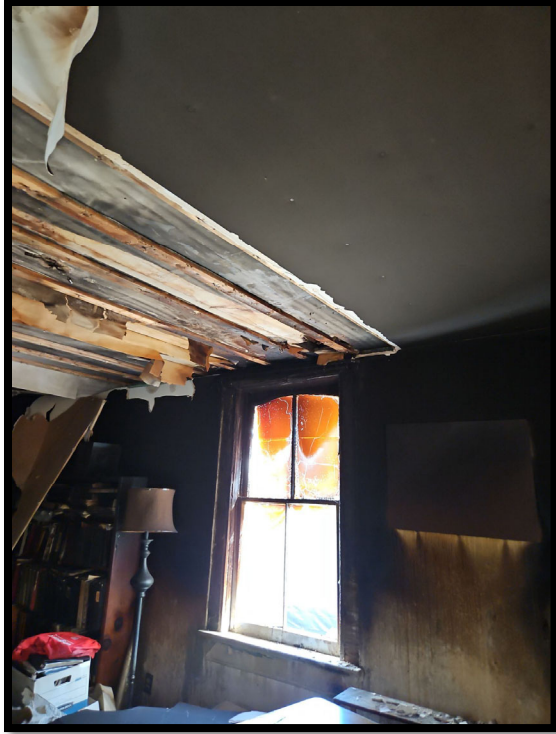
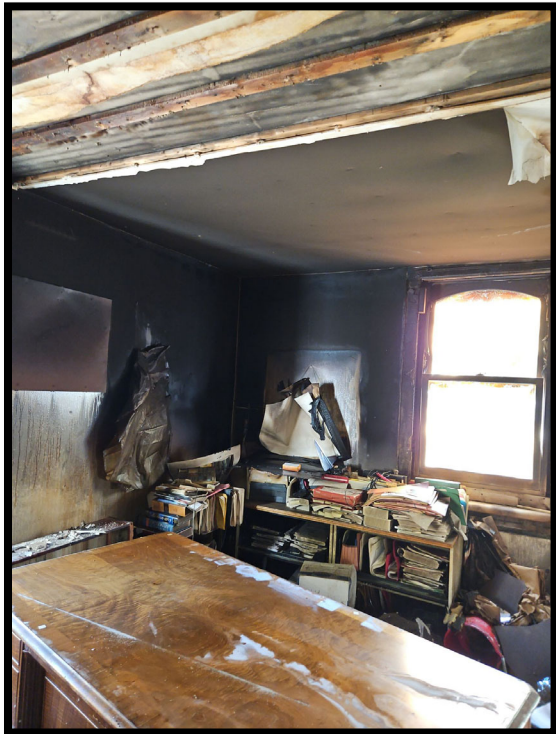
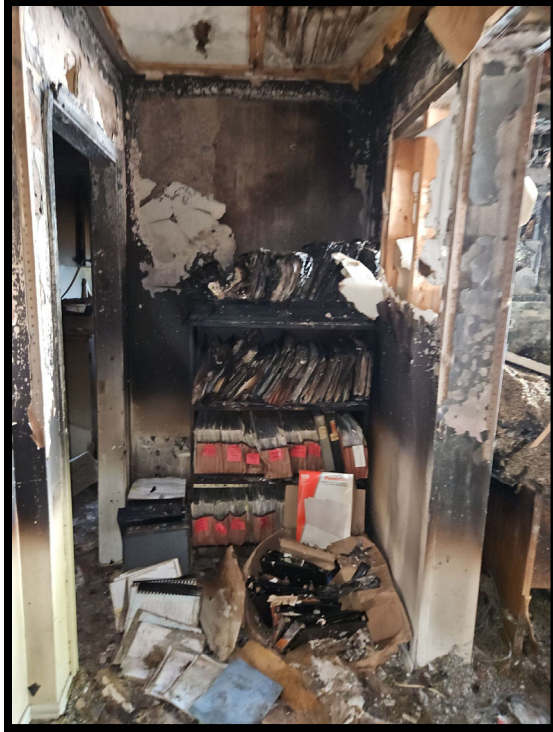
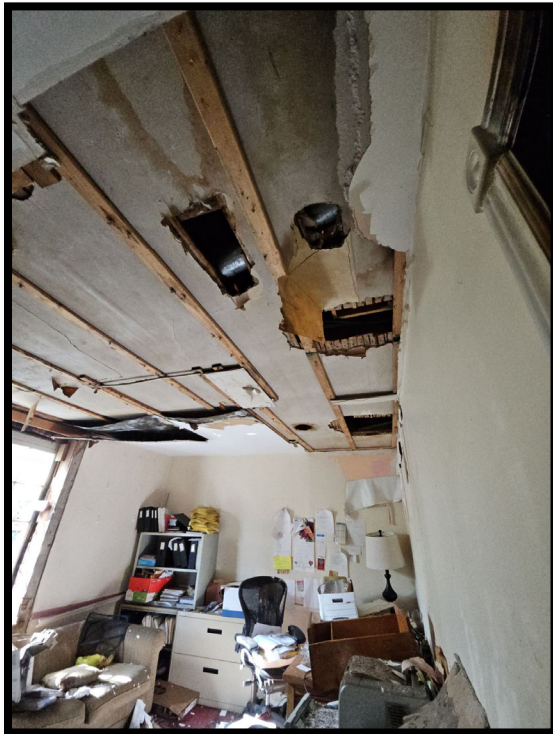
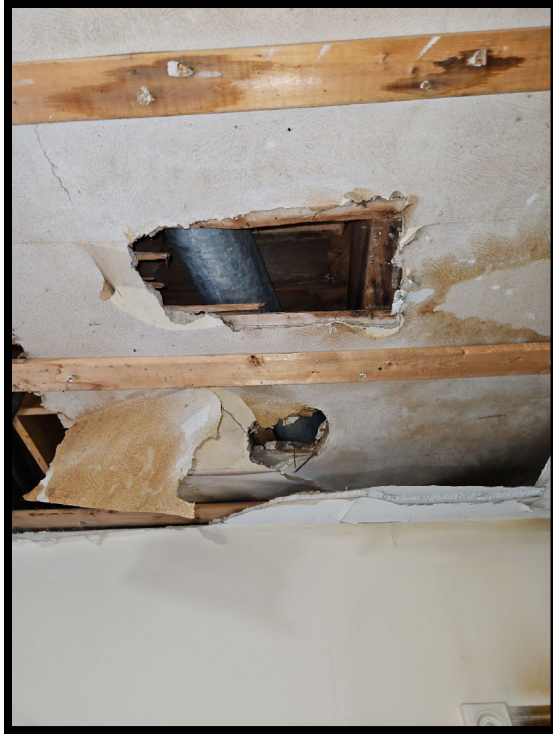
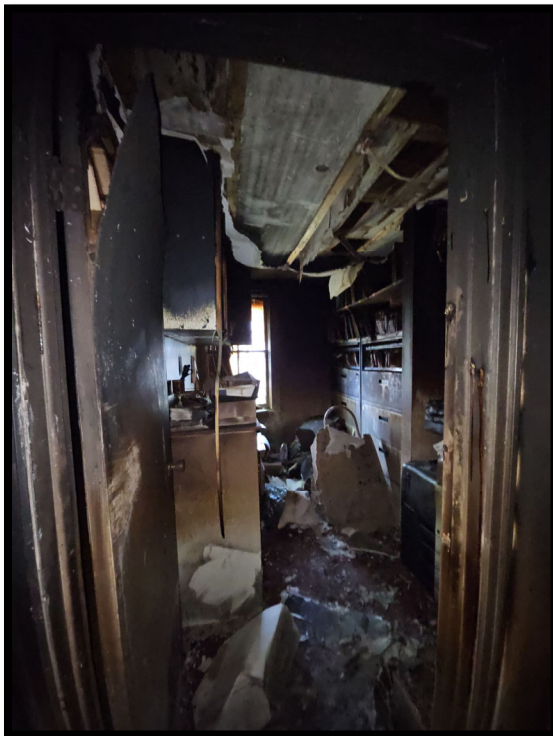
Photographs No. 25 to 32 provide views within the main floor of the 'original' portion of the building. All interior finishes and contents, which largely consisted of paper-based file records had been saturated from fire-suppression activities and had sustained heavy smoke contamination. The floor and wall systems did not appear to be damaged by the fire directly at this floor level.

In order to address water damages, smoke contamination and mould growth within the building, all interior finishes at all levels must be removed. All exterior cladding including the brick veneer must also be removed in order to remediate the aforementioned conditions as well as the brick being unfit to remain given its aged and dilapidated condition.

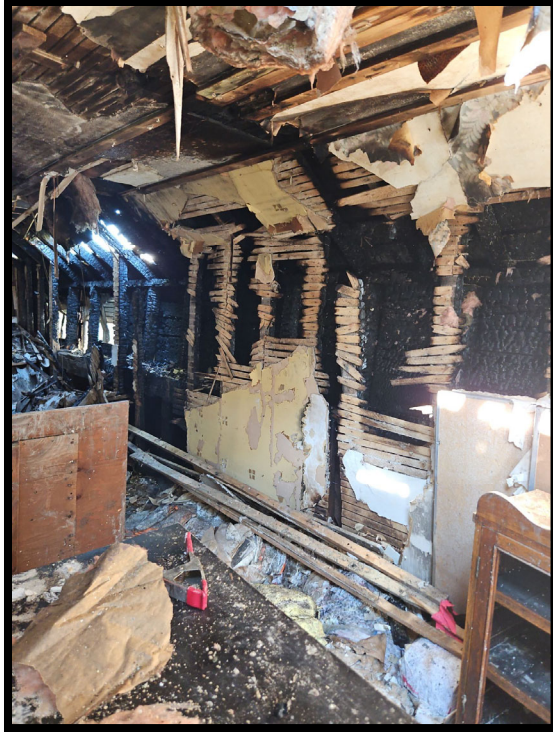
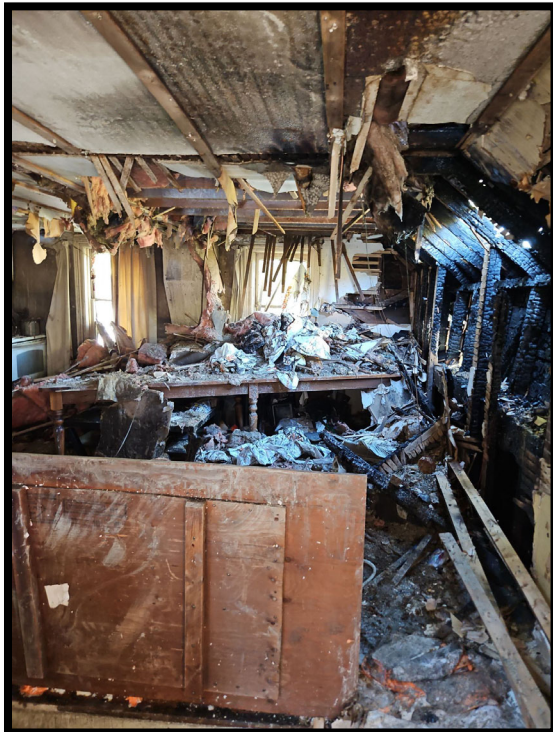
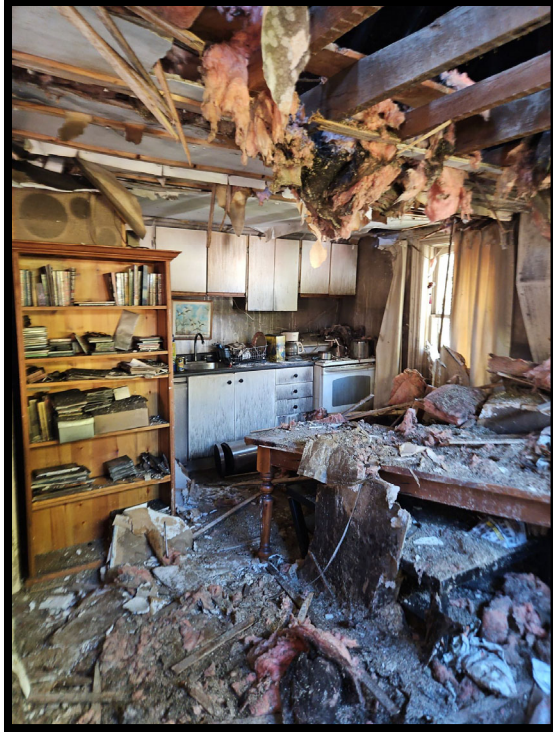
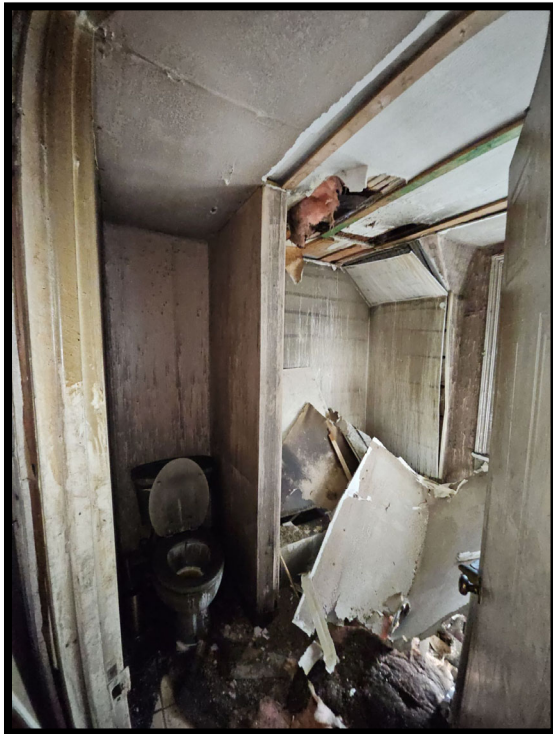
Photographs No. 33 to 41 provide views of the attic loft and roof framing of the 'original' portion of the building. The interior finishes and contents, which largely consisted of paper-based file records, had been saturated from fire-suppression activities and had sustained heavy smoke contamination. The majority of the ceiling finishes on this level had fallen onto the floor system

and remained in that position at the time of our inspection. The roof framing and sheathing had been heavily charred by the loss event and cannot be relied upon to perform predicably. As visible in Photographs No. 37 to 41, the primary wood post and beam structure, which appeared to be continuous from the main floor level to the roof connection had been heavily charred and compromised as a result of the fire. Heavy charring to critical roof connections (i.e. rafter to wall, ceiling joist to rafter) was observed and is also visible in these photographs. The extent of damage to the framing at this level necessitates removal and replacement of the framing.

Given the debris throughout this floor level, temporarily shoring the roof is not a viable approach as the debris would have to be removed in order to do so, and given the poor and unstable condition of the roof, ceiling and sections of the exterior walls, no manual construction or shoring work should be performed for risk of unintended collapse and/or injury.

The entirety of the roof of the ‘original’ portion of the building is also in a severely compromised state and cannot be relied upon to perform predictably, as such, shall also be removed in its entirety. Shoring the roof for the interim is not a viable option as the widespread presence of saturated contents and building debris prohibit the installation of sound bearing and connections for prospective shoring framing/systems, and manual removal of the debris shall not be performed due to the risk to human safety in undertaking this work given the current condition of the building.

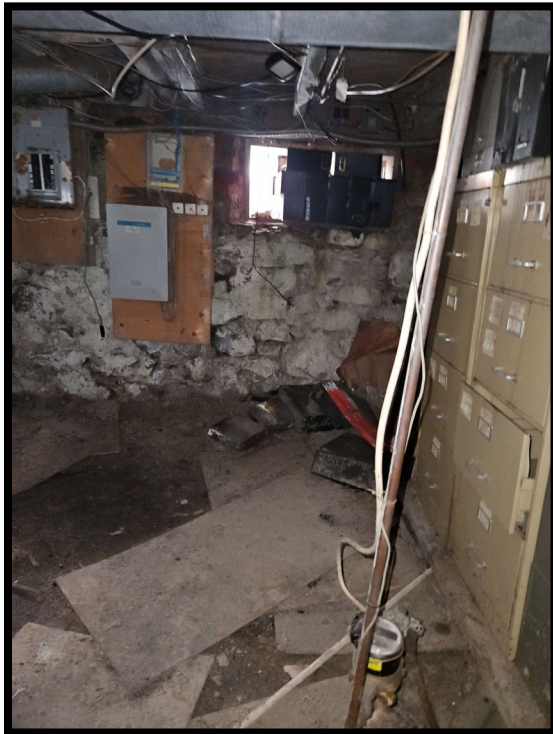
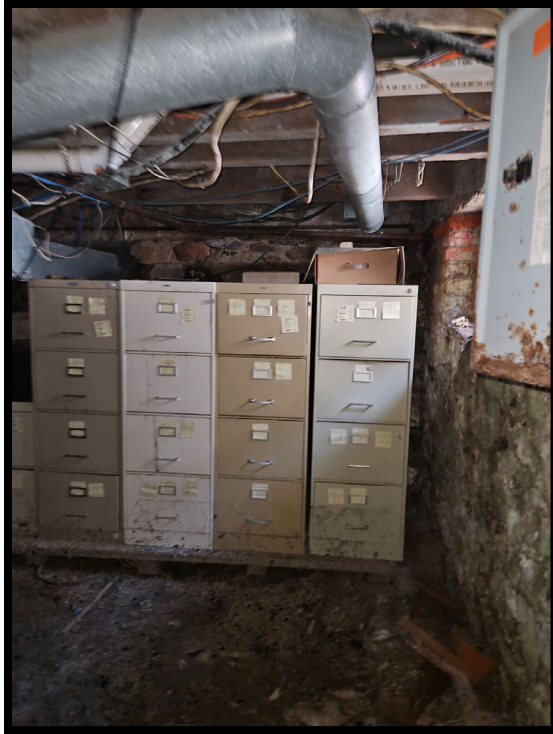
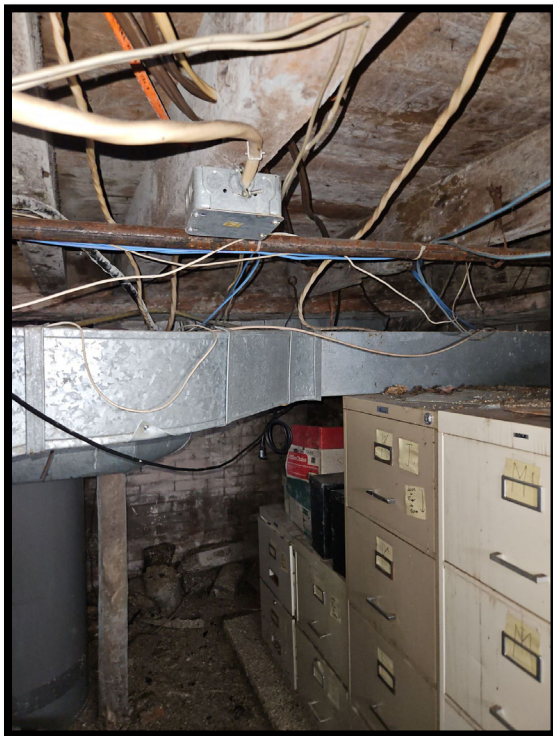
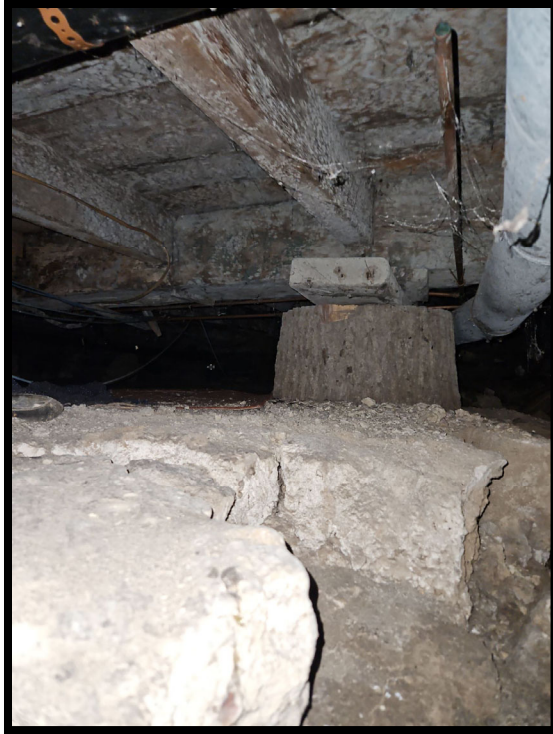
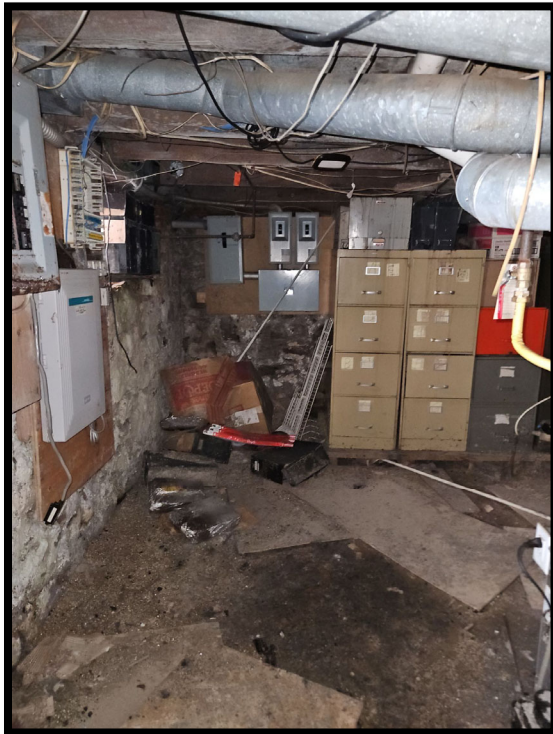
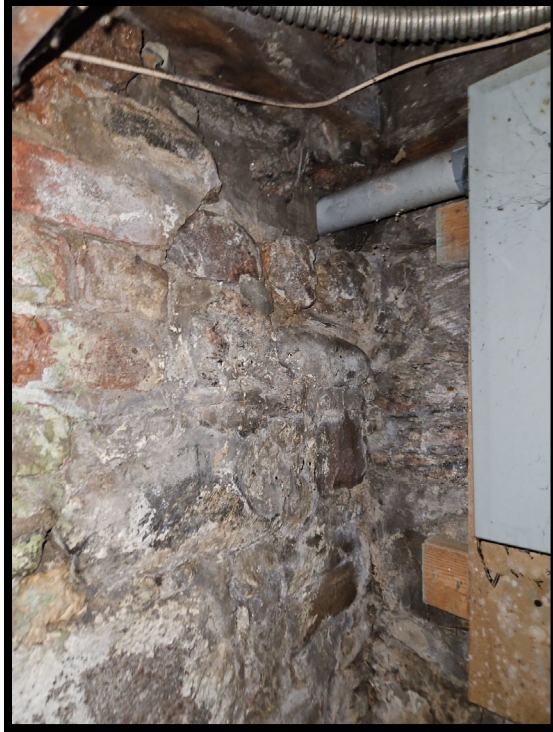
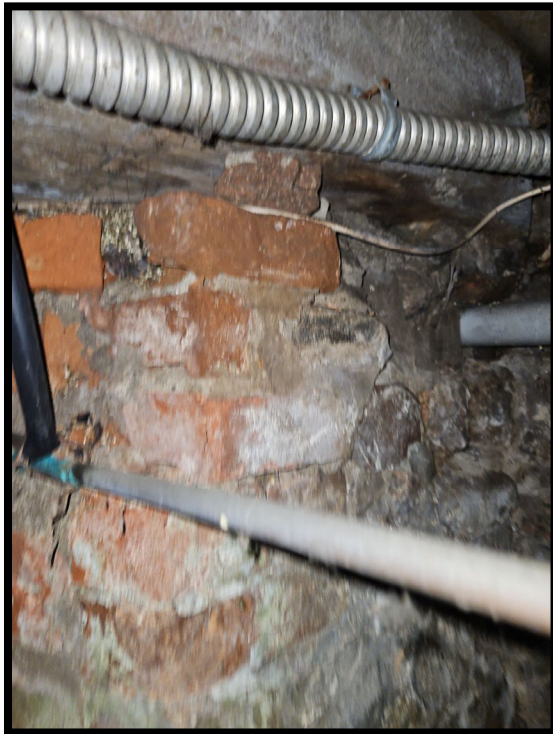
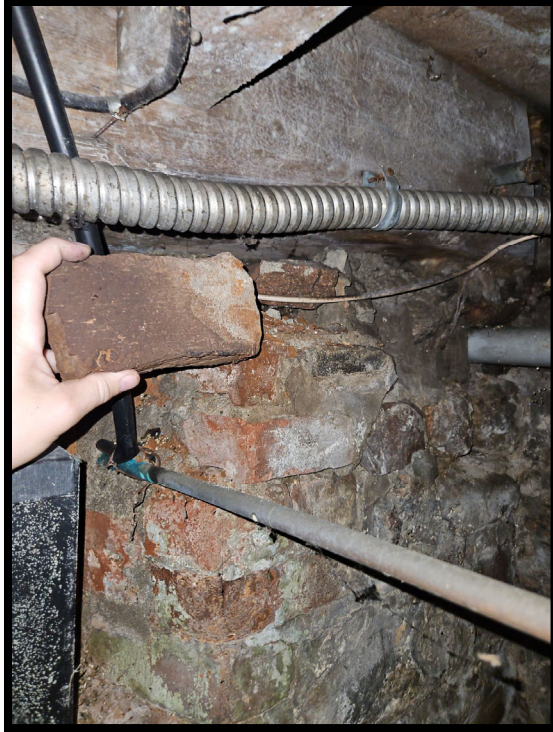
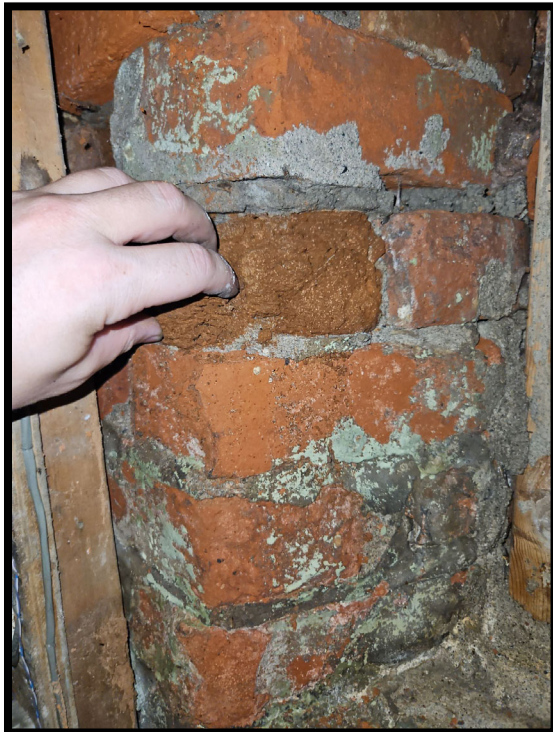
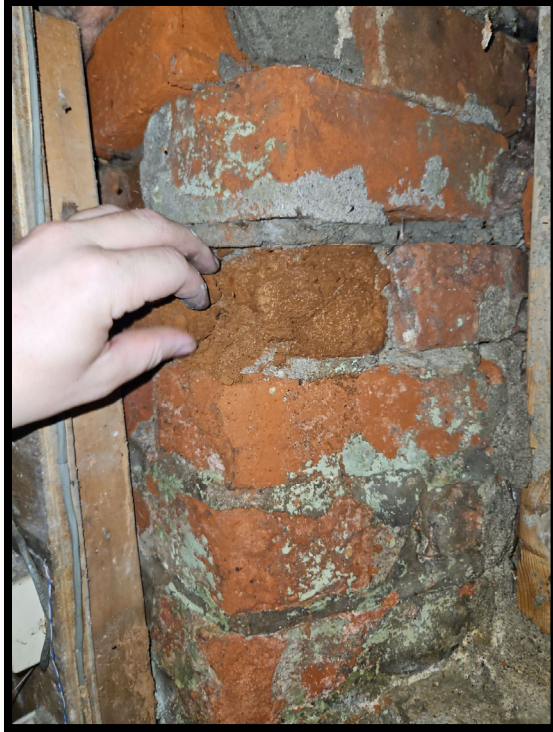
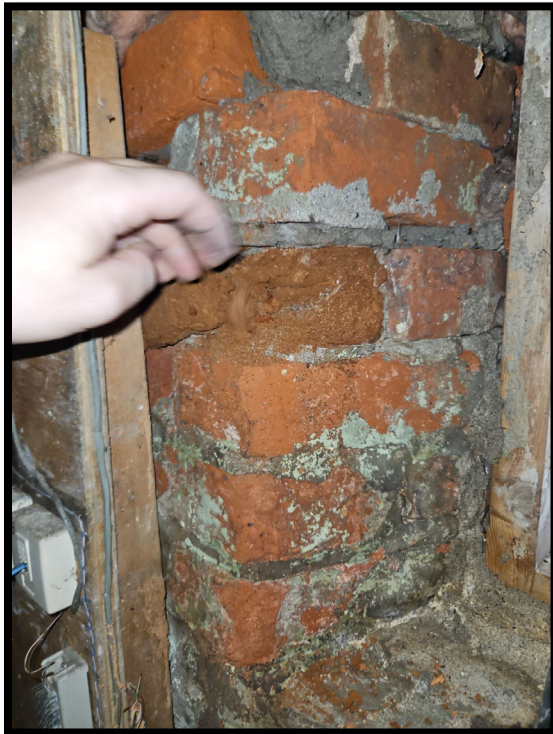
Photographs No. 42 to 52 provide general views within the crawlspace of the original dwelling. Similar to the exposed framing within the building at the time of our inspection, the visible floor framing and sheathing had sustained significant mould-like growth and soot-containing water damage. The exterior foundation walls consisted of a combination of brick/stone and mortar and were observed to be in a deteriorated condition wherein several locations the stones were loose and the brick had reduced to fines (Photographs No. 49 to 52). Interior bearing conditions consisted of various materials including a wood stump and various shims. The presence of long-term moisture infiltration was noted throughout the crawlspace as evidenced by heavy efflorescence, which is consistent with a presumed lack of dampproofing around the perimeter of the building and an observed lack of impermeable ground cover throughout the crawlspace where a concrete slab floor was not present. The foundation cannot remain in its current condition from both the perspective of degraded structural condition and ability to resist water ingress.

The foundation and framing of the ‘original’ building where not directly exposed to fire-related damage, as noted previously in this report, are in an aged and, specifically with respect to the foundation, dilapidated condition. It is our opinion that the foundation and main floor framing are not suitable for use in a reconstruction effort for the building given that these elements are of archaic construction, show signs of age related deterioration and are grossly inadequate with respect to the requirement of the current Ontario Building Code without additional investigation (removal of all finishes, perimeter excavation, etc) and significant upgrades.

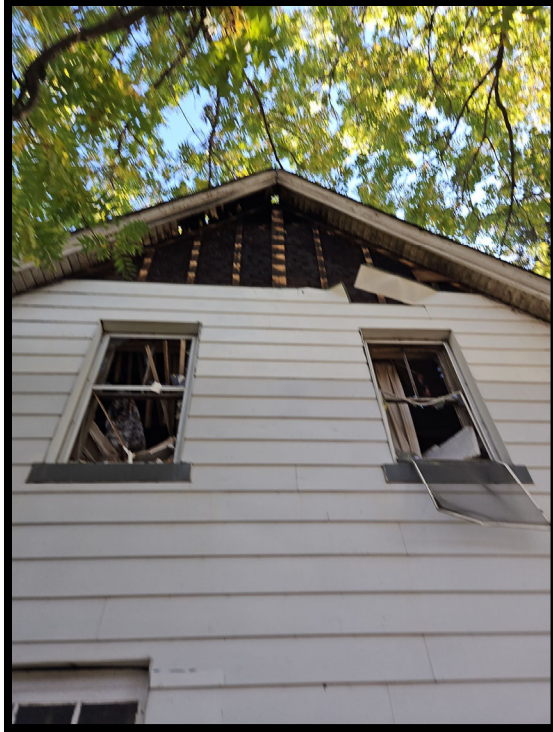
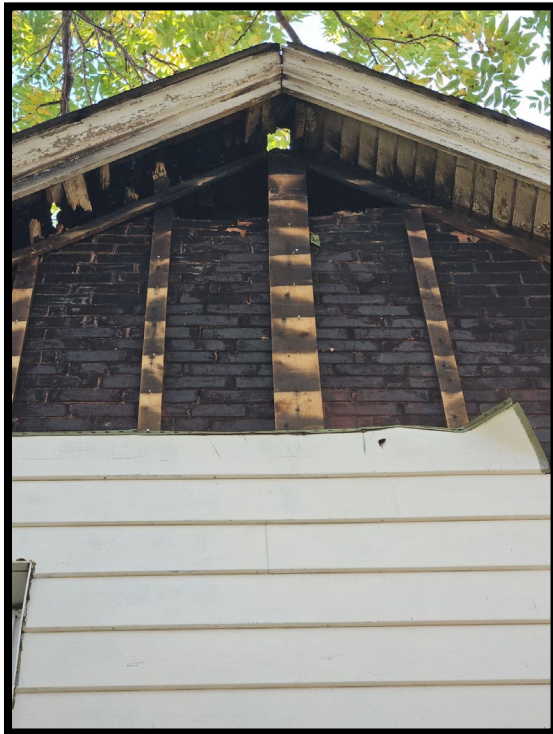
These photographs provide views of the exterior brick exposed from behind the aluminum siding along the west exterior wall of the 'original' portion of the building. Photographs No. 53 and 54 show the extent of smoke contamination behind the siding below the eaves. It is common for soot to be driven out of the soffits onto and behind exterior cladding when a fire occurs within an attic space. It is likely that similar smoke contamination exists behind the siding and brick around the remainder of the building where not specifically exposed to date.
