**DAHL GROUP**  
ENGINEERING

October 24, 2025  
File No.: DGE25178

**Re: Engineering Assessment – Building Exposed to Fire Loss Event**

Property Owner: Burlew, Edward & Heather  
Property Address: 16 John Street, Thornhill, ON.

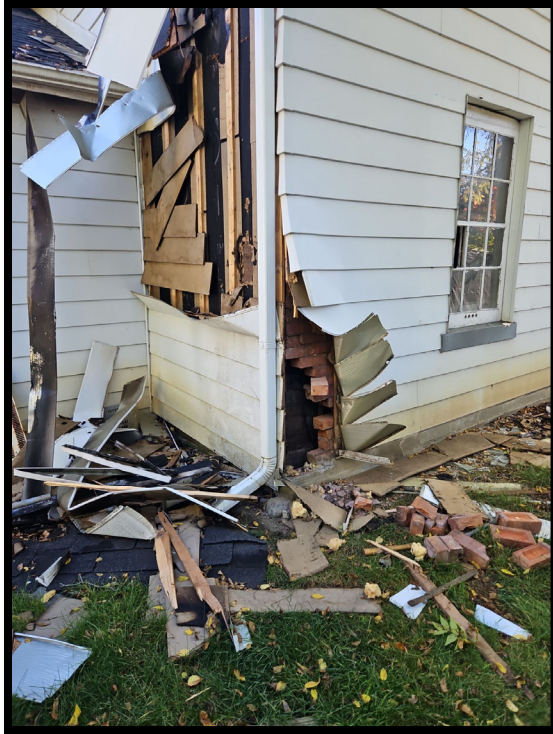
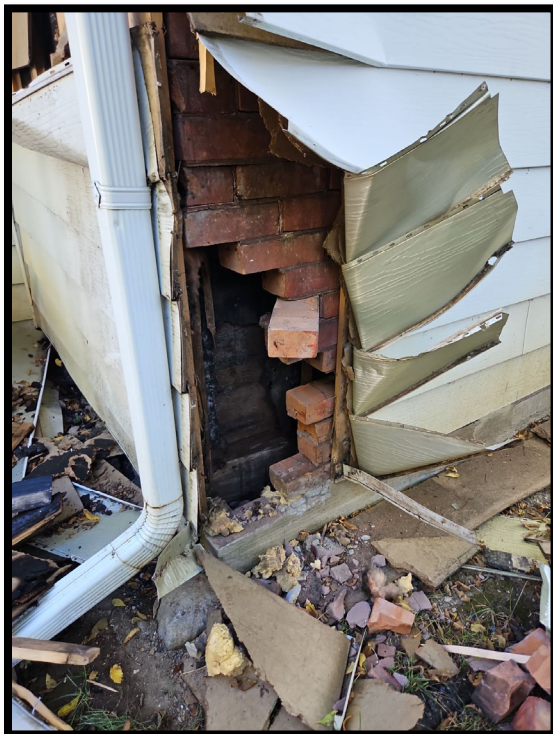
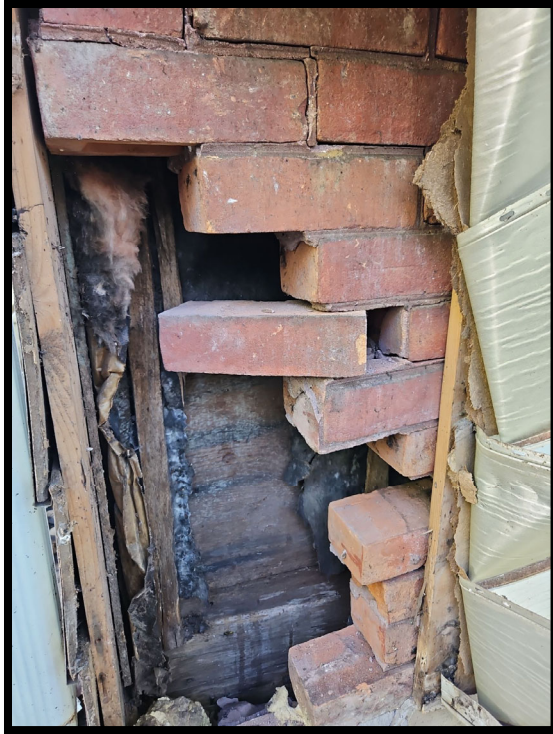
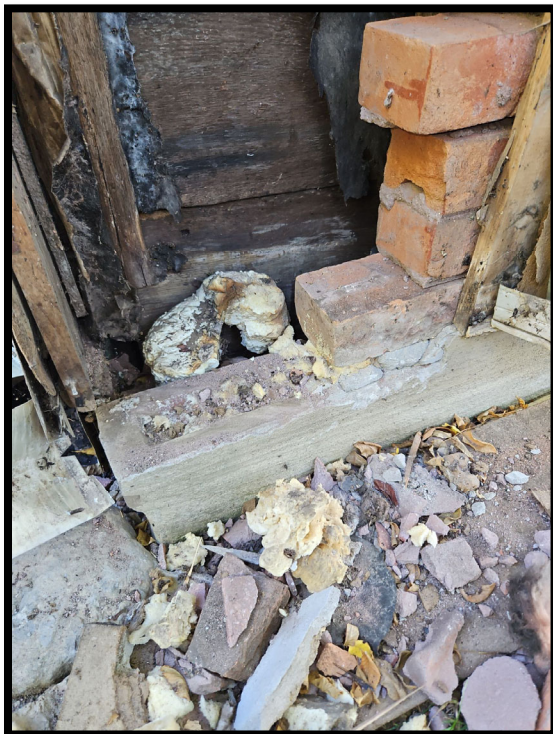
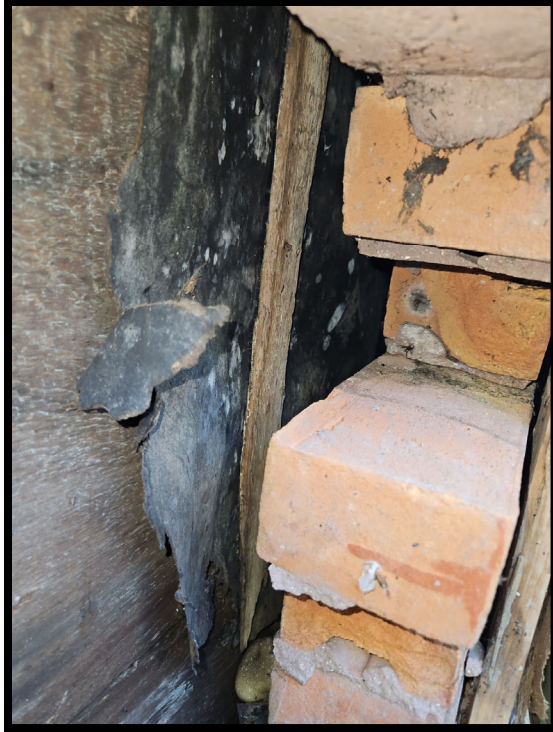
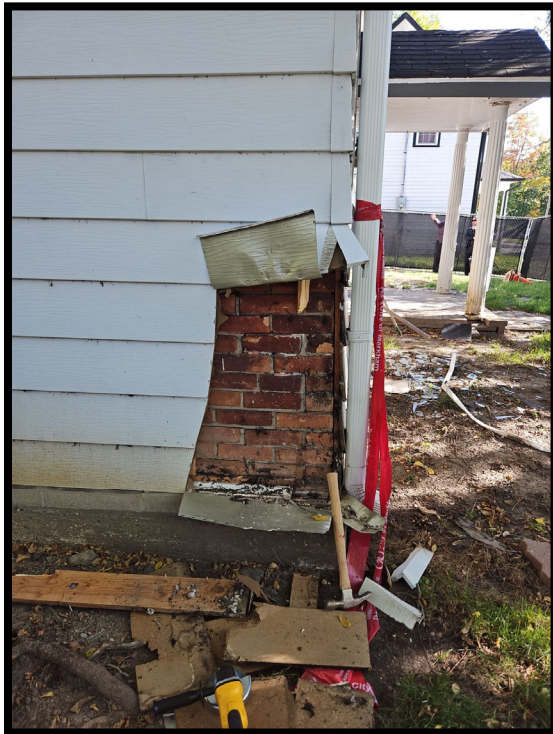
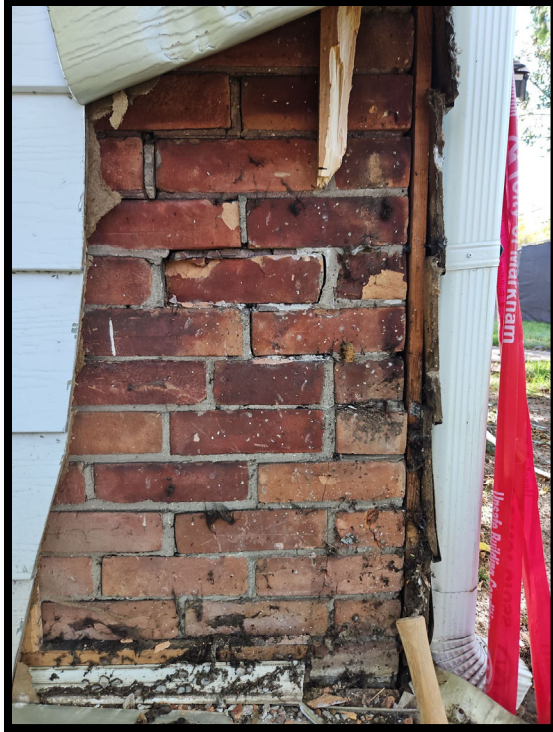
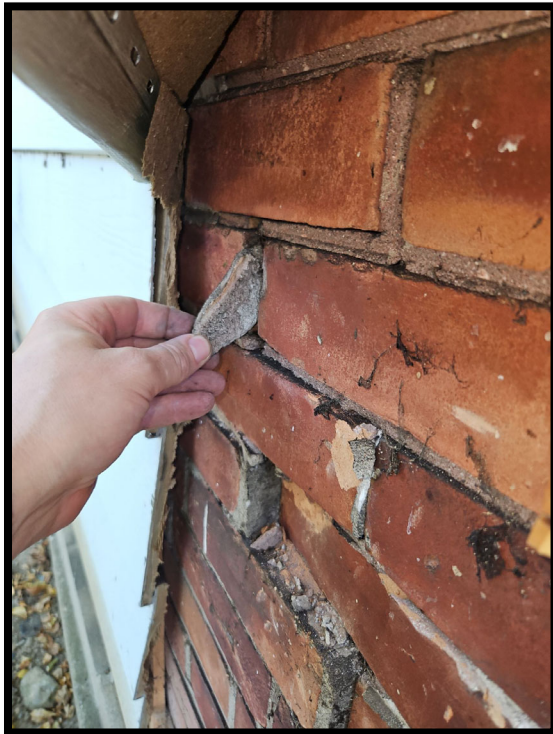
Photographs No. 55 to 62 provide views of the exterior brick at the base of the exterior wall exposed by means of test cuts in the aluminum siding. The exposed brick was observed to be degraded and in poor condition. Within the small sample area of exposed brick near the base of the wall, the mortar was no longer bonded to the brick and could be easily removed by hand. The majority of the exposed brick contained step cracking with dislodged mortar and several bricks could be manually displaced. Exposure of the brick to smoke contamination was evidenced by soot on the mortar and the debris remaining between the brick and the siding. Abundant mould-like growth was also observed on the exposed plankboard sheathing and tarpaper behind the brick.

Visibility behind the brick was limited at the time of our inspection; however, no connection of the brick to the wall structure was observed in the exposed area. It is unlikely based on our

observations and the vintage of the building that the brick is adequately secured to the building. Wood strapping was observed on the exterior face of the exposed brick veneer (which must be replaced due to smoke contamination). In our opinion the strapping, albeit likely not intended to do so, is serving as tension strapping to the exterior face of the brick assisting in stabilizing the otherwise degraded and unbonded brick veneer system.

Based on the degraded condition of the brick cladding, the exposure of the brick cladding, tarpaper and exterior sheathing to water, smoke contamination and apparent fungal growth, and the apparent lack of mechanical fastening of the brick to the building, the current brick must be removed from the building.
