APPENDIX C: ENTRANCE FEATURE PHOTOGRAPHS

Report to: General Committee

Meeting Date: March 23, 2020

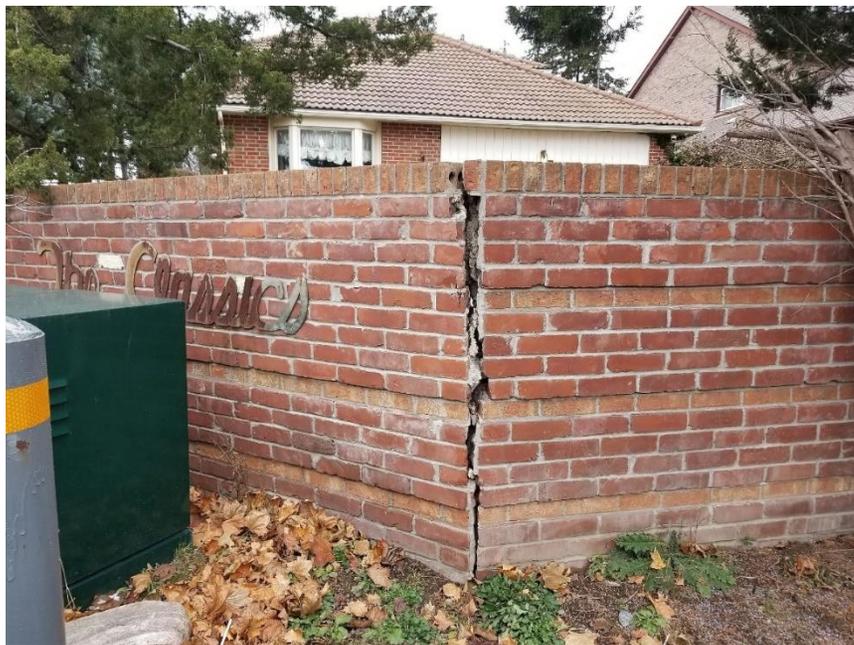
Figure 1: Montgomery Crt & Hwy 7 (immediate replacement)

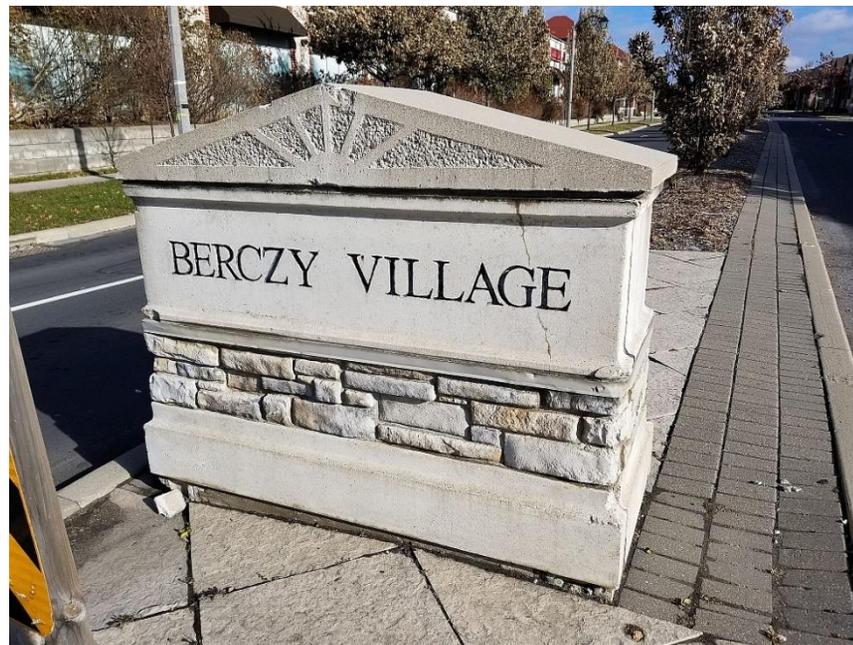
Figure 2: Bur Oak Ave & Kennedy Rd (1-5 years)

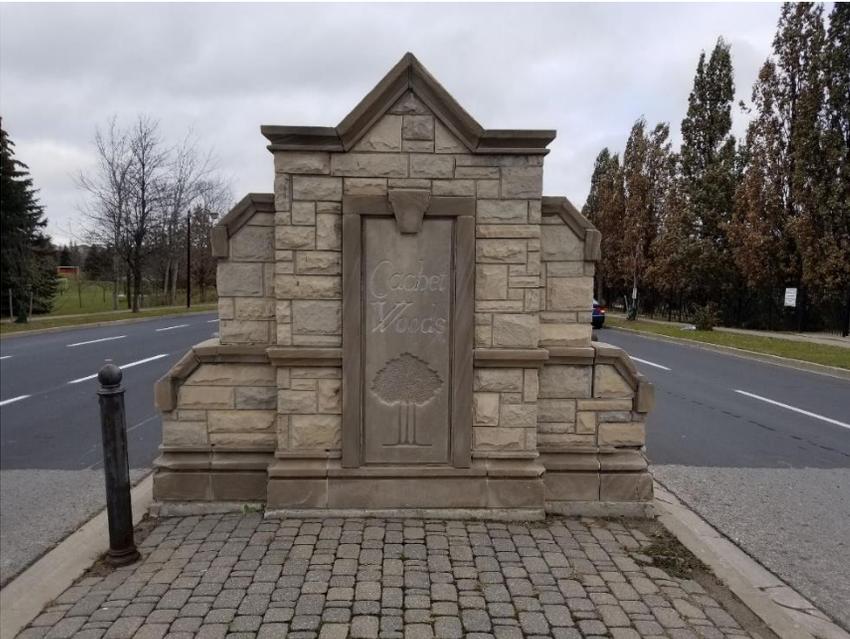
Figure 3: Woodbine Ave & Calvert Rd (6-10 years)

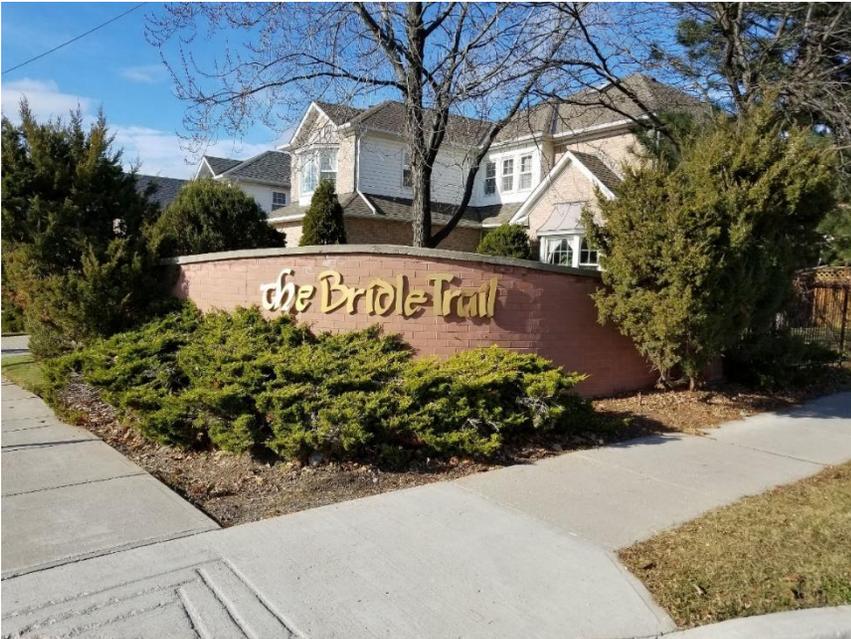
Figure 4: Halterwood Cir & Carlton Rd (11-15 years)

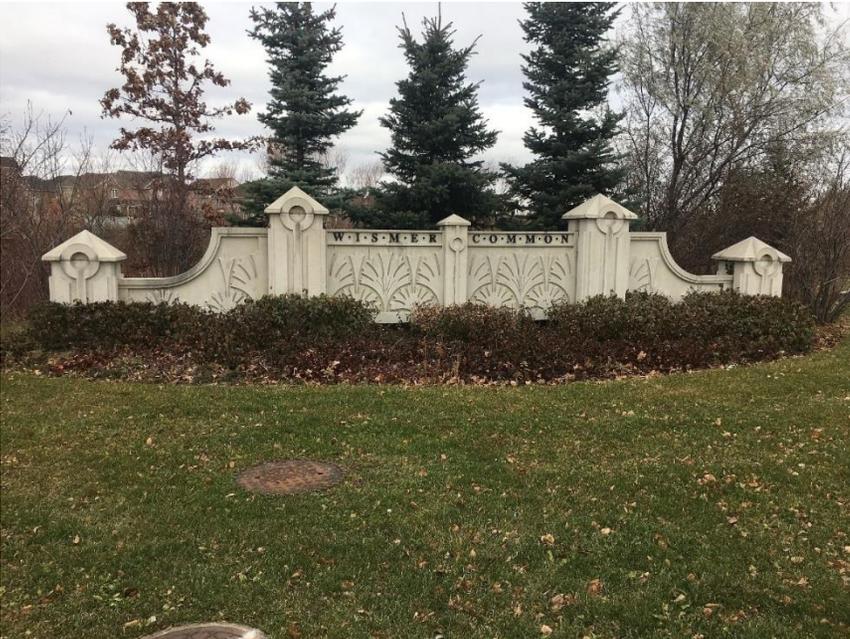
Figure 5: Roy Rainey Ave & 16th Ave (16-20 years)

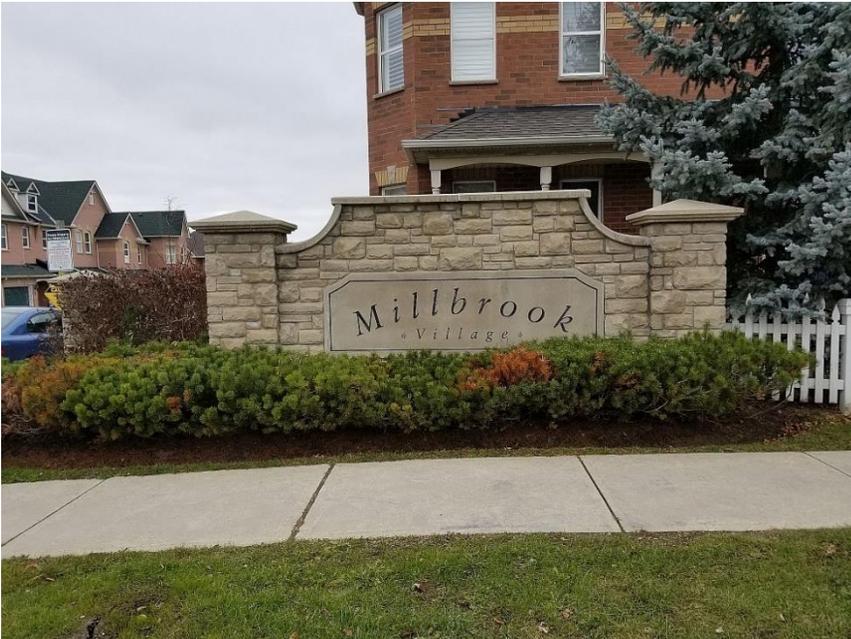
Figure 6: 16 Natasha Way & Woodbine Ave (21-25 years)

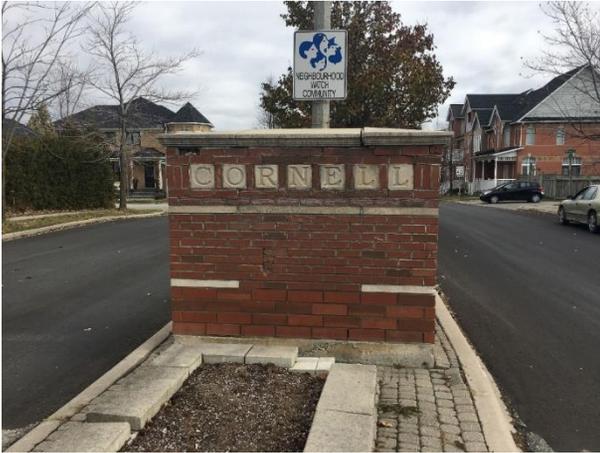
Figure 7: Cornell Park Ave at 9th Line - Before

Both of these features had significant damage to their tops and were missing bricks. These two features were also blocking the sight lines when approaching 9th Line, putting pedestrians in danger. Operations removed both in 2018 and restored the sites with interlock pavers and sod.
