Exterior

EAST (FRONT) ELEVATION

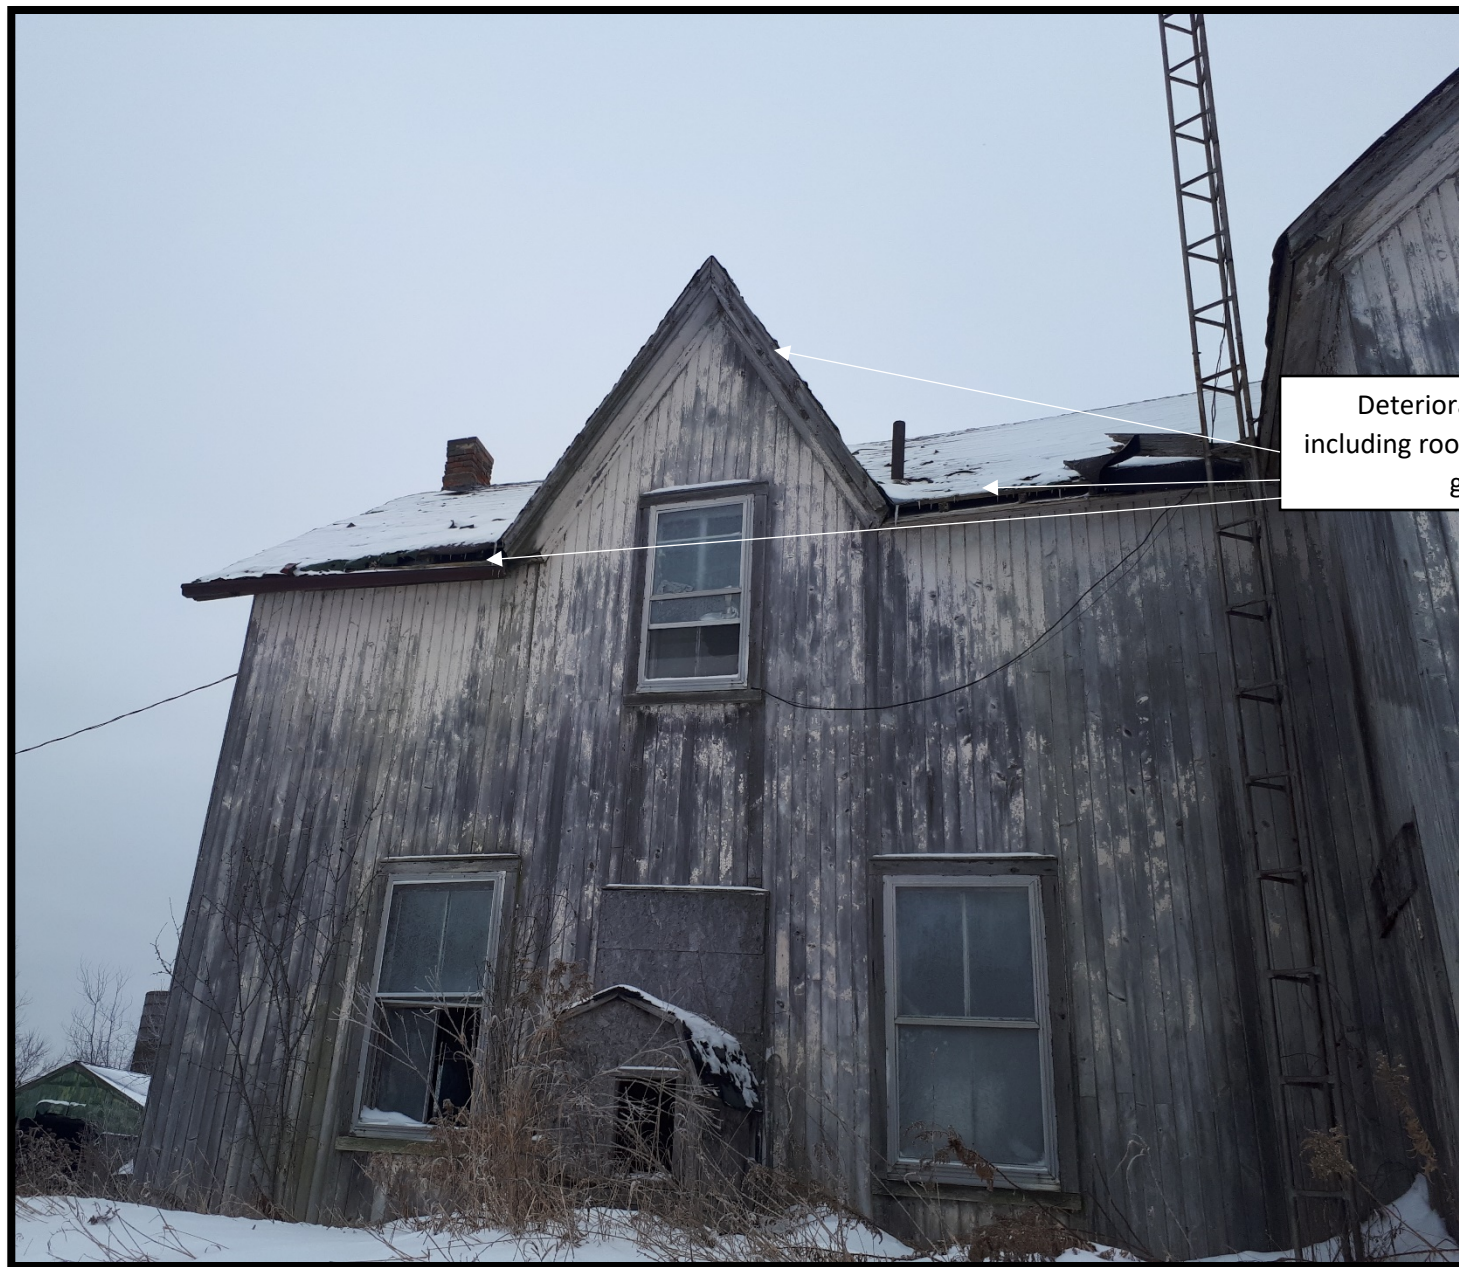
Photo 2

Deterioration of roof
including roofline and pitched
gable

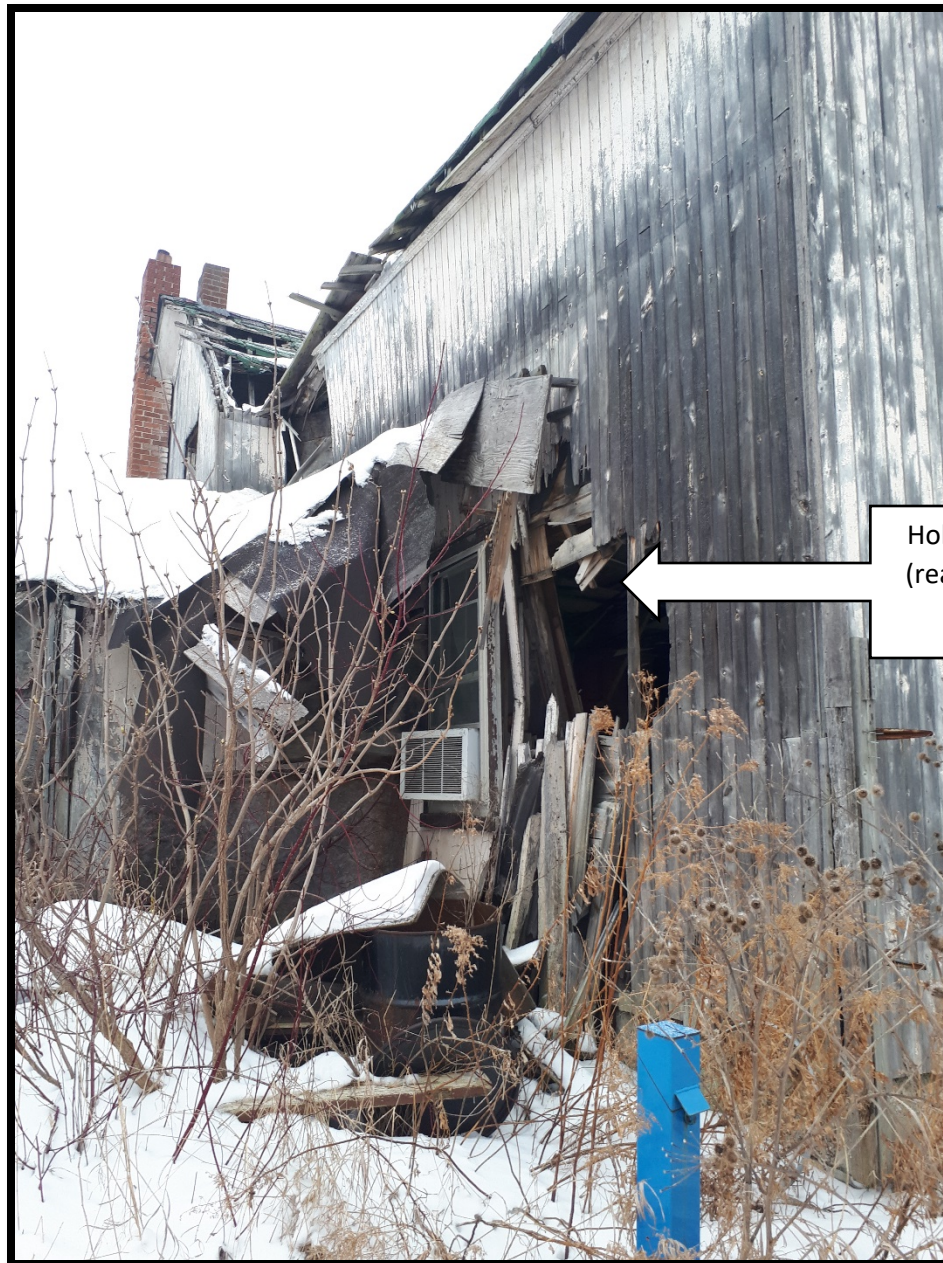
Photo 11

Hole in the right side of the west
(rear elevation) exposing interior
to the elements.

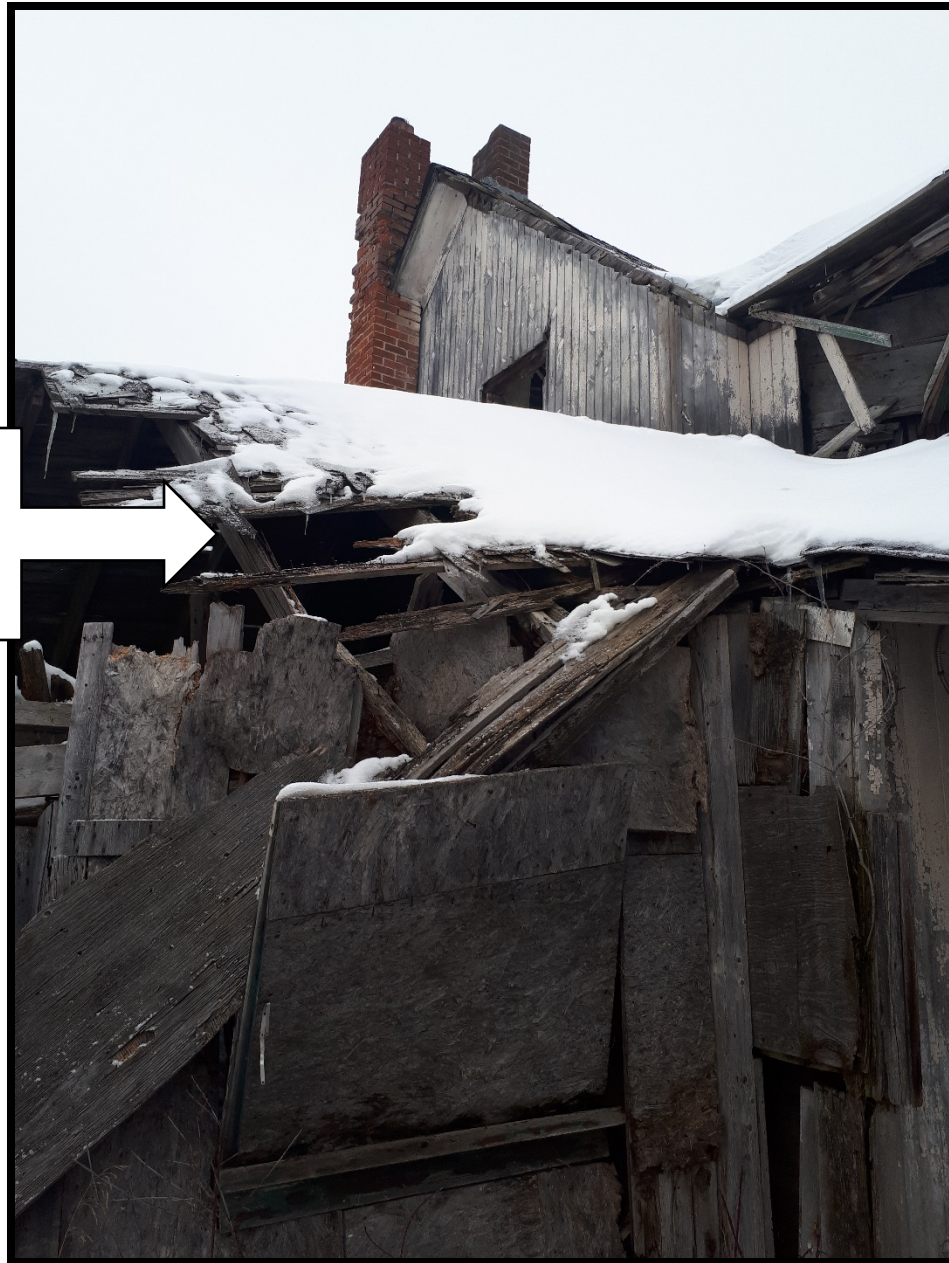
Photo 12

Detailed view of poor
condition of rear addition.

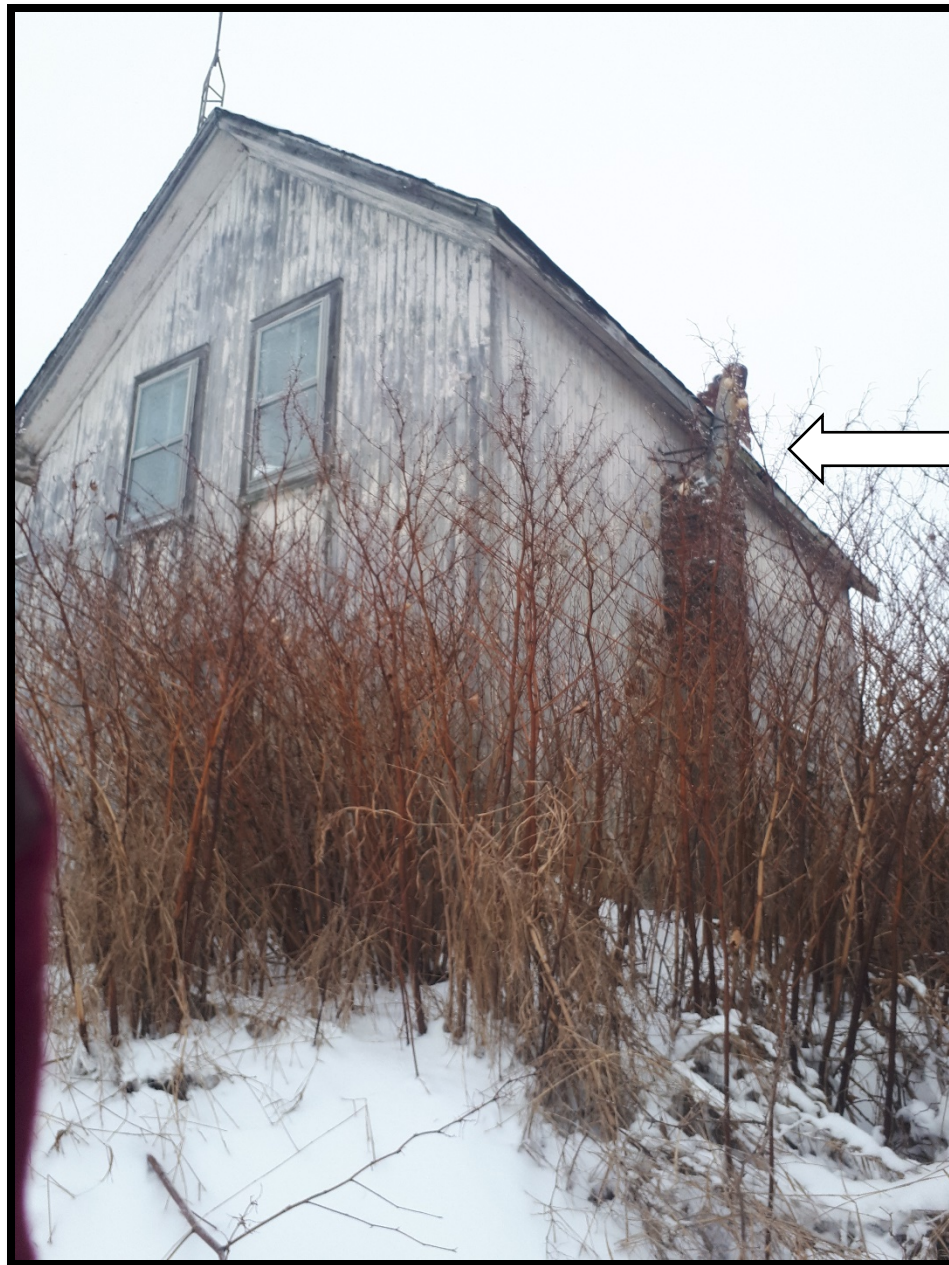
Photos 15

Deterioration/ collapse of
brick chimney shaft

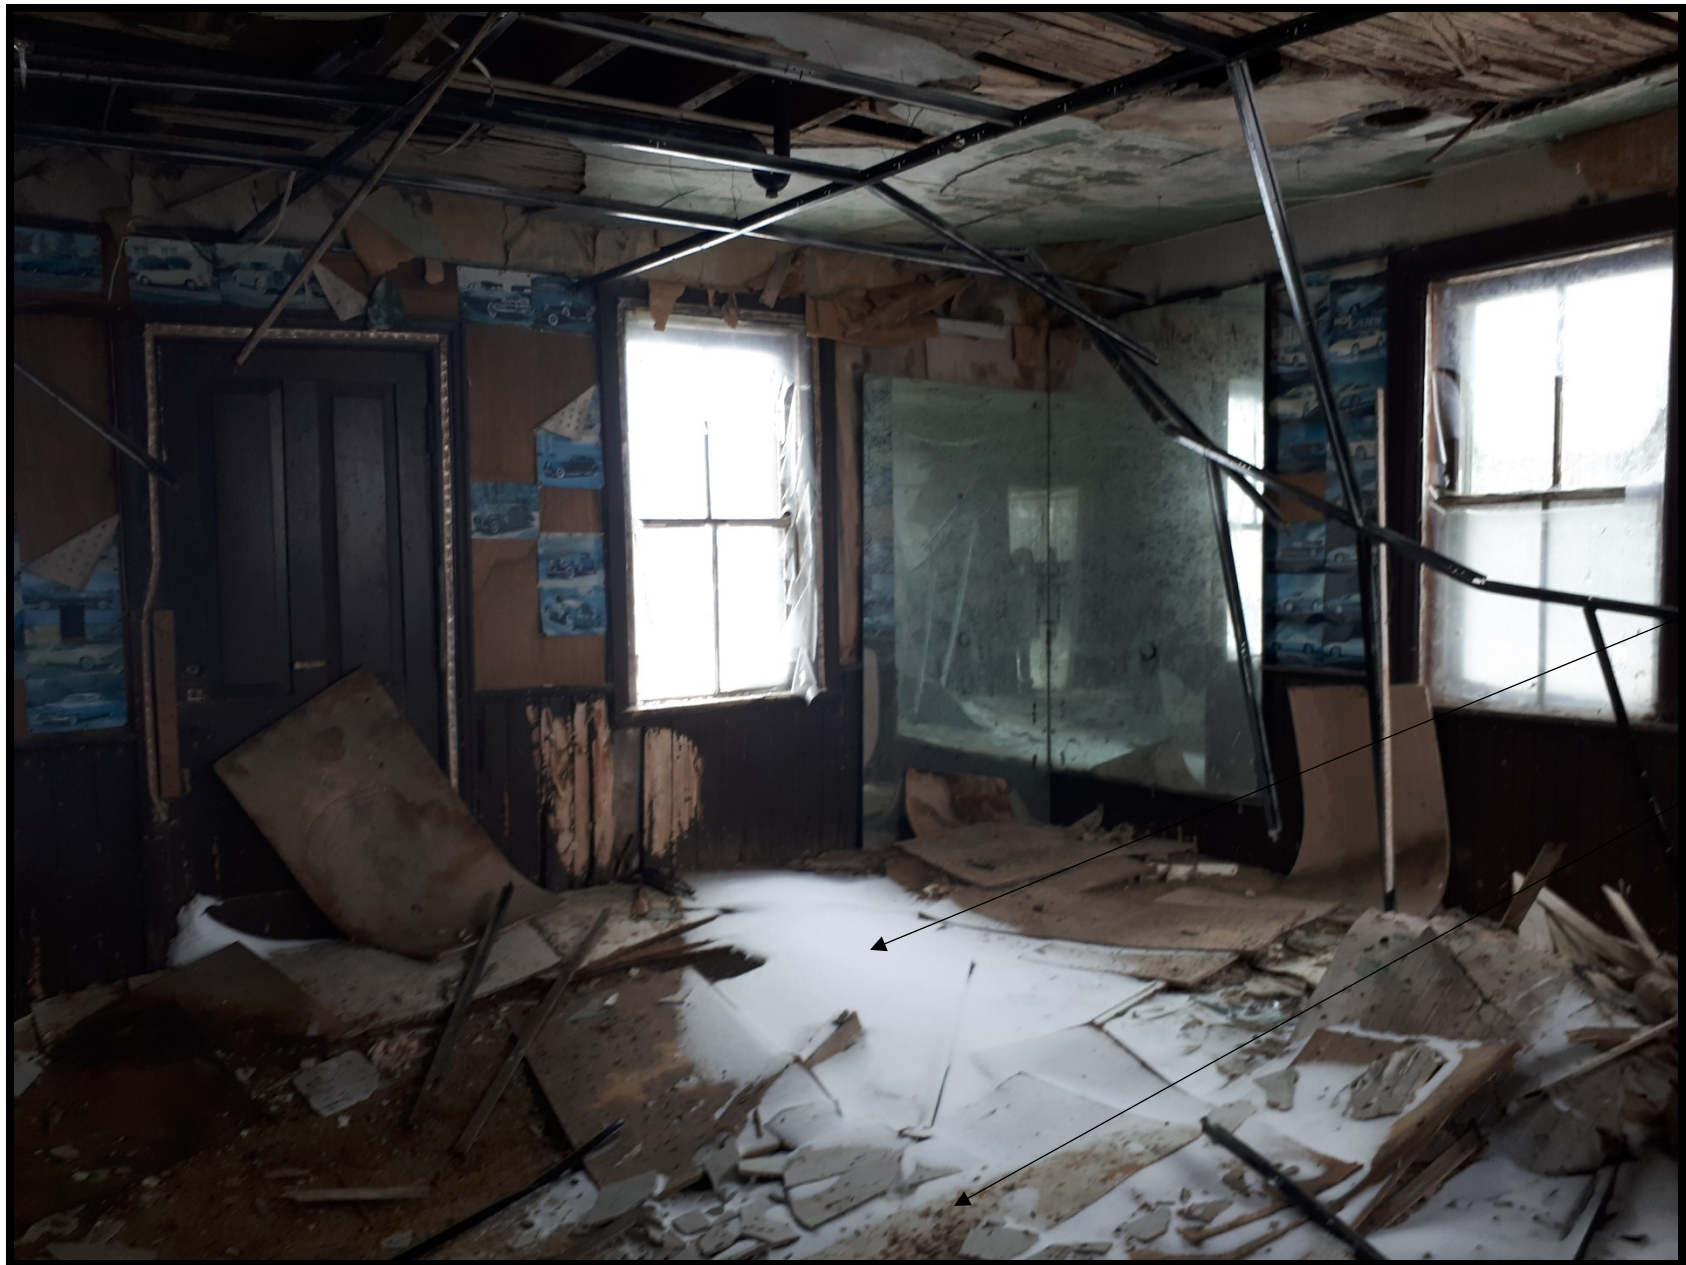
Photo 17

View of interior of main building showing that it has been exposed to the elements and vermin
