Revised July 31, 2019

Cultural Heritage Impact Assessment Report for 4638 Major Mackenzie Drive East, Markham, Ontario

Prepared for: Major Kennedy South Developments Limited

Prepared by: Chris Uchiyama, M.A., CAHP

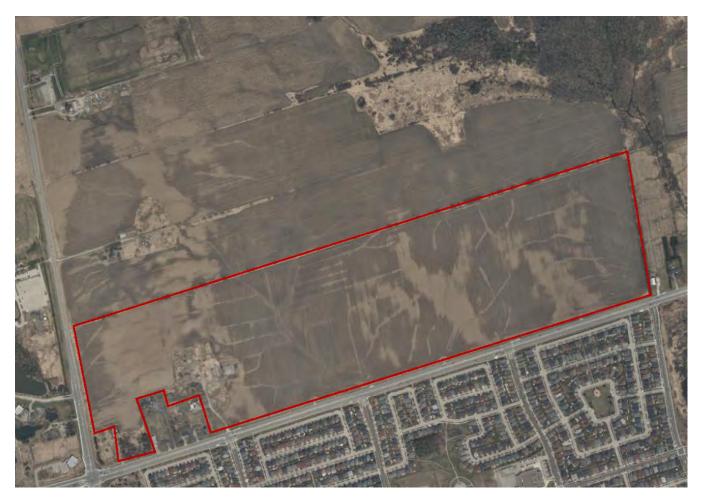
Figure 2: 4638 Major Mackenzie Drive East, current conditions

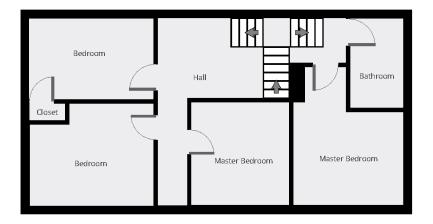
Figure 9: Second Floor Plan (not to scale)

On the second floor, the three bedrooms towards the west of the structure likely date to the turn of the century construction of the second floor and their configuration would suggest that the current location of the stairs is original to the construction of the second floor (Figure 9).

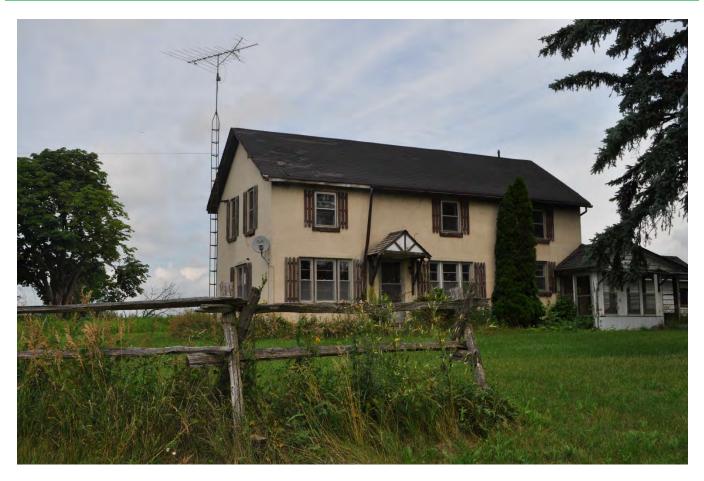
Photo 1: 4638 Major Mackenzie Drive East, front elevation facing north

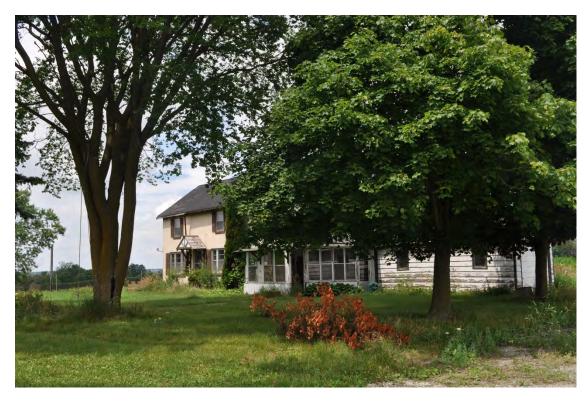
Photo 2: 4638 Major Mackenzie Drive East, front elevation looking northwest

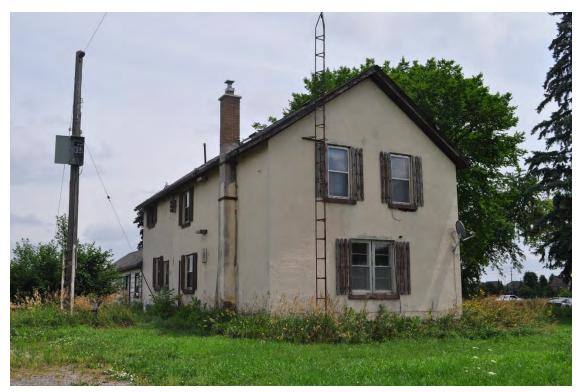
Photo 3: 4638 Major Mackenzie Drive East, west and north (rear) elevations

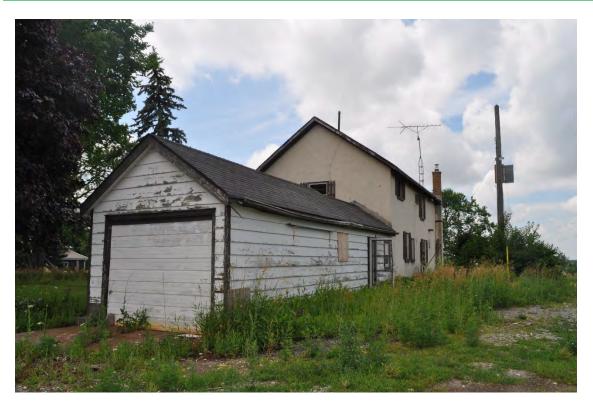
Photo 4: 4638 Major Mackenzie Drive East, east and north (rear) elevations

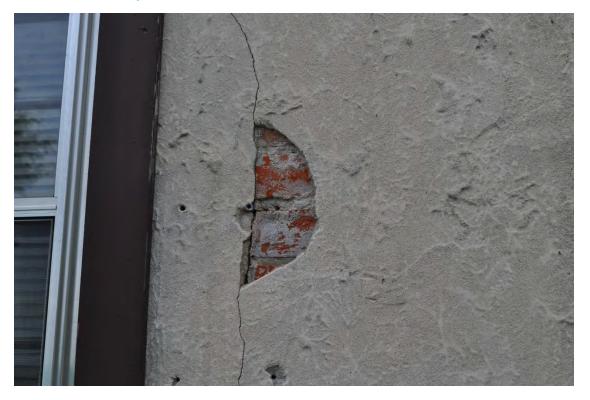
Photo 5: Detail of visible brick structure below cracking stucco

O.Reg.9/06 Criteria	Criteria Met (Y/N)	Justification
			and – although some of the exterior brick walls are extant below the stucco cladding, their condition and ability to convey information regarding materials and construction methods is unclear. Attempts to record this information would likely be intrusive, if not destructive.
iii.	demonstrates or reflects the work or ideas of an architect, artist, builder, designer or theorist who is significant to a community.	N	The builder/designer is unknown. The property does not meet this criterion.
The prope	erty has contextual value because it,

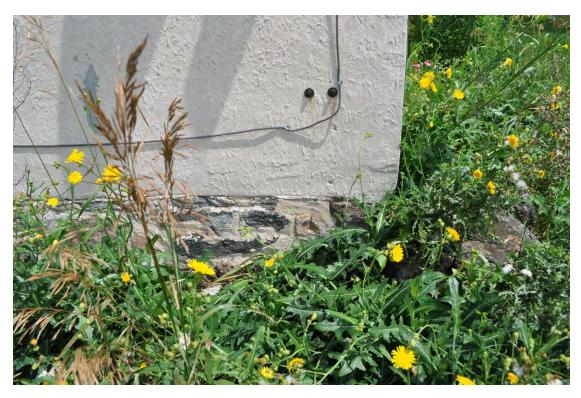
Photo 6: Detail of foundation stones along west elevation

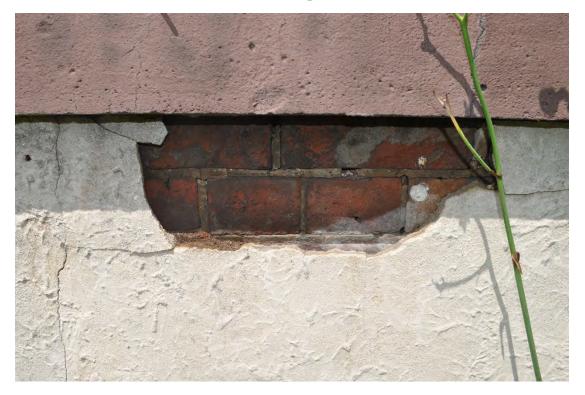
Photo 7: Detail of foundations, near southeast corner of structure

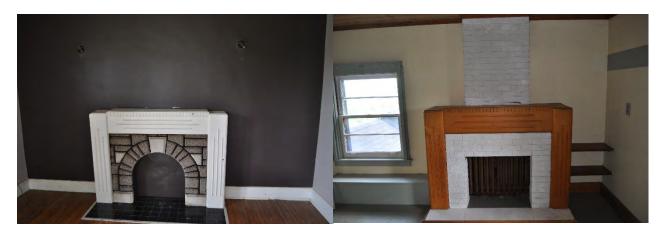
Photo 8: Fireplaces, first floor (left), second floor (right)
