LEA Consulting Ltd.

October 23, 2017

Re: 9900 Markham Rd., Markham

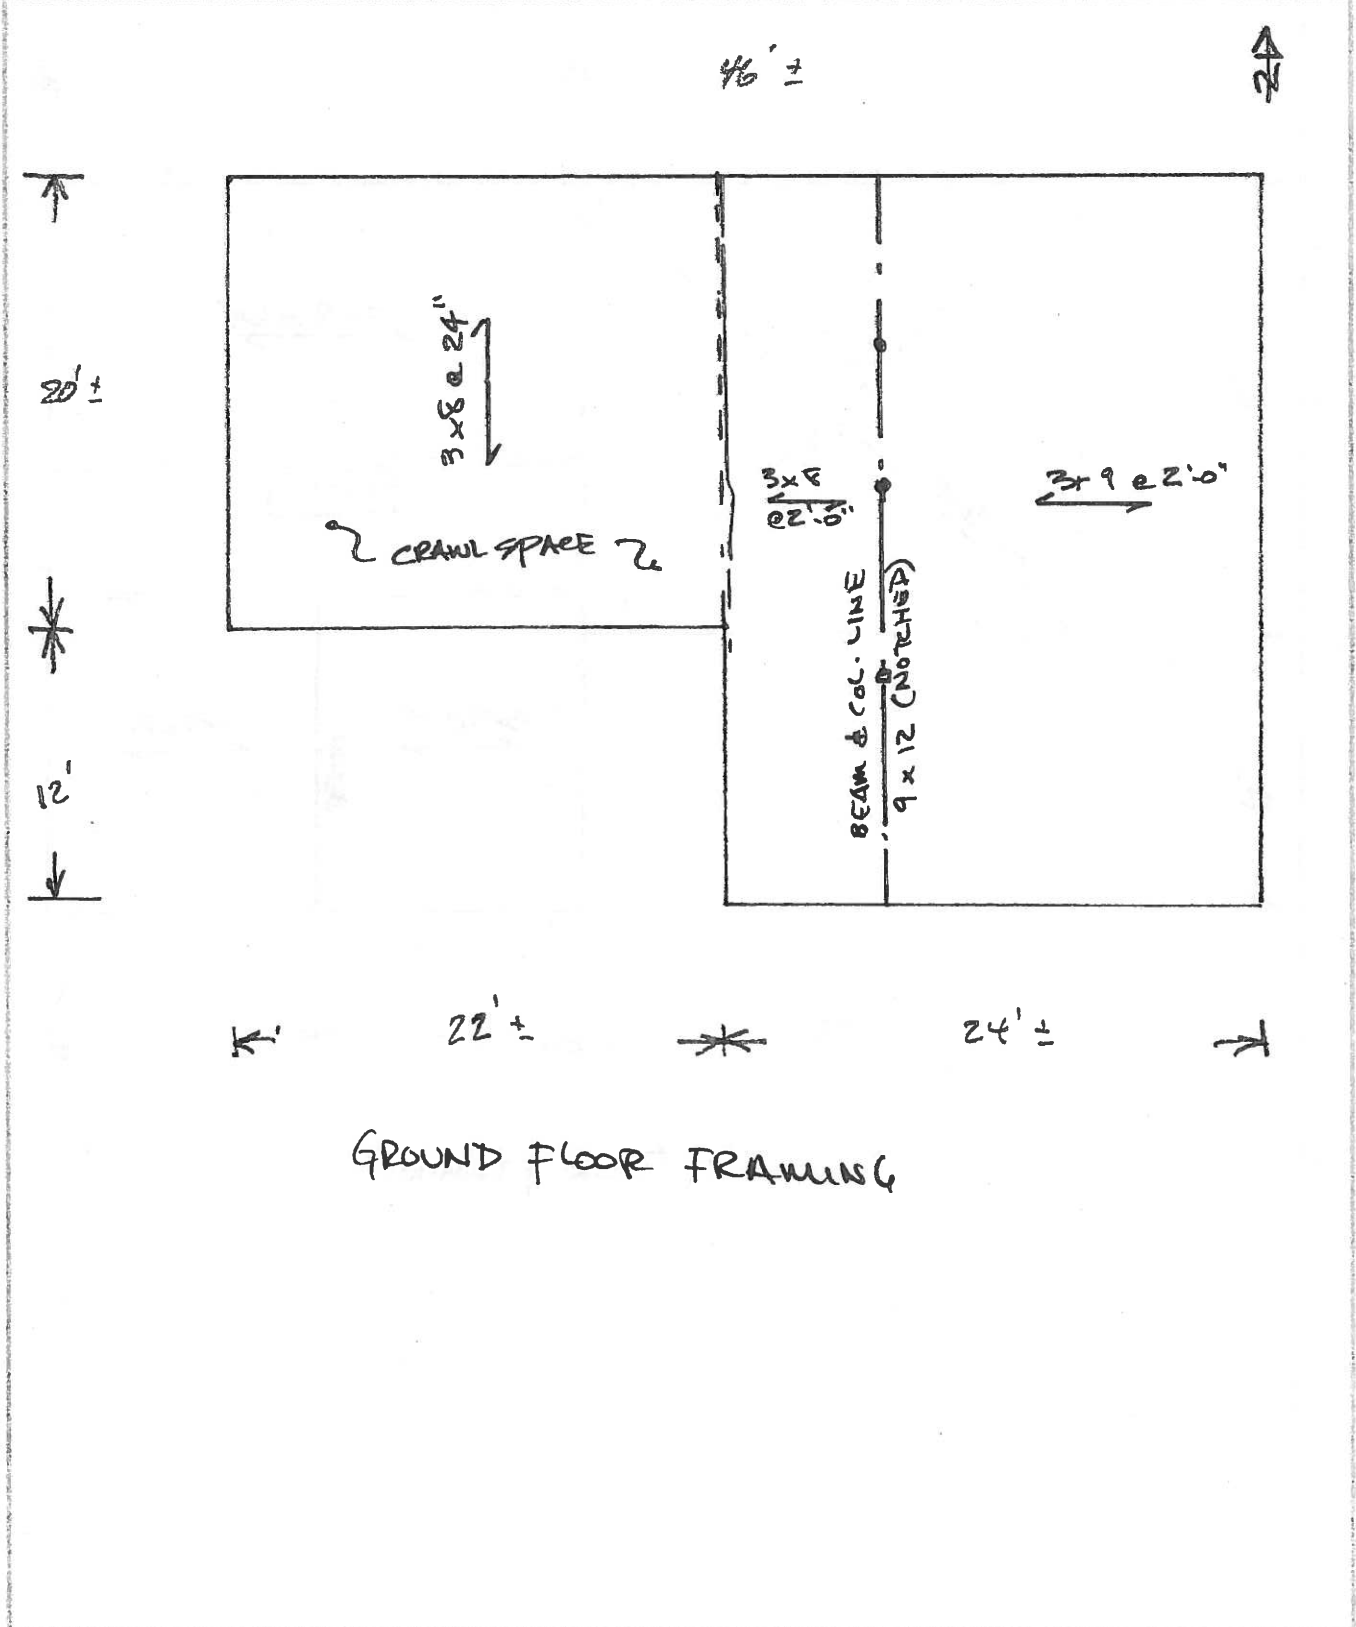
GROUND FLOOR FRAMING

The ground floor in the east wing consist of 3" by 9" and 3" by 8" joists spanning in EW direction and spaced at 24" on centre. There is a wood beam supported on sporadic make shift posts at random locations. The beam was in poor condition and signs of crushing at the post locations can be seen. The joists over the crawl space consist of 3" by 8" sawn lumber spanning in the EW direction and spaced at 24" on centre. We couldn't get close to the joists in the crawl space but in the basement area, we observed signs of rot on the joists. The joists seem to have been painted in the past and all the paint is peeling and the wood is rotting. The rot was measure about ¼" from the outer surface.

The beam in the ground floor needs replacement and new piers and footings are needed. The floor joists are anywhere from 114% to 123% utilized fail in deflection criteria. The floor decking needs replacement or reinforcing and joists would require installation of new ones in between the existing joists.

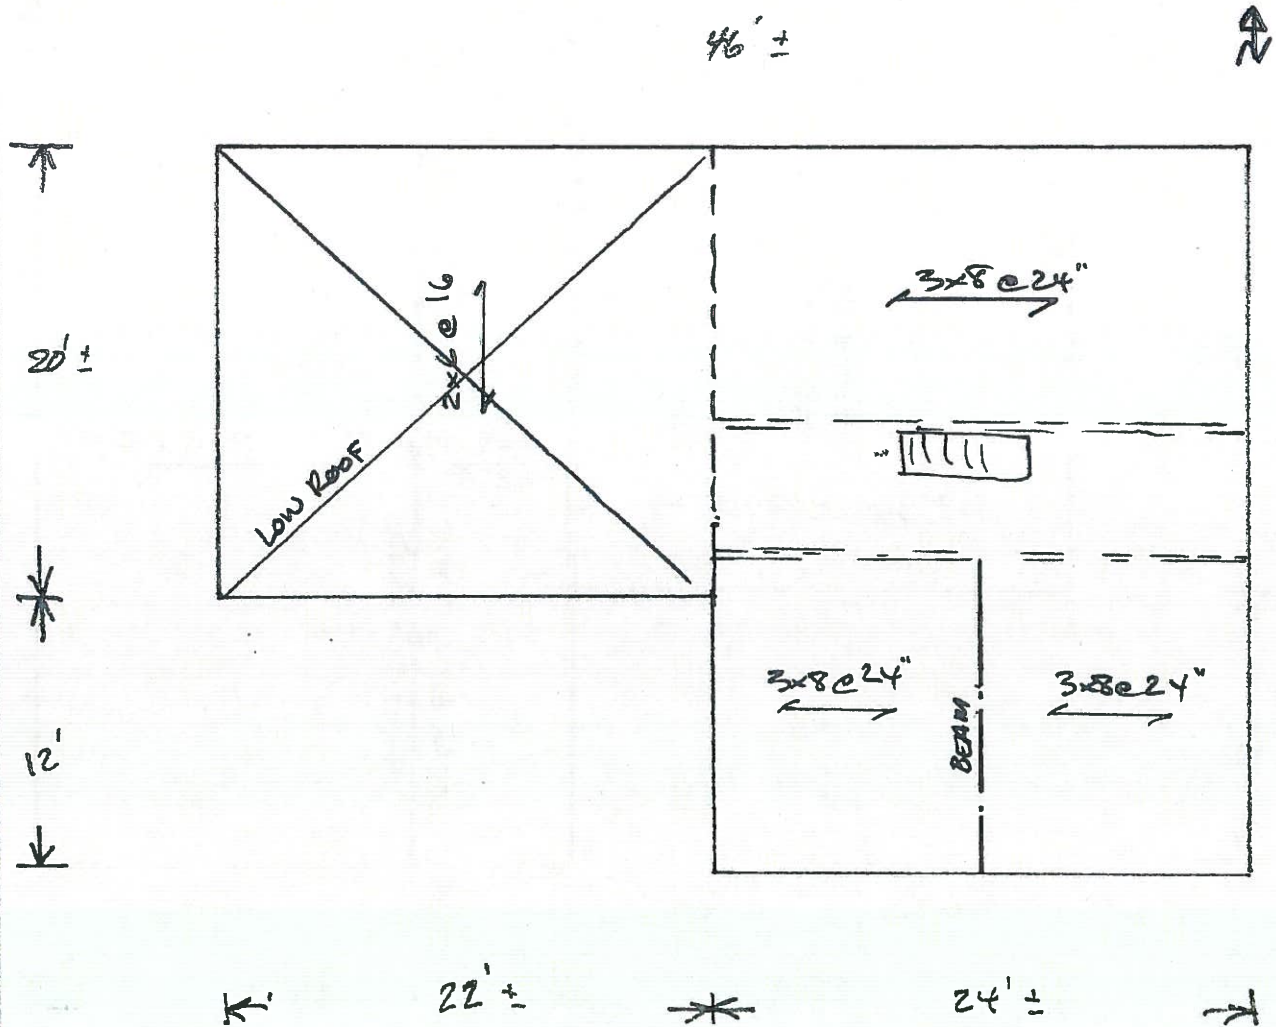
SECOND FLOOR FRAMING

There is a low roof at the second-floor level at the west side. The rest of the area is bedrooms and hallways. The floor framing is captured in the attached sketch plan. the floor joists are primarily 3" by 8" (full size) sawn lumber spaced at 24" on centre. The floor deck is wood decking spanning between the joists. Over the living room and kitchen, the drywall was in place in most areas and limited review was possible. The framing is unusual and doesn't appear to have been constructed by qualified contractors. It is unusual to see floor joist spaced this far and spanning in the longer direction.

The second-floor joists over the living room area are about 110% utilized have a L/110 live load deflection under design live load. This area would require new joists in between existing ones. The decking also need repairs, either full removal or additional ¾" plywood over the existing floors. The joists over the dining room and kitchen have shorter spans and are adequate. However, the deck would have to be either reinforced or replace.

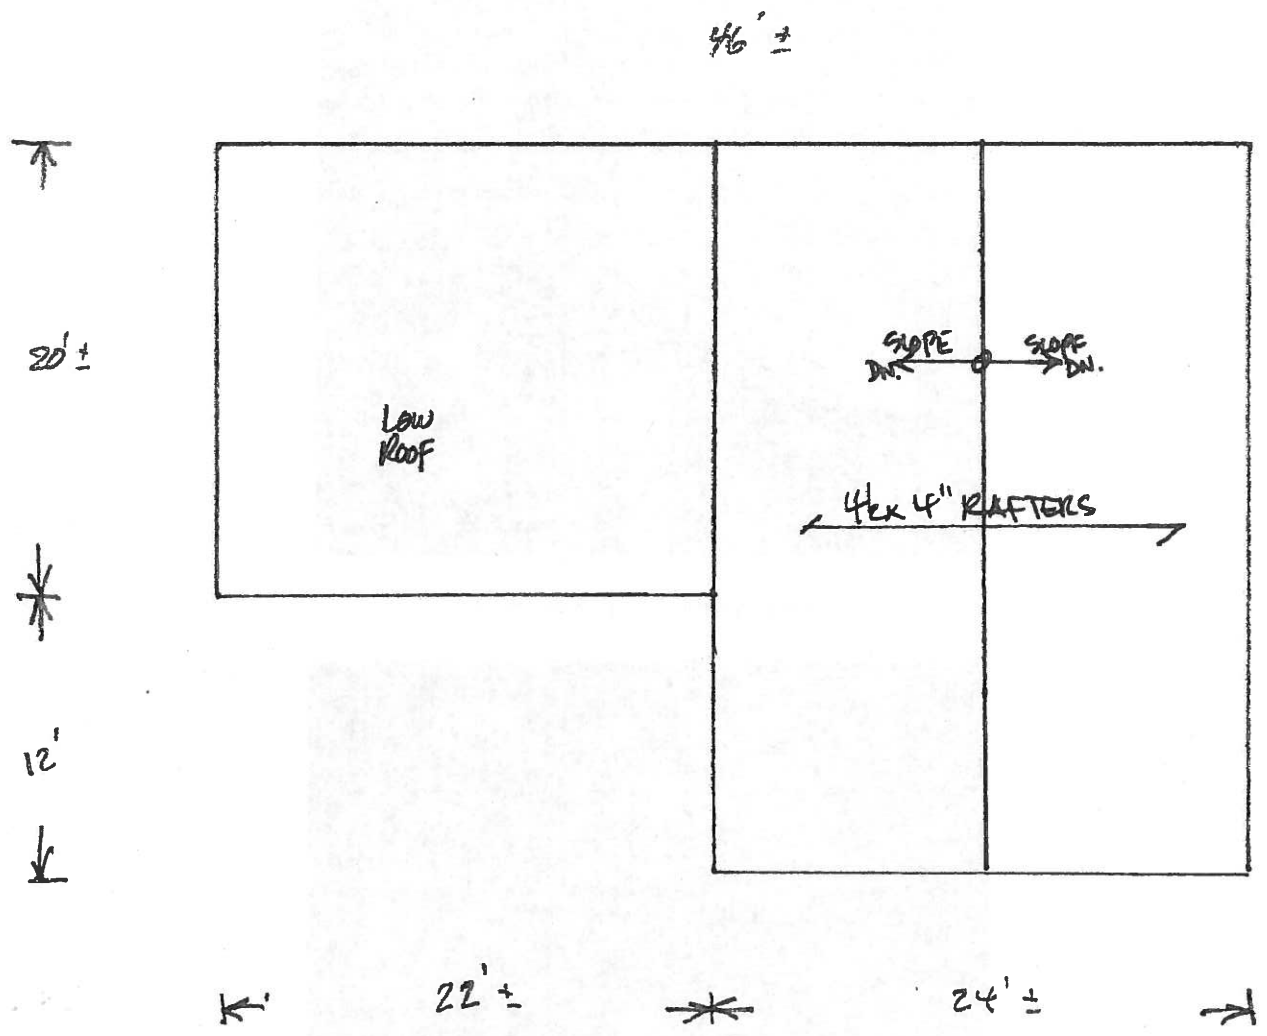
ROOF FRAMING PLAN

The roof is sloped as shown in the attached plan sketches. The roof joists consist of 4 ½" by 4" wood rafters spanning in the EW direction at 24" on centre. There appears to be collar ties at the ceiling level that support the ceiling and ties the roof rafters. There is no ridge beam at the peak of the roof which creates stability issues. The roof sheathing is wood decking with extensive sign of moisture damage and rot. Daylight can be seen in certain areas and a large tarp is placed to reduce water penetration. The finishes have been damaged extensively. We used a drill and screw driver to determine the condition of the wood. The outer ¼" appeared to be soft in certain areas. This is a sign of rot over the years.

The roof rafters in both low and high roof are under sized for current snow loads. In the past, buildings were not properly insulated and as a result snow accumulation tends to be small. If the house is renovated and properly insulated, the roofs must be able to support current snow loads prescribed in Ontario building Code. The roof rafters on the high roof are 115% utilized and have L/80 deflection performance. The low roof joists are 228% utilized under design snow loads (no snow accumulation has been considered). Therefore, both roof structures will require reinforcing. The existing rafters can remain in place but in our opinion, it may be more economical to remove the roof structure and replace with new joist, decking and roofing. If existing structure is to remain, the new decking would be required and new joists/ rafters would have to be added in between existing ones.

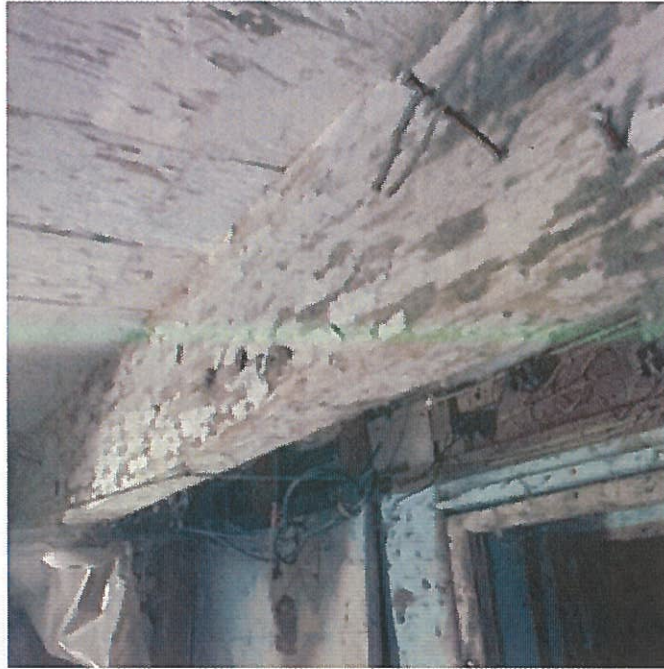
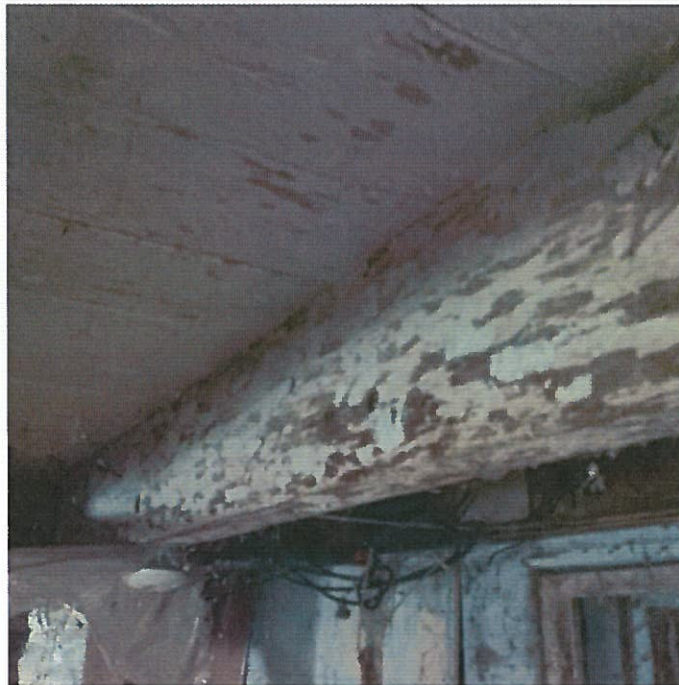
Main wood beam in basement

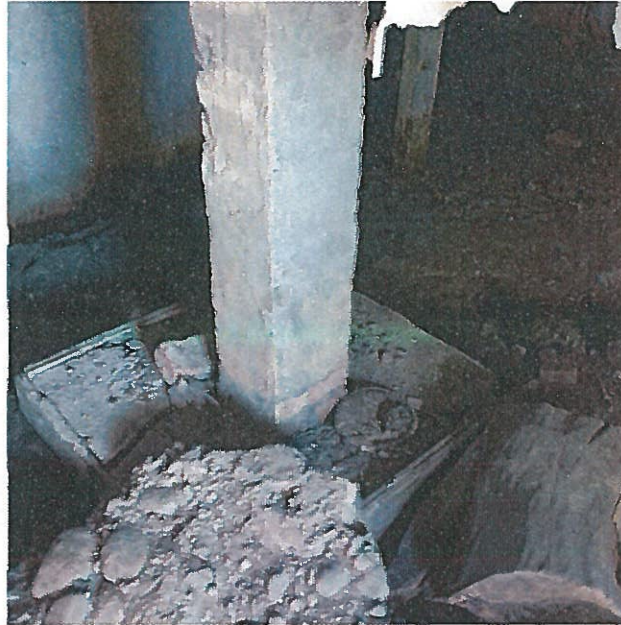
Brick pier under the beam in basement

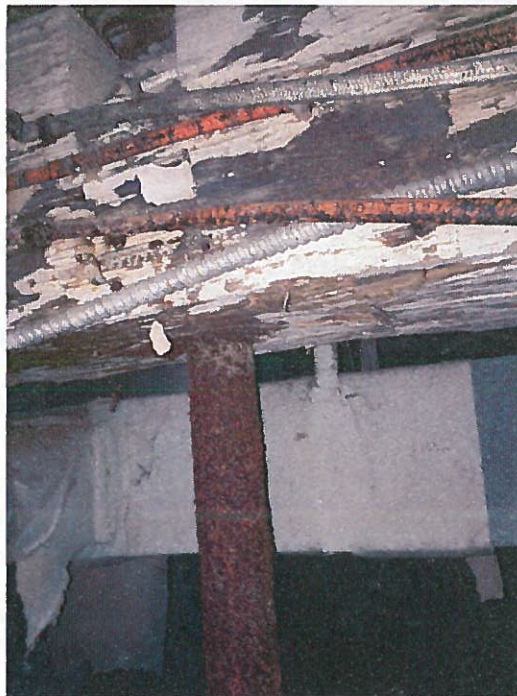
Steel post crushing into beam (no footing can be seen)

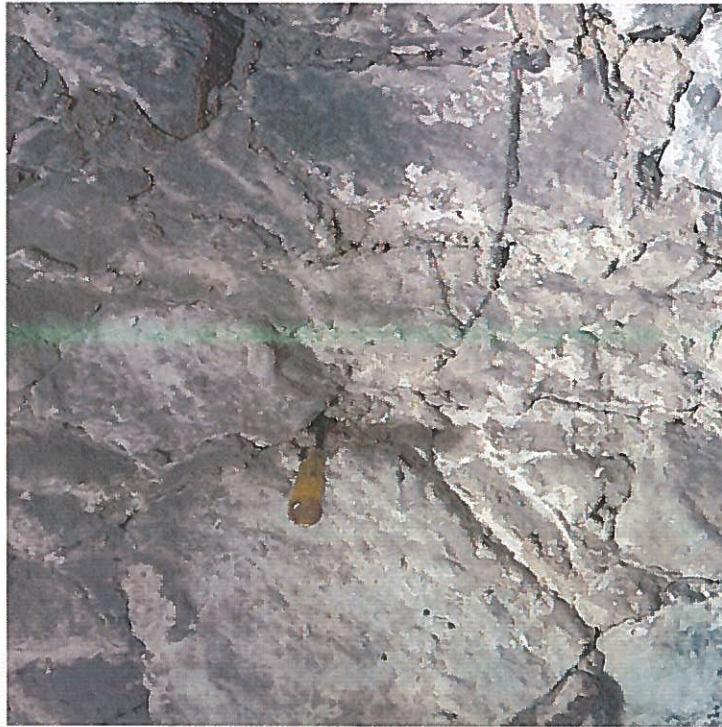
The basement walls are constructed with rubble. We were not able to see any footings under the perimeter wall. In older houses, it is common that walls are constructed of flat stone. The mortar in many areas have deteriorated and is soft when poked with a screwdriver. In many areas, the stones have dislodged and cracked. Efflorescent is present in many areas which is a sign of water leakage.

Foundation wall in basement (Screwdriver through mortar)

Similarly, the foundations walls need repointing and replacement in some areas. We have assumed that 50% of the wall will require repointing and repair. If the wall is going to be reused, the exterior of the wall will require moisture protection. This would require excavation around the house and waterproofing applied. We would recommend adding 6" concrete wall against the foundation walls. Since there is shifting of the footings, the foundation will likely require underpinning to ensure the wall is bearing on solid bearing surface. Alternatively, helical piles can be added along with a new layer of foundation wall.

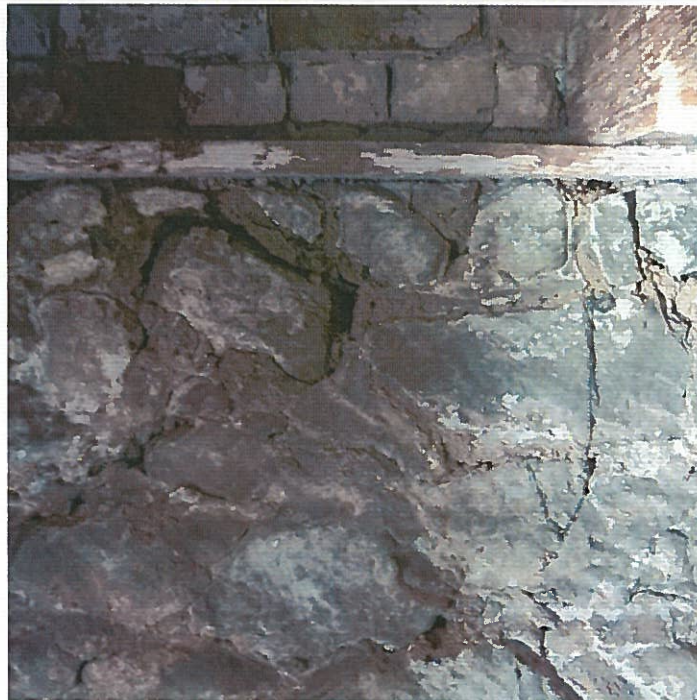
Deterioration of basement wall

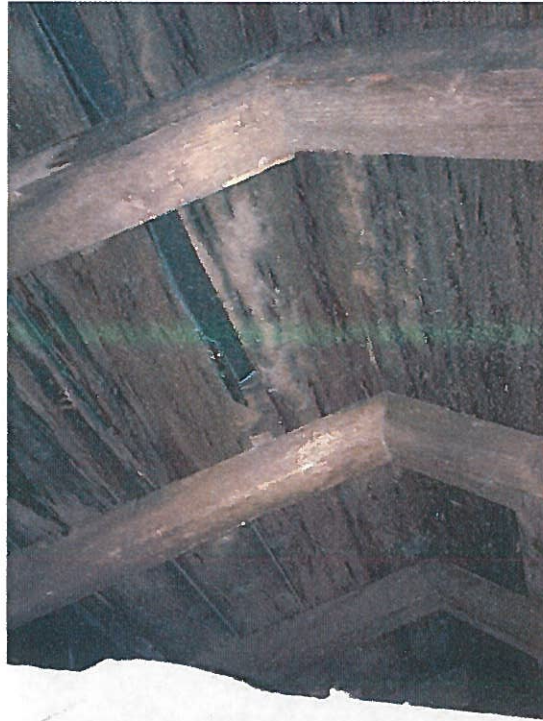
Roof rafters

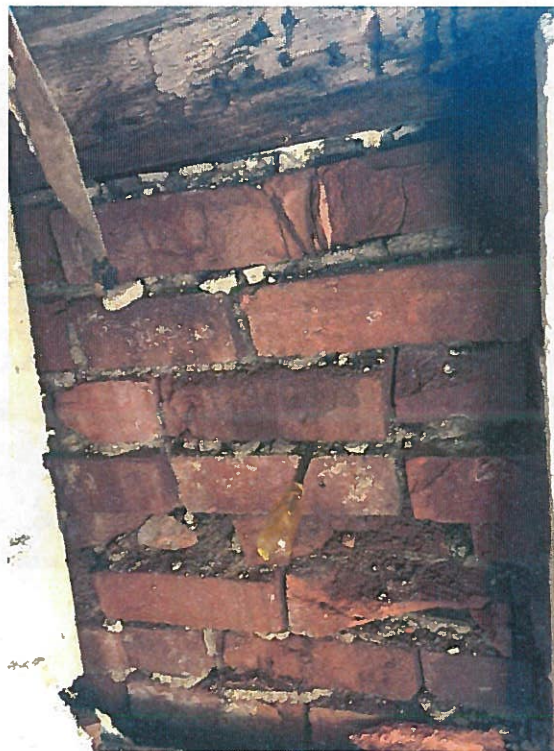
Wall at dormer location

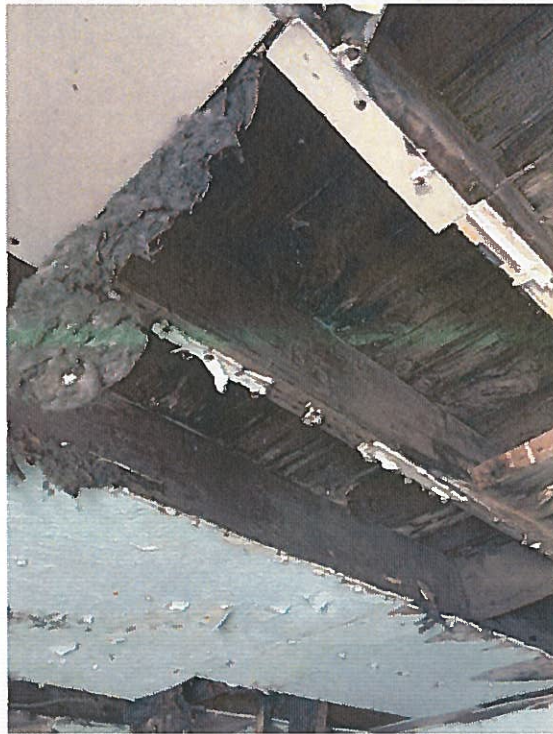
The low roof comprises of 2" by 6" (full size) spaced at 16" on centre spanning the full 20' distance in the NS direction. The roof showed signs of leakage and deterioration in various areas.

Roof joists at low roof

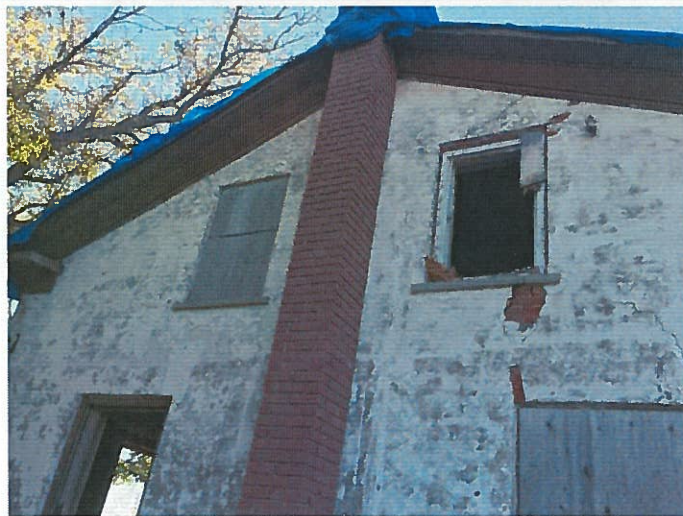
The outside walls consist of double wyths of red brick. There are many locations where the bricks have been significantly deteriorated to a point where we could poke a screw driver right through the brick and mortar joints. These are areas near eave of the roof where water has been infiltrating. At the corners of the house there are many step cracking which is an indication of settlement or heave. Since the building has been unheated and unprotected, chances are that freezing conditions caused heaving and movements in the foundations. The lintels are either wood or brick arches and have cracked due to movements.

Exterior wall cracking at lintels

The outside masonry walls require replacement and repointing in many areas. The long-term exposure to the elements have deteriorated the mortar and bricks in locations. For purpose of pricing, we estimate that 60% of the walls will require replacement or repointing. There appears that thick parging and in some locations insulation were added without proper vapour barrier. This can trap moisture and would not allow the wall to breath and dry off causing deterioration of the brick and mortar.

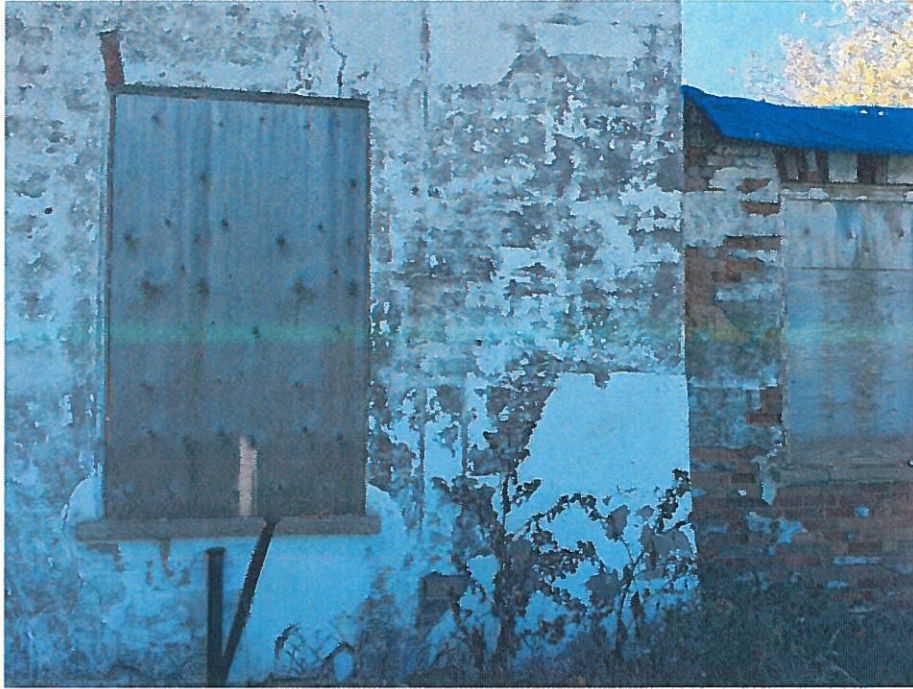
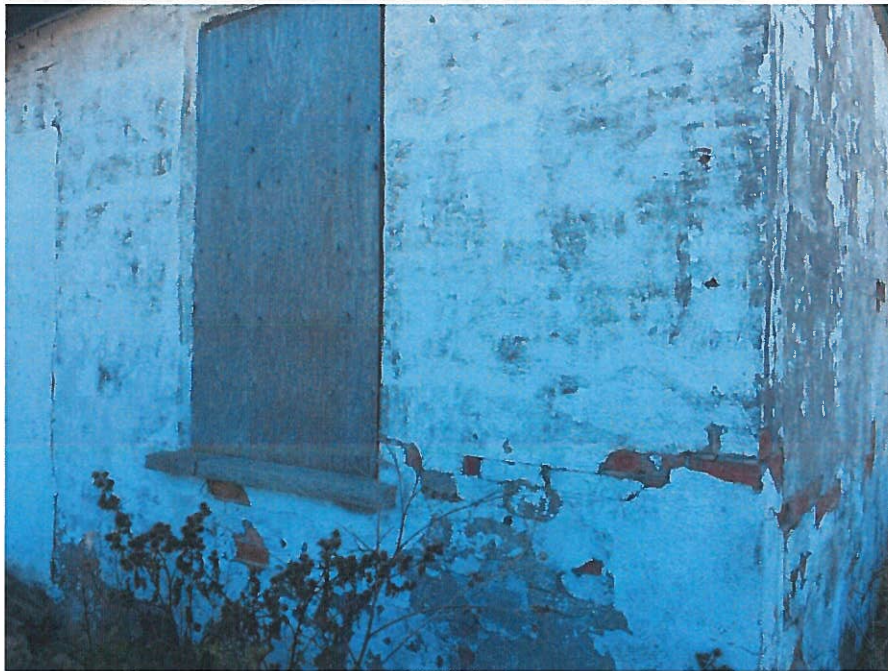
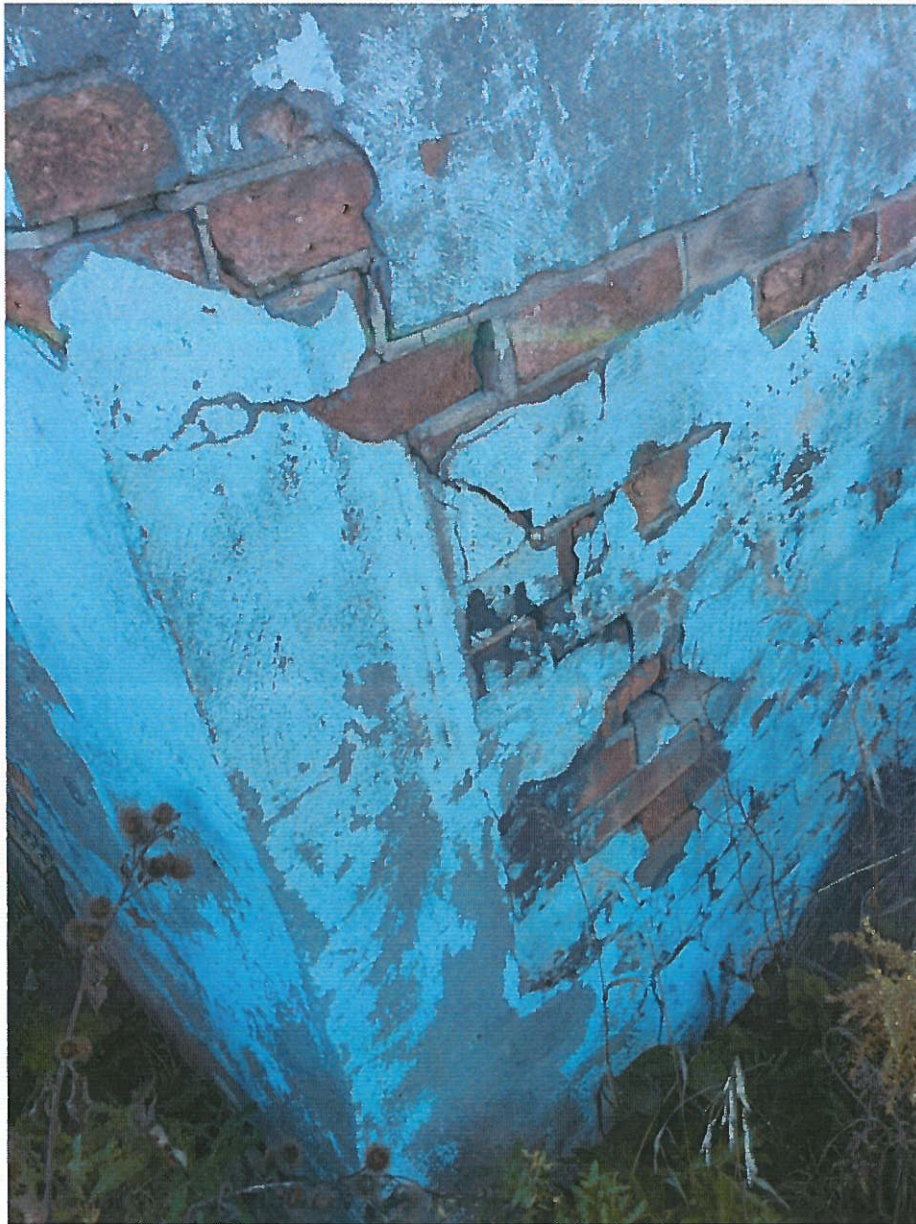
Typical cracking at corners
