**HERITAGE BUILDING CONDITION SURVEY  
WILLIAM CLARRY HOUSE  
9900 MARKHAM ROAD  
MARKHAM, ONTARIO**

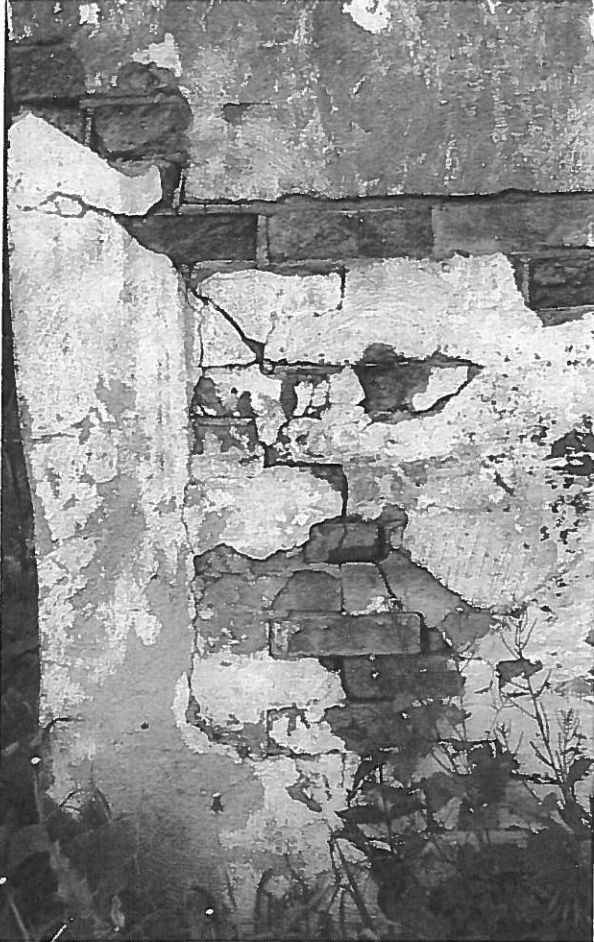
- Here we see deteriorated and cracking foundation walls.

- To the right: Foundation is cracked due to freezing in winter which causes the foundation to expand and contract.

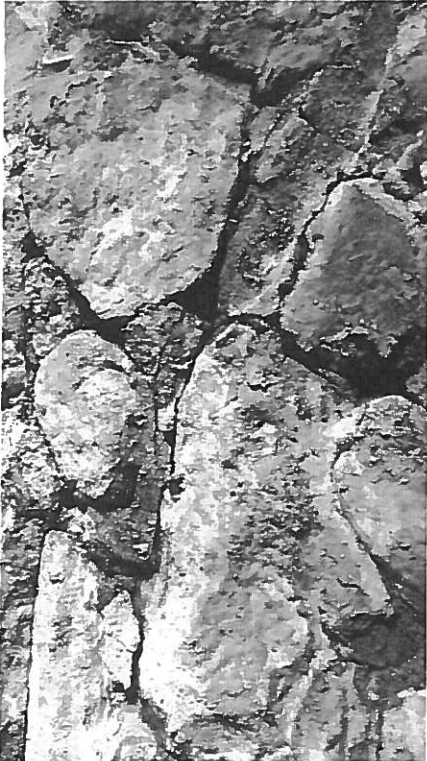
- Typical old stone and rubble foundation. Not sound (subject to shifting with freeze –thaw conditions).
- ZERO structural integrity.
- Moisture able to enter with use of this material. No waterproofing or damp proofing.

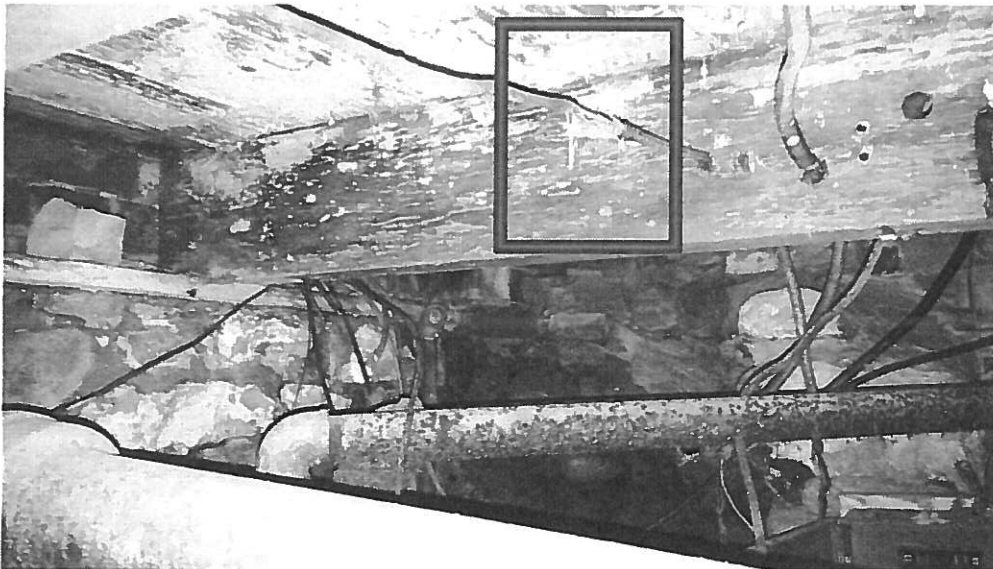
Electrical wiring is required to be completely removed.

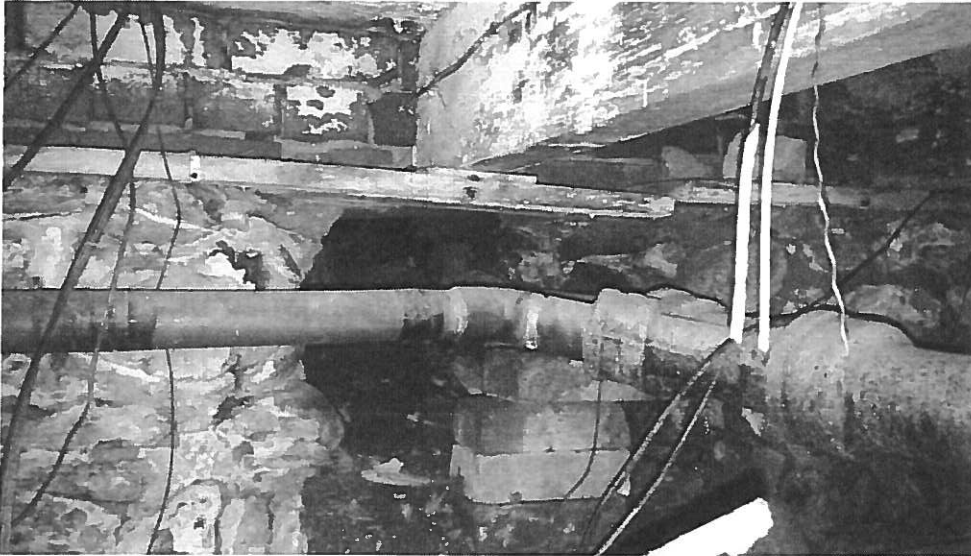
- Suspended plumbing pipe supported by stone blocks and wiring to be completely removed within the entire dwelling.

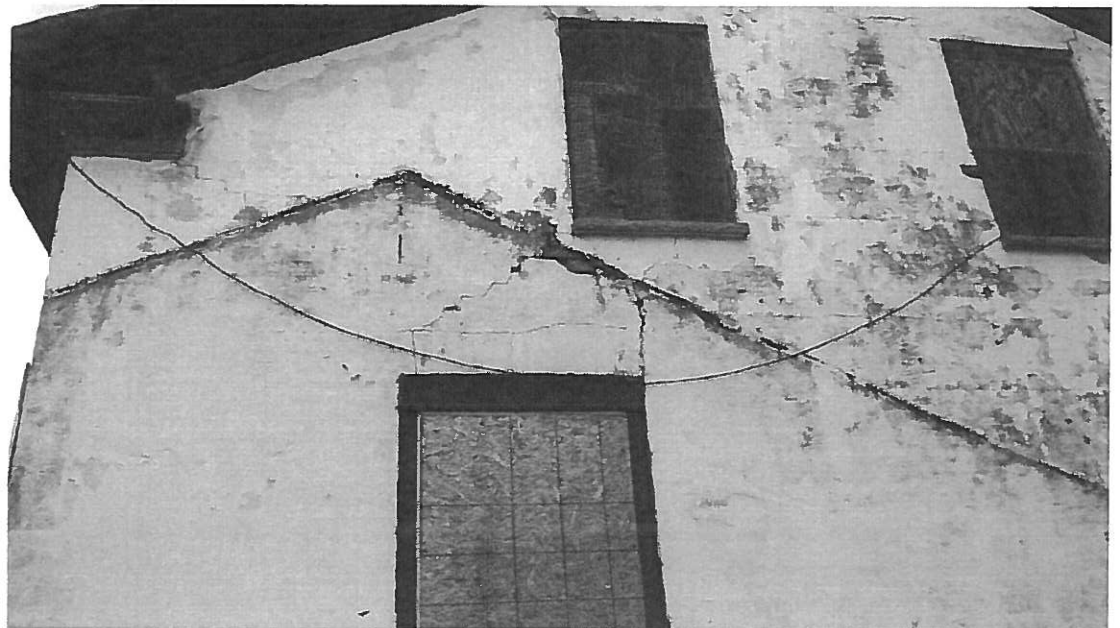
- Damage to the exterior wall. This means water or simply moisture can make its way into the home. This results in accelerated deterioration. ALSO leads to mold inside and between walls. Very bad to breathe in.

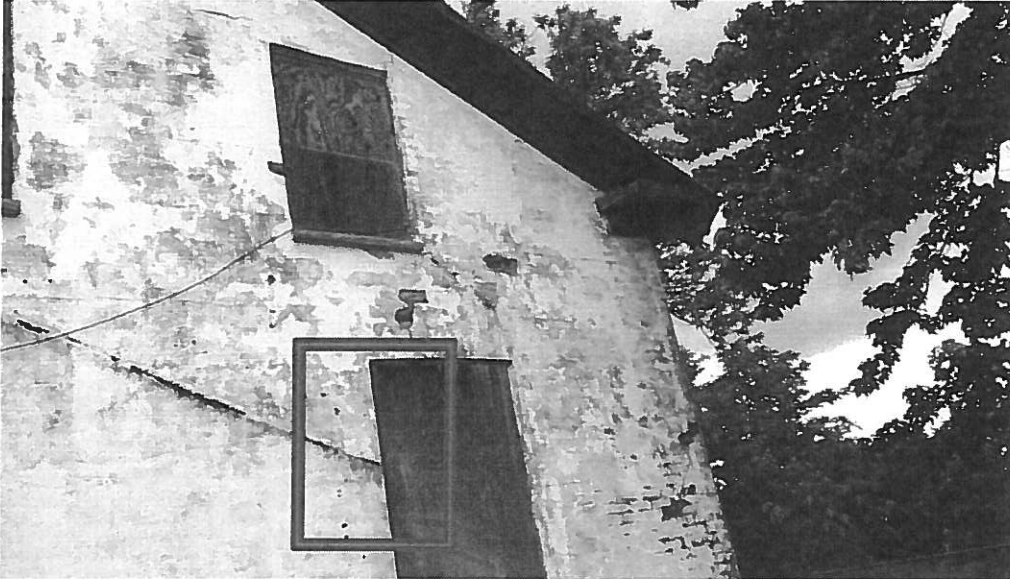
- The crack in the exterior wall continues to the window opening.

- We noted that consistent throughout this structure, the deteriorated masonry is covered by stucco.

- No structure lintel above door.

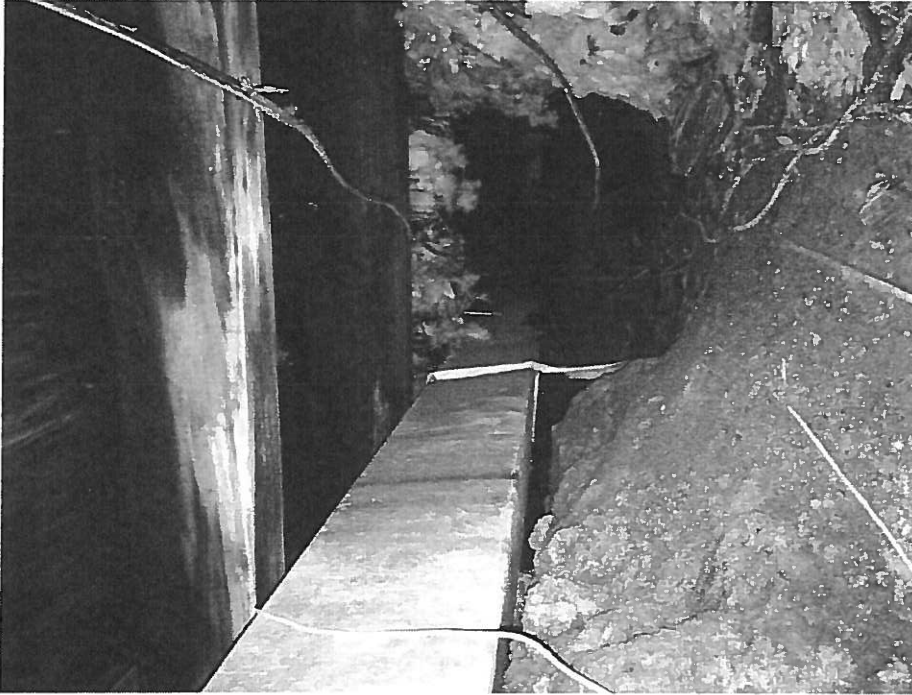
- To the left: Existing foundations are broken, overstressed and failing. This dwelling must be shored immediately.

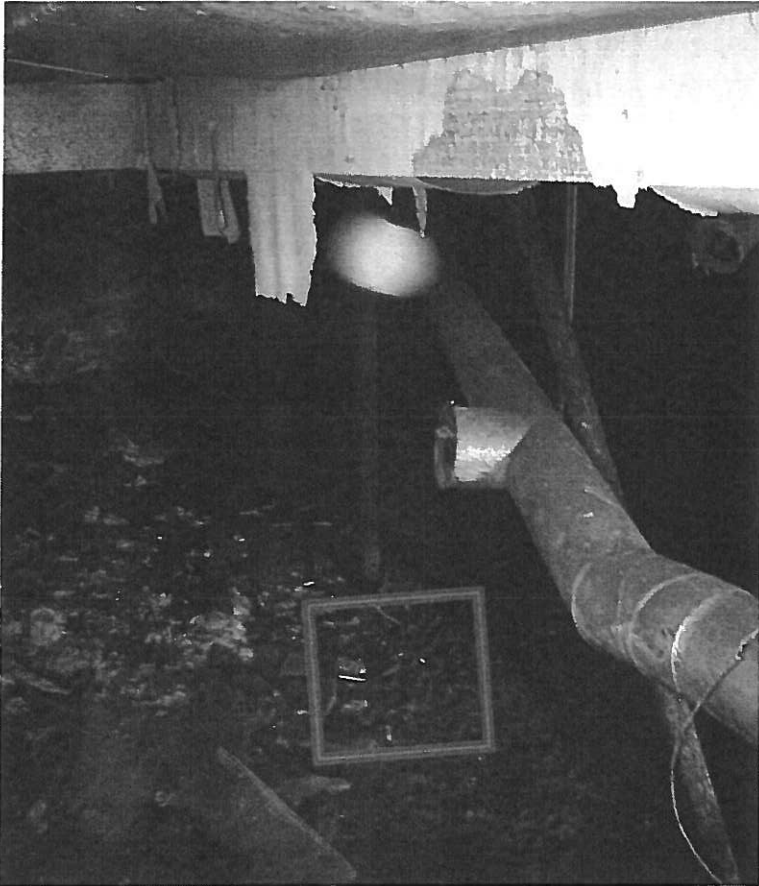
- Support column sitting on top of soil. NO PROPER FOUNDATION.

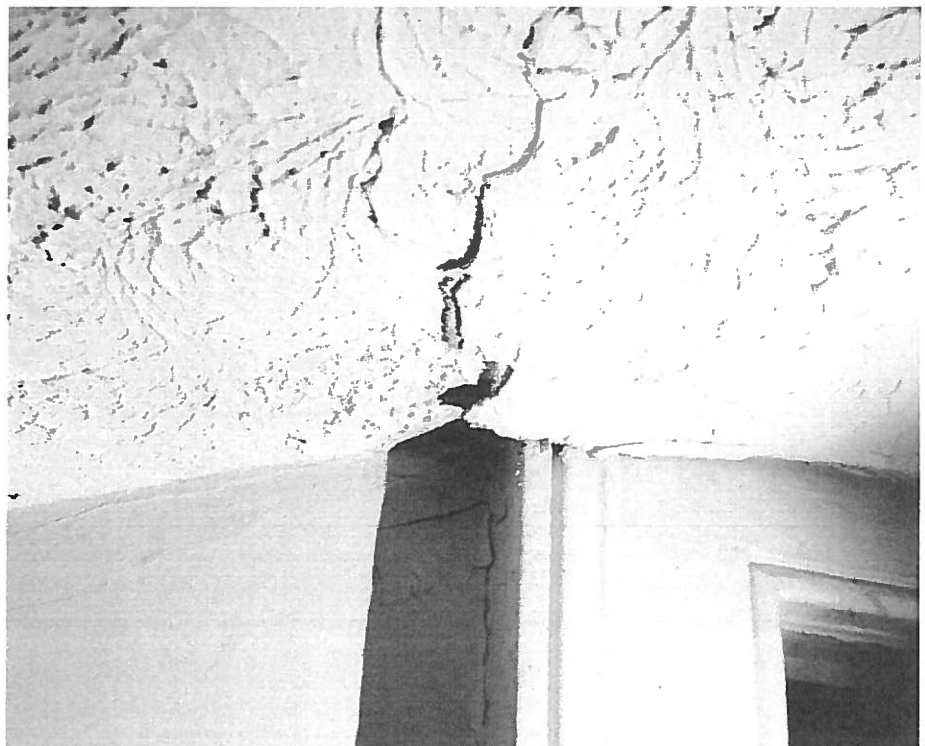
- To the right:  
Cracked moldings,  
cracks  
continue into  
ceiling,  
demonstrating  
overstressing  
of the roof  
structure.

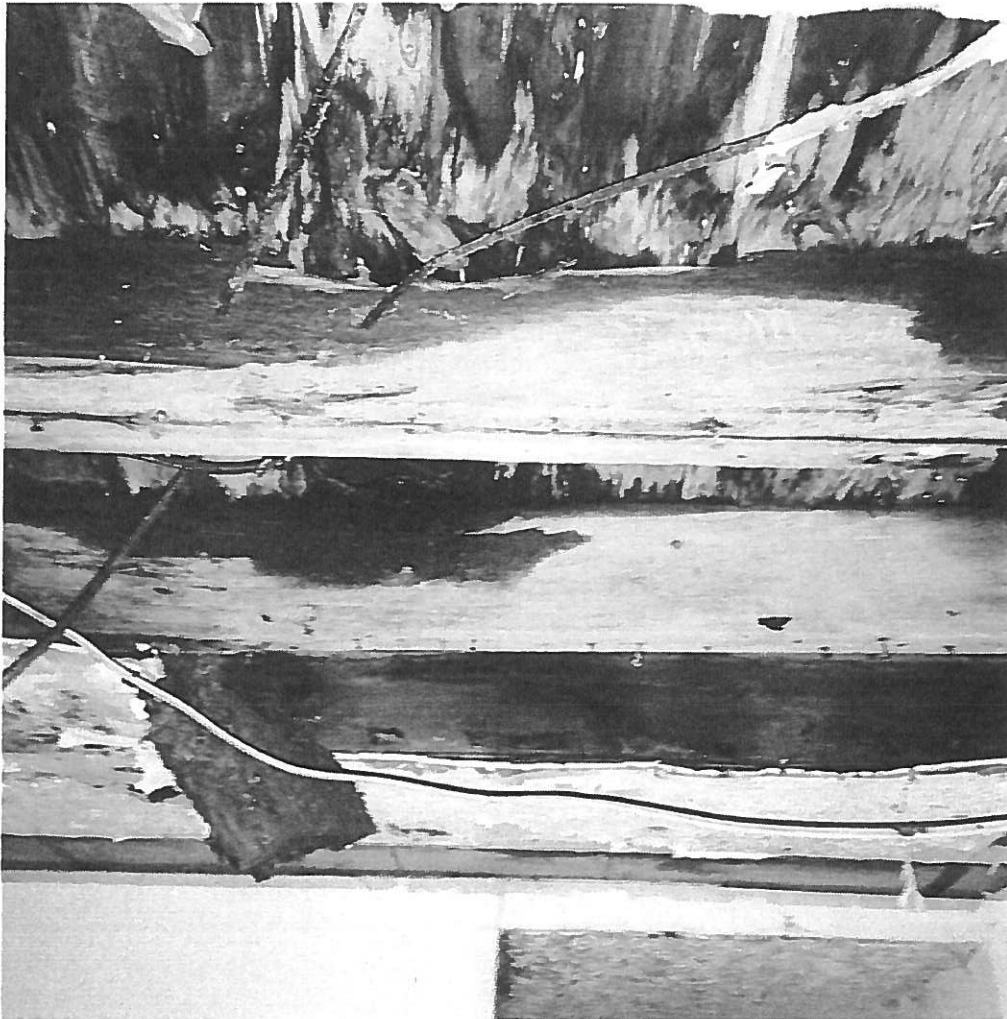
-To the left:  
Deteriorated  
flooring... The  
exposed joists are  
saturated with  
moisture and  
mold; and rapid  
deterioration  
occurs. Joists  
could catch fire  
and easily spread.

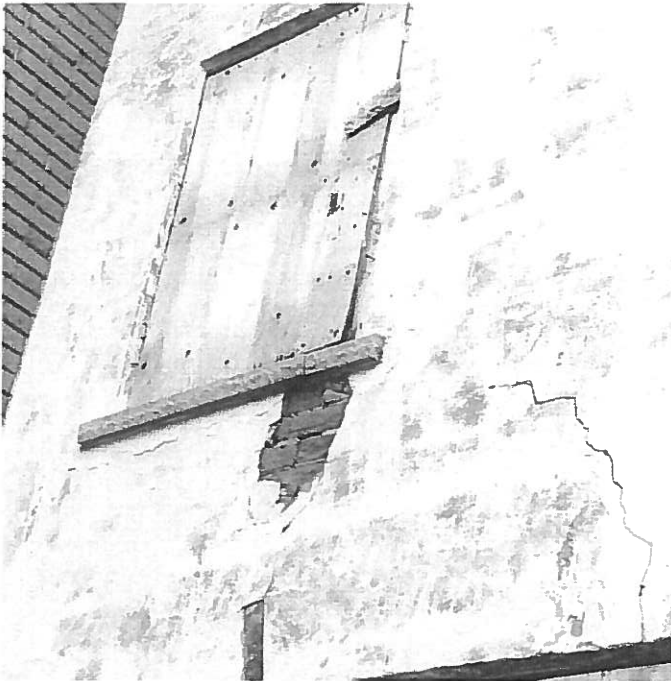
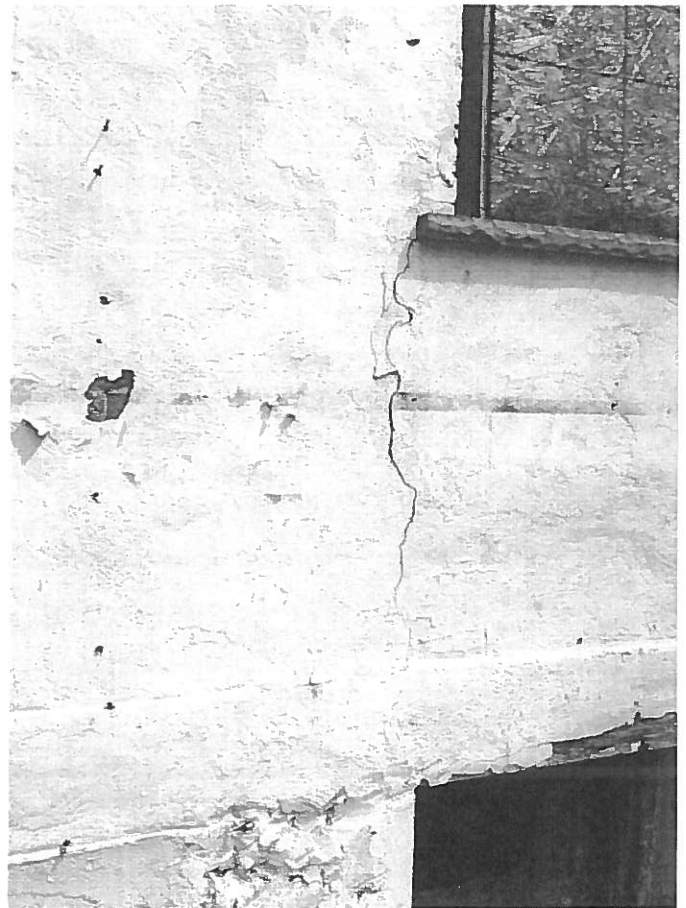
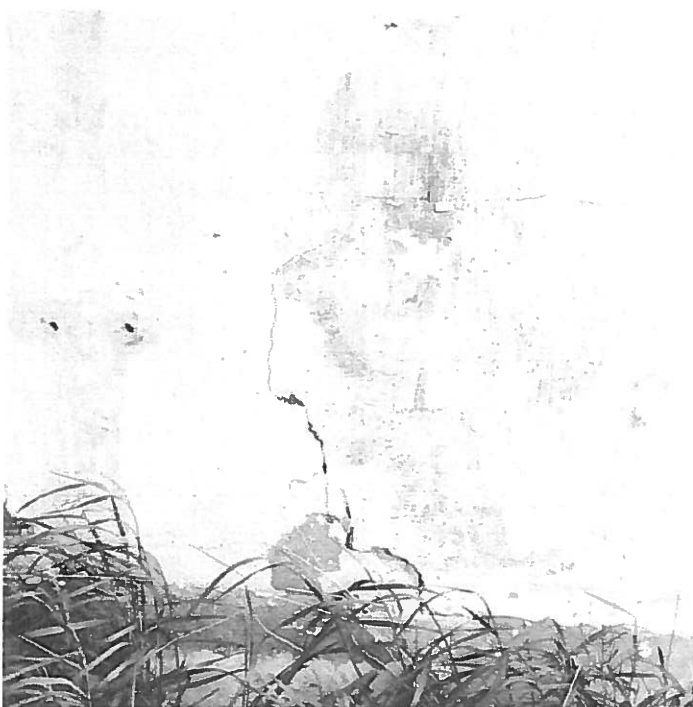
- Exterior cracks are consistent throughout the outside walls as shown again on this page.

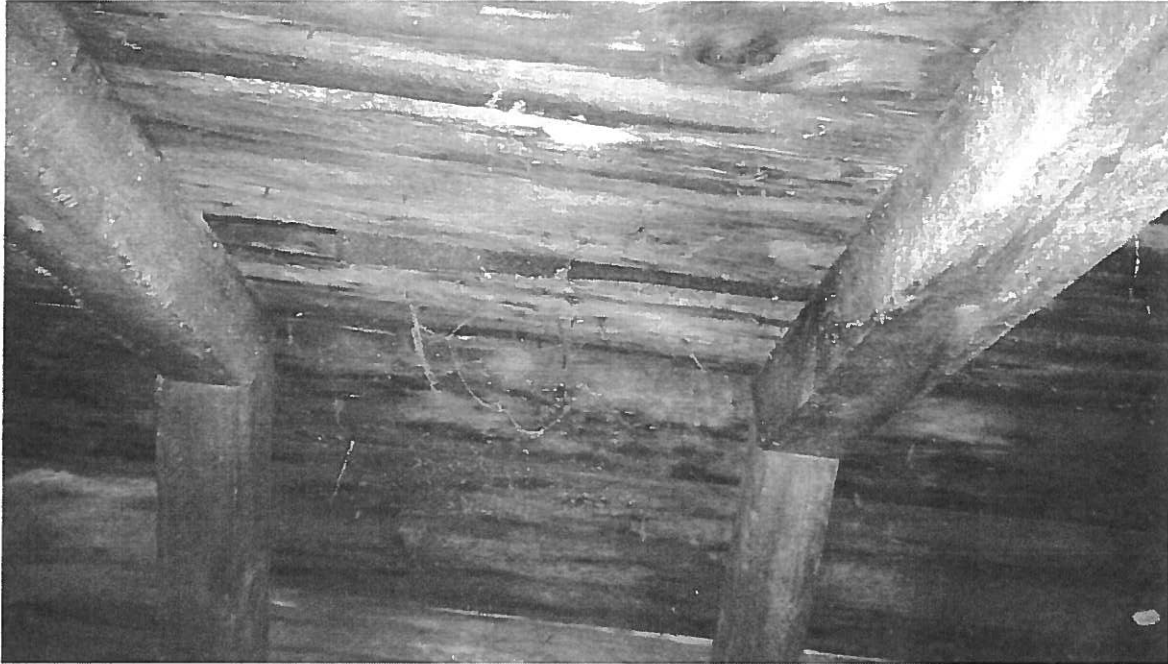
- With this roof structure, there is no ridge beam present. This does not comply with code requirements. In current state, the roof is subject to collapse at any point.

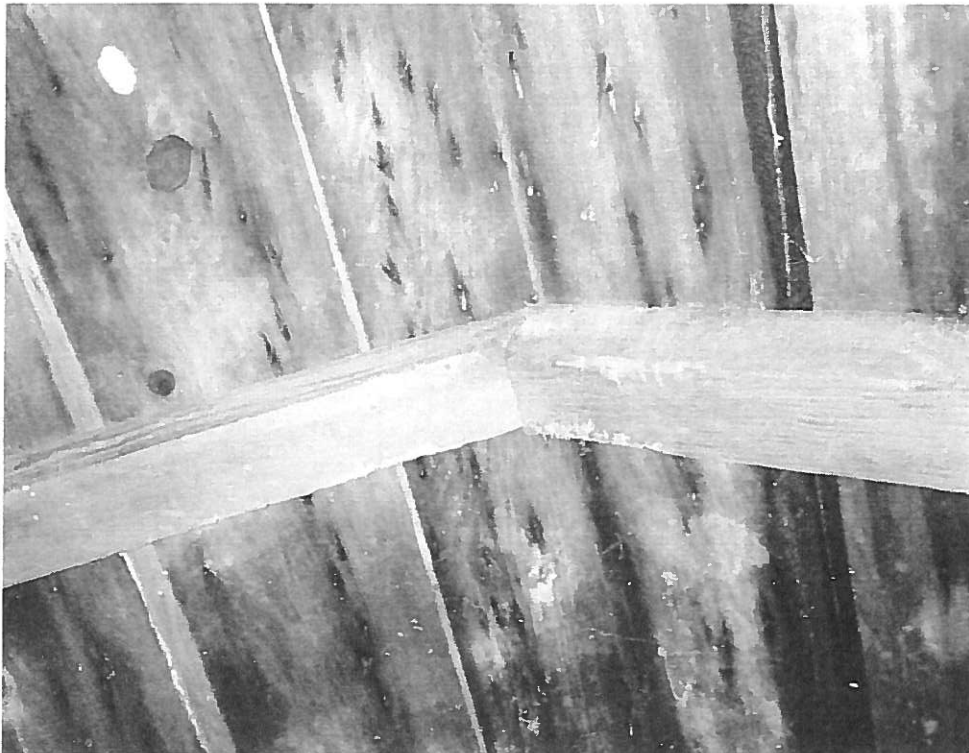
- Exterior walls are out of plum resulting in significant eccentric loading that cannot be supported by the vertical members.

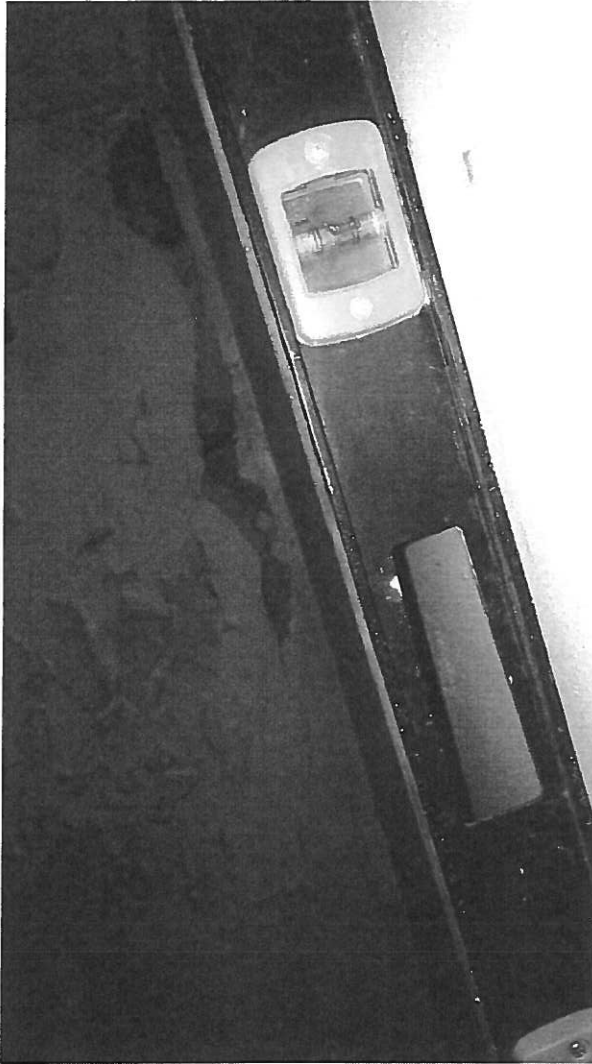
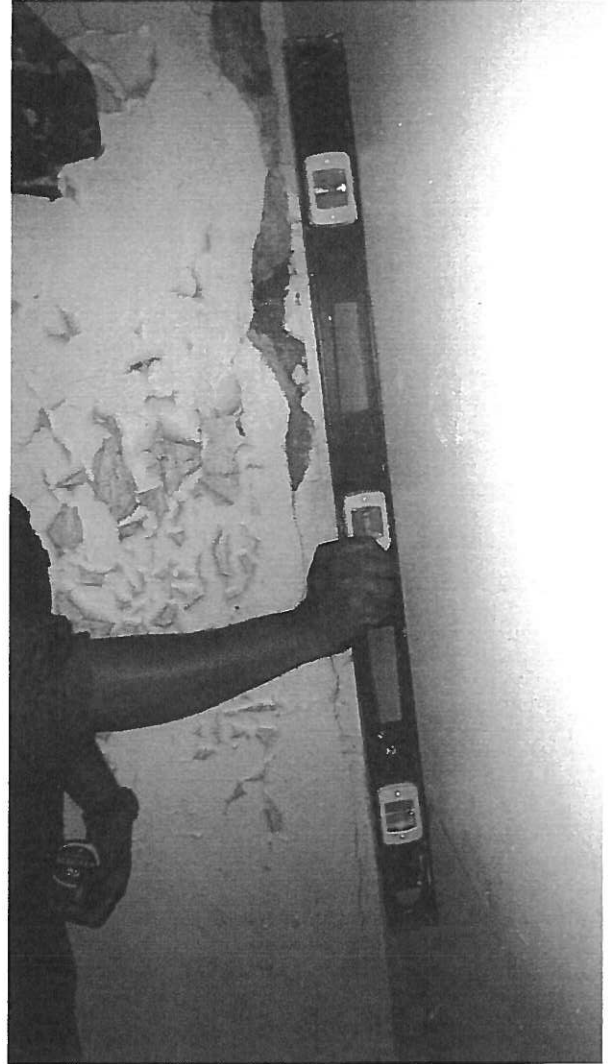
- Above is showing that the interior bedroom walls are out of plumb and uneven.

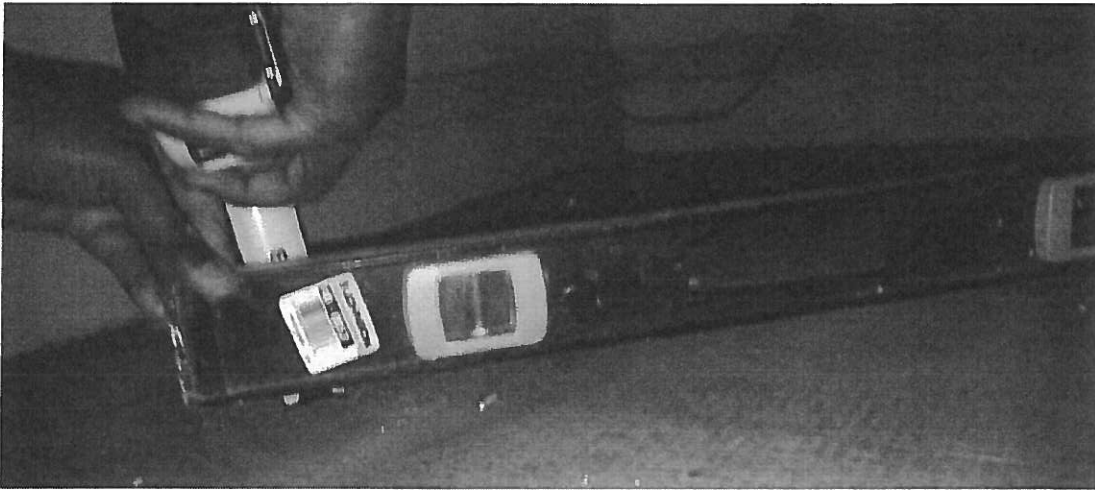
- Floor is out of level beyond what is acceptable by code.

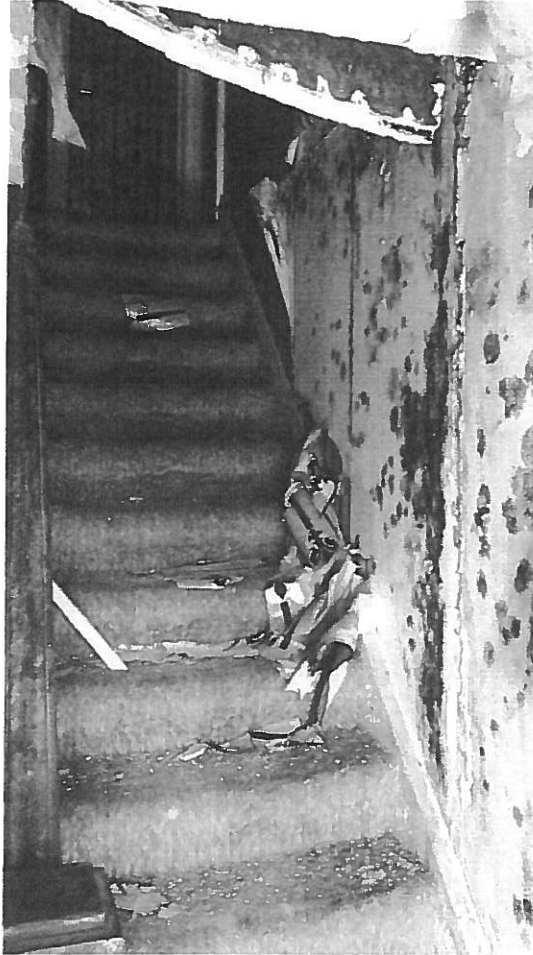
- Main floor staircase. Above, significant amount of mold present. Mold is very hazardous and can be harmful.
