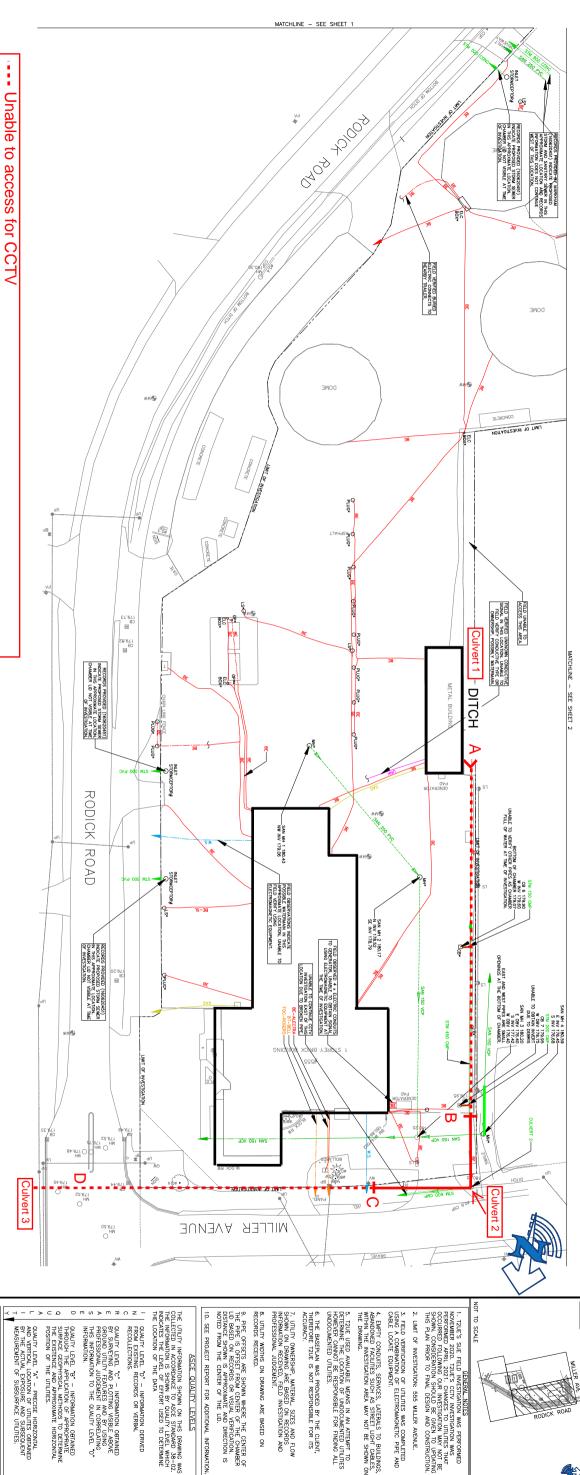
- CCTV access
- A upstream inlet to 450mm CMP pipe could not be located. Likely buried
- B Blockage & extensive debris
- B to Culvert 2 Pipe in poor condition to point of failure
- C Broken pipe, extensive damage & debris

C to D - Likely filled with debris & sediment

existing storm sewer system in the intersection vicinity Culvert 3 - Some clean out of the ditch may minimize a surcharge condition in the
