## MEMORANDUM

**TO:** Heritage Markham Committee

**FROM:** Regan Hutcheson, Manager-Heritage Planning

**SUBJECT:** Request for Feedback  
Proposed Demolitions – 2023  
Rouge National Urban Park

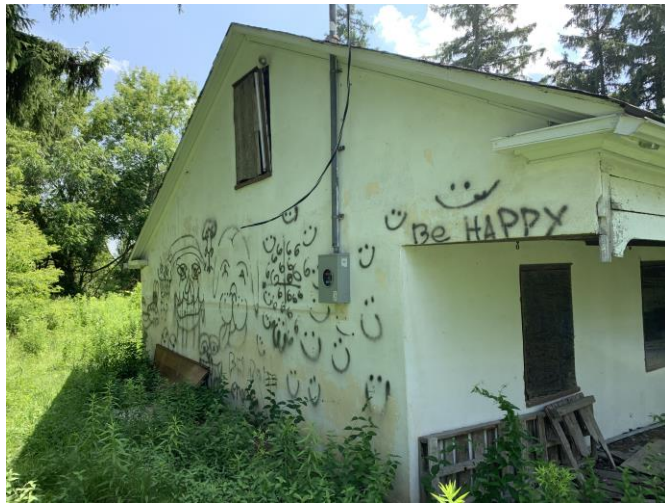
East Elevation, July 4, 2023 (RH) returned eaves

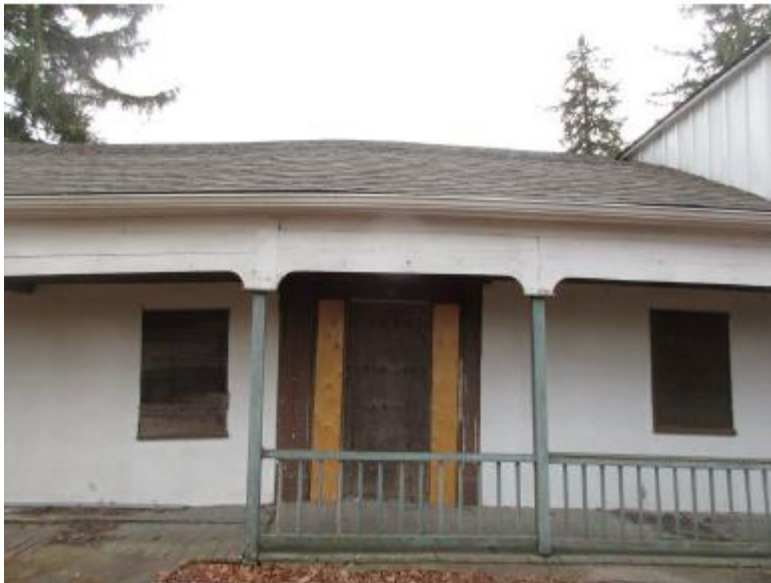
Photo No. 2: North elevation - leaning to the west

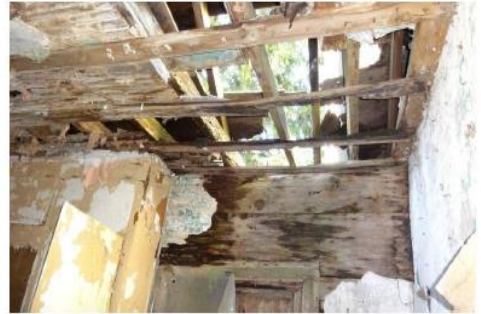
Photo No. 3: Addition - Hole in Roof

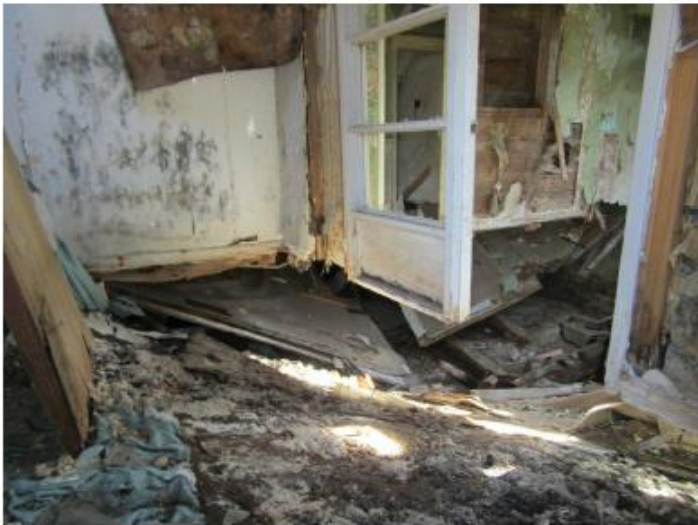
Photo No. 4: Collapsed ground-floor structure

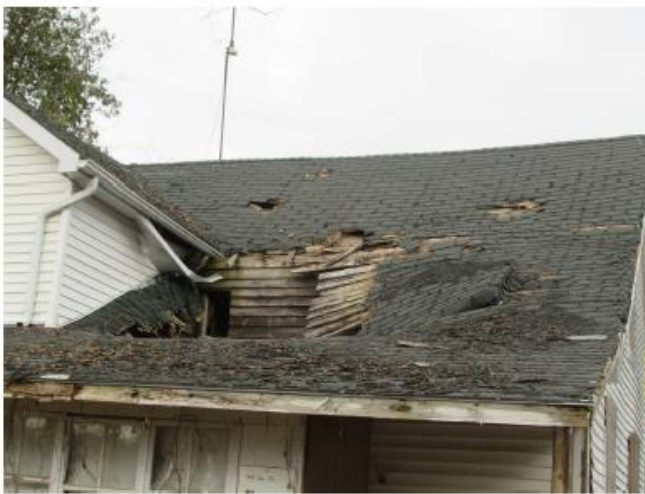
Photo No. 5: Collapsed roof structure from exterior

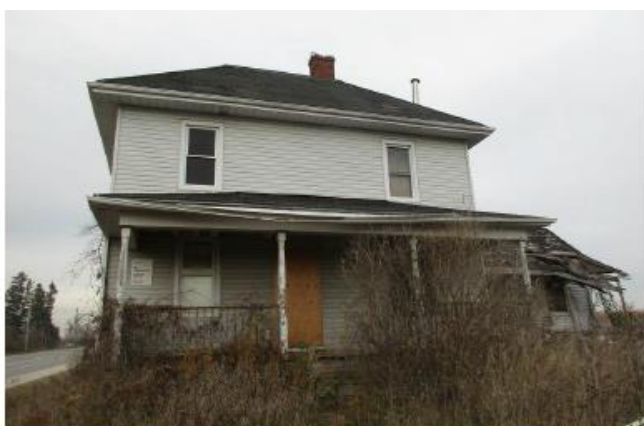
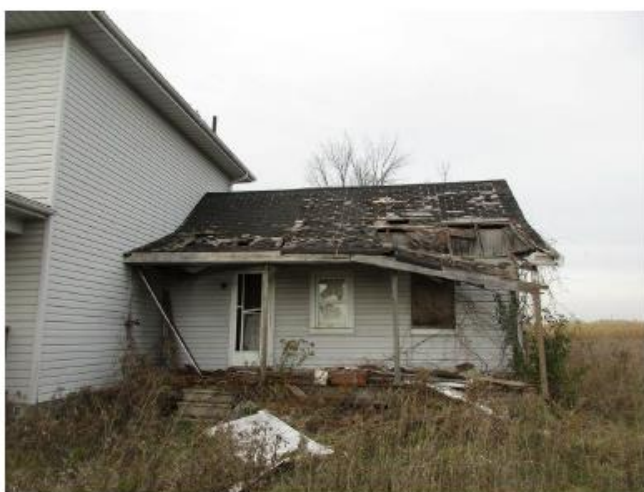
<b>Address</b>	<b>10295 Ninth Line</b>
<b>Heritage Status</b>	Part IV Designation
<b>Location of Building</b>	Close to Ninth Line Overgrown Conditions
<b>Historical</b>	<ul style="list-style-type: none"> <li>• James Brison Johnson House, c. 1915</li> <li>• Noteworthy frame version of an American Foursquare</li> <li>• First owner was a farmer- lived here until 1967</li> <li>• May have replaced an earlier house</li> <li>• Remnant of the agricultural community</li> </ul>
<b>Physical Condition</b>	<p><b>WSP Condition Rating:</b> D2-Structurally Compromised</p> <p><b>WSP Comments:</b></p> <ul style="list-style-type: none"> <li>- Walls are horizontally-oriented <b>vinyl siding</b>, estimated to have been installed in the past 10-20 years. <b>Windows are modern</b> (likely similar vintage to the siding) double-glazing in vinyl frames.</li> <li>- The building <b>structure is compromised</b> and the <b>envelope is severely deteriorated</b>, posing health and safety risks upon entry.</li> <li>- The building is <b>vacant</b> and has not been inhabited for an unknown period of time.</li> <li>- <b>Interior finishes are substantially deteriorated</b> and the building is <b>heavily mould-contaminated</b>. Major abatement and full renewal of all finishes would be required.</li> <li>- A portion of the addition at the <b>east side has a collapsed roof</b> at the junction between the main house and the addition, and about 9' (2.7m) at the east side. Major repairs and rebuilding would be required. The <b>east porch (below the collapsed areas)</b> is also in an advanced state of deterioration.</li> <li>- About half of the concrete <b>slab-on-grade in the basement is heaved and cracked</b>. Replacement would be required. There is an interior concrete foundation wall that is deteriorated and requires replacement (repair is not likely possible as the concrete is weak).</li> <li>- There are <b>holes in the roof, as seen from the attic</b> and the asphalt shingles are old. Full re-roofing, some local wood plank replacements, and finish repairs would be required.</li> <li>- Where seen from grade, the brick <b>chimney is deteriorated</b>.</li> <li>- The <b>furnace is old and corroded</b>. The <b>oil tank is missing</b>. Making the system functional would require chimney repairs (see above), possible relining, replacing the furnace, providing a new oil tank, and extensive improvements/remediation/replacement of the ductwork.</li> <li>- The <b>well head and septic bed were not located</b>. If these have not been maintained, new systems may need to be installed. The domestic hot water tank is very old (likely several generations). A new tank would need to be installed, as well as new water treatment/filtration systems and distribution piping.</li> <li>- The <b>hydro service is disconnected</b> at the service drop and there is no meter. These would need to be reinstated. The main <b>electric breaker panel are old and corroded</b> would require replacement. The distribution wiring would also require replacement</li> </ul>

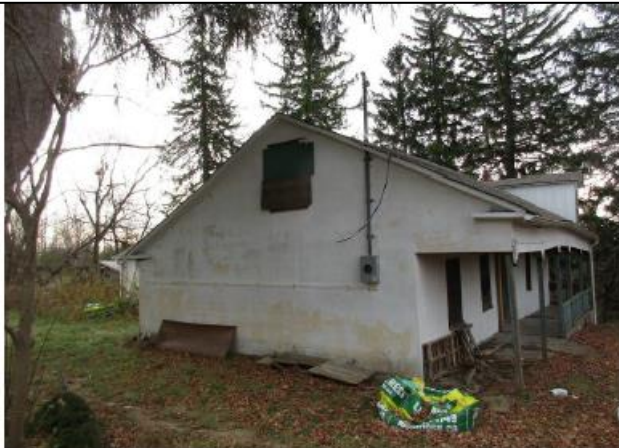
Photo No. 14: East elevation

<b>Address</b>	<b>7933 14<sup>th</sup> Avenue</b>
<b>Heritage Status</b>	Part IV Designation
<b>Location of Building</b>	Close to 14 <sup>th</sup> Ave Overgrown Conditions Adjacent to a parking lot/trail
<b>Historical</b>	<ul style="list-style-type: none"> <li>• James Dimma House, c.1840</li> <li>• Property sold to James Dimma in 1843</li> <li>• 1851 Census- Dimma's in a 1 ½ storey log building</li> <li>• Was a cooperage on the property in 1851 (barrels)</li> <li>• Dimma family came from Scotland- immigrated in 1835</li> <li>• Scottish Presbyterians organized the Zion Church- James was a church elder</li> <li>• Property became Willowdale farm</li> <li>• Building appears to be two structures put together</li> <li>• Early construction techniques</li> </ul>
<b>Physical Condition</b>	<p><b>WSP Condition Rating:</b> D2-Structurally Compromised</p> <p><b>WSP Comments:</b></p> <ul style="list-style-type: none"> <li>- The building structure is compromised and the envelope is severely deteriorated, posing health and safety risks upon entry. With appropriate safety precautions, immediate abatement activities can be completed, before recommended deconstruction.</li> <li>- The building is vacant and has not been inhabited for an unknown period of time.</li> <li>- The building foundations are unstable, and the structure is leaning towards the west at the north wing. The stone foundation walls are cracked and show movement at the northwest and southwest corners and at the joint between the brick chimney and the stone wall. Some exterior repairs have been made, but these are inadequate and have re-cracked due to ongoing movement. Slope and foundation stabilization would be required, in addition to foundation wall and superstructure repairs.</li> <li>- The front porch at the north side is also leaning to the west along with the rest of the structure, and several posts (which support the roof) are hanging freely (i.e., not supported from below). The porch guards are also inadequately supported. Structural repairs would be required.</li> <li>- At the second floor, there is a gap between the stairwell and the east room. The east room slopes down to the east slightly. Structural repairs would be required.</li> <li>- The south wing is also leaning towards the south. The kitchen ground floor is sloped downwards, and is soft underfoot. The crawlspace below is inaccessible, so the extent of deterioration was not confirmed. There is a small hole in the ground floor near the bathroom. In addition to flooring replacements, structural repairs would be required.</li> <li>- Interior finishes are substantially deteriorated and the building is heavily mould-contaminated. Major abatement and full renewal of all finishes would be required.</li> <li>- The stucco cladding is deteriorated. There are cracks throughout, missing sections (typically at the bottom and at corners), peeling finish, and graffiti throughout. Restoration would require abatement/removal and replacement.</li> <li>- All of the windows are boarded up and some are broken; all</li> </ul>

<p>would require replacement.</p> <ul style="list-style-type: none"> <li>- The top of the brick chimney is deteriorated and a clay chimney insert is at an angle. There are loose bricks on the roof.</li> <li>- The furnace and oil tank are missing. The ductwork is corroded and mould-contaminated, and missing in some locations. The domestic hot water tank is very old (likely several generations). A new tank would need to be installed, as well as new water treatment/filtration systems and distribution piping.</li> <li>- The hydro service is disconnected at the service drop and there is no meter.</li> <li>- These would need to be reinstated. The electrical breaker panel could be salvaged/re-used, but the distribution wiring would also require replacement.</li> </ul>
<b>Other Info</b>	City of Markham invested in this property when owned by TRCA- used money provided to City through Southeast Collector project to install new roof

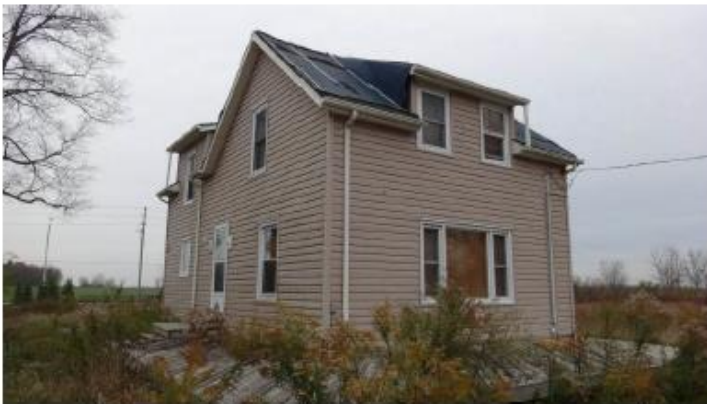
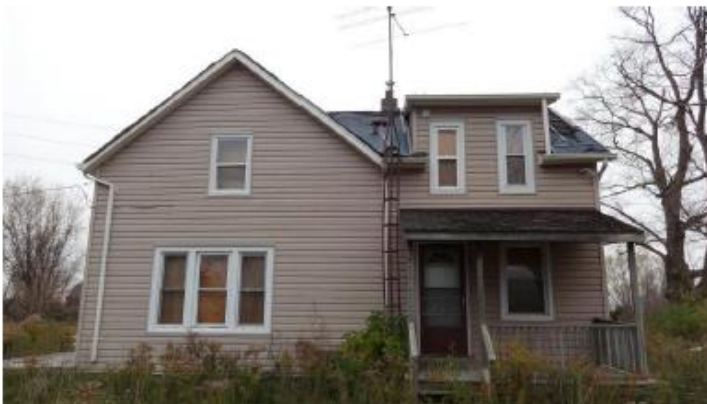
<b>Address</b>	<b>8331 14<sup>th</sup> Avenue</b>
<b>Heritage Status</b>	Listed on Register
<b>Location of Building</b>	Close to 14 <sup>th</sup> Ave/corner lot at York Durham Line Overgrown Conditions
<b>Historical</b>	<ul style="list-style-type: none"> <li>• David Badgerow House, c. 1840</li> <li>• 1851 lists Badgerow and family in a 1 ½ storey log home on this property</li> <li>• 1861 Census – 1 storey log</li> <li>• Badgerow are the only settlers of French origin know to have settled in Markham Township (arrived in early 1800s)</li> <li>• Active in first Markham Baptist Church</li> </ul>
<b>Physical Condition</b>	<p><b>WSP Condition Rating:</b> D2-Structurally Compromised</p> <p><b>WSP Comments:</b></p> <ul style="list-style-type: none"> <li>- vinyl siding appears to <b>be installed over the original wood siding</b>. Windows are vinyl framed units with insulating glass units.</li> <li>- The building <b>structure is compromised</b> and <b>portions of the envelope are severely deteriorated</b>, posing health and safety risks upon entry. With appropriate safety precautions, immediate abatement activities can be completed, before recommended deconstruction.</li> <li>- The windows and doors are <b>currently boarded</b> up except for one access door located on the north elevation. The building appears to have been <b>vacant for at least the past 5 years</b>, but possibly more.</li> <li>- The <b>roofing is in poor condition</b> and a tarp has been installed (several years ago) to mitigate ongoing leakage, which does <b>not appear to have proven effective</b>. There is a <b>hole in the roof above the second floor bathroom</b>. We note <b>extensive wood rot of the roof and wall framing members at this location</b> and the floor framing below was also noted to be soft underfoot, likely due to prolonged exposure in this area. There is also evidence of <b>leakage at the northwest second floor bedroom</b>. The roof and wall framing members in this area are also soft and water stained from ongoing leakage. We expect structural repairs would be required at these areas and likely other areas that are covered by the finishes and show similar <b>heavy water staining</b>.</li> <li>- The <b>interior finishes are substantially deteriorated</b> and the building <b>likely contains designated substances</b>. Major abatement and full renewal of all finishes is required.</li> <li>- Within the basements, there are numerous additional supports installed at the mid-spans and other locations to <b>address sagging floor joists</b>. These supports are installed without proper foundations and lateral restraint.</li> <li>- The mechanical and electrical systems are not operational and have likely been in this state for some time. <b>Complete renewal of the mechanical and electrical equipment would be required</b>. This would include, but not limited to, replacement of furnace, oil tank and portions of the distribution ductwork, domestic hot water tank heater and distribution piping, the main electrical panel, and likely most of the associated wiring as a large portion of the wiring is of an older vintage.</li> <li>- The <b>vinyl cladding and windows are generally in fair condition</b> with no major concerns noted. We suspect the cladding and windows are about 15 years old. However, the <b>underlying wall structure is locally compromised</b> and we expect at least partial replacement of the cladding would be required in order to properly address structural deterioration.</li> </ul>

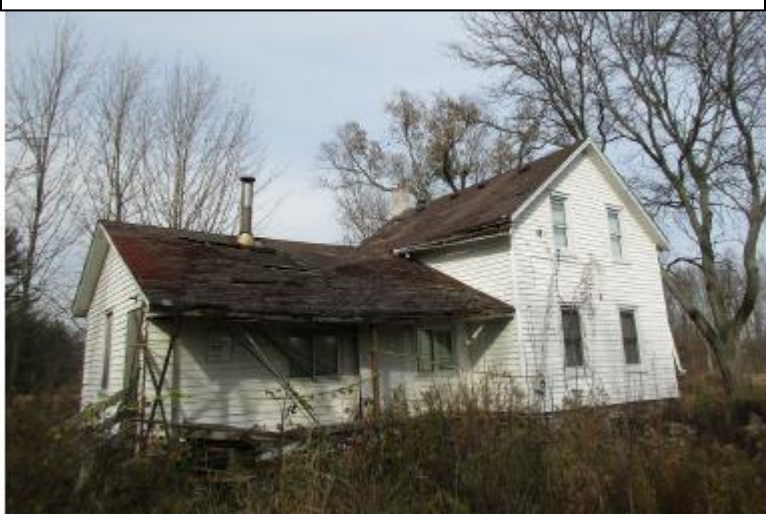
Photo No. 1: South elevation

<b>Address</b>	<b>10676 Reesor Rd</b>
<b>Heritage Status</b>	Part IV Designation
<b>Location of Building</b>	Fair Distance from Road Overgrown Conditions
<b>Historical</b>	<ul style="list-style-type: none"> <li>• Adam Betz House, c. 1871</li> <li>• 1 ½ storey frame near crossroads of Elgin Mills and Reesor (Mongolia)</li> <li>• Classic Ontario Farmhouse</li> <li>• German immigrant who was a farmer</li> <li>• Descendants owned the property until 1955</li> <li>• Remnant of the Markham's agricultural community</li> </ul>
<b>Physical Condition</b>	<p><b>WSP Condition Rating:</b> D2-Structurally Compromised</p> <p><b>WSPComments:</b></p> <ul style="list-style-type: none"> <li>- Exterior walls are clad with vinyl siding, which is clad over Insulbrick (similar to asphalt shingles with a stamped brick pattern) over the original wood tongue-and-groove.</li> <li>- The building structure is compromised and the envelope is severely deteriorated, posing health and safety risks upon entry. With appropriate safety precautions including items noted below, immediate abatement activities can be completed, before recommended deconstruction.</li> <li>- The building is in an advanced state of deterioration.</li> <li>- Foundation walls are mortared field stone; they are generally free of major deterioration or displacement;</li> <li>- Joists are largely intact, but considerable wetness in subflooring; there may be sections of weakened subflooring due to many years of being covered by wet insulation and plaster;</li> <li>- Basement joists and subflooring are generally intact;</li> <li>- Wood cover on the exterior basement/cellar steps is rotted and unsafe;</li> <li>- Studs and sheathing in the south wall in the west extension, at the south porch, are substantially rotted due to exposure to water over the long term;</li> <li>- Porch roof structure has partially collapsed; the extension roof rafters remain in place but there are large holes in the sheathing;</li> <li>- Main east portion stud walls appear to be mostly intact on the ground floor as there is no evidence of leakage through walls and windows;</li> <li>- Main roof rafters and sheathing have not failed; since there are holes in the west slope of the main roof, leakage has been occurring down the southwest side of the 2nd floor - we made exploratory openings in the finishes in this area and found limited rot in one stud and top plate but no extensive framing damage;</li> <li>- Did not enter the attic.</li> <li>-The structure can be made safe enough for workers to carry out hazardous materials remediation</li> </ul>

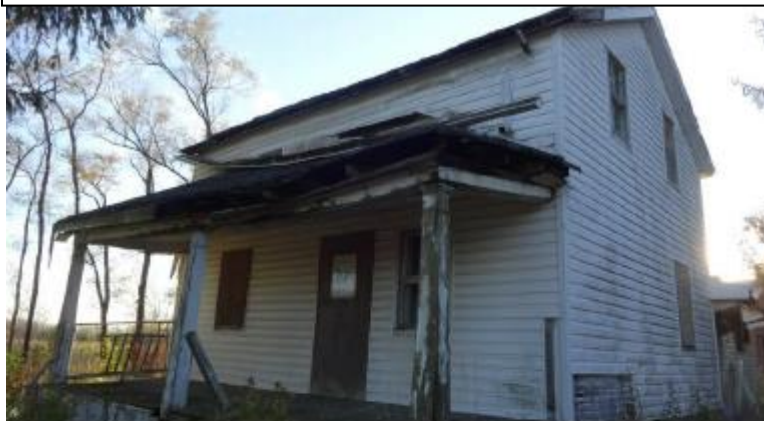
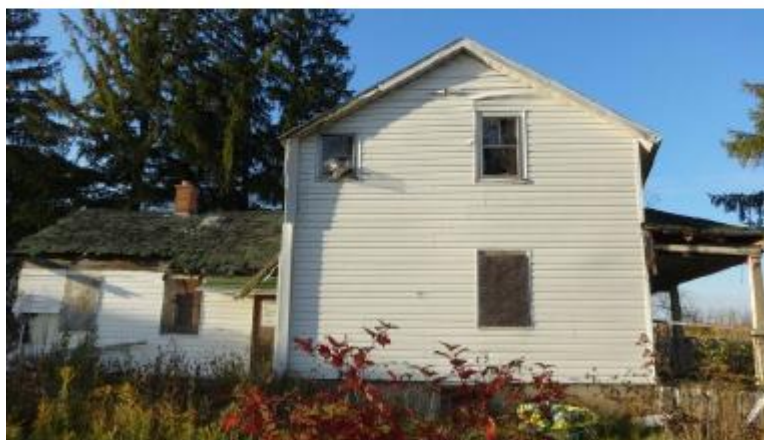
<b>Address</b>	<b>11122 Reesor Rd</b>
<b>Heritage Status</b>	Part IV Designation
<b>Location of Building</b>	Fair Distance from Road Overgrown Conditions
<b>Historical</b>	<ul style="list-style-type: none"> <li>• Noble Tenant Farmer's House, c. 1840</li> <li>• Originally a Crown reserve lot</li> <li>• American Ambrose Noble purchase in 1840 who lived in Mount Joy and operated a tannery (in 1851, the property was occupied by John Smith)</li> <li>• Appears he rented this house to others</li> <li>• Modestly scaled frame house- Georgian tradition - front veranda c. early 20<sup>th</sup> C</li> <li>• One storey kitchen wing that may be the earliest part of the building</li> <li>• Part of the Mongolia hamlet community/remnant of agricultural history</li> <li>• Barn is associated with the house</li> </ul>
<b>Physical Condition</b>	<p><b>WSP Condition Rating:</b> D3- Structurally Unsafe/ D2 Structurally Compromised (Main House)</p> <p><b>WSP Comments:</b></p> <ul style="list-style-type: none"> <li>- Exterior walls are clad in vinyl siding over the original wood siding. Windows and doors are boarded up but consist of original wood sliders with outer metal storm windows.</li> <li>- The building is partially collapsed and unfit to enter. It poses an imminent health and safety risk upon entry and within the immediate surrounding. Entry to the north addition for investigation, rehabilitation or abatement is not feasible in its current condition. Demolition is recommended.</li> </ul> <p>However, the original house should be classified as a D2 – Structurally Compromised. The building structure is compromised and the envelope is severely deteriorated, posing health and safety risks upon entry. With appropriate safety precautions, immediate abatement activities can be completed, before recommended deconstruction.</p> <ul style="list-style-type: none"> <li>- The floor of the west addition has collapsed, likely due to prolonged exposure to moisture. Visible from the basement, the central beam supporting the floor joists in this area has failed. The roof has a large hole and is also partially collapsed. THIS AREA SHOULD NOT BE ENTERED.</li> <li>- The structure of the original (two storey east portion) house is compromised due to continued poor performance of the roofing. Wood rot was noted at framing members in multiple locations.</li> <li>- The cladding system is in very poor condition and is no longer providing an acceptable barrier to the elements. There are areas of the cladding that are partially detached and at risk of falling.</li> <li>- In order to safely complete abatement activities at the main house level, the following is required: <ul style="list-style-type: none"> <li>- provide means of safely accessing the house; the structure of the front porch is compromised and will need to be re-enforced to allow multiple workers from entering and exiting the house.</li> <li>- clear excessive amount of debris from rooms and floors so that workers can safely perform duties. This will also allow for closer inspection of flooring in some areas.</li> </ul> </li> </ul>

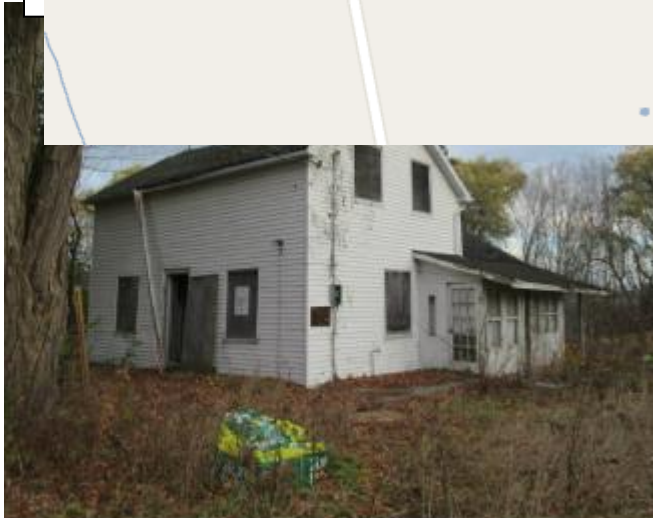
Photo No. 1: Southwest view

<b>Address</b>	<b>11223 Reesor Rd</b>
<b>Heritage Status</b>	Part IV Designation
<b>Location of Building</b>	Short Distance from the Road Overgrown Conditions
<b>Historical</b>	<ul style="list-style-type: none"> <li>• James Collins House, c.1850</li> <li>• 1 ½ storey frame dwelling</li> <li>• Typical example of modest tradesman house</li> <li>• Vernacular Georgian Tradition</li> <li>• Collins was an Irish immigrant who purchase the land in 1849</li> <li>• Carpenter by trade and likely built this house</li> <li>• Sold to the Vanzant family holdings in 1865</li> <li>• Part of hamlet of Mongolia; remnant of the agricultural community</li> </ul>
<b>Physical Condition</b>	<p><b>PC Condition Rating:</b> D3- Structurally Unsafe</p> <p><b>Comments:</b></p> <ul style="list-style-type: none"> <li>- The building is wood and timber-framed on stone foundation walls. The exterior walls are clad in vinyl siding which has been installed over preexisting cladding systems including Insulbrick and original wood siding. Windows and doors are boarded up but consist of vinyl-framed windows with IGUs and wood doors.</li> <li>- There is significant structural deterioration</li> <li>- Roof structure of the addition has partially collapsed;</li> <li>- Large opening in the roof over the addition, damaged/cracked wood framing throughout, and wood rot at ground floor framing where water exposure is evident;</li> <li>- Significant heaving of the concrete slab-on-grade and cracking throughout in the basement; and</li> <li>- East foundation wall of the original building is leaning and there is mortar deterioration and missing stones in the west foundation wall.</li> <li>- Based on the extent of structural deterioration, we confirm that the building be demolished. Based on the condition of the roof structure and basement/foundation structure, we do not believe the building is structurally safe to perform abatement activities prior to demolition.</li> </ul>

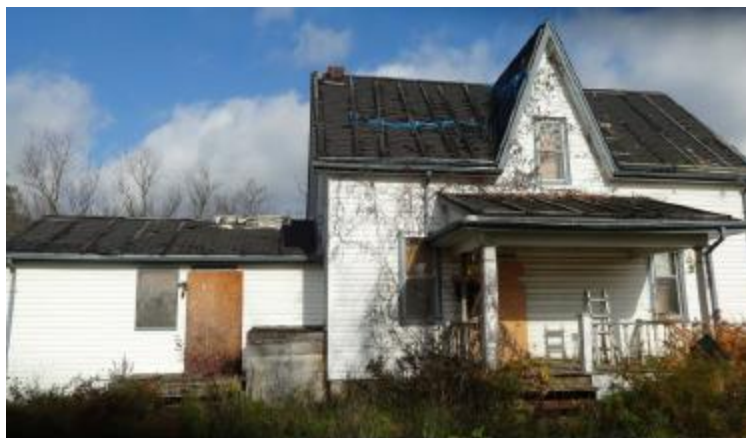
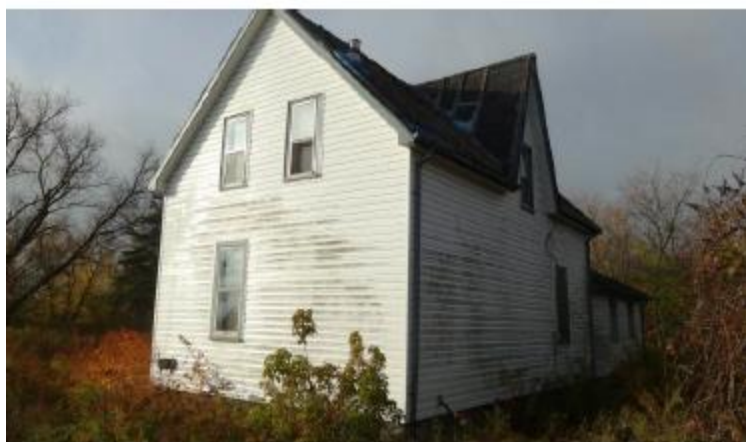
<b>Address</b>	<b>8200 York Durham Line</b>
<b>Heritage Status</b>	Listed on the Register
<b>Location of Building</b>	Close to the Road, boundary with Pickering Overgrown Conditions
<b>Historical</b>	<ul style="list-style-type: none"> <li>• William Boyd House, c. 1890</li> <li>• Gothic Revival design</li> <li>• Located in former crossroad community of Bedford (at 5<sup>th</sup> line in Pickering)</li> <li>• Boyd operated a general store and post office in Bedford during the early 1880s</li> </ul>
<b>Physical Condition</b>	<p><b>WSP Condition Rating:</b> D2-Structurally Compromised</p> <p><b>WSP Comments:</b></p> <p>. The above-grade structure is wood-framed. The original house has stone and mortar foundation walls and the addition has some cast-in-place concrete foundation walls. There are supplemental steel beams and steel posts to support the original main floor structure at the east side.</p> <p>- The exterior walls are wood-framed and clad with vinyl siding. The vinyl siding appears to be installed over the original wood siding. Windows are a combination of vinyl framed units with insulating glass units and single-glazed and wood-framed.</p> <p>- The building structure is compromised and portions of the envelope are severely deteriorated, posing health and safety risks upon entry. With appropriate safety precautions, immediate abatement activities can be completed, before recommended deconstruction.</p> <p>- The building is currently vacant and windows and doors are boarded up. It appears that the house has been vacant for about 10 years but this could not be confirmed.</p> <p>-The basement appears to have been subject to (likely repeated) flooding events.</p> <p>- The structure is generally adequate for abatement activities, however, we note a number of structural concerns including the following:</p> <ul style="list-style-type: none"> <li>- extensive water damage at the the west addition due to large openings in the roof and prolonged exposure to the elements of the underlying wood structure;</li> <li>- corroded bases of the supplemental steel posts at the basement level;</li> <li>- localized floor joists that are water damaged at the perimeter foundation walls;</li> <li>- missing treads and weakened staircase leading to the basement;</li> <li>- the porches at the south side are generally in poor and unsafe condition and require full rebuilding; we assume minor/temporary reinforcements can be completed prior to abatement activities.</li> <li>- localized erosion of mortar within stone foundation walls, likely due to prolonged moisture exposure and freeze-thaw cycles.</li> </ul> <p>- In advance of abatement activities, we recommend a general contractor make local reinforcements as required to ensure safety for workers.</p> <p>- This applies primarily to entrance steps and basement steps and some joists.</p> <p>- The roofing is in poor condition and a tarp was installed (several years ago) to mitigate ongoing leakage. The tarp has since deteriorated and is absent. There are holes in the roof of the addition and evidence of ongoing leakage in other areas of the house</p> <p>.-The vinyl siding is generally intact but aged and has a stained appearance. - Windows are old and wood-framed with outer storm windows and will require</p>

<p>replacement due to a large number of broken units.</p> <ul style="list-style-type: none"> <li>- The interior finishes are substantially deteriorated and the building likely contains designated substances. Major abatement and full renewal of all finishes would be required.</li> <li>- The mechanical and electrical systems are not operational and have likely been in this state for some time. The electrical supply to the building is disconnected and the oil tank is no longer present. Complete renewal of the mechanical and electrical equipment would be required. This would include, but not limited to, replacement of the furnace, oil tank and portions of the distribution ductwork, domestic hot water tank heater and filtration/sterilization equipment and distribution piping, the main electrical panel, and likely most of the associated wiring as a large portion of the wiring is of an older vintage</li> </ul>

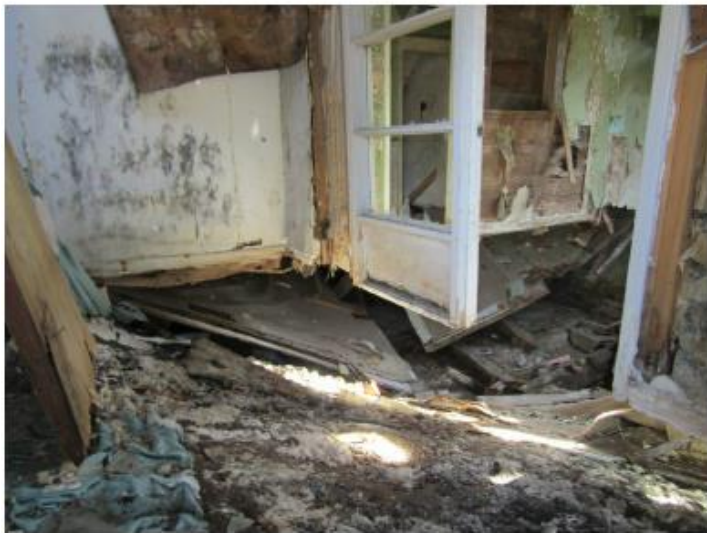
<b>Address</b>	<b>11190 York Durham Line</b>
<b>Heritage Status</b>	Part IV Designation
<b>Location of Building</b>	Close to Road Overgrown Conditions
<b>Historical</b>	<ul style="list-style-type: none"> <li>• John Boyles House, c 1870</li> <li>• 1 ½ storey frame dwelling, Classic Ontario farmhouse</li> <li>• Has canted bay windows on the north and south gable ends</li> <li>• One storey kitchen wind</li> <li>• Boyles was an American of German origin – purchased the property in 1839</li> <li>• Boyles was a labourer, sawyer and farmer</li> <li>• Appears to be his retirement home after his son took over the family farm</li> <li>• Remnant of agricultural community/ Mongolia/ retirement theme</li> </ul>
<b>Physical Condition</b>	<p><b>WSP Condition Rating:</b> D3- Structurally Unsafe</p> <p><b>WSP Comments:</b></p> <ul style="list-style-type: none"> <li>- The house has been abandoned for an unknown period of time. Most window and doors are boarded up.</li> <li>- Where accessible to view (addition), the house is founded on concrete block foundation walls.</li> <li>- The above grade structure is wood-framed.</li> <li>- The exterior walls are clad with horizontally-oriented vinyl siding. Where the siding is missing on the original portion of the house, the siding is installed over faux brick asphalt shingle. Where accessible to view, the windows are in wood frames. However, the second-floor windows are vertical sliders in either aluminum or vinyl frames.</li> <li>- The overall building condition is classified as D3 - Structurally Unsafe. The building is partially collapsed and unfit to enter. It poses an imminent health and safety risk upon entry and within the immediate surrounding. Entry for investigation, rehabilitation or abatement is not feasible in its current condition. Demolition is recommended.</li> </ul> <p>There are several severe conditions that warrant this building as structurally unsafe. These are as follows:</p> <ul style="list-style-type: none"> <li>- The entirety of the ground-floor structure has collapsed; this leaves the main floor inaccessible and the structure above vulnerable to collapse.</li> <li>- There are holes in the roof that have led to moisture damage to the roof wood decking, rafters and interior finishes.</li> <li>- The east canopy roof also has a hole in it that has led to moisture damage to the wood decking (and possibly the wood rafters) and the wood soffit.</li> <li>- We could not enter the house to confirm the condition of the electrical breaker panel and furnace, but these are likely in a state of disrepair given the overall condition of the house. We could not confirm the location of the septic system</li> </ul>

Photo No. 4: Collapsed ground-floor structure
