MEMORANDUM

TO: Heritage Markham Committee

FROM: Regan Hutcheson, Manager-Heritage Planning

SUBJECT: REQUEST FOR FEEDBACK – SITE VISIT
PROPOSED DEMOLITIONS – 2023
ROUGE NATIONAL URBAN PARK

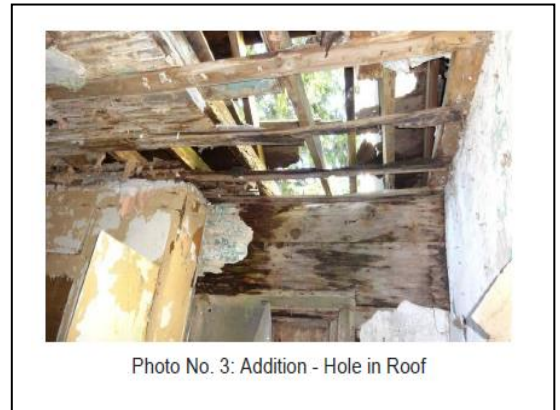
Photo No. 3: Addition - Hole in Roof

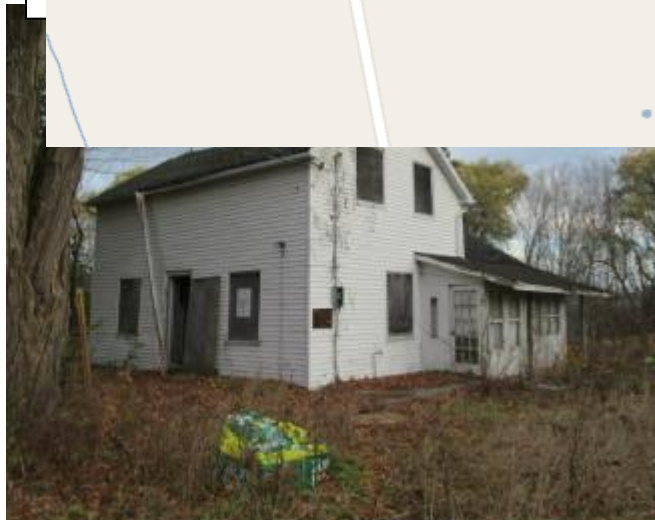
Address	11223 Reesor Rd
Heritage Status	Part IV Designation
Location of Building	Short Distance from the Road Overgrown Conditions
Historical	<ul style="list-style-type: none"> • James Collins House, c.1850 • 1 ½ storey frame dwelling • Typical example of modest tradesman house • Vernacular Georgian Tradition • Collins was an Irish immigrant who purchase the land in 1849 • Carpenter by trade and likely built this house • Sold to the Vanzant family holdings in 1865 • Part of hamlet of Mongolia; remnant of the agricultural community
Physical Condition	<p>PC Condition Rating: D3- Structurally Unsafe</p> <p>Comments:</p> <ul style="list-style-type: none"> - The building is wood and timber-framed on stone foundation walls. The exterior walls are clad in vinyl siding which has been installed over preexisting cladding systems including Insulbrick and original wood siding. Windows and doors are boarded up but consist of vinyl-framed windows with IGUs and wood doors. - There is significant structural deterioration - Roof structure of the addition has partially collapsed; - Large opening in the roof over the addition, damaged/cracked wood framing throughout, and wood rot at ground floor framing where water exposure is evident; - Significant heaving of the concrete slab-on-grade and cracking throughout in the basement; and - East foundation wall of the original building is leaning and there is mortar deterioration and missing stones in the west foundation wall. - Based on the extent of structural deterioration, we confirm that the building be demolished. Based on the condition of the roof structure and basement/foundation structure, we do not believe the building is structurally safe to perform abatement activities prior to demolition.

Photo No. 1: Southwest view
