MEMORANDUM

SUBJECT: **Demolition Permit Application**
10 Ruggles Avenue, Thornhill (Langstaff) - Munshaw House
Fire Damage

FILE: 24 179349 DP

**Re: 10 Ruggles Avenue (Munshaw House), Thornhill – Structural Condition Assessment
Facet Group Inc. project no. 202418**

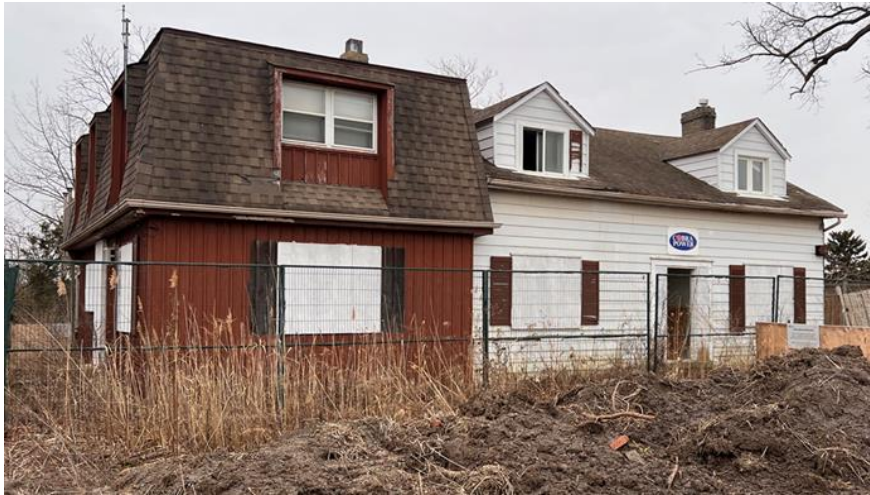
Prior to the removal of the newer addition

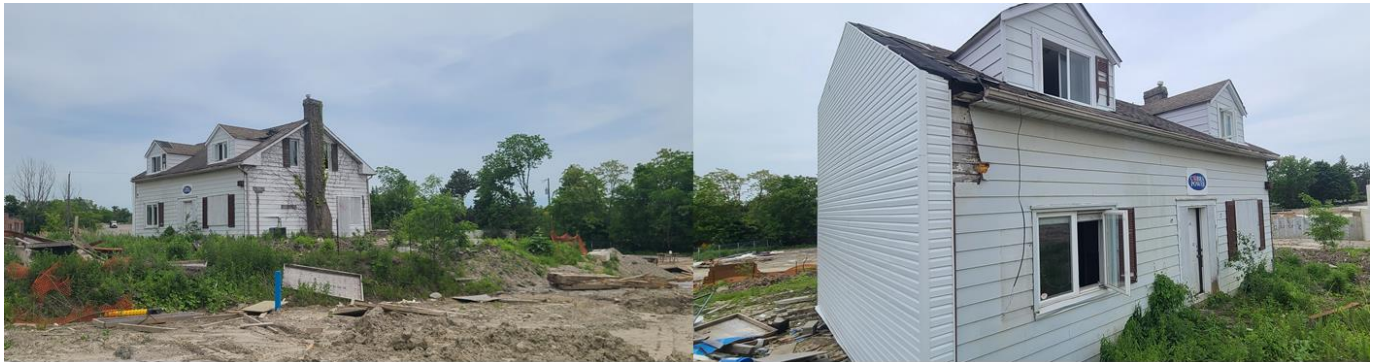
After the removal of the newer addition

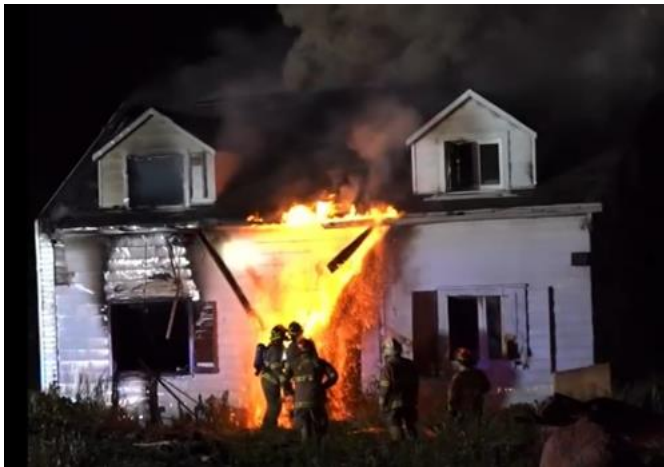
During the fire

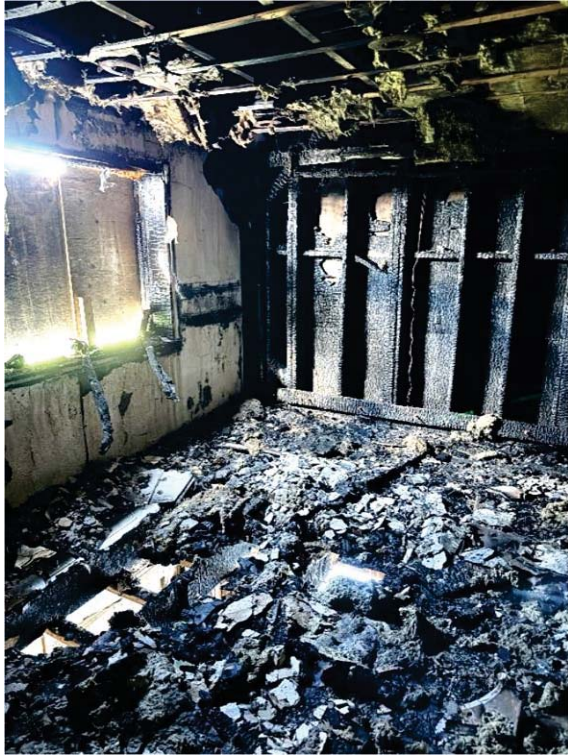
GROUND FL LOOKING NORTH EAST

The building was subject to a major structural fire on June 15, 2024. The fire appears to have been concentrated in the east half of the building, and the second floor and attic. A later east addition was found to have been removed, a timber framed shear wall was constructed to enclose the gable end.

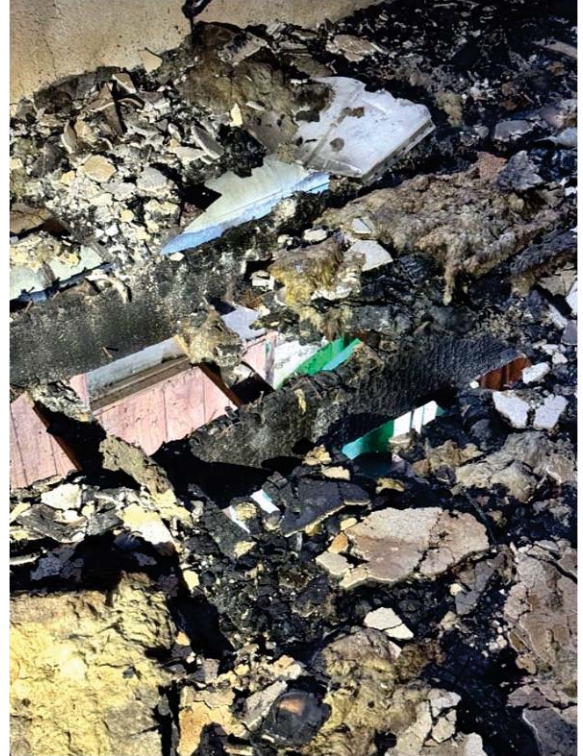
Areas of the ground floor sheathing were found to have been missing or lost to the fire, specifically in the east half; visible douglas fir floor joists were found to have sustained moderate to severe damage. Areas of original lathe and plaster at the north elevation and the north south interior demised wall were found to have been lost to the fire; the douglas fir stud framing members, including the bottom and top plates were found to have sustained severe damage and areas of total loss.

GROUND FL JOISTS AND SHEATHING

The remaining sound attributes, specifically the original douglas fir ground floor joists from the west portion of the building, may be salvaged during the demolition and cleanup. The original front doorframe and multi-paned sidelights may be able to be salvaged once the roof and second floor framing are removed. Areas of the clapboard siding or representative samples should be able to be salvaged. The foundation and plinth stone can be salvaged.

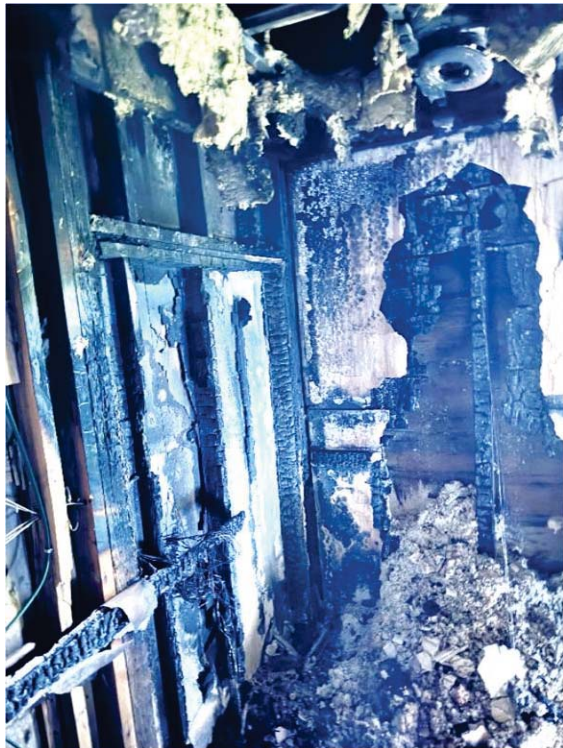
GROUND FL DEMISED WALL

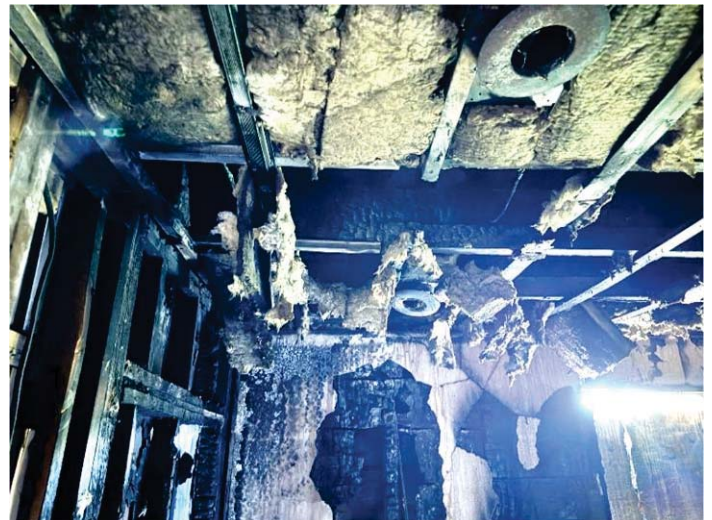
The ceiling finishes were found to have let go and were destroyed by the fire; the second floor framing members generally appeared to have sustained moderate fire damage with select members in the east portion sustaining severe damage.

SECOND FL FRAMING

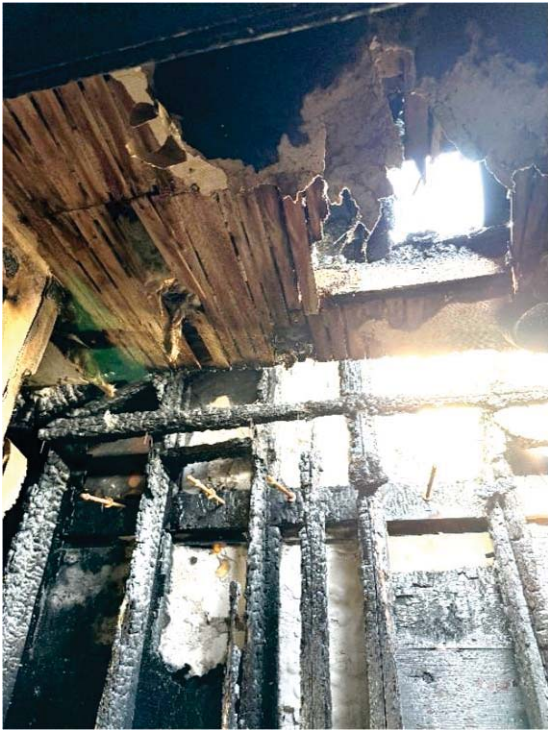
SECOND FL AND CEILING FRAMING

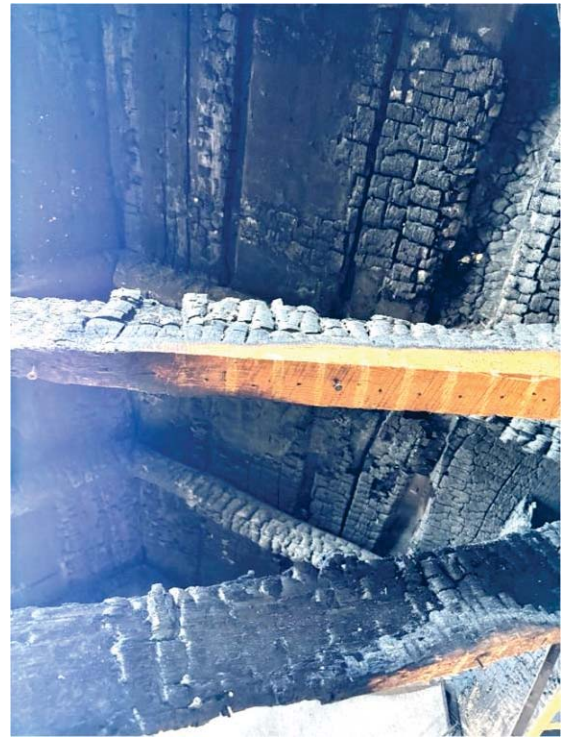
The second floor and attic framing were found to have sustained moderate to severe damage. The original rafters were found to have been constructed using 50 x 100 douglas fir timber spaced at +/- 600mm and sheathed with 25mm barn boards; the roof was constructed without a ridge beam. The rafters and sheathing, sill plates, rafter tails, and the soffit framing were found to have sustained severe damage including areas of total loss.

ROOF FRAMING 1

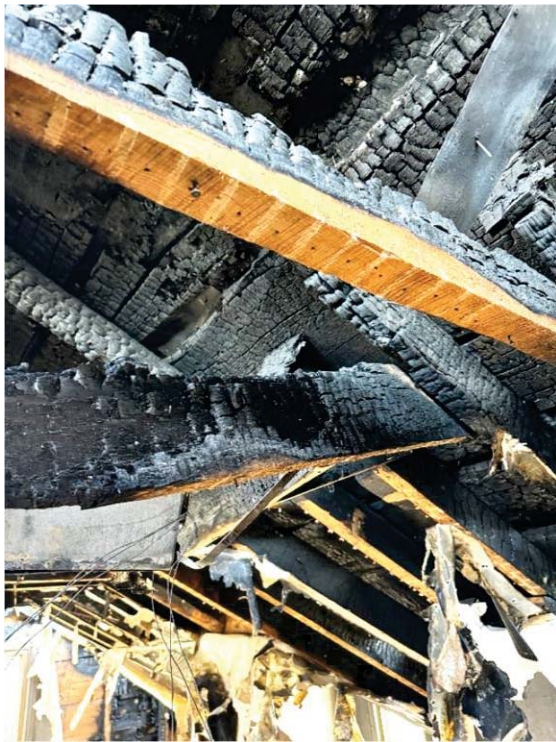
ROOF FRAMING 2

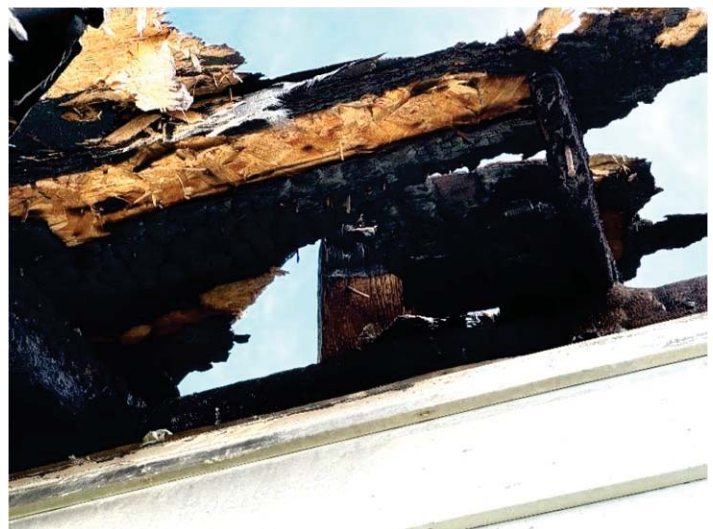
RAFTER TAIL AND SOFFIT FRAMING

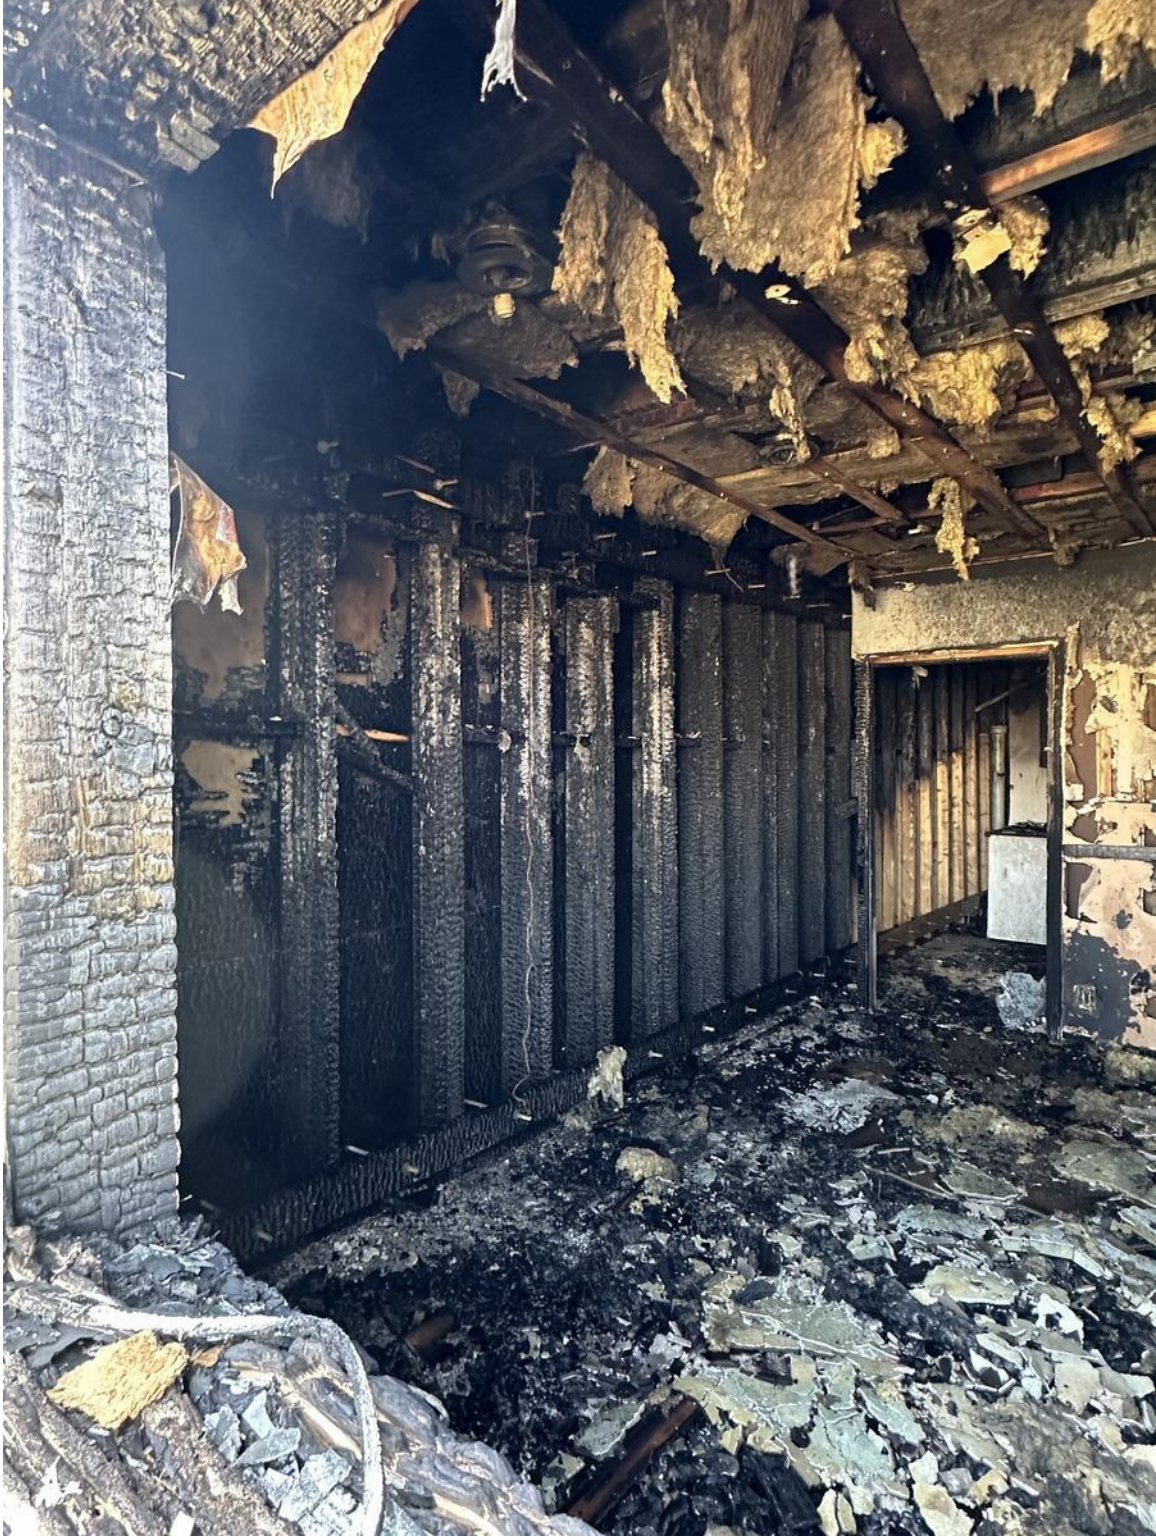
- Smoke and fire damage around the exterior of upper and lower floor windows and some areas of the roof.
- Significant charring of wall studs.
- Significant charring of joists above the main floor.
- Loss of the flooring structure on the main floor and significant charring of the underlying floor joists.
- Interior finished have been destroyed or smoke damaged.

Photo 5 – Interior View Showing Significantly Charred Wall Studs

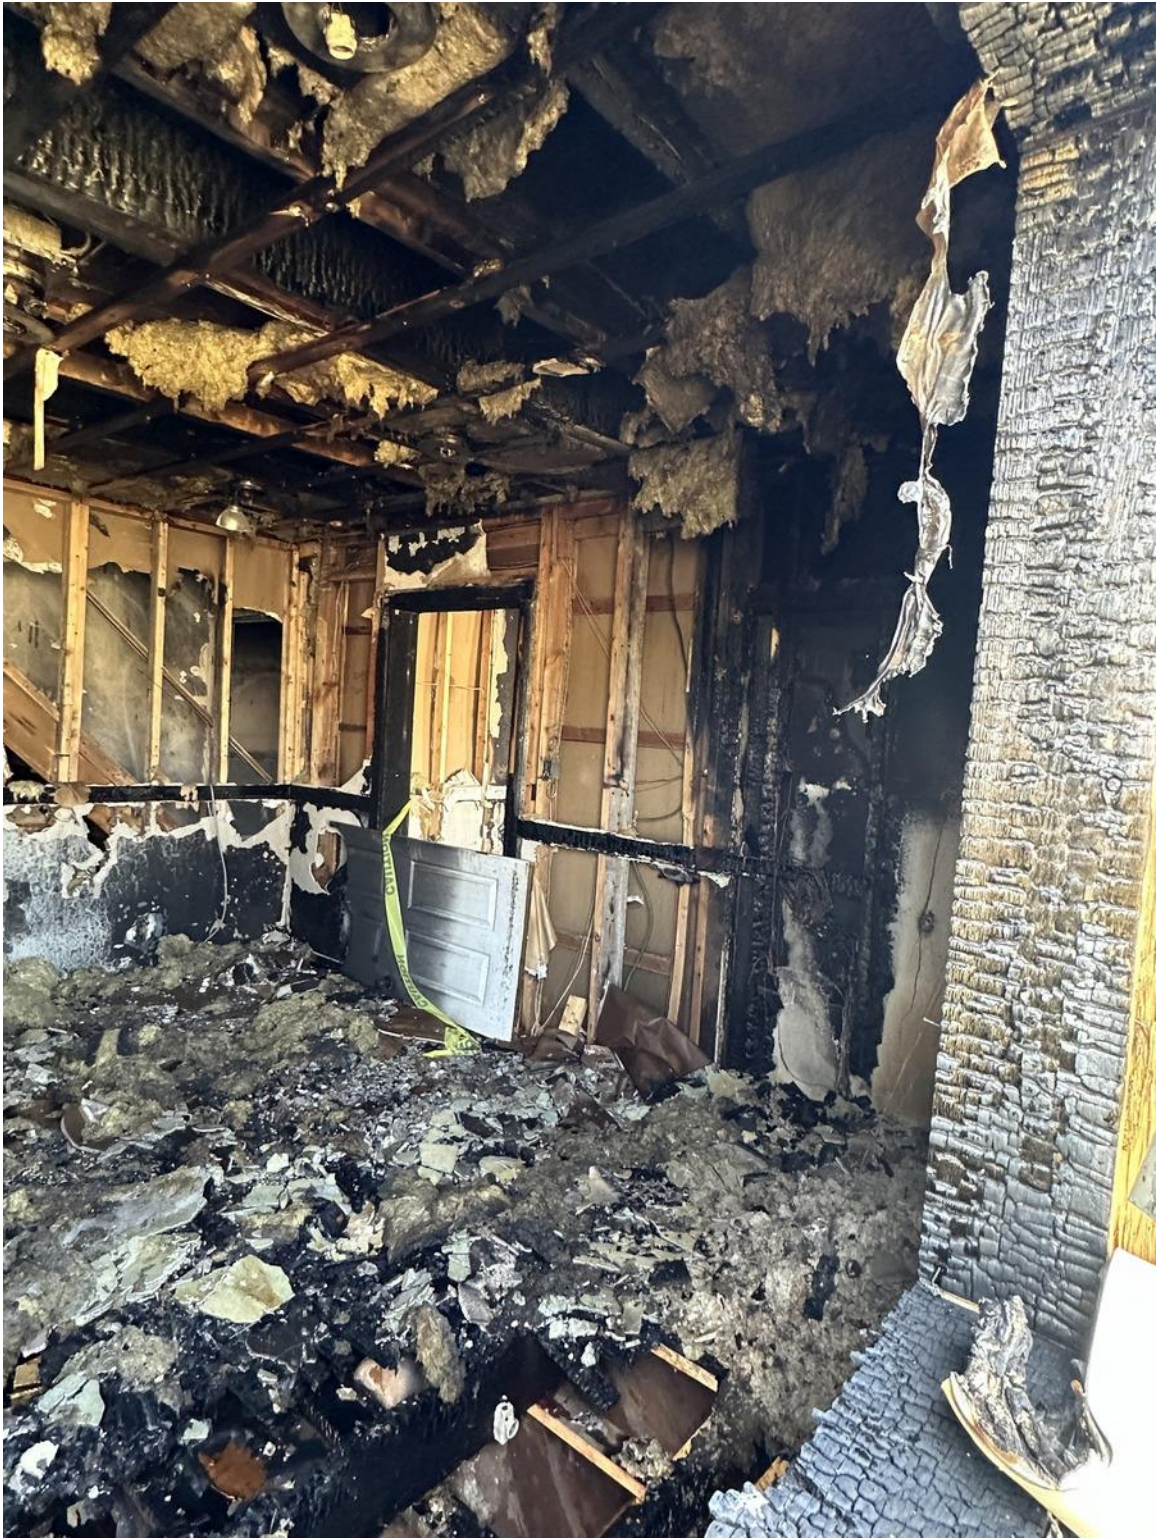
Photo 6 – Interior View Showing Damage to Floor Structure Above and Below Main Floor

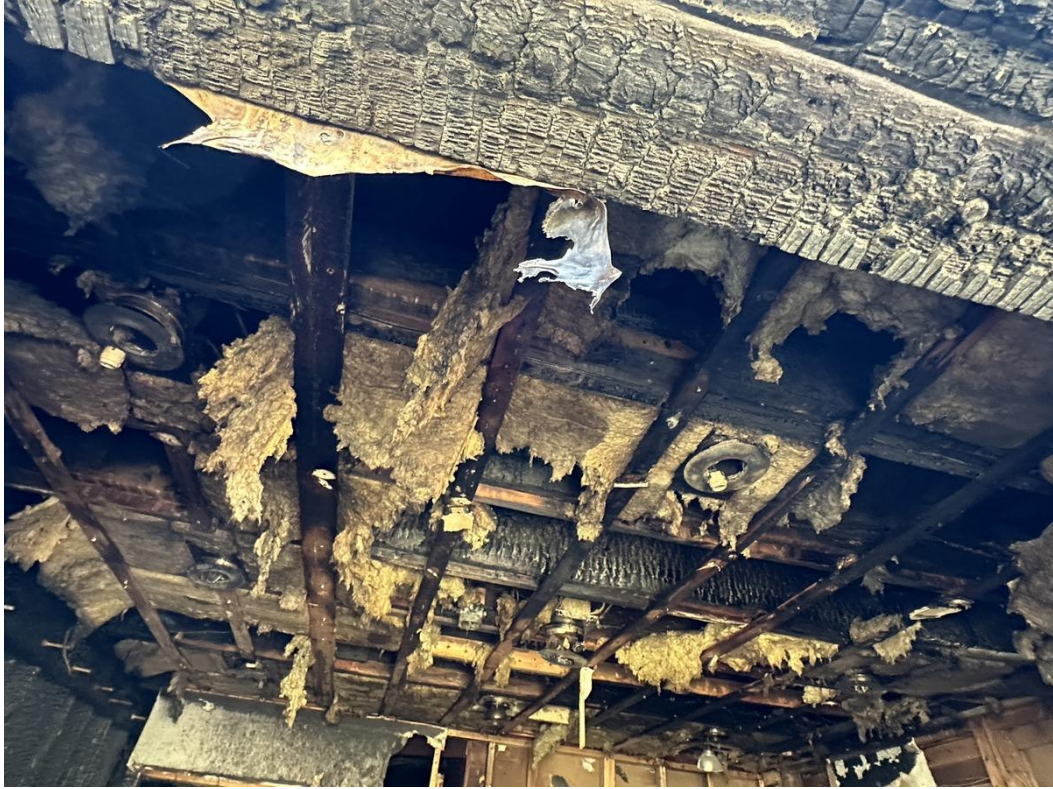
Photo 7 – View of Significantly Charred Joists Above Main Floor

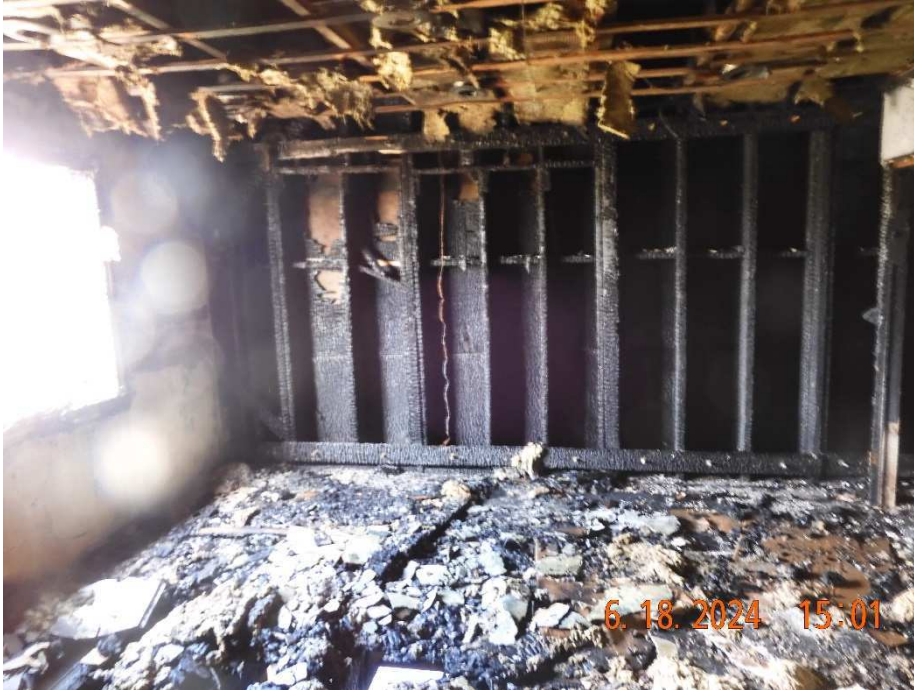
A major fire occurred June 15th, 2024 within the East end of the building causing extensive damage to the ground floor, 2nd floor & roof. The wall stud, floor joists & roof rafter were burned off indicating that the charred wood was subject to heat from the fire. The existing wood frame is a total loss and not suitable for any structural support as a result of the heat and water damage.

Wood stud wall frame @ east side (from inside & ground floor level)

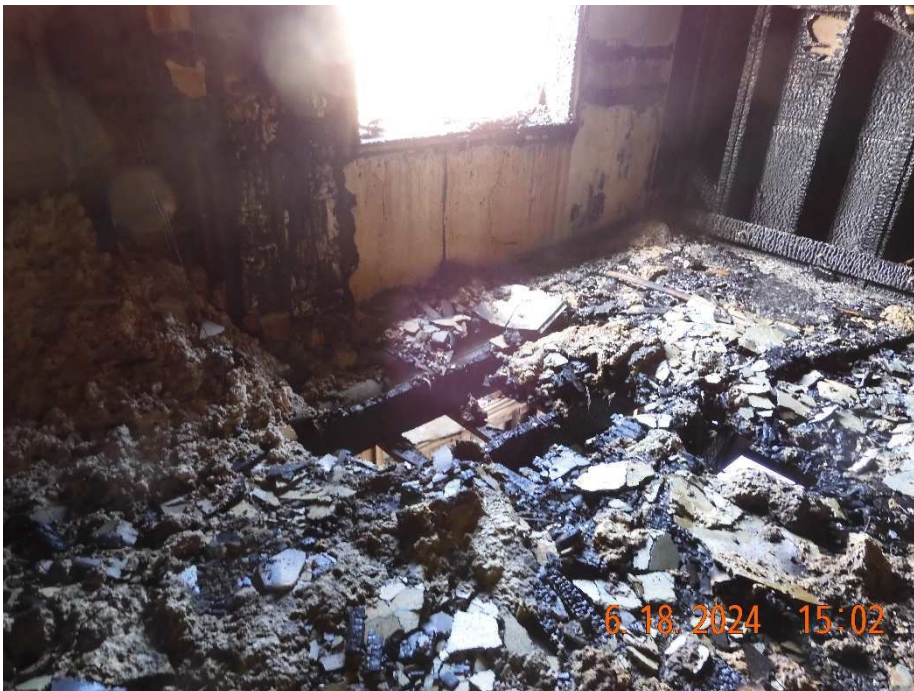
Ground floor level @ north east corner of building

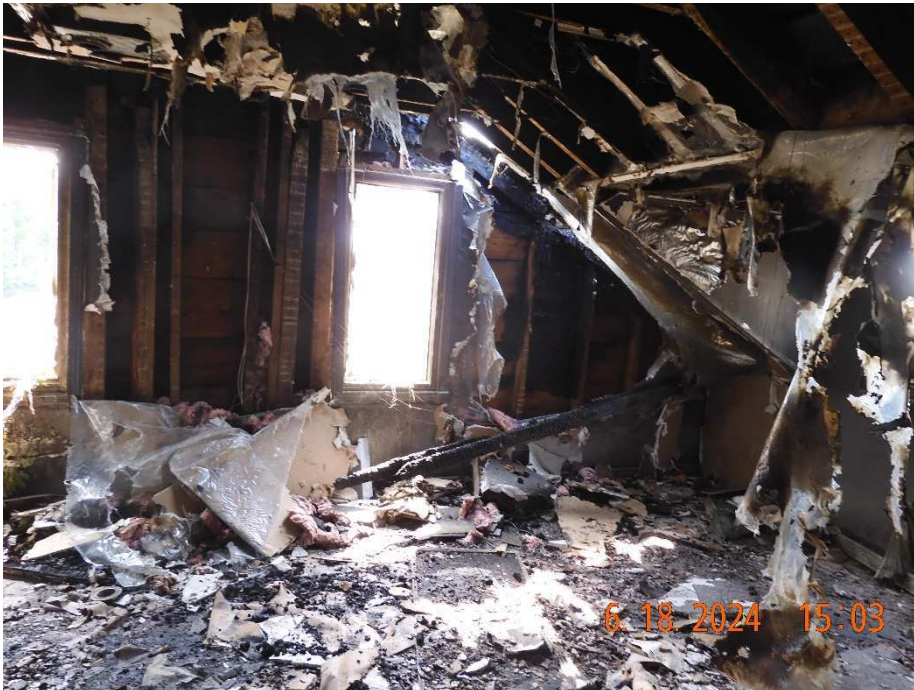
Roof level @north west corner of building (from 2nd floor level)

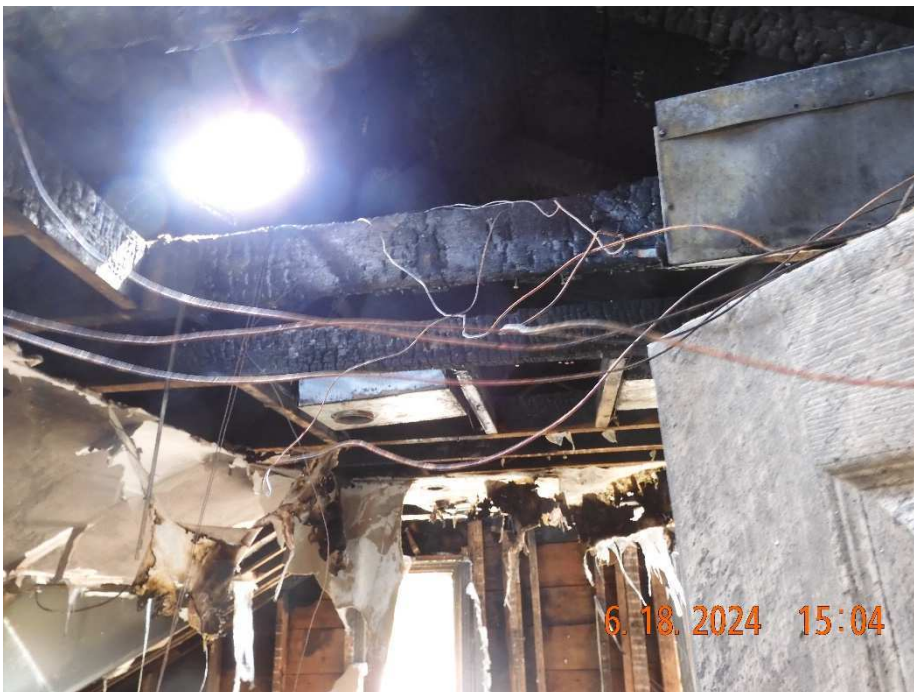
Roof rafter & collar tie (from 2nd floor level)

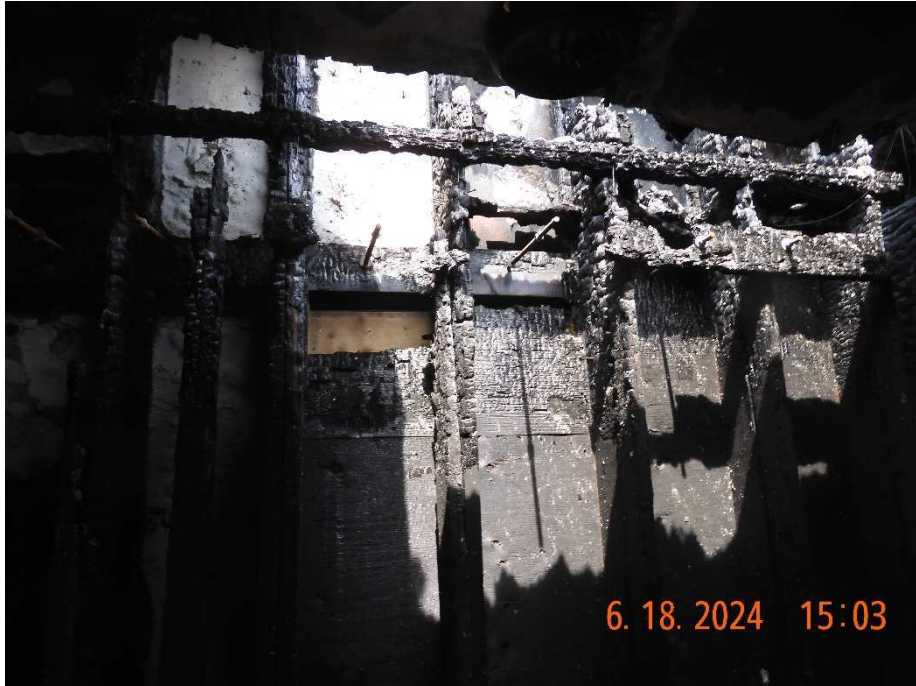
Wood stud wall frame @ east side (from inside & 2nd floor level)

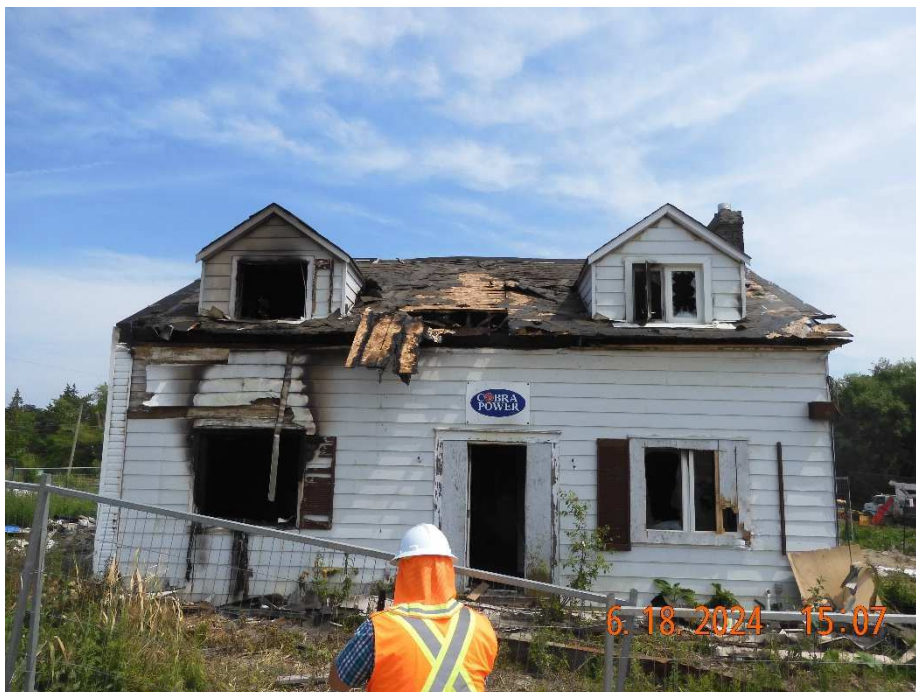
Roof deck @ south side of building
