Report to: Development Services Committee Meeting Date: May 28, 2018

SUBJECT: Request for Demolition of the Barn and Designation of the

Property

11091 Warden Avenue

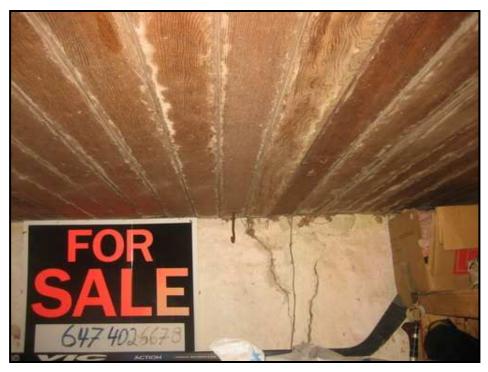
Photograph 29: Crack in interior parging

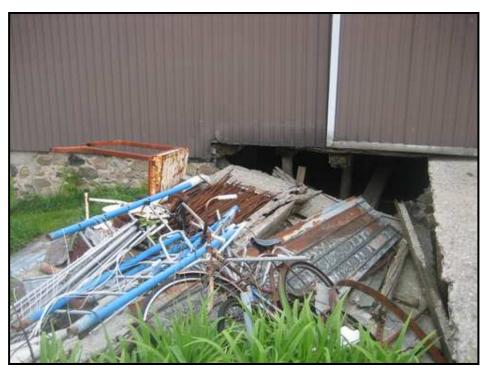
The barn is located east of the original farmhouse and is a timber framed structure with a field stone foundation wall in the main western area and a clay tile foundation wall in the eastern area. A section of the eastern foundation has collapsed and the concrete apron slab at the large, sliding barn doors has also collapsed (Photographs 30 & 31). The barn was reviewed from the floor level just inside of the sliding doors.

Photograph 30: Collapsed slab

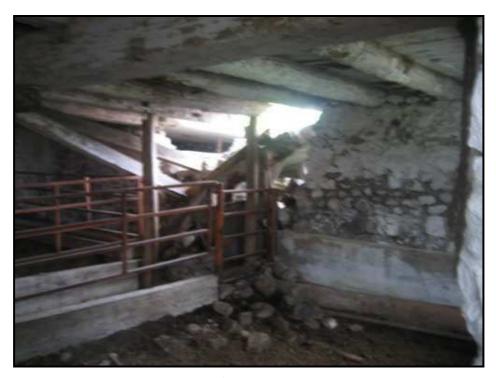
Photograph 31: Collapsed foundation wall

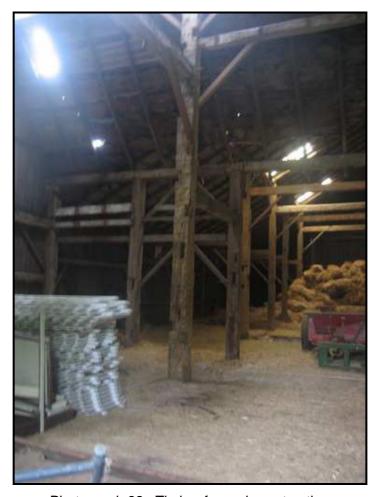
The timber framing is made of hand hewn timbers with mortise and tendon joinery. The barn is classic heavy timber framed construction (Photograph 32). The main upper floor used for hay and livestock feed storage is constructed of heavy timber planks supported on hand hewn timber beams.

Photograph 32: Timber framed construction

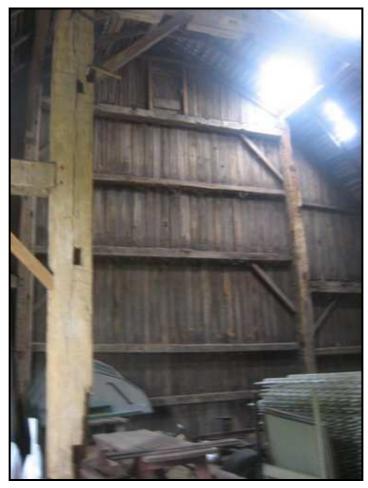
The original vertical wood siding is visible from the interior (Photograph 33) and sheet metal siding panels have been installed on the exterior of the walls. The roof is clad with sheet metal panels on what appeared to be the original roof deck boards. Sections of the roof panels were missing at the time of the site visit (Photograph34).

Photograph 33: Interior of barn wall

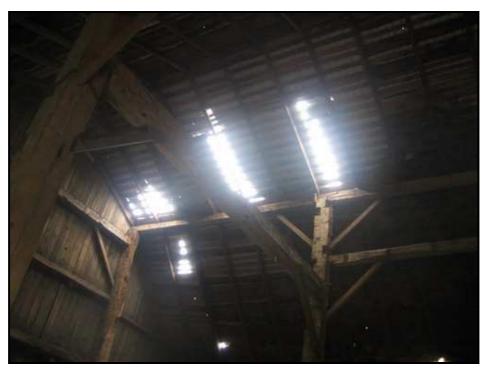
Photograph 34: Roof panels missing

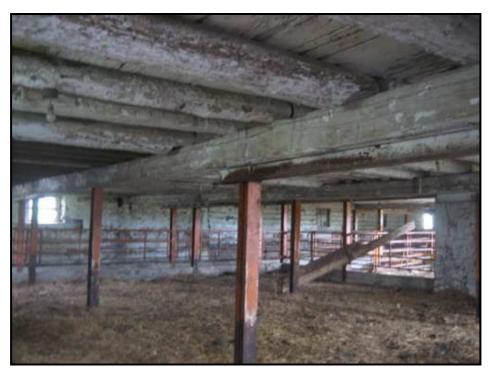
The lower level of the barn is used for livestock shelter (Photograph 35). The concrete slab on grade along the perimeter of the east foundation wall is cracked and has heaved along the entire length of the wall (Photograph 36).

Photograph 35: Lower barn level

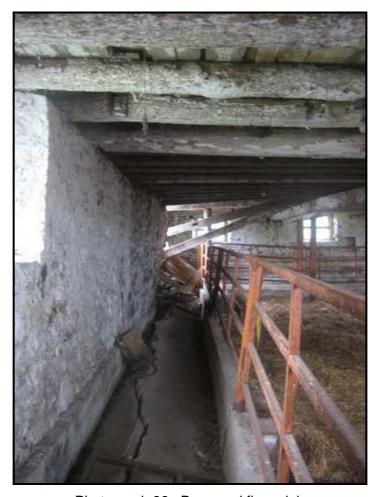
Photograph 36: Damaged floor slab

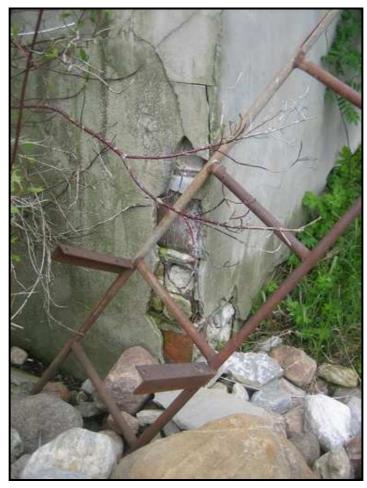
The field stone foundation wall has portions of mortar missing or the voids between the stones were not fully filled during original construction. There are several cracks in the foundation wall, in addition to the damage in the area of the collapsed section of foundation wall. The clay tile foundation has a parged finish on the exterior. The clay tile and parging are damaged at the northwest corner (Photograph 37).

Photograph 37: Damaged clay tile foundation
