Report to: Development Services Committee

SUBJECT:	Eligibility of the Alfred Read House for relocation to Markham Heritage Estates 2780 19 th Avenue, Ward 2
PREPARED BY:	Peter Wokral, Heritage Planner, ext. 7955
REVIEWED BY:	Regan Hutcheson, Manager of Heritage Planning ext. 2080

PROPERTY CONDITION ASSESSMENT

2780 19th Avenue,
Markham, ON

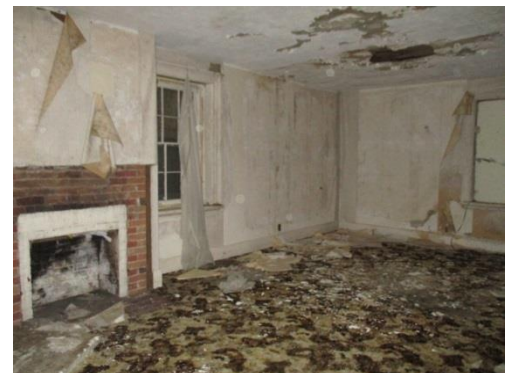
- .1 General view of the finishes in the living room on the ground floor. Finishes are water damaged and are in very poor condition.

Interior finishes are water damaged due to exposure to prolonged water leaks through the roof and are in very poor condition. Growth of mold was observed in various locations. We did not access the 2nd floor and the basement due to unsafe conditions (the suspended floor framing is sagging and appears to be unstable). In our opinion complete removal and replacement of the interior finishes (wall, ceiling and floor coverings, partition doors, millwork, cabinetry and countertops) within the house is currently required. We have provided an allowance of **\$115,000** for this repair work. The requirements detailed in the City of Markham's by-laws and the current edition of the Ontario Building Code must be followed when carrying out the repair work.

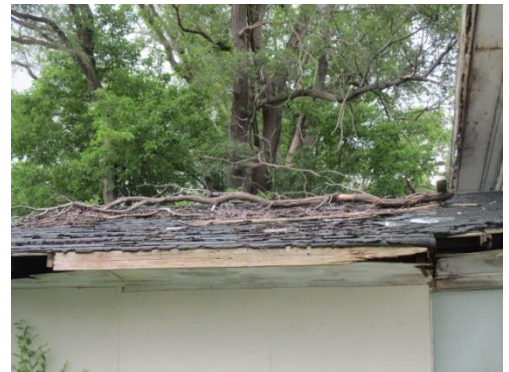
- .4 General view of the roof area above the north section. Asphalt shingles covering the roof area appear to be poor condition.

The asphalt shingles covering the roof of the farmhouse have exceeded their service life and are in poor condition. There is a hole in the roof at the north side and water leakage may have occurred at this location for an extended period of time. Significant water damage to finishes on the ground floor was observed during our review, likely as a result of prolonged water leakage through the roof. Replacement of the asphalt shingles covering the sloped roof areas is currently required.

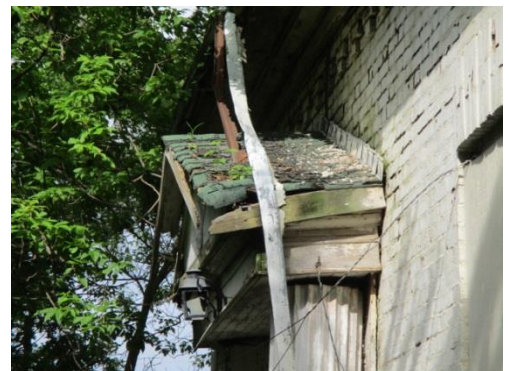
- .5 General view of the canopy at the main entrance along the south side. Wood fascia and soffit boards are rotted and the asphalt shingles are in poor condition.

The wood fascia and soffits at the eaves of the sloped roof areas appear to be in generally poor condition with peeling paint and localized areas of wood decay. We are of the opinion that the wood fascia and soffits will require replacement and painting. The metal eaves troughs and downpipes are severely deteriorated and will require replacement when the asphalt shingles are replaced.

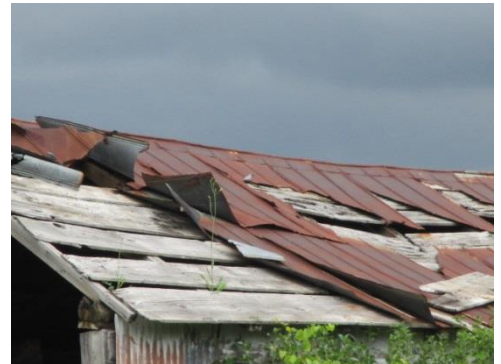
- .7 General view of the sloped roof areas above the Storage Barn that are covered with steel panels.
- .8 Several roof panels are missing, dislodged or torn. The galvanizing coating is typically deteriorated and underlying steel is corroded.

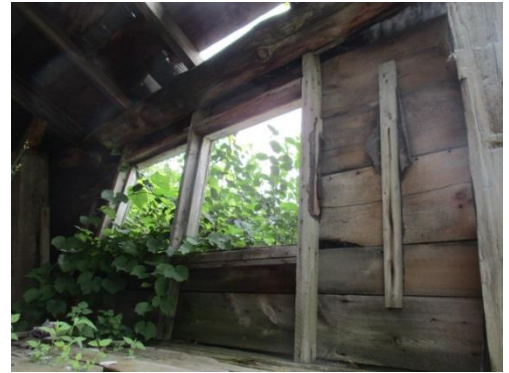
.17 All the doors and windows at the barn are missing.

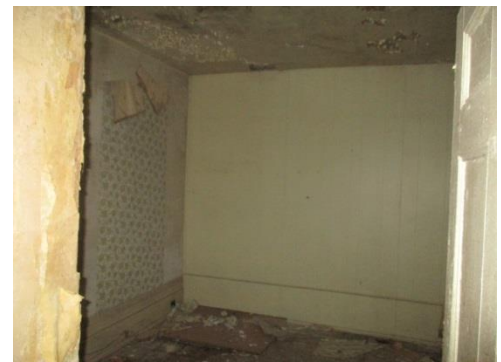
- .1 Structural framing members on the ground floor of the house were concealed by finishes and were not visible for review.

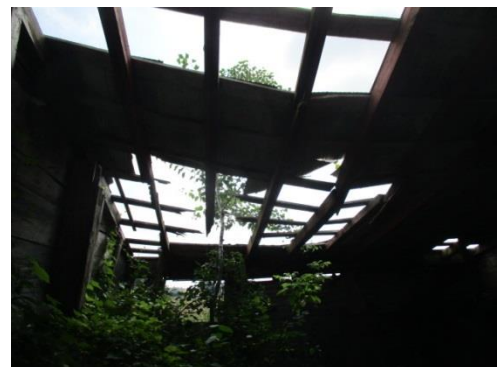
- .3 General view of the underside of gable roof framing. There are water stains at the underside of the wood plank roof deck and several wood planks are decayed due to exposure to prolonged water leakage through the roof. Some wood roof planks are missing.
- .4 The sloped roof of the shed at the east side of the barn is collapsed and the framing members appear to be in very poor condition. Several wood boards, purlins and rafters are decayed/damaged due to prolonged water leakage through the roof.

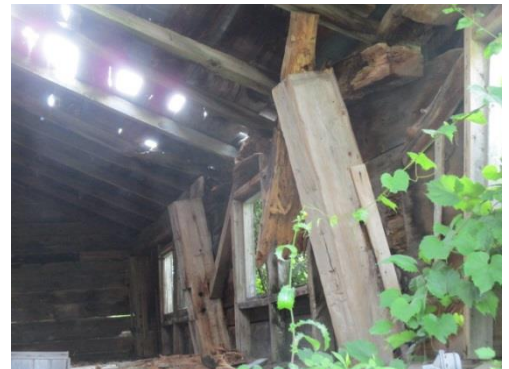
- .7 Several wood columns are dislodged and are out of plumb.

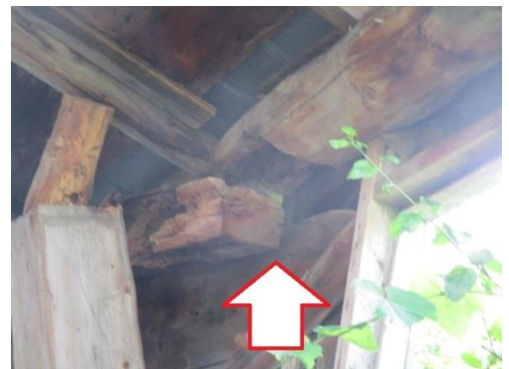
- .8 Some wood beams are dislodged at the joints. Some wood beams appear to be decayed due to prolonged water leakage through the roof and walls.

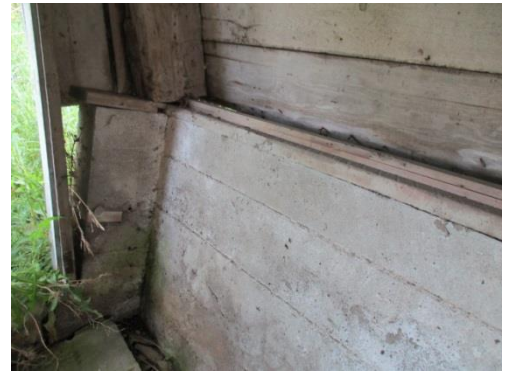
- .10 The poured concrete foundation walls are out of plumb and appear to have rotated outwards.

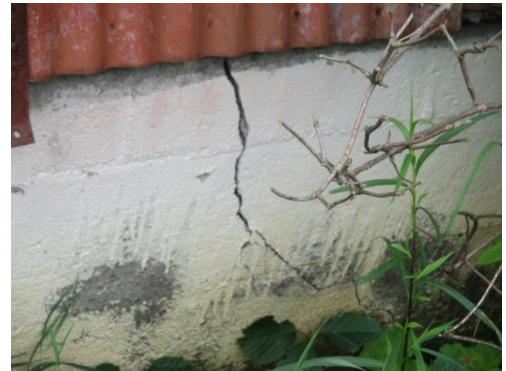
- .11 There are several large cracks in the poured concrete foundation walls.

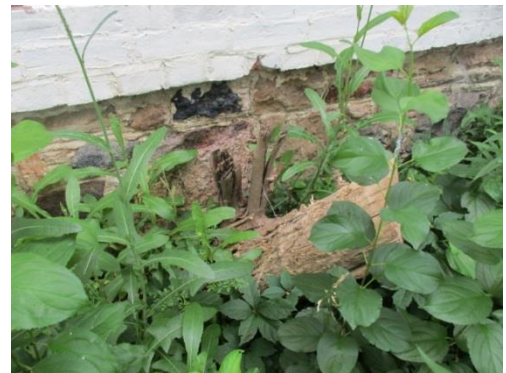
- .8 There are tree trunks adjacent to the house at the west side.

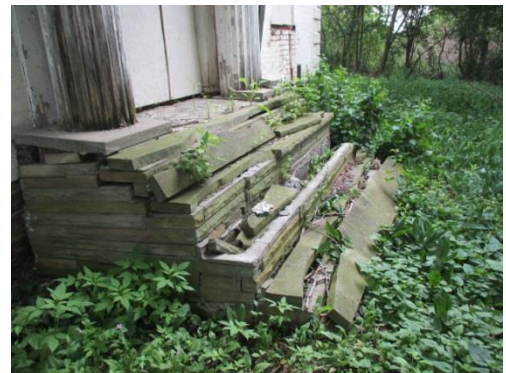
- .9 Steps at the main entrance that are formed by precast concrete units and natural stone slabs are settled/collapsed and this condition poses a potential safety hazard.
