RE: Robb House Restoration, 66 Monique Court, Town of Markham

Re: Independent Engineering Inspection of Damage to a Relocated

Current Site Address: 66 Monique Court (formally 7205 Markham Road)

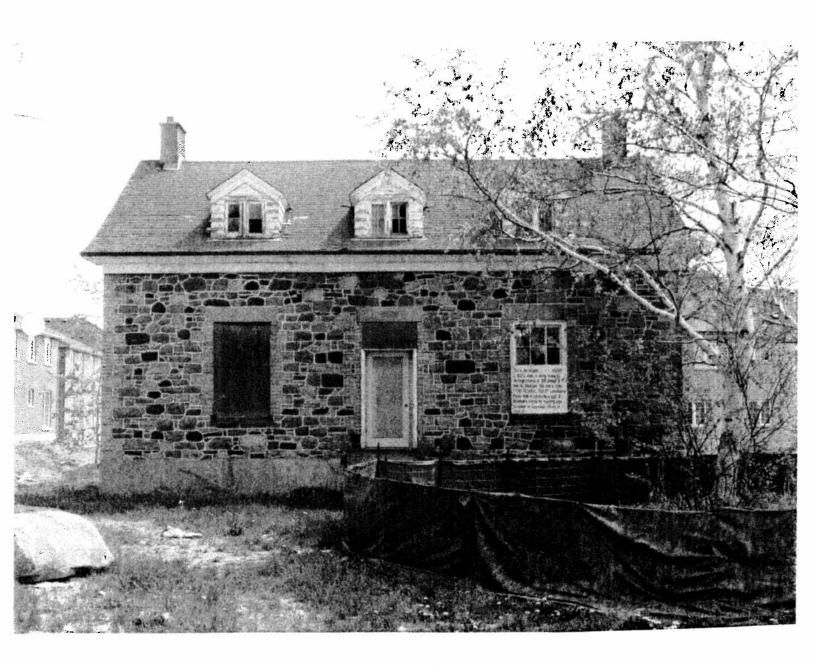
## FIGURE 2:

William Robb House, prior to relocation.

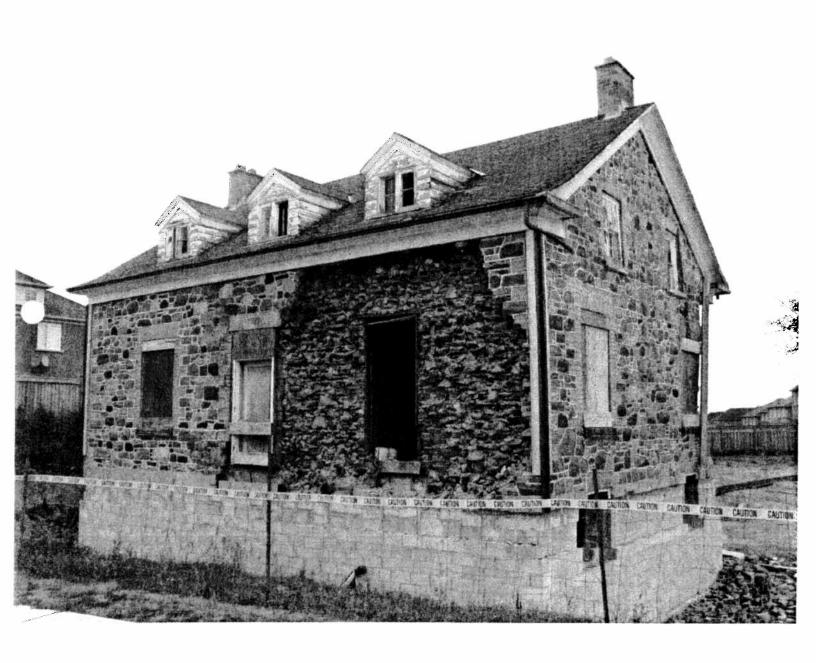
## FIGURE 3:

Robb House, damage to front wall following relocation. (2007 photo)

Failure of approximately 40% of the west exterior wall outer wythe occurred at the south half, leaving the subject wall in an unstable condition.

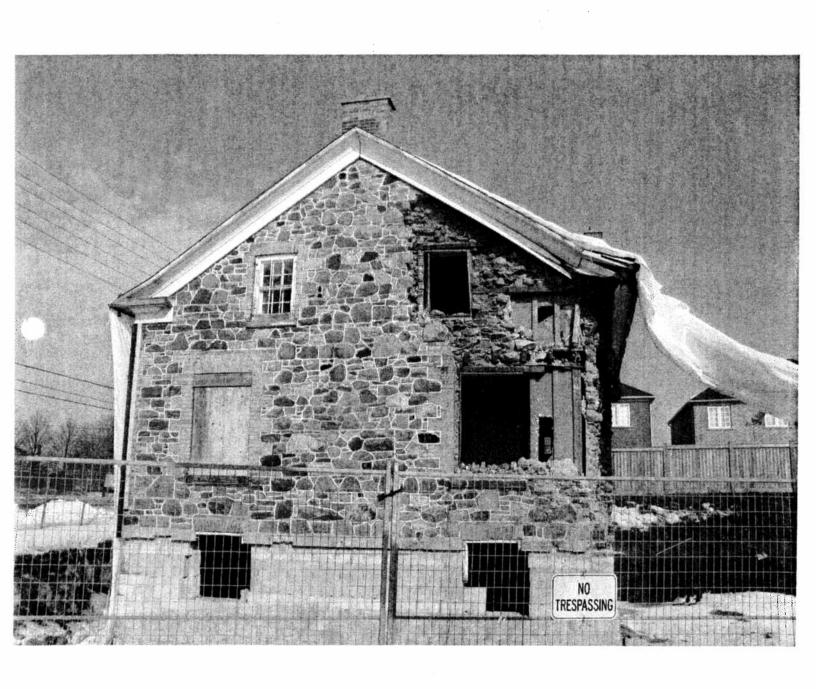
Robb House, damage to south east corner, recent condition. (2008 photo)

Failure encompassing both the inner and outer wythes occurred at the southeast corner, resulting in displaced and fractured structural members.

The subject walls at the above-noted damaged areas are currently in an unstable condition. As well, due to similar foundation support conditions around the remainder of the perimeter of the dwelling, the remainder of the exterior stone outer wythe must be considered, at this time, to be unstable.

We recommend the structural be demolished as soon as practical for the purpose of creating a safe site condition.
