# Asset Management Department

Information Session on Street Lighting  
Project – Inventory Data Collection and  
Condition Analysis of Existing  
Infrastructure

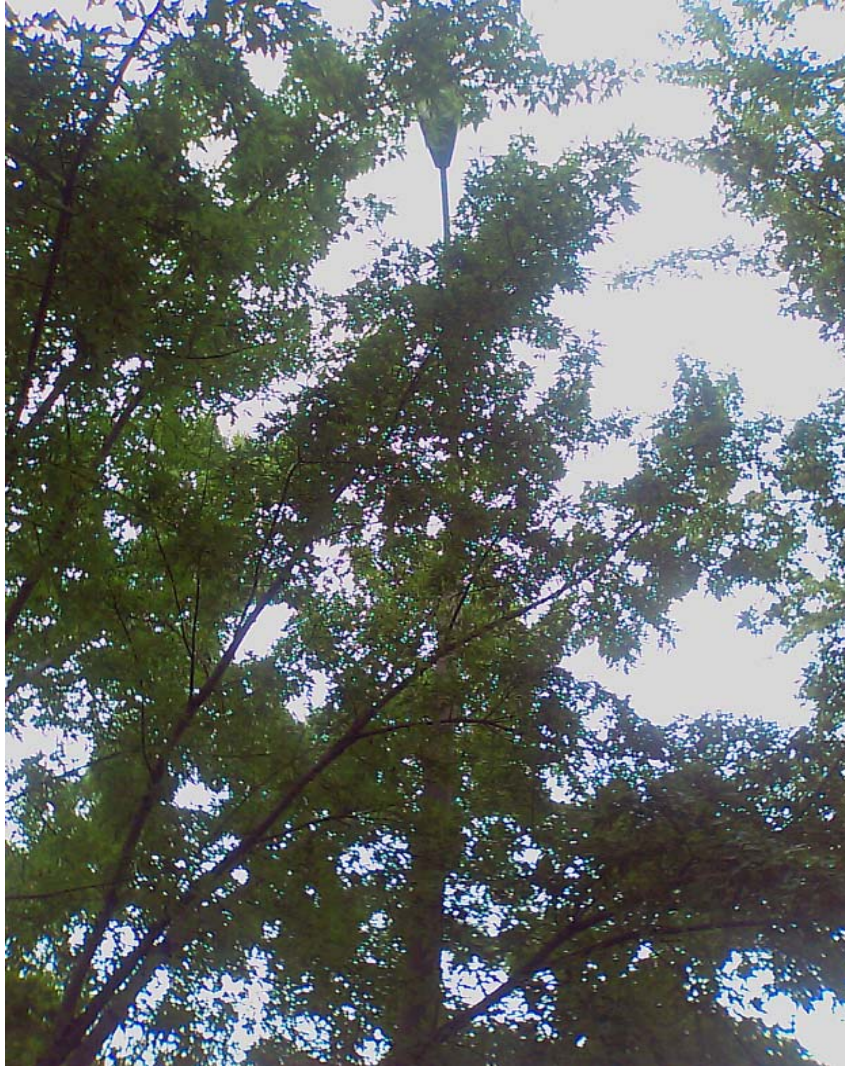
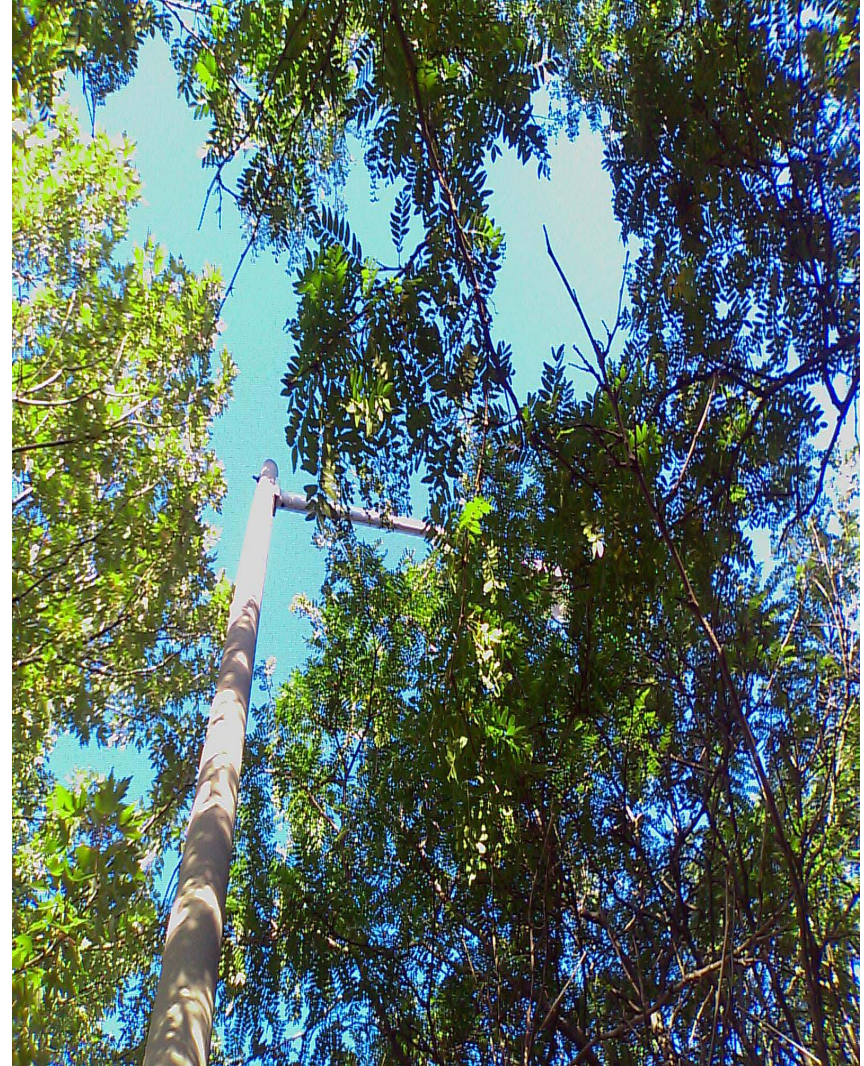
### Typical Pole Condition 3 Light Pole Obstruction

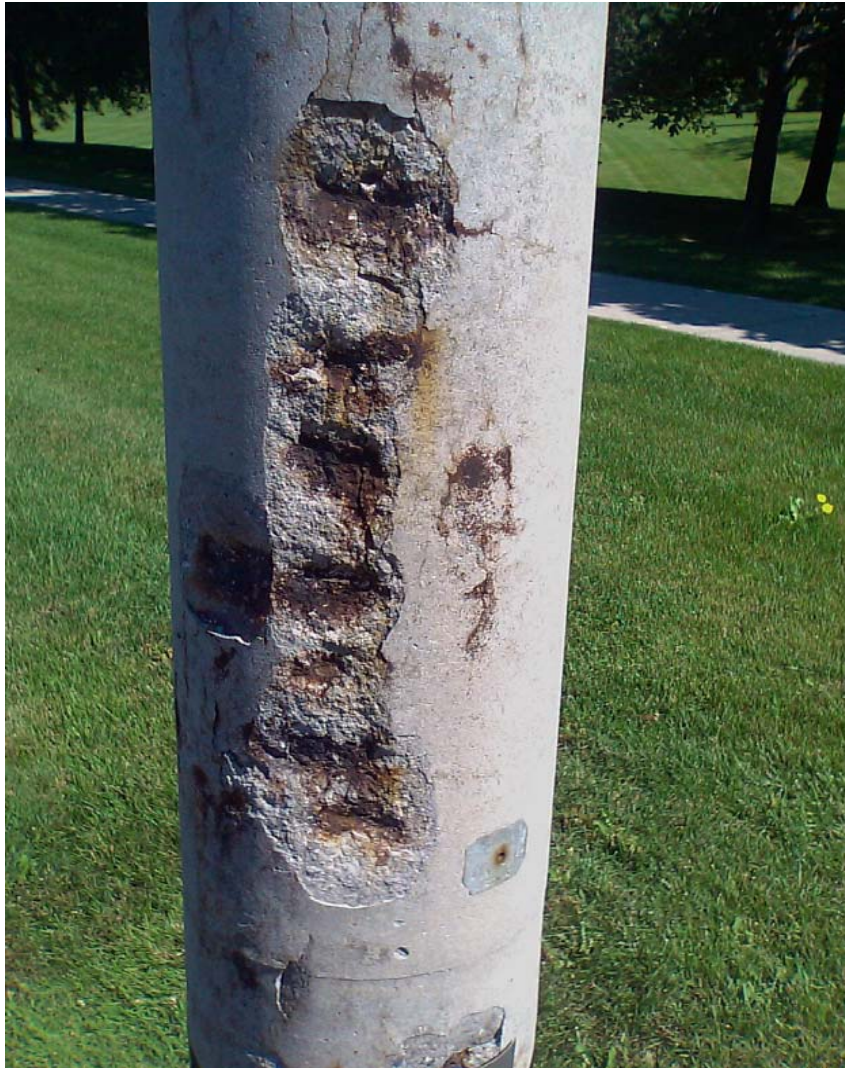
Typical Pole Condition 3  
Light Pole Concrete Failure

CONCRETE SPALLING, RUSTING,  
EXPOSED REINFORCING BARS

- Approx. 200 poles and 200 handhold covers need to be further reviewed for the repair /replacement program. ( Note- a complete pole replacement is estimated to cost approx. \$4,000-5,000/pole)
- No luminaires or brackets were identified with significant problems at present.

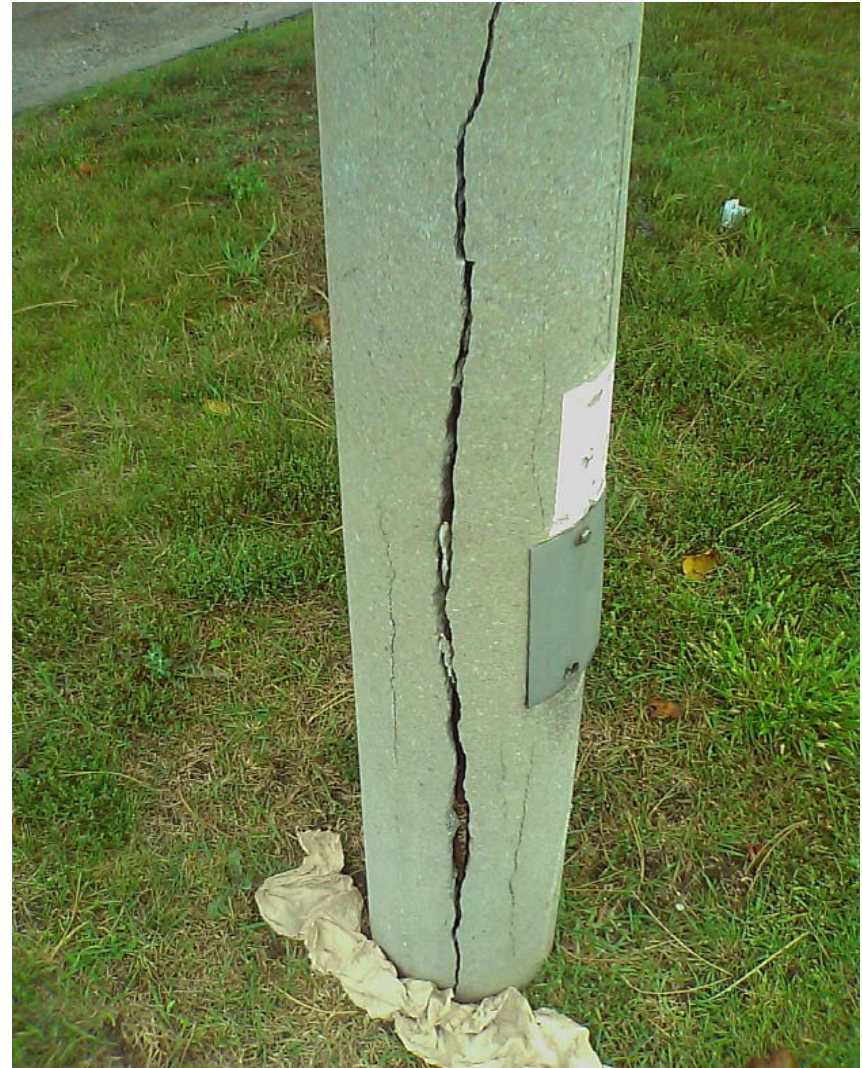
CONCRETE CRACKING

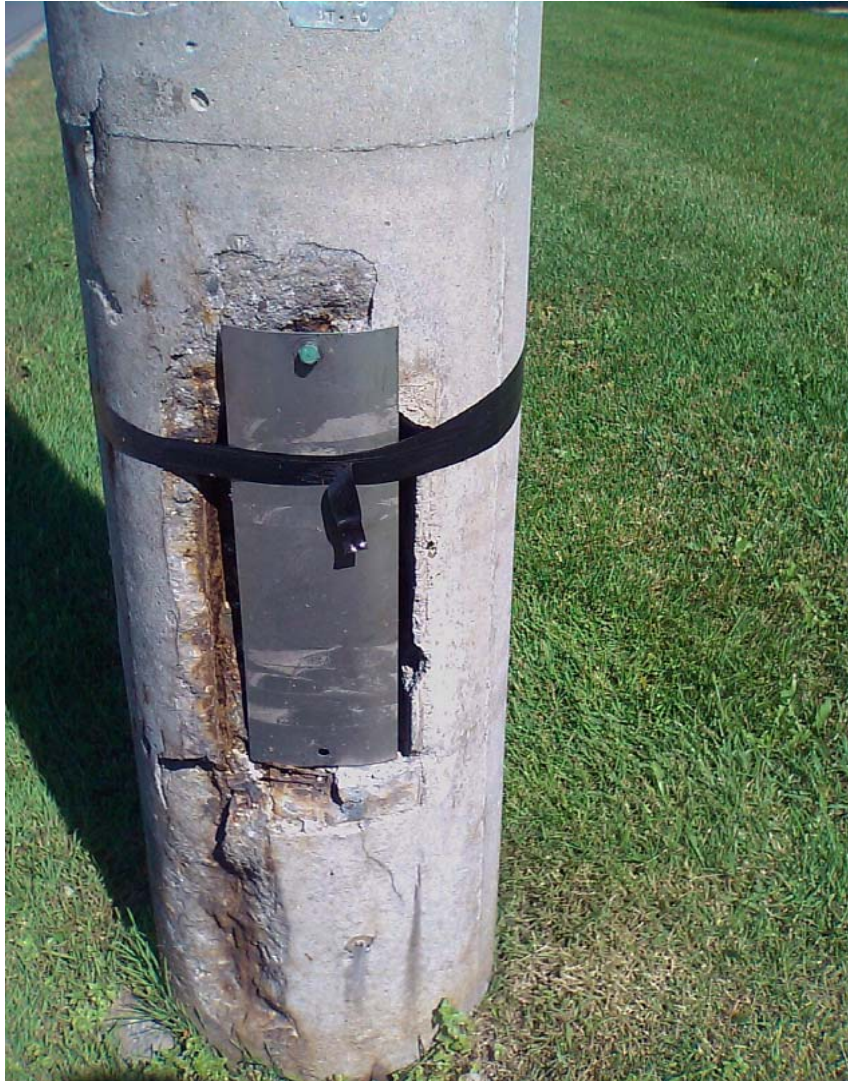
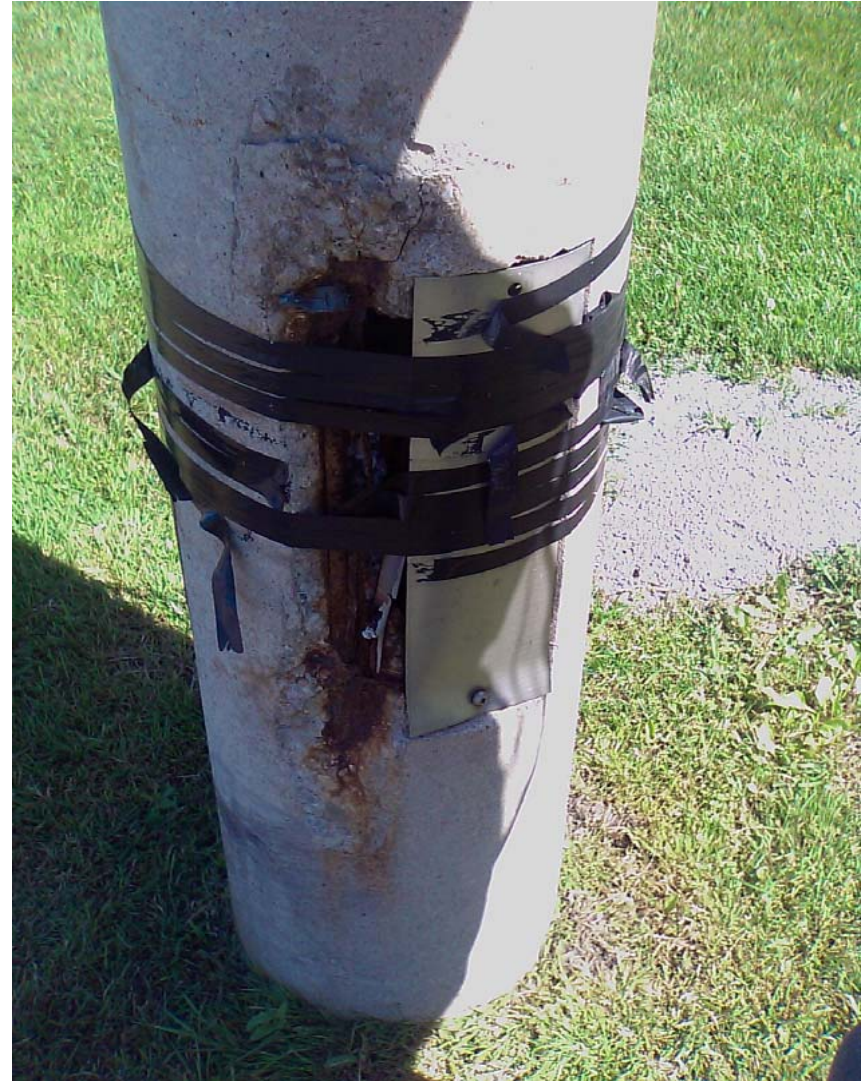
### Typical Pole Condition 3 Hand Well Covers (Corrosion)

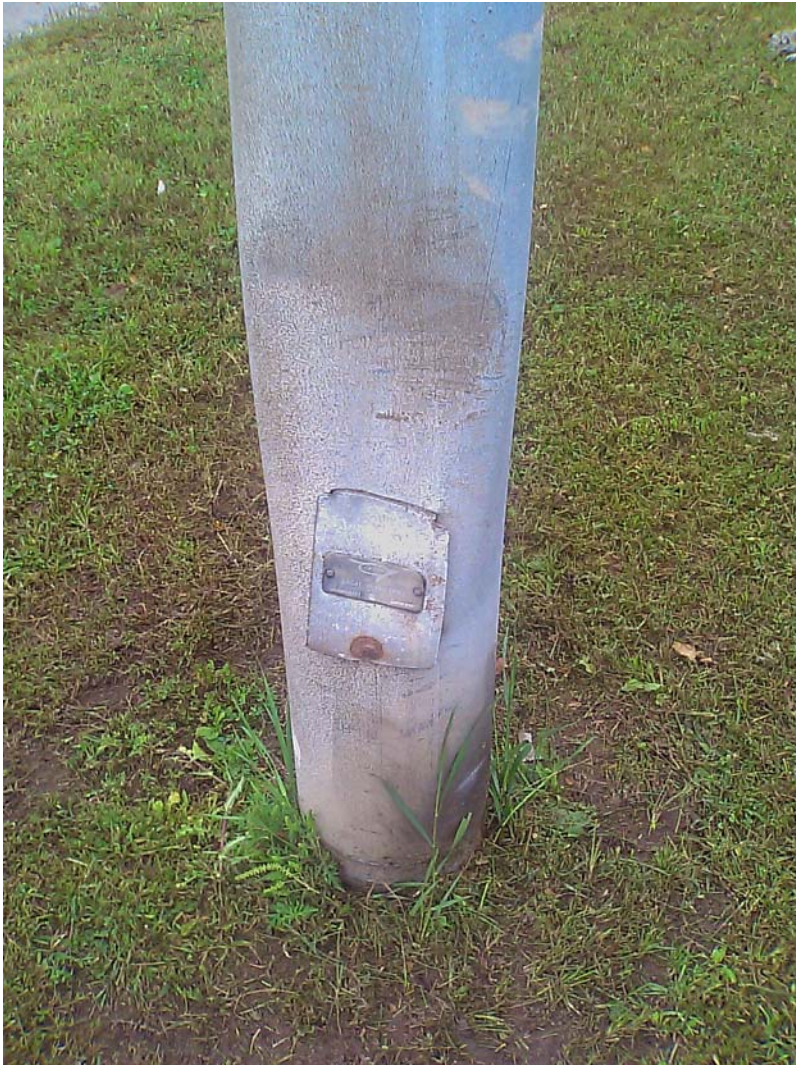
Typical Pole Condition 3  
Light Pole - Metal

DENTED STEEL

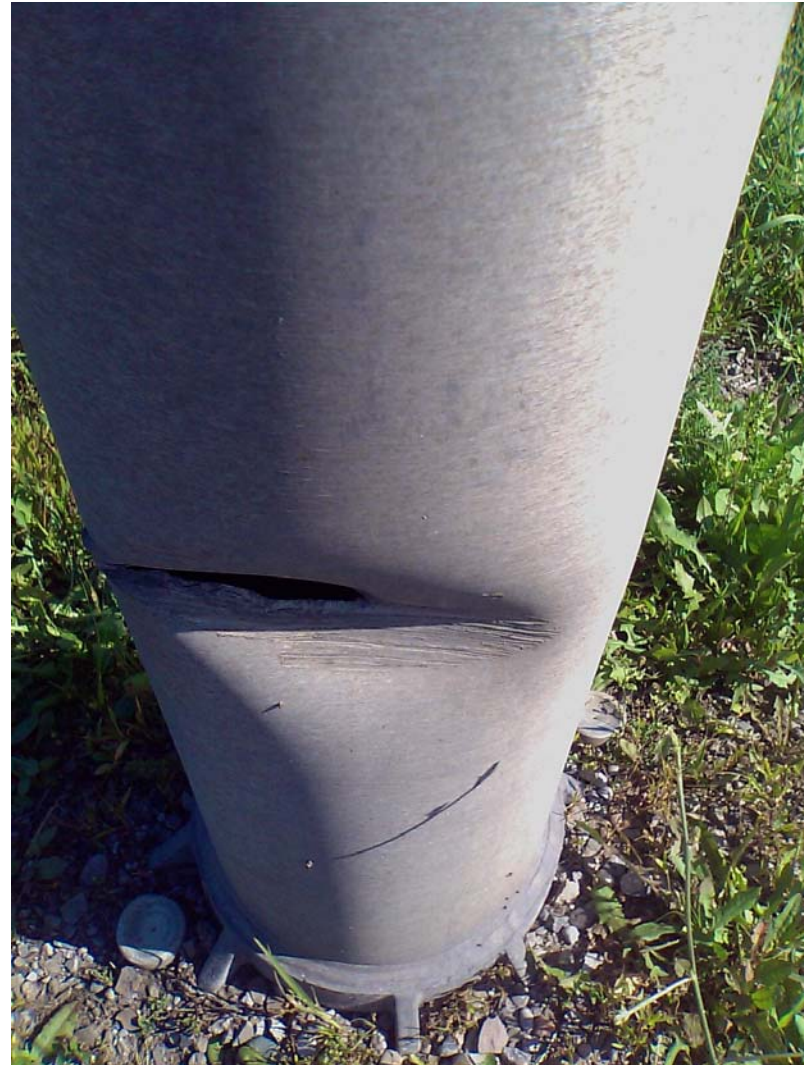
DENTED ALUMINIUM

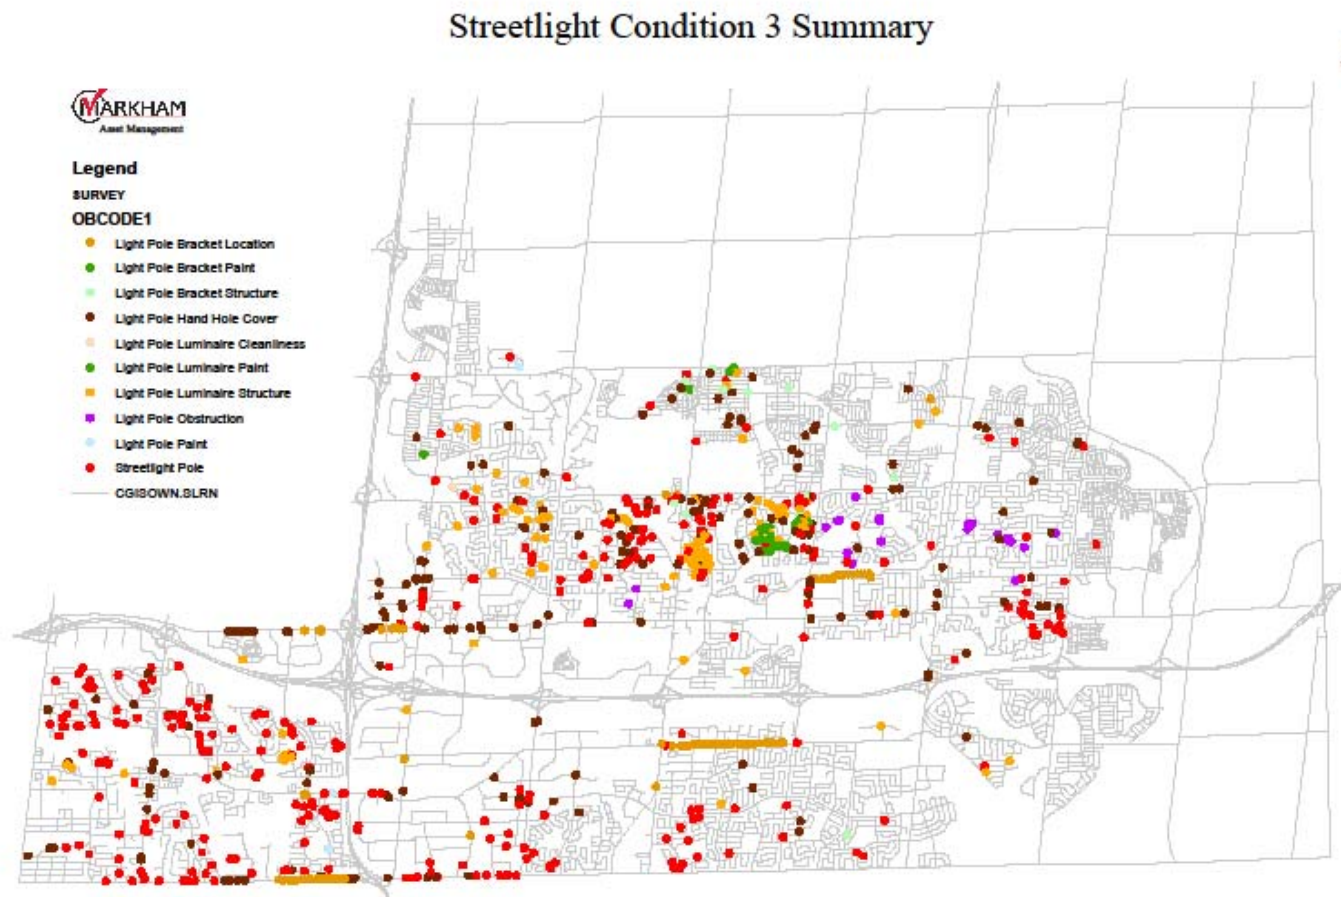
# EXAMPLE FROM DATA BASE – MAPPING SHOWING LOCATION/SUMMARY OF CONDITION 3 INFRASTRUCTURE
