Report to: Development Services Committee

SUBJECT:	Eligibility of the Alfred Read House for relocation to Markham Heritage Estates 2780 19 th Avenue, Ward 2
PREPARED BY:	Peter Wokral, Heritage Planner, ext. 7955
REVIEWED BY:	Regan Hutcheson, Manager of Heritage Planning ext. 2080

PROPERTY CONDITION ASSESSMENT

2780 19th Avenue,
Markham, ON

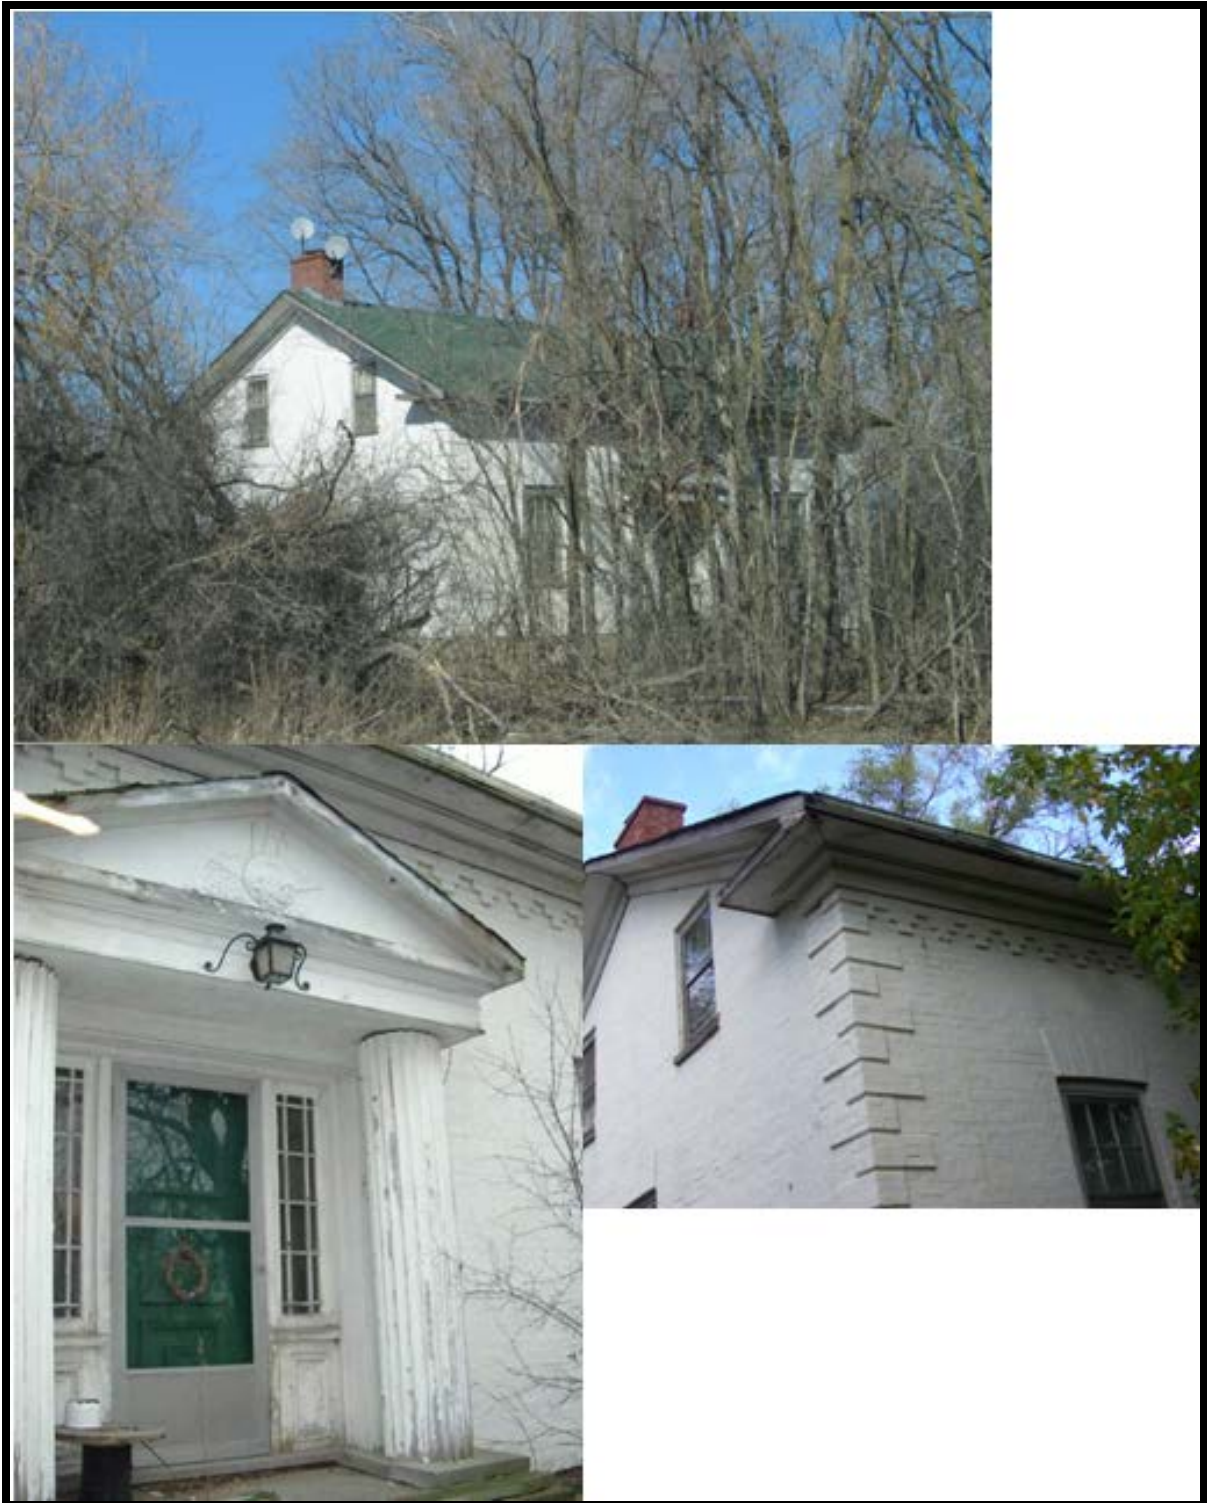
Figure 2- Photographs of the Alfred Read House taken in 2004 and 2008

In 2008, a site inspection of the Alfred Reed House conducted by members of Heritage Section Staff and Heritage Markham revealed that the house was vacant, and in deteriorating condition. Recent photos taken in 2016 by another person interested in relocating the Alfred Read House to Heritage Estates show that damage to the interior is now much more extensive, as there are holes in the roof, extensive water damage, the presence of mould, portions of the second floor ceiling have collapsed, and the main floor has been left open to the elements, vandalism, and salvaging of valuable interior heritage components. (See attached interior photographs, Figure 4).

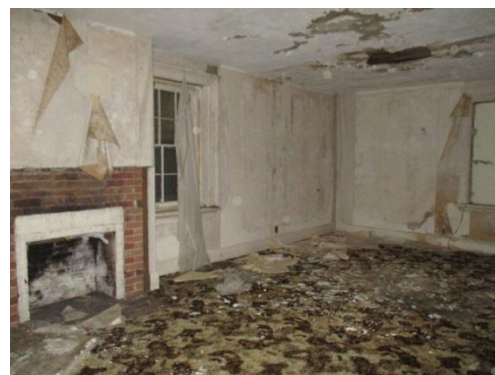
- .1 General view of the finishes in the living room on the ground floor. Finishes are water damaged and are in very poor condition.

Interior finishes are water damaged due to exposure to prolonged water leaks through the roof and are in very poor condition. Growth of mold was observed in various locations. We did not access the 2nd floor and the basement due to unsafe conditions (the suspended floor framing is sagging and appears to be unstable). In our opinion complete removal and replacement of the interior finishes (wall, ceiling and floor coverings, partition doors, millwork, cabinetry and countertops) within the house is currently required. We have provided an allowance of **\$115,000** for this repair work. The requirements detailed in the City of Markham's by-laws and the current edition of the Ontario Building Code must be followed when carrying out the repair work.

A designated substance survey is required prior to scheduling any repair or demolition work. We have provided an allowance of **\$10,000** for this survey.

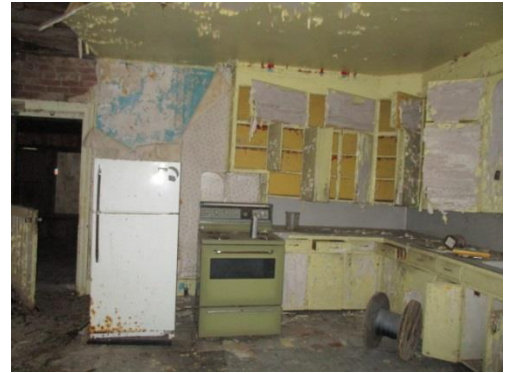
- .2 General view of the finishes in the kitchen on the ground floor. Finishes and cabinetry are water damaged and are in very poor condition.

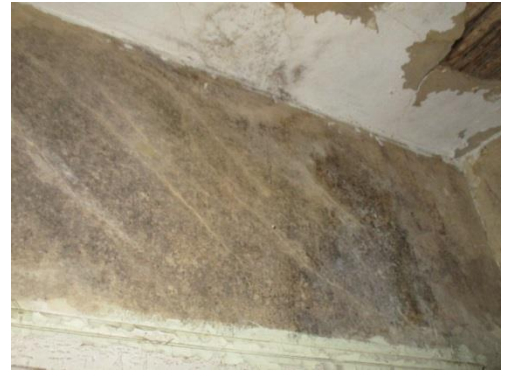
- .3 It appears that there is mold growth on the finishes.

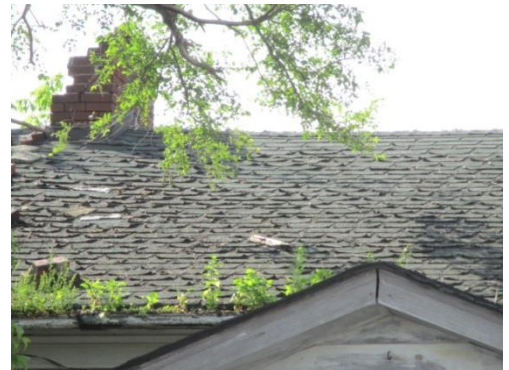
- .1 General view of the north side of the sloped roof area. Asphalt shingles covering the roof area are in poor condition with many shingles with curled or missing tabs. The roof system appears to be in excess of 15 years old.

The asphalt shingles covering the roof of the farmhouse have exceeded their service life and are in poor condition. There is a hole in the roof at the north side and water leakage may have occurred at this location for an extended period of time. Significant water damage to finishes on the ground floor was observed during our review, likely as a result of prolonged water leakage through the roof. Replacement of the asphalt shingles covering the sloped roof areas is currently required.

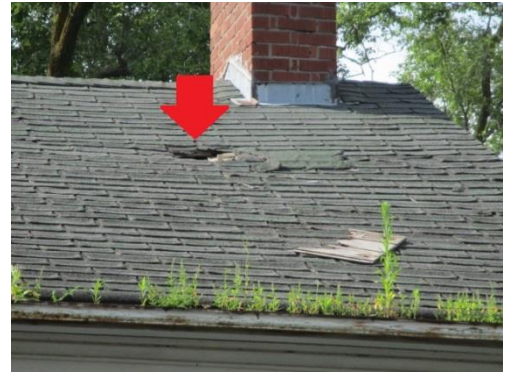
- .2 There is a hole at the north side of the roof area that appears to penetrate the roof deck.

Furthermore, we are of the opinion that it is likely that some wood decay is present at the wood roof deck and supporting wood framing members (i.e., rafters, collar ties, ceiling joists, etc.). These conditions can only be fully assessed when the asphalt shingles are removed and the underlying framing is exposed for assessment. **In our opinion, an allowance of \$25,000 should be provided for potential repairs to the wood roof deck and other concealed roof framing members.**

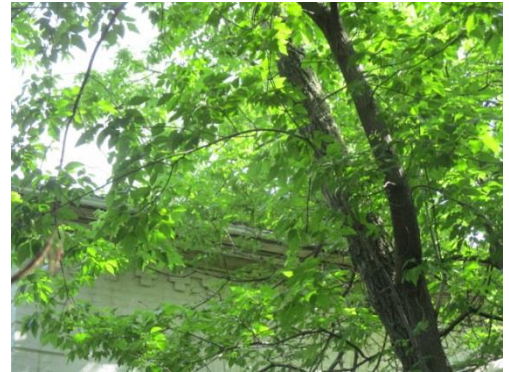
- .3 The south side of the sloped roof area was obstructed from view by trees adjacent to the building. Tree trimming is required as some of the tree branches are abrading the roof surface.

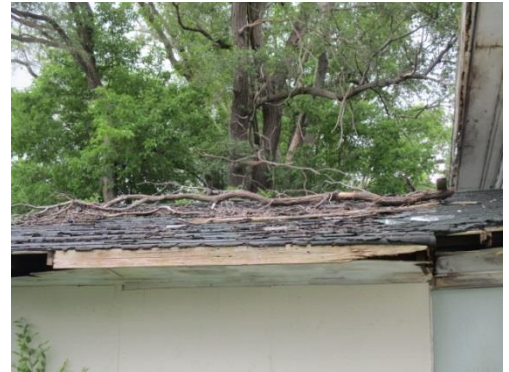
- .4 General view of the roof area above the north section. Asphalt shingles covering the roof area appear to be poor condition.

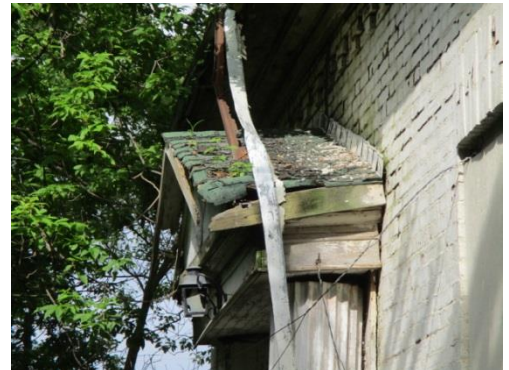
- .5 General view of the canopy at the main entrance along the south side. Wood fascia and soffit boards are rotted and the asphalt shingles are in poor condition.

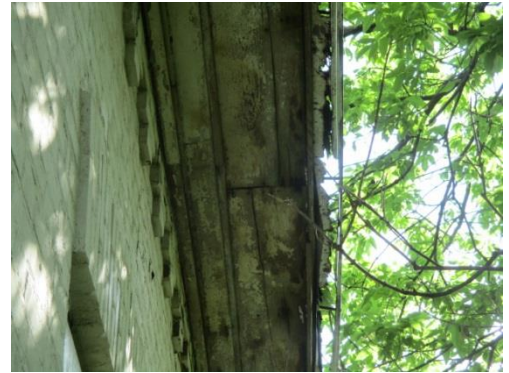
- .6 The paint finish on the wood soffits and fascia boards is peeled and in generally poor condition. In many locations wood soffits and fascia boards are decayed. Metal eaves troughs and downpipes are typically filled with organic debris and corroded. In some locations the corrosion has resulted in perforation of the base metal.

The wood fascia and soffits at the eaves of the sloped roof areas appear to be in generally poor condition with peeling paint and localized areas of wood decay. We are of the opinion that the wood fascia and soffits will require replacement and painting. The metal eaves troughs and downpipes are severely deteriorated and will require replacement when the asphalt shingles are replaced.

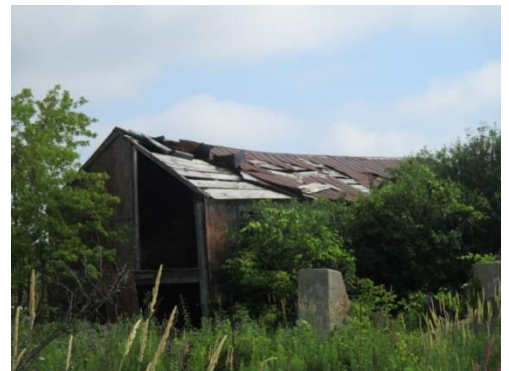
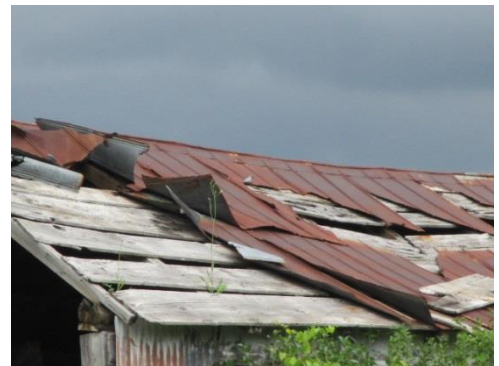
- .7 General view of the sloped roof areas above the Storage Barn that are covered with steel panels.
- .8 Several roof panels are missing, dislodged or torn. The galvanizing coating is typically deteriorated and underlying steel is corroded.

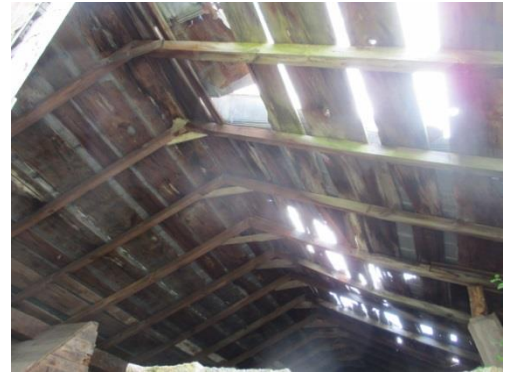
- .9 Many of the wood boards below the steel roof panels are water stained, decayed or missing.

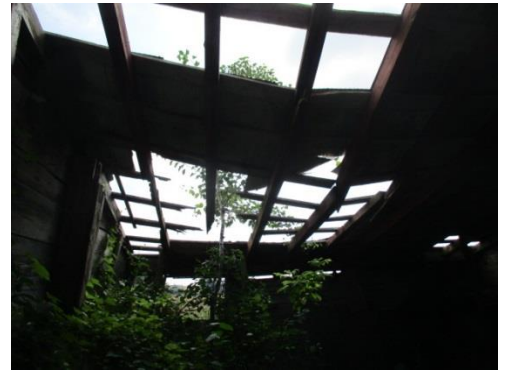
- .10 The sloped roof of the shed at the east side of the barn has collapsed and is in poor condition. Several steel panels and the underlying wood boards forming the roof deck are missing.

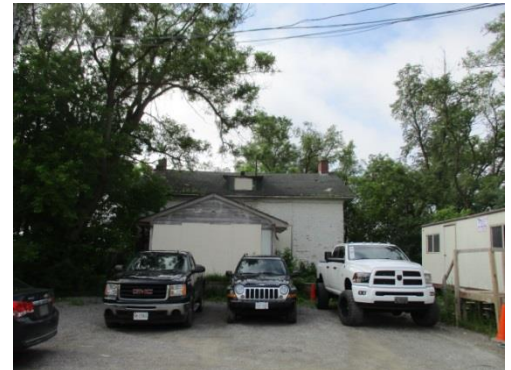
- .1 General view of the north elevation. The brickwork is painted and the paint coating is peeled or stained in several locations. The wood siding covering the exterior walls of the addition is covered by plywood sheets and was not fully visible for review. Walls of the dormer are covered with asphalt shingles. The asphalt shingles are in very poor condition.

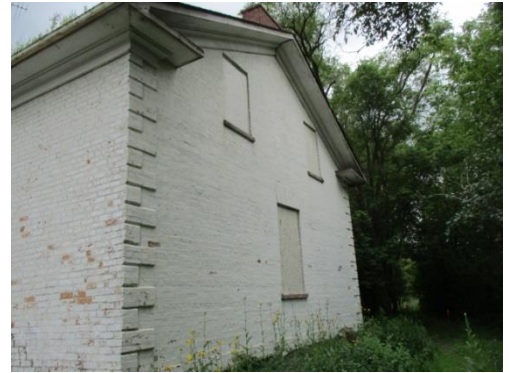
- .2 General view of the west elevation. This wall appears to be bowed inwards (minor) and, in our opinion, this condition is likely original to the building. The brickwork is painted and the paint coating is peeled or stained in several locations.

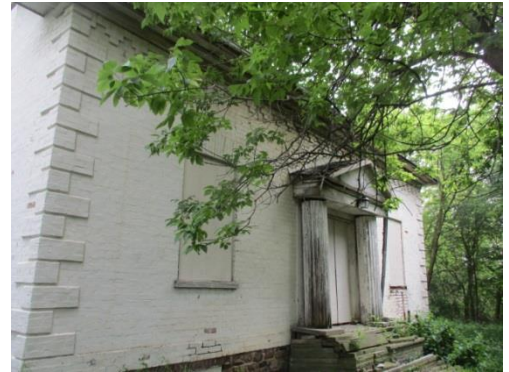
- .3 General view of the south elevation. The brickwork is painted and the paint coating is peeled or stained in several locations.

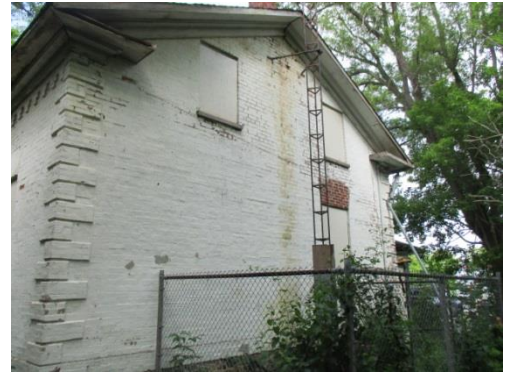
- .4 General view of the east elevation. The brickwork is painted and the paint coating is peeled or stained in several locations.

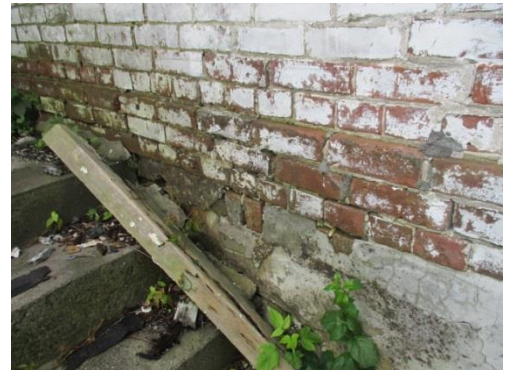
- .5 Mortar joints in the brickwork are deteriorated in some locations due to freeze-thaw cycling of the brickwork while in wet condition. Parging material installed over the brickwork at these locations is deteriorated (stained, cracked and spalled).

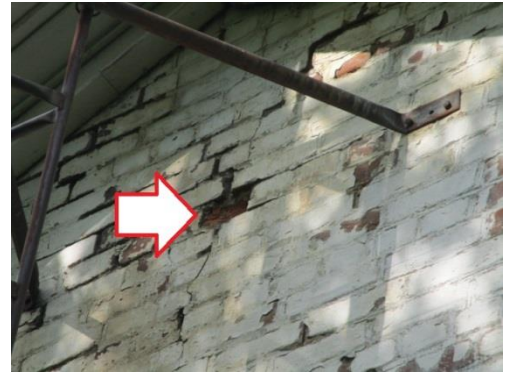
- .6 There are spalled bricks in several locations along the exterior walls.

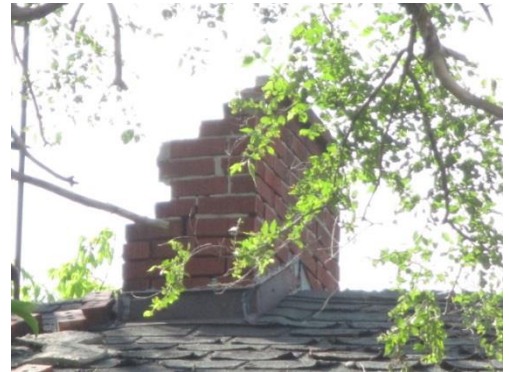
- .7 Many of the bricks forming the chimney at the east side are dislodged or missing.

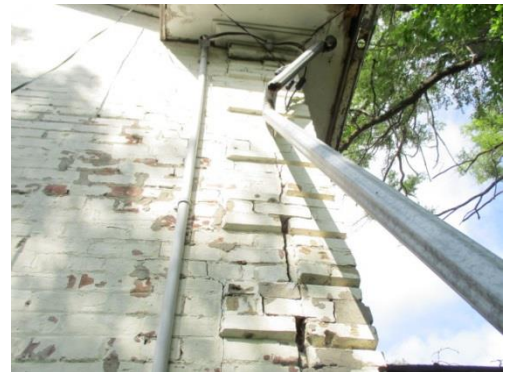
- .8 The brickwork is cracked in several locations, especially at the north-east and north-west corners. These cracks appear to be the result of settlement of the building over time.

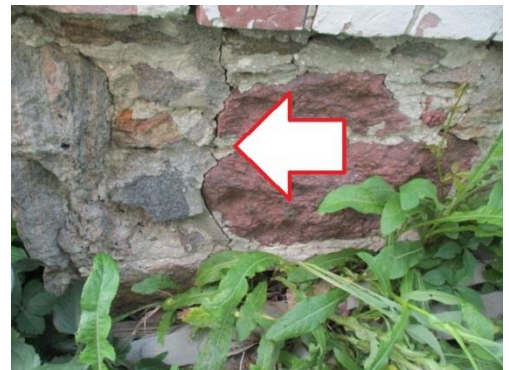
- .9 Cracks have developed in the foundation walls in many locations. These cracks appear to be the result of settlement of the building over time.

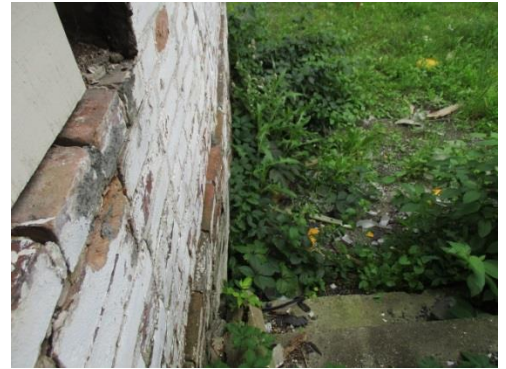
- .10 The foundation wall at the north side is bowed outwards near the west end.

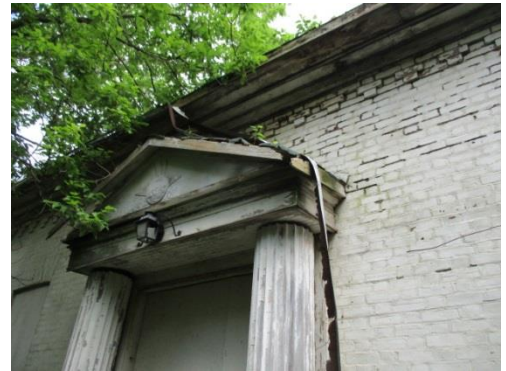
- .11 The paint finish on the wood soffit, fascia boards, trim work and columns at the entrance canopy is peeled and the underlying wood is weathered.

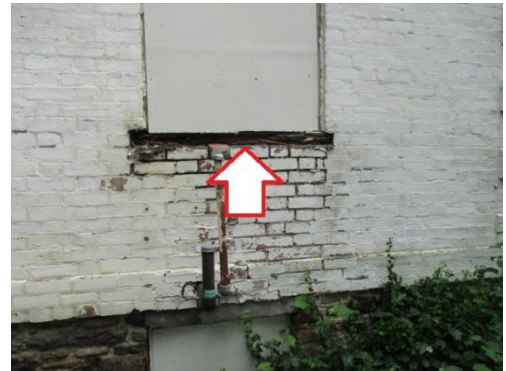
- .12 Several wood window sills are decayed.

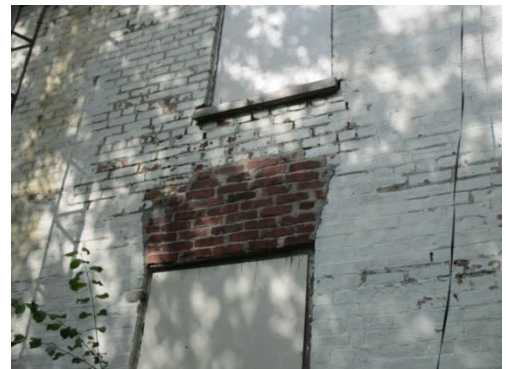
- .13 Bricks appear to have been replaced in one location at the east side above a window.

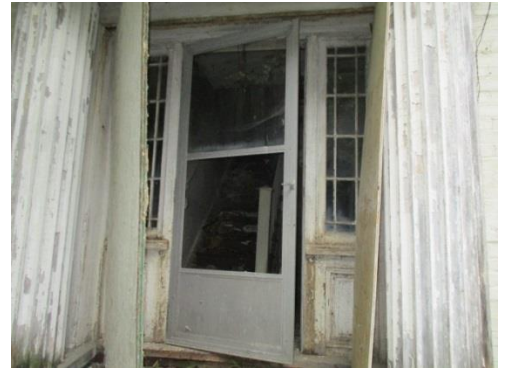
- .14 General view of the main entrance. The entrance door is missing. The aluminum storm door is in generally poor condition.

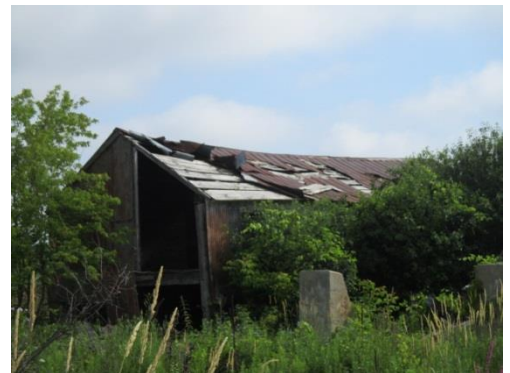
- .15 General view of the exterior walls of the barn. The exterior walls are covered with corrugated steel panels installed over wood boards. Several steel panels are missing.

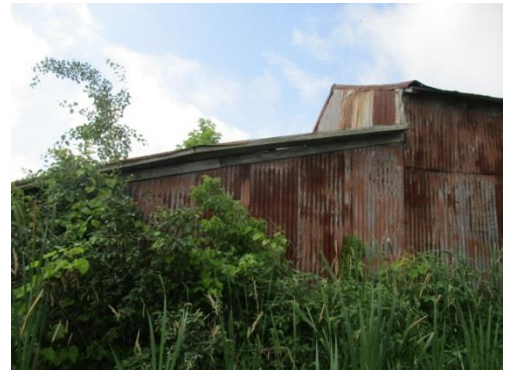
- .16 Where visible, the galvanized coating is typically deteriorated and the underlying steel is corroded.

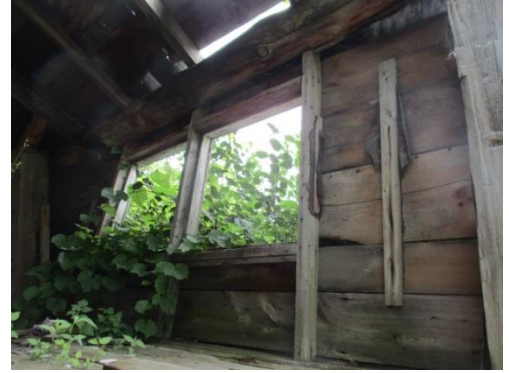
.17 All the doors and windows at the barn are missing.

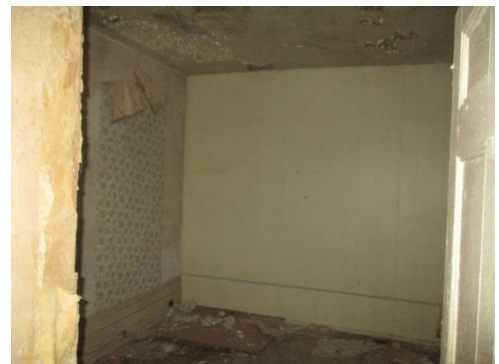
- .1 Structural framing members on the ground floor of the house were concealed by finishes and were not visible for review.

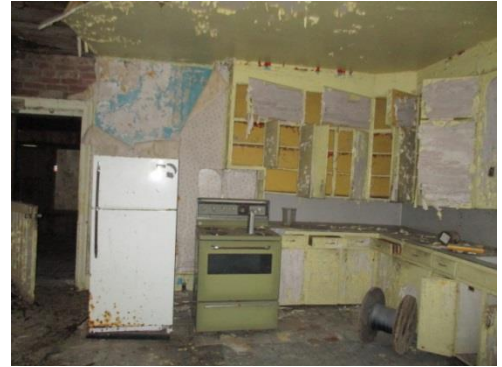
- .2 Wood floor deck in the kitchen appears to be decayed in some locations by prolonged exposure to water leakage.

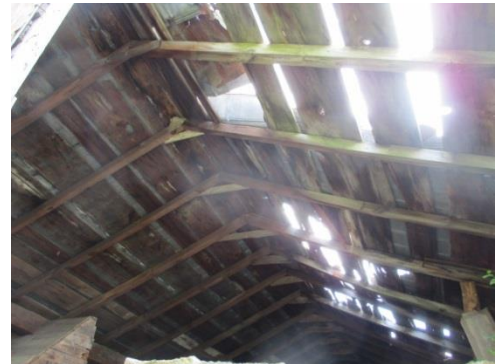
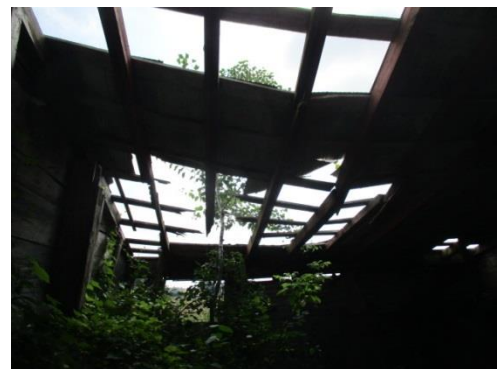
- .3 General view of the underside of gable roof framing. There are water stains at the underside of the wood plank roof deck and several wood planks are decayed due to exposure to prolonged water leakage through the roof. Some wood roof planks are missing.
- .4 The sloped roof of the shed at the east side of the barn is collapsed and the framing members appear to be in very poor condition. Several wood boards, purlins and rafters are decayed/damaged due to prolonged water leakage through the roof.

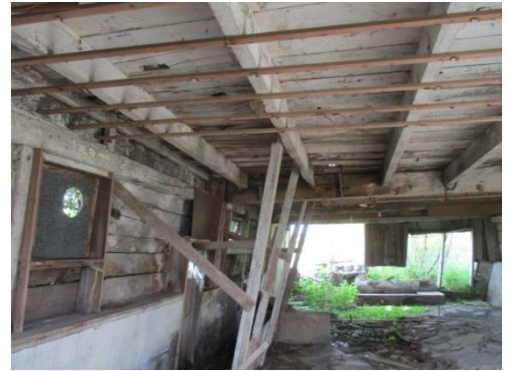
- .5 General view of the underside of the second floor framing of the barn. The wood floor deck is supported by wood joists that span between wood beams that frame into wood columns.

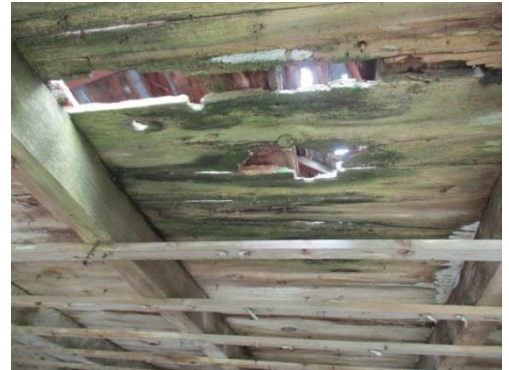
- .6 Several wood planks at the second floor are decayed due to exposure to prolonged water leakage through the roof. We did not access the 2nd floor level at the time of our site visit due to unsafe conditions (wood floor boards are decayed).

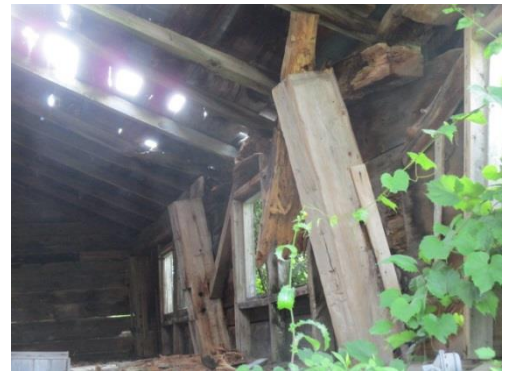
- .7 Several wood columns are dislodged and are out of plumb.

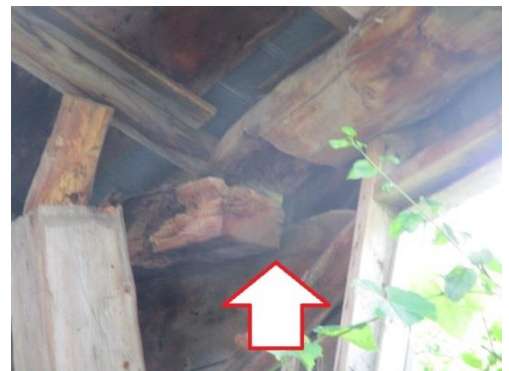
- .8 Some wood beams are dislodged at the joints. Some wood beams appear to be decayed due to prolonged water leakage through the roof and walls.

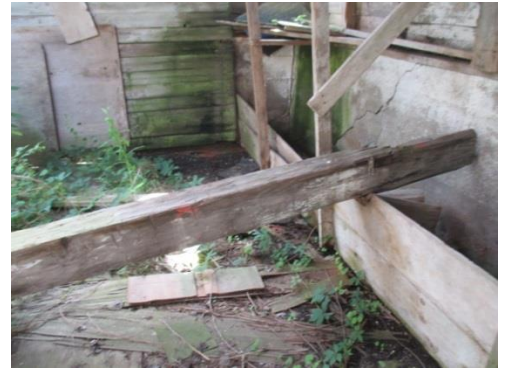
- .9 There is a dislodged wood beam on the ground floor.

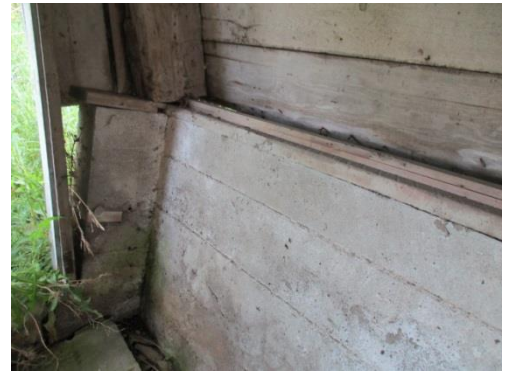
- .10 The poured concrete foundation walls are out of plumb and appear to have rotated outwards.

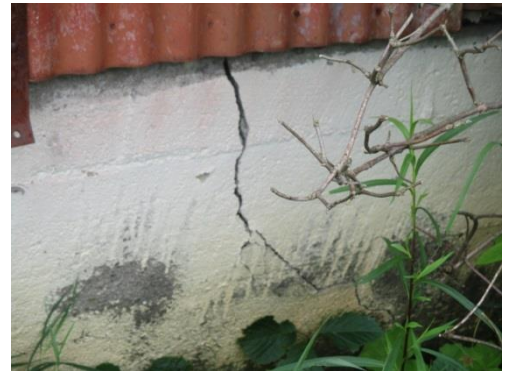
- .11 There are several large cracks in the poured concrete foundation walls.

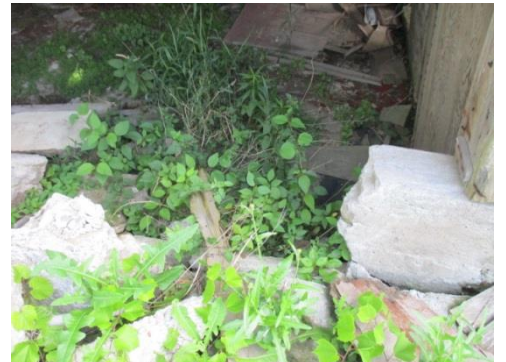
- .12 Some sections of the foundation wall have collapsed.

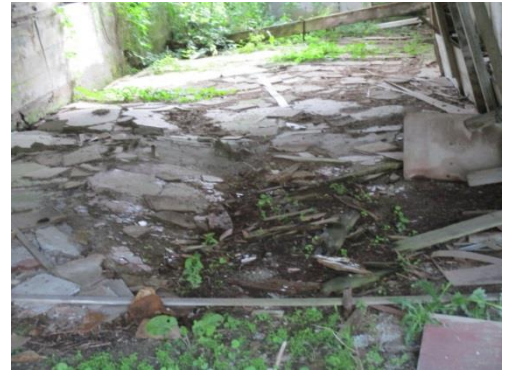
- .13 The poured concrete slab-on-ground forming the ground floor is cracked and settled and in poor condition.

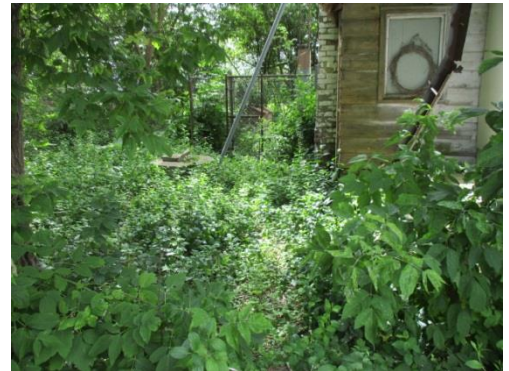
- .1 General view of the east side of the house that is covered with weeds, shrubs, bushes and trees that are not maintained. The site is not maintained.

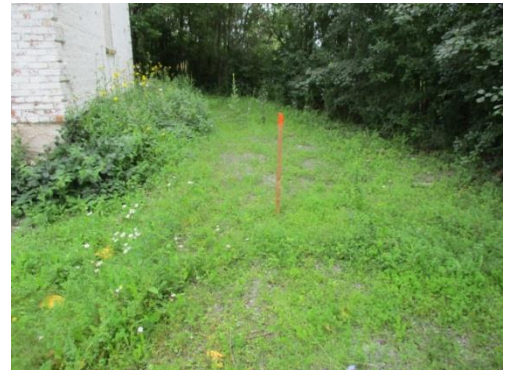
- .2 General view of the east side of the house that is covered with weeds, shrubs, bushes and trees that are not maintained.

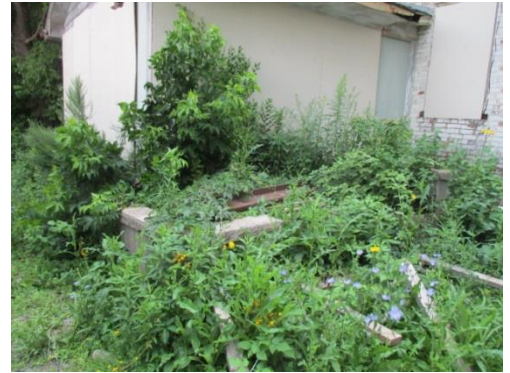
.3 Same comment as above.

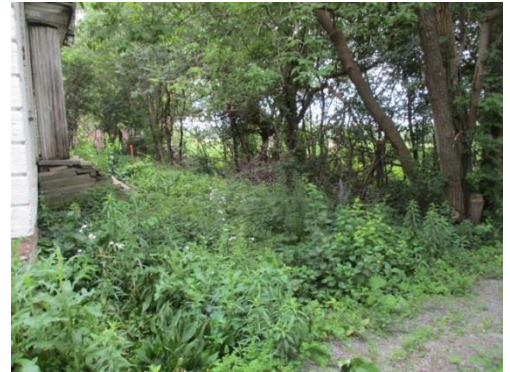
.4 General view of the south side of the house that is covered with weeds, shrubs, bushes and trees that are not maintained.

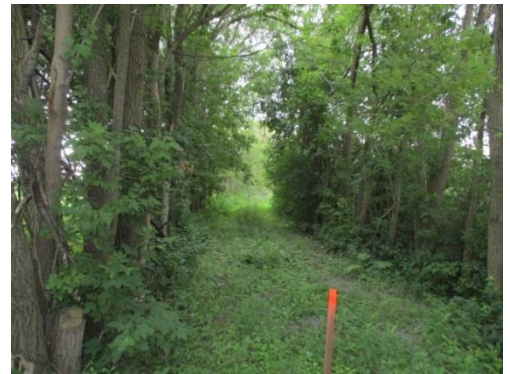
.5 General view of the original entrance driveway to the house from the street that is covered with weeds, shrubs, bushes and trees.

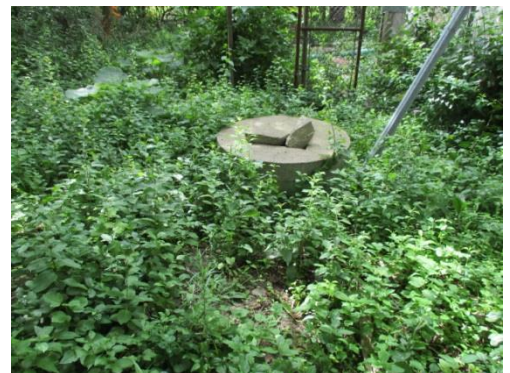
.6 General view of the abandoned well at the east side.

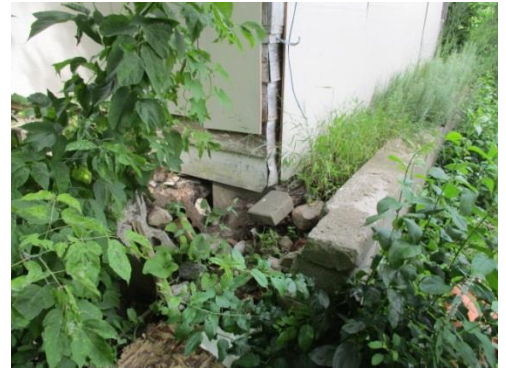
- .7 The retaining wall adjacent to the north section of the house that is formed by precast concrete units has collapsed in several locations.

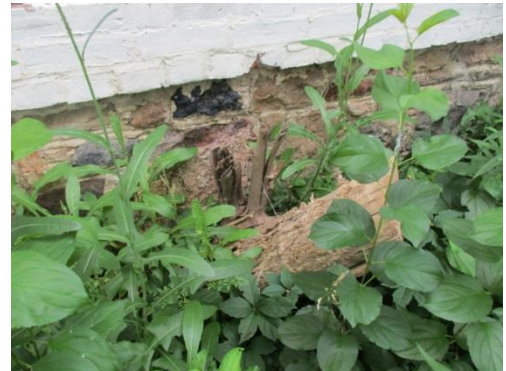
- .8 There are tree trunks adjacent to the house at the west side.

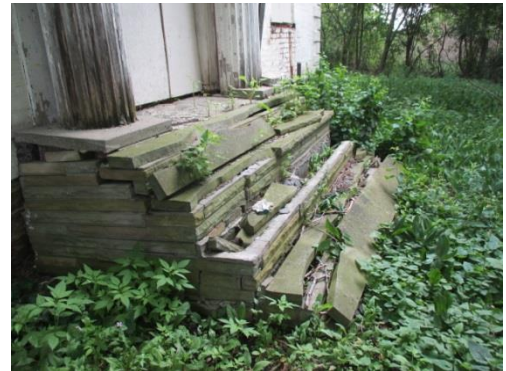
- .9 Steps at the main entrance that are formed by precast concrete units and natural stone slabs are settled/collapsed and this condition poses a potential safety hazard.

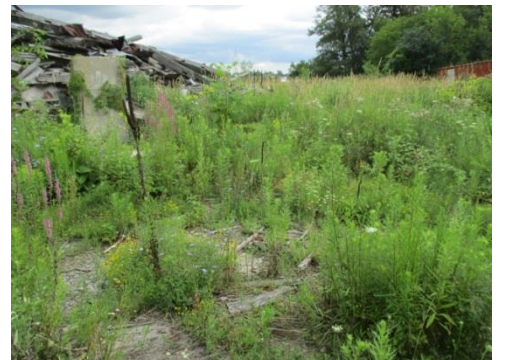
- .10 There is a pile of construction debris adjacent to the barn.
- .11 Ground adjacent to the barn is covered with weeds, shrubs, bushes, trees, etc. and is not maintained.

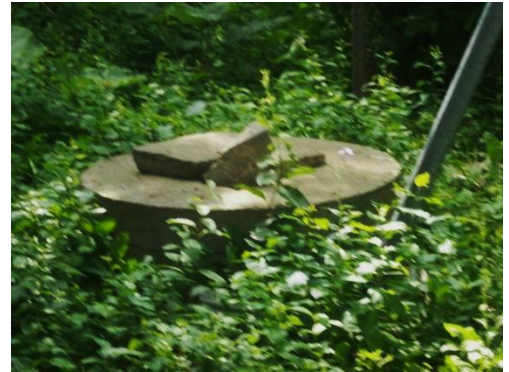
- .1 The domestic water supply to the 1½ storey residential dwelling is fed from an existing well. We did not sample the water or confirm that water is present in the well

In our opinion an allowance of \$25,000 should be anticipated for the provision of a new well.

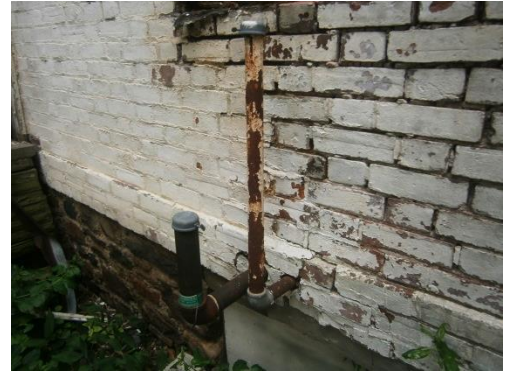
- .1 We observed an oil fill pipe and vent pipe located along the south-west residential dwelling exterior wall. We understand that an existing oil storage tank is located in the basement level. We recommend removing the existing oil storage tank.

In our opinion an allowance of \$15,000 should be anticipated for installing a natural gas supply to the residential dwelling.

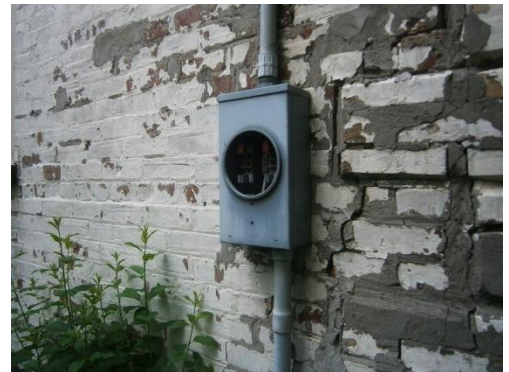
- .1 We observed that the electrical power supply and meter to the 1½ storey residential dwelling has been disconnected.

We recommend retaining a licensed electrician to restore the electrical power supply and re-connect the electrical meter to the residential dwelling.

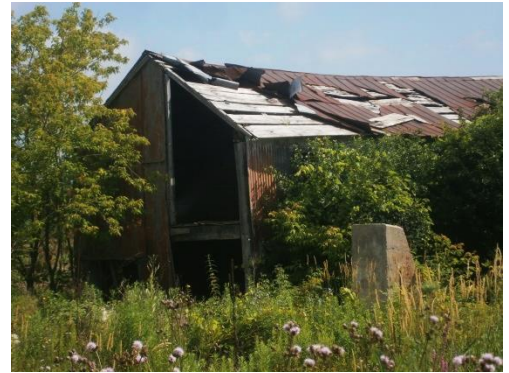
- .2 We observed no electrical power supply to the barn. We recommend retaining a licensed electrician to install an electrical power supply and disconnect switch to the barn.

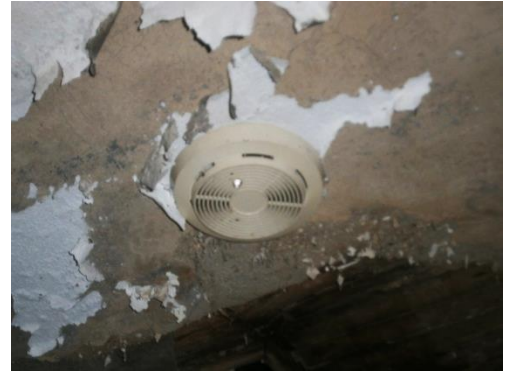
- .1 We observed the 1½ storey residential dwelling main floor ceiling is equipped with a battery operated smoke alarm.
