2021-2022 Thornlea Pool Restoration

General Committee

March 22, 2021

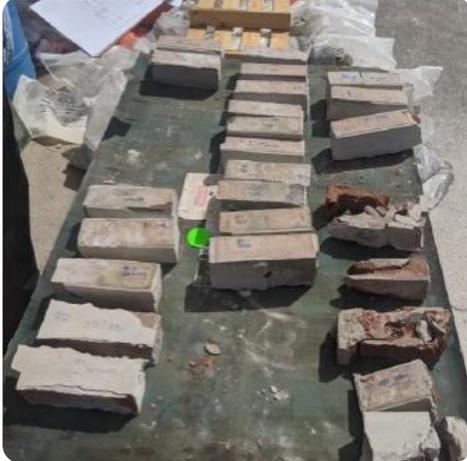
Brick Sampling. Spalled brick on lower right of photo too damaged to test

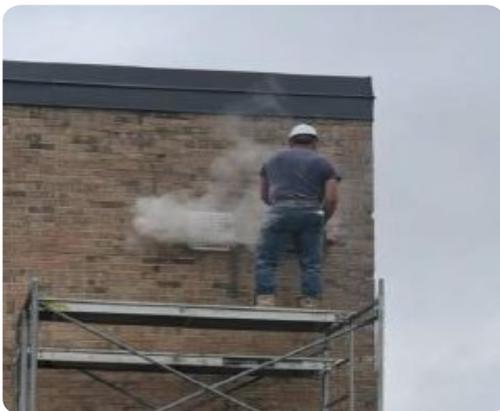
Contractor performing sawcut for probe opening at area of distressed bricks

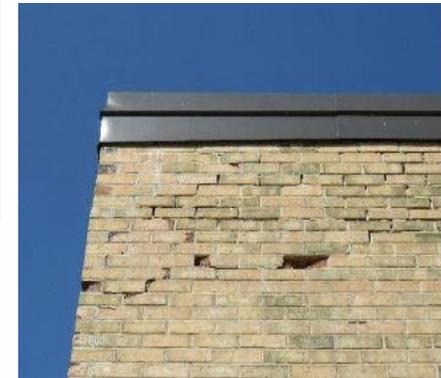
Image 1 – Spalled brick and eroded mortar joints along east facade

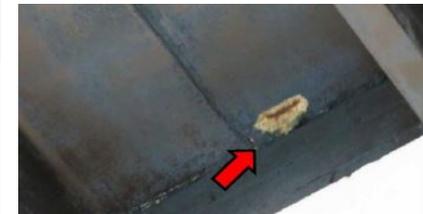
- April, 2020
 - Staff reported concrete pieces falling from the pool roof during operational hours.
 - Staff observed loose pieces of concrete falling from the underside of the pool roof.

Image 2 – Concrete spall at underside of precast double-tee above swimming pool area

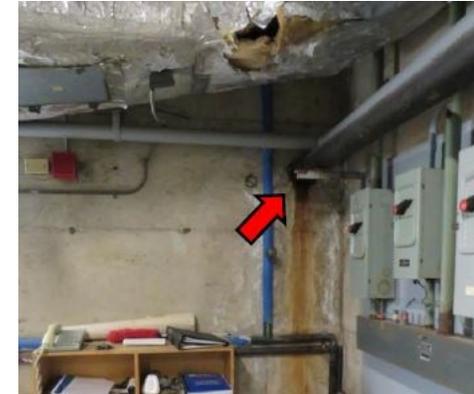
Image 3 – leak at pipe seal near circuit breakers

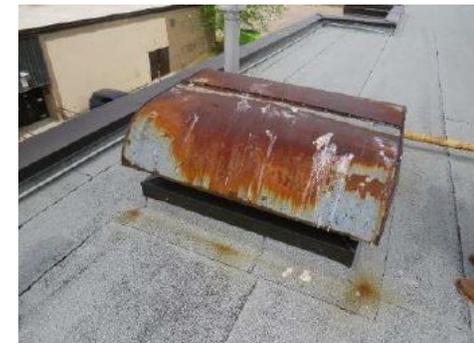
Image 4 – Existing HVAC infrastructure with galvanized coating corroded
