MEMORANDUM

SUBJECT: Demolition Permit Application
10 Ruggles Avenue, Thornhill (Langstaff) - Munshaw House
Fire Damage

Re: Building Structural Review for fire damaged Dwelling Structure
- 10 Ruggles Ave, Thornhill, ON
Our Project Number: S24-115

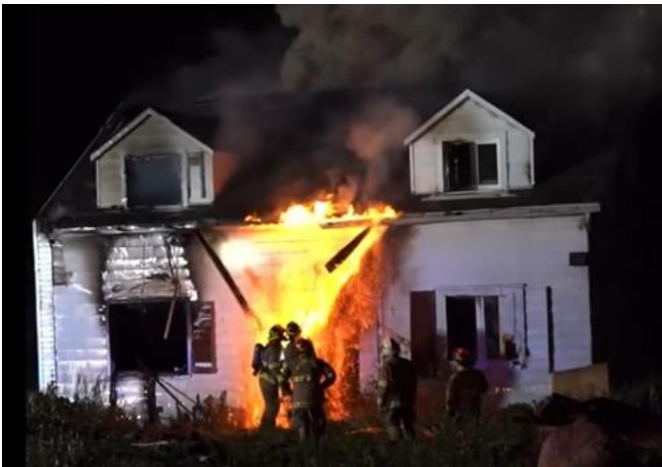
During the fire
