Summary of 2011 Commercial Façade Grant Requests

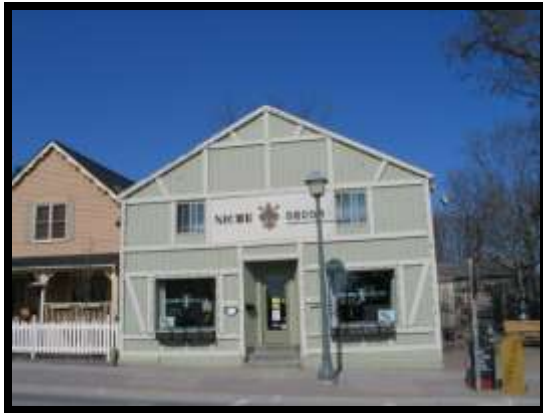
147 A Main St. Unionville (Niche Décor)

Status: Class 'A' building constructed in 1857 as a shed for a farm implement dealer, remodelled in 1873 by Christopher Chant to have a second storey residence with an undertaking and cabinet making business on the ground floor, followed by the taxidermy studio of Edwin Dixon in 1911.

Staff Comment: Given the Class 'A' status of this building, any potential grant funding should be directed to restore the missing historical features of this building including the siding, storefronts, entrance door and upper windows, rather than cosmetic improvements to the existing appearance.

| Proposed Work | Quote 1 | Quote 2 |
|--|--|---|
| <ul style="list-style-type: none">• Replace front door• Replace storefront and upper windows with new vinyl windows• Install two canvas awnings• Prepare and a paint wood and metal siding• Remove existing parging on front foundation and re-parge• Install two new light fixtures• Close off area above wrought iron enclosure and fill in area with wood board and batten siding | <p>\$1,837.00</p> <p>\$4,660.00</p> <p>\$2,200.00</p> <p>\$1,040.00</p> <p>\$1,020.00</p> <p>\$2,720.00</p> | |

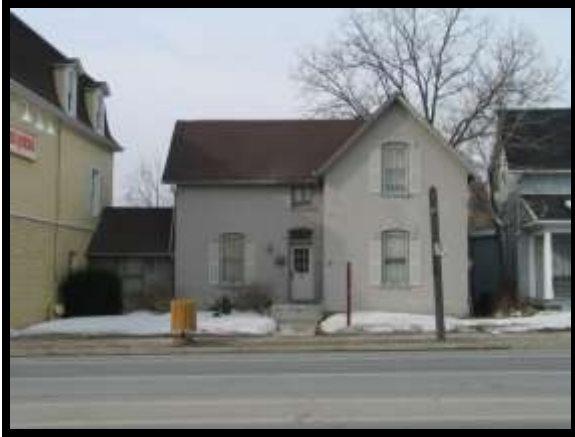
8 Main St. N. Markham Village

Status: Class 'A' building constructed circa 1880's for members of the Speight Family.

Staff Comment: The proposed work is appropriate for funding and is a required by the owner's site plan application for the property.

| Proposed Work | Quote 1 | Quote 2 |
|--|---|---|
| Replace existing shutters on front of house with appropriate historical shutters fitting the window openings | Canadian Custom Shutters | Emily Creek Woodworking |

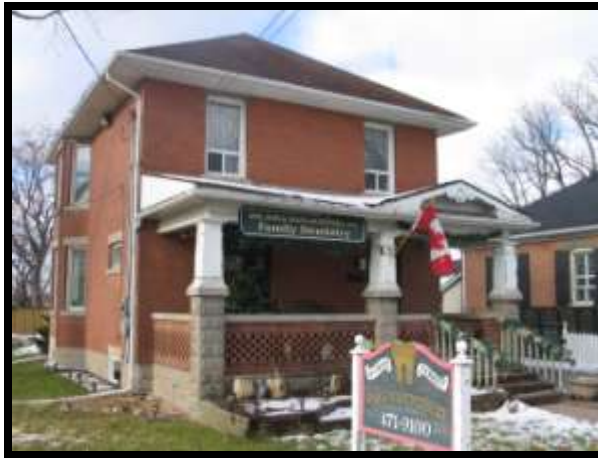
190 Main St. N. Markham Village

Status: Class 'A' building

Staff Comment: Lack of maintenance to the veranda roof is the reason why this veranda now has to be replicated, and normally this would make this project ineligible for grant assistance, as the program is not intended to reward poor stewardship. However, Heritage Markham supported the owner of the property using grant money to repair the veranda provided that it was done in conjunction with other significant façade improvements such as replacing the inappropriate modern windows and door that face Main St. N. and Bullock Drive.

| Proposed Work | Quote 1 | Quote 2 |
|--|---|---|
| Replace inappropriate windows of heritage house on Main St. N. and Bullock Drive with appropriate heritage windows | Not available at this time | Not available at this time |
| Rebuild veranda roof and posts | Not available at this time | Not available at this time |
