Property Condition Assessment

Thornlea Pool Building 8075 Bayview Avenue Markham, ON

YORK REGION DISTRICT SCHOOL BOARD

PROJECT NO. 1044354

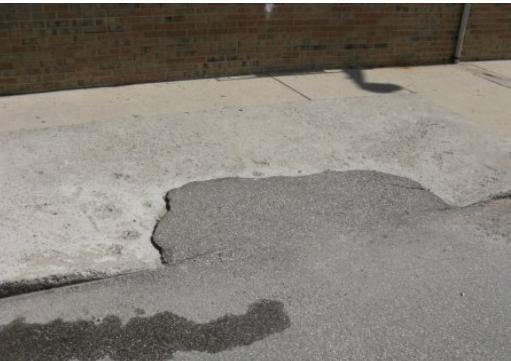
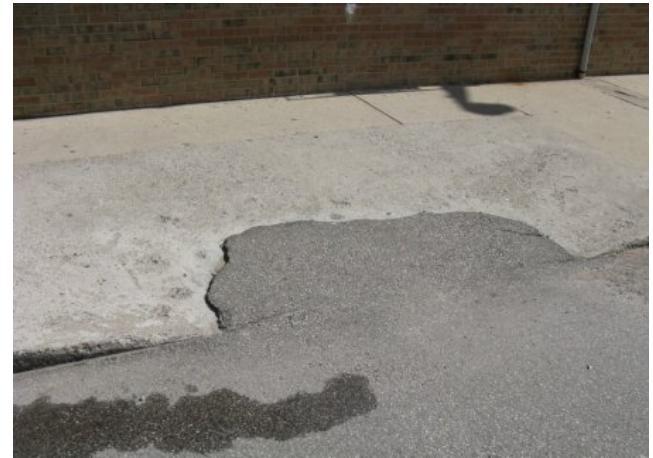
Assessment:	Not Applicable
Recommendation:	Not Applicable
Flat-Work	
Description:	There are cast in place concrete sidewalks located to the west and north of the building.
	A barrier free access ramp connects the west concrete sidewalk to the main entrance.
Assessment:	Localized scaling and longitudinal cracking of the concrete sidewalks were observed during the assessment, particularly around the main west entrance. Repair of the deficient areas is recommended to prevent pedestrian trip hazards.
Recommendation:	Based on observed conditions, localized repairs to the cast-in-place sidewalks are recommended. An allowance for these repairs is included in the cost table.

Localized deteriroation of concrete sidewalk.

COST SUMMARY Recommendation	Expected Useful Life (yrs)	Effective Age	Remaining Useful Life (yrs)	Year	Cost
Repair localized scaling and cracking of concrete sidewalks	20-25 yrs	Varies	Varies	1	\$10,000.00
Landscaping and Appurtenances

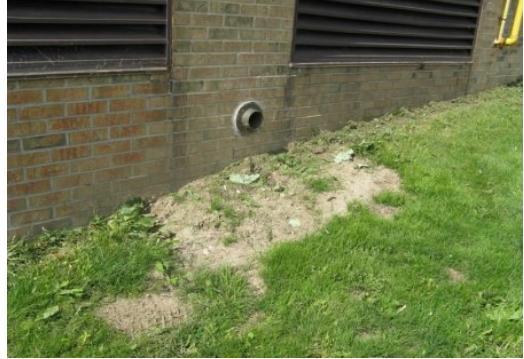
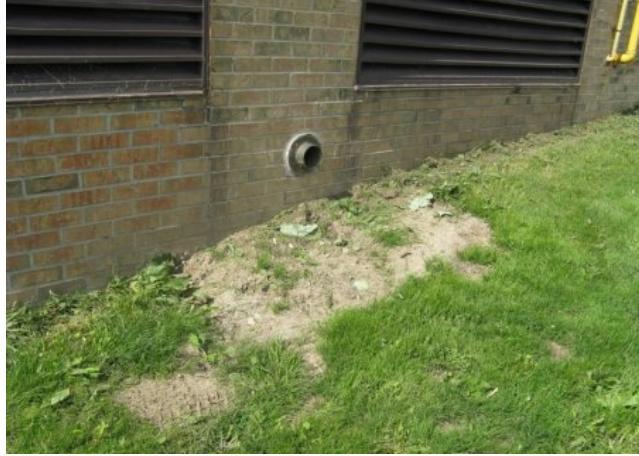
5.2 STRUCTURAL FRAME	& BUILDING ENVELOPE
Foundation	
THORNLEA POOL	
Description:	The type and extent of building footings are not known. The basement pool tunnel has poured concrete walls and a concrete slab-on-grade. As-built drawings were not available for review.
Assessment:	No significant cracking, settlement, or heaving of building elements that would suggest a potential foundation problem were noted at the time of the assessment.
	On the east elevation, the exterior wall, which is a poured concrete wall, is partially below grade. Here water infiltration is reported to occur, and this is evident in storage room. Water damaged interior finishes, including peeling paint and damaged floor tiles, were observed.
	An excavation reportedly to check the source of the water infiltration was recently undertaken. Findings of the excavation were not available for review during the assessment. It is likely that water infiltration is the result of an ineffective waterproofing system on the wall.

Evidence of previous excavation at site of moisture infilration through foundation wall.

Recommendation:	Reported water infiltration and interior damage are indicative of failure of the foundation waterproofing. Replacement of the waterproofing system, and repair of the building foundation wall, including parging is reportedly scheduled to be undertaken. An allowance for this replacement and repair is included in the cost table.

Thornlea Pool Repair foundation wall and waterproofing on east elevation

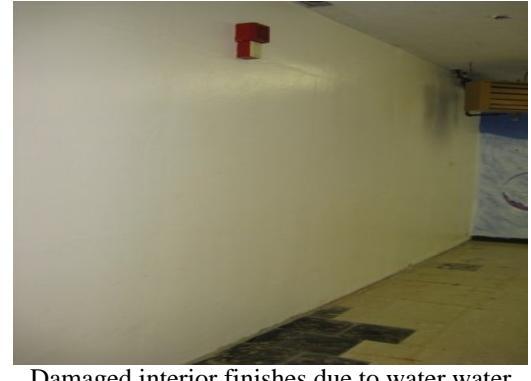
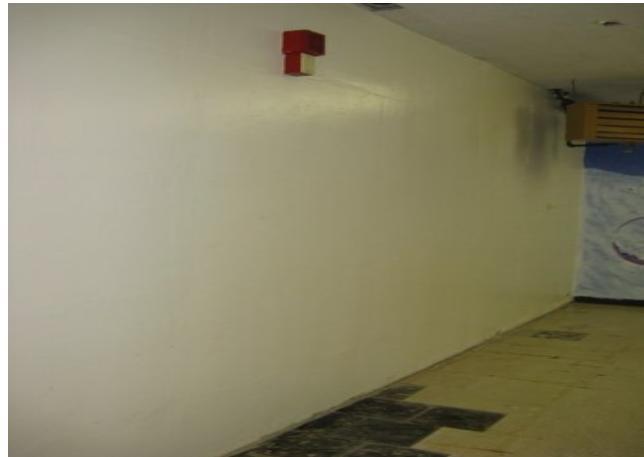
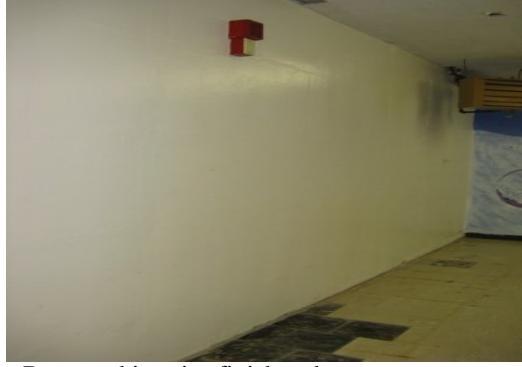
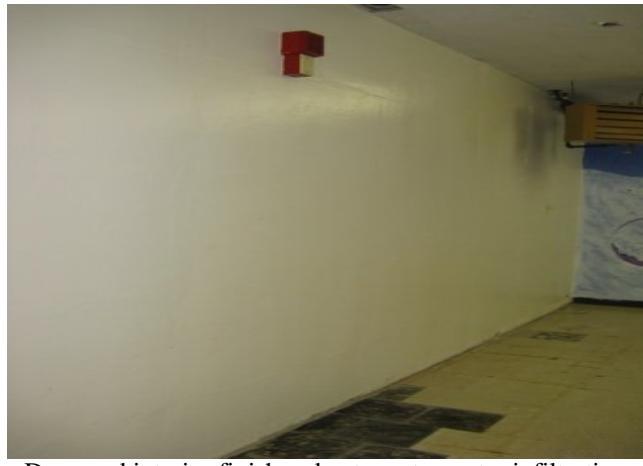
Damaged interior finishes due to water water infiltration through foundation wall.

Repainting of the concrete masonry walls and gypsum ceilings is reportedly undertaken periodically. Paint finish generally appears to be in good to fair condition. Exceptions are the 2nd floor men's change room ceiling and main floor storage room walls. Repainting of the these locations should be undertaken in the short term as recent repairs and water damage have resulted in discoloured and peeling paint.

Recommendation: The 2nd floor men's change room ceiling and the main floor storage room walls will require repainting in the short term due to discolouration and peeling paint. Costs to undertake the painting are included in the opinion of cost table.

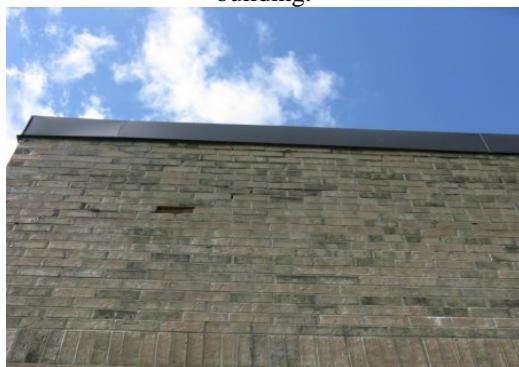
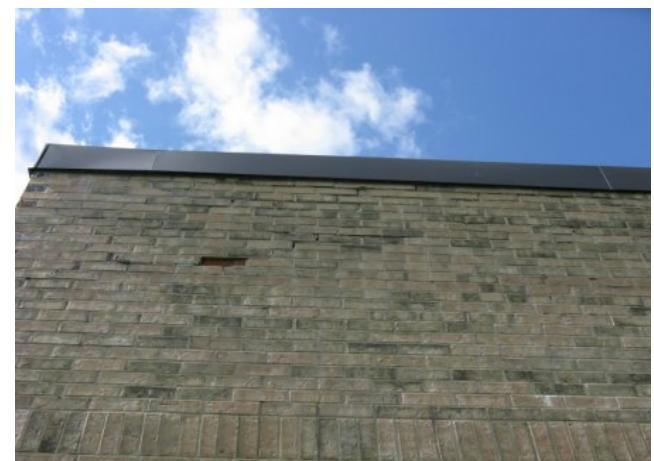
Brick spalling observed on the east elevation.

Repair of localized spalling brick is required to prevent falling brick on the north elevation. Repairs should be undertaken in the immediate term to mitigate risk, and should be handled as operations and maintenance cost.

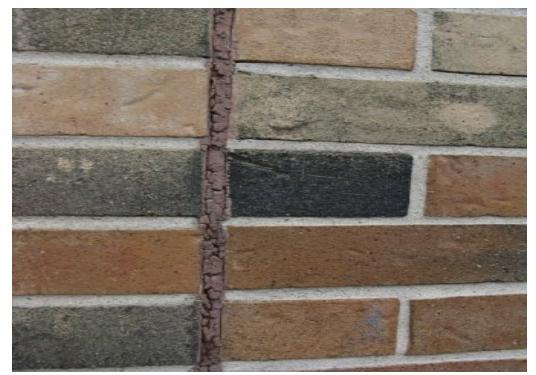
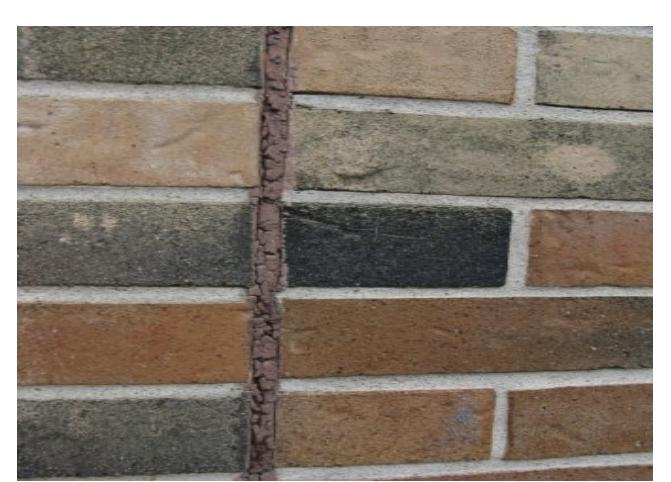
The window and door perimeter sealant was observed to be in fair condition with signs of deterioration in localized areas. The building control joint sealant is in poor condition, with cohesive failure observed in most locations.

Deteriorated control joint sealant.

Based on the observed condition, it is recommended to replace the deteriorating sealant on building control joints. The associated costs are included in the costs table.

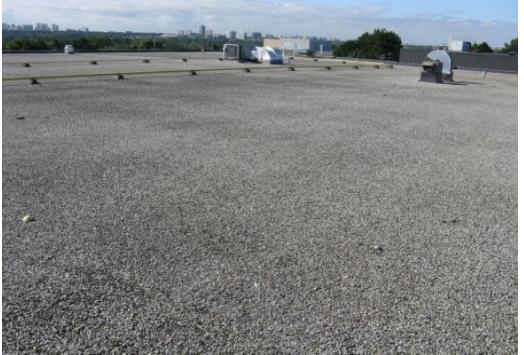
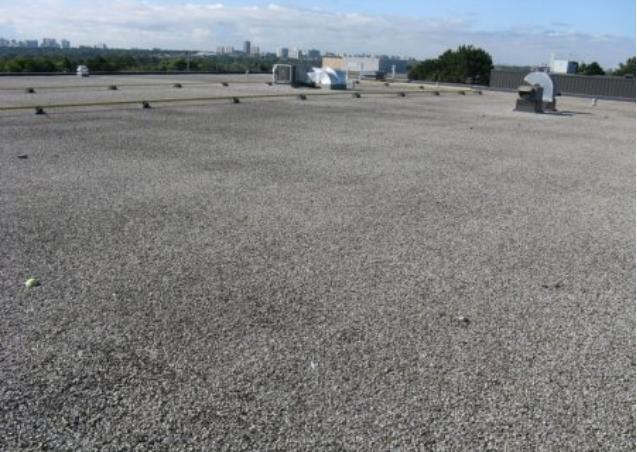
THORNLEA POOL	
Description:	The roof assembly system on the building is a conventional insulated type in that the membrane is installed directly on rigid roof insulation. The inclusion of a vapour retarder in this roof construction was not confirmed as no core tests were conducted.
	The membrane component of this roofing system is a built-up roof (BUR)membrane, consisting of multiple plies of reinforced felts and waterproofing bitumen. The membrane is surfaced with a flood coat of bitumen and pea gravel.
Assessment:	No deficiencies associated with the roofing assembly system were reported or observed at the time of the site visit. According to the chief caretaker the roof assembly system was replaced in approximately 1998. This appears to be consistent with the observation made during the assessment.
Recommendation:	Similar roof assembly systems are known to have a service life of approximately 22 years. The service life is subject to construction, type of materials used and maintenance. Based on age and conditions observed during the assessment replacement of the roof assembly system is not anticipated between 2008 and 2018.

General view of Built up roof assembly.

Roof replacement is subject to maintenance, and immediate repair roof leaks, which may occur. A provision to undertake interim repairs is included in the Replacement Reserve cost table.

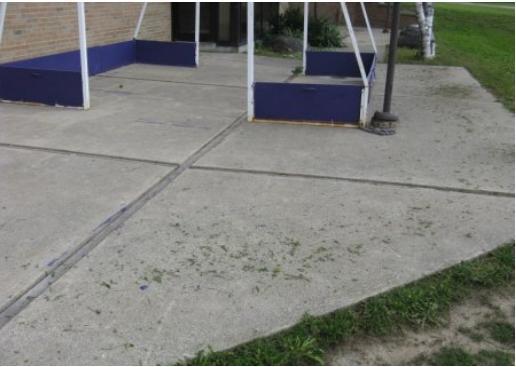
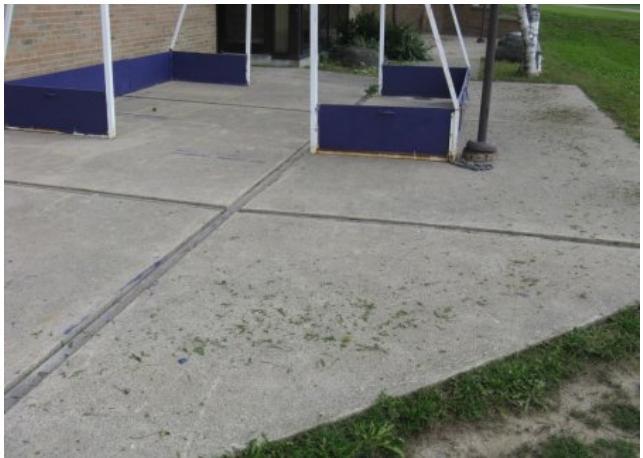
5.	2 STRUCTURAL FRAME	& BUILDING ENVELOPE continued
Pa	ntio, Terrace, and Balcony	
	THORNLEA POOL	
	Description:	A patio/terrace constructed with cast-in-place concrete is located to the south of the building.
	Assessment:	Differential settlement was observed during the assessment, on the cast-in-place concrete patio. The differential settlement is likely the result of poor construction on the underlying soils.
	Recommendation:	In its current condition the concrete patio is a potential tripping hazard. Reconstruction will require removal of the existing concrete and engineering the underlying soils to support the concrete patio and to minimize future settlement. A cost to reconstruct the concrete patio is provided in the cost table.

Uneven settlement of concrete patio at the south side of the building.

COST SUMMARY Building	Recommendation	Expected Useful Life (yrs)	Effective Age	Remaining Useful Life (yrs)	Year	Cost
Thornlea Pool	Reconstruction of the south concrete patio	20-25 yrs	20-25 yrs	1 yr	1	\$20,000.00

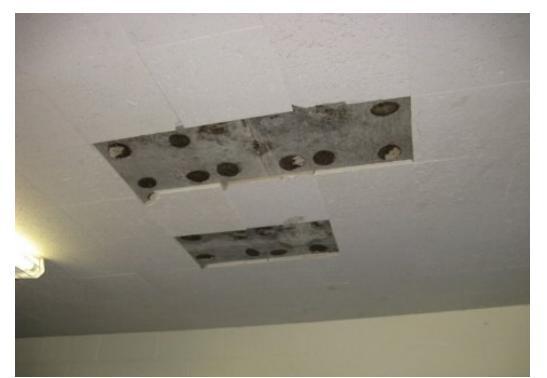
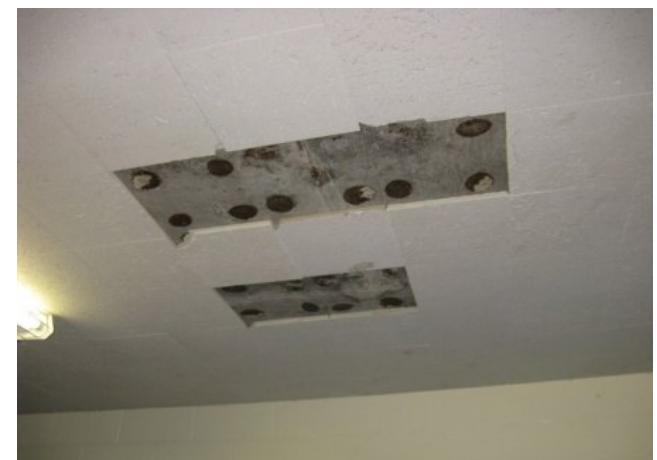
The vinyl tile floor in the gymnasium storage room is in poor condition. Debonded, discoloured and missing tiles were observed as result of the experienced water infiltration. Stained and debonded ceiling tiles were also observed. The existing tiles have likely been in place since construction of the building in 1977. Replacement of the storage room finishes is anticipated within the evaluation period.

Debonding of direct applied ceiling tiles in gymnasium storage room.

Interior finishes in the gymnasium storage room are in poor condition. Replacement of the vinyl floor tile and direct-applied ceiling tiles is recommended due to age and poor condition. An allowance for their replacement is provided in the cost tables.

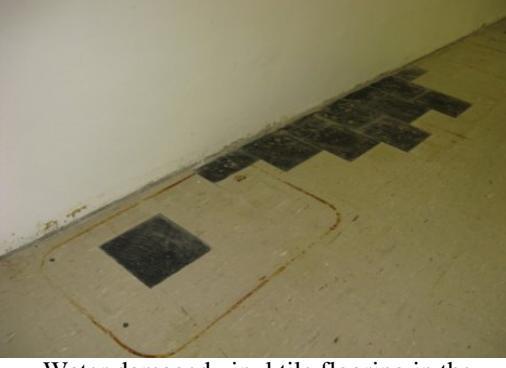
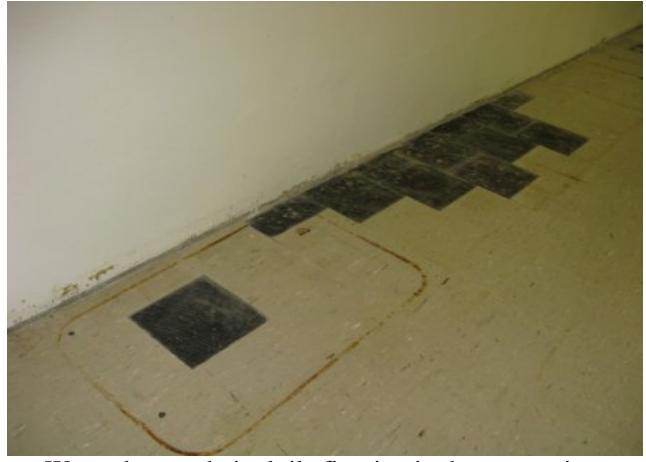
Water damaged vinyl tile flooring in the gymnasium storage room.

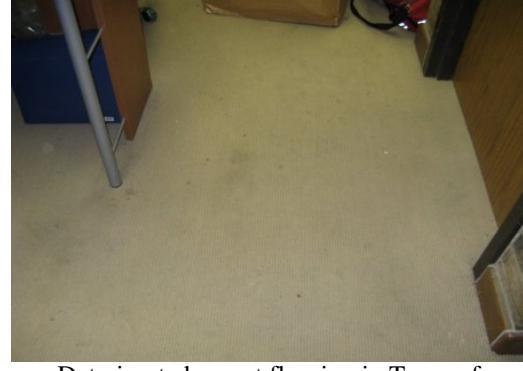
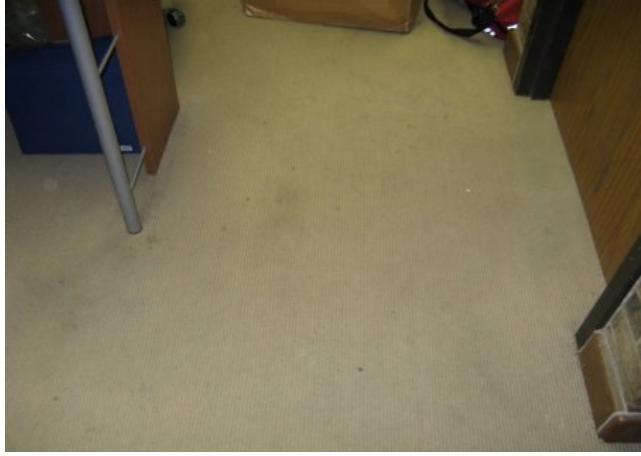
Carpet in the Town of Markham office is also in poor condition, with visible wear and stains.

Deteriorated carpet flooring in Town of Markham office.

The carpet in the Town of Markham office in poor condition, with visible wear and stains. Replacement is recommended in the short term and a cost is included in the cost table.

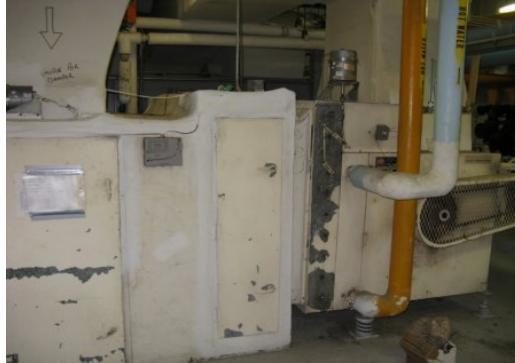
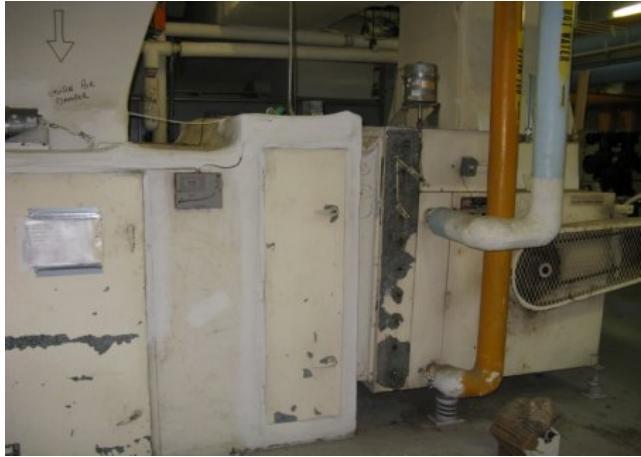
Original Air Handling Unit for Gymnasium area.

Recommendation:	Air handling units have an Expected Useful Life (EUL) of 25-30 years, replacement of the two air handling units is anticipated between 2008 and 2018.
	The pool area Dectron unit is reported to require frequent maintenance and repair. Based on age and reported maintenance history, an allowance for the refurbishment and part replacement is provided to ensure uninterrupted operation and extended service life.

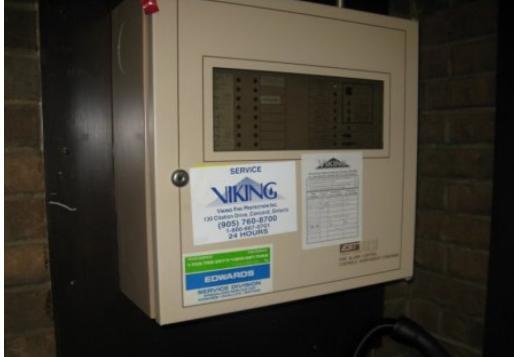
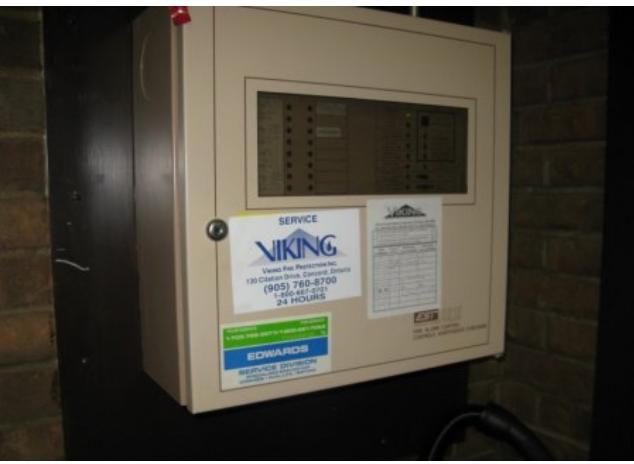
Main fire alarm panel.

COST SUMMARY Building	Recommendation	Expected Useful Life (yrs)	Effective Age	Remaining Useful Life (yrs)	Year	Cost
Thornlea Pool	Replace main fire alarm panel and end devices	20 yrs	15 yrs	5 yrs	5	\$60,000.00
Thornlea Pool	Replace exit signs in the building.	15	15	0	3	\$5,000.00

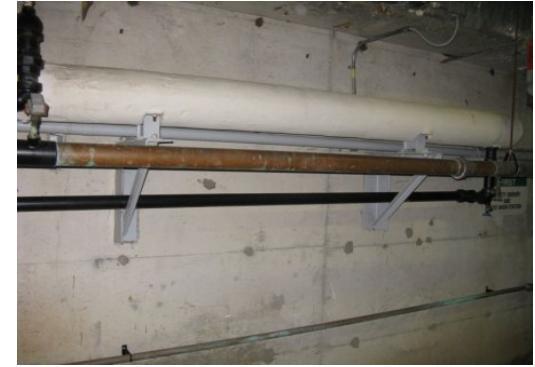
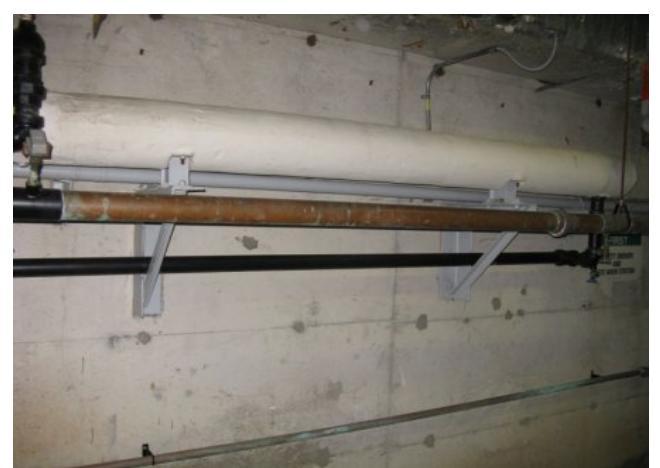
Shell and tube heat exchanger for pool water heating.

Recommendation: of 15 years. Given the age of the shell and tube heat exchanger replacement is recommended.
