Heritage Markham Committee Agenda

August 12, 2020, 7:00 PM Electronic Meeting

The Seventh Heritage Markham Committee Meeting of The Corporation of The City of Markham in the year 2020.

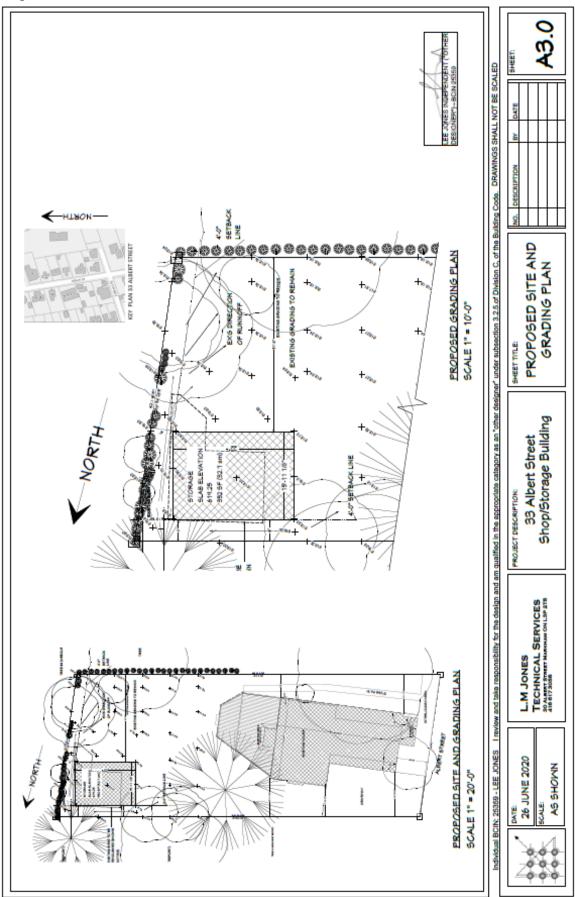
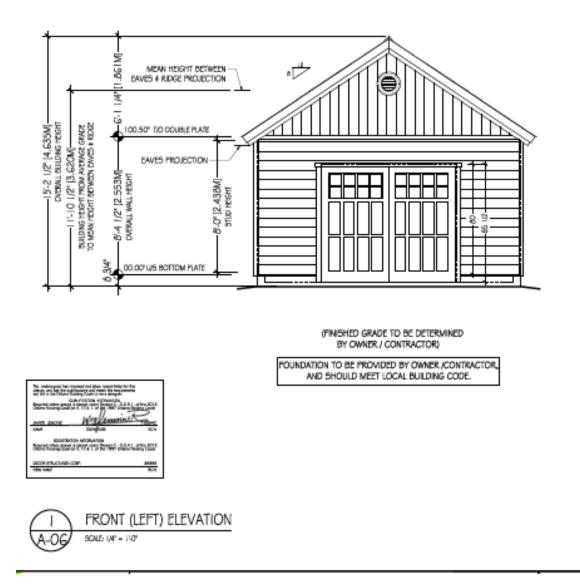
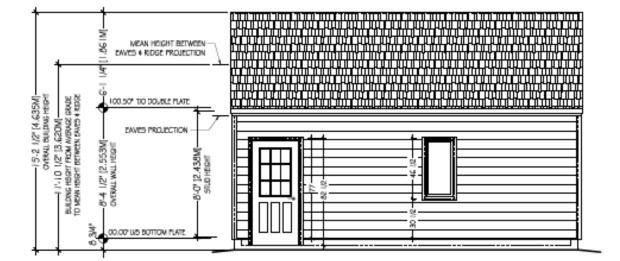
(FINISHED GRADE TO BE DETERMINED BY OWNER / CONTRACTOR)

FOUNDATION TO BE PROVIDED BY OWNER, CONTRACTOR, AND SHOULD MEET LOCAL BUILDING CODE.

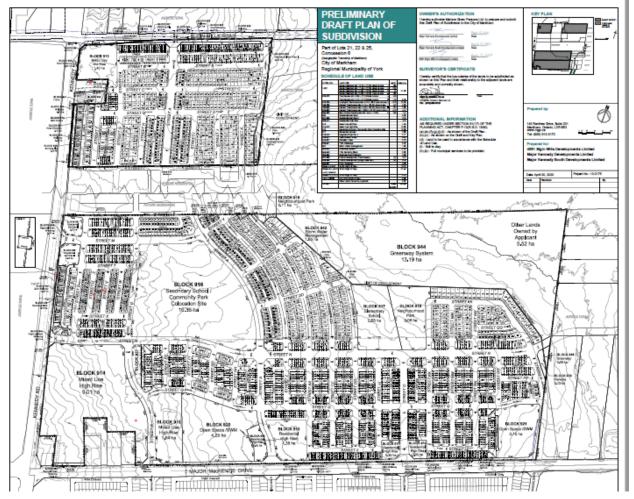
Plan of Subdivision

Cultural Heritage Resource at north west corner is not include in the current plan of subdivision submission – see highlight area

- The draft plan of subdivision identifies the current placement of the cultural heritage resources, but does not place them in a context for preservation and integration into the development plan. Typically this information is worked out prior to draft plan approval so that the conditions can specify the location of heritage buildings on a particular lot or block which is appropriate to the resource's future use and is compatible with surrounding land uses/types of development.

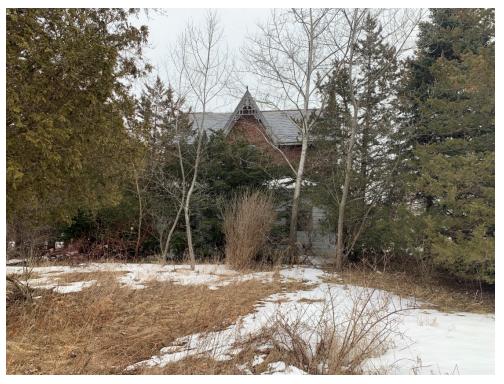
Figure 14: View front façade (CU 2020).

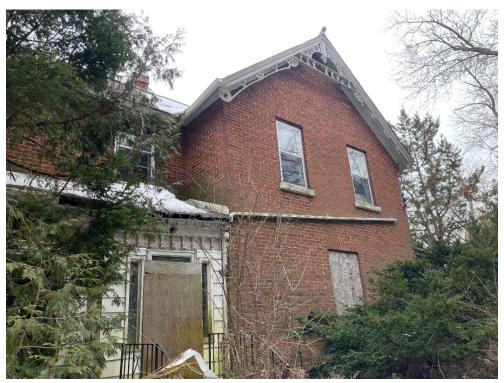
Figure 15: North elevation (CU 2020).

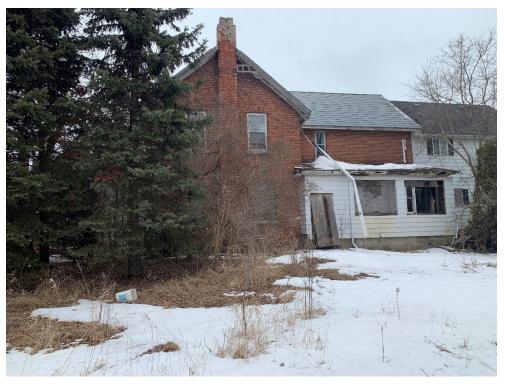
Figure 16: South elevation showing chimney, brickwork, and additions (CU 2020).

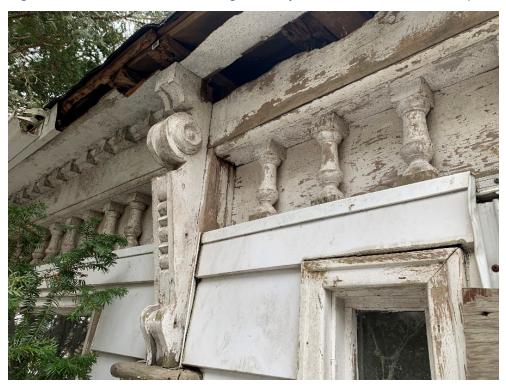
Figure 17: Detail of woodwork along north porch (CU 2020).

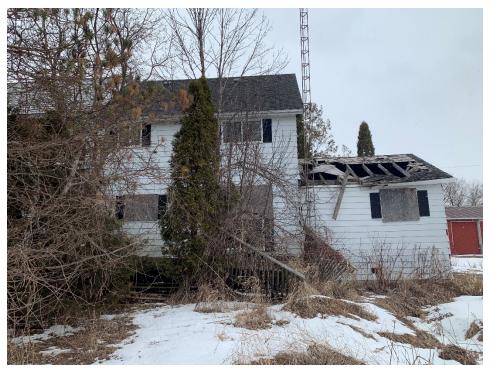
Figure 18: Two rear additions, constructed between 1978 and 1988 (CU 2020).

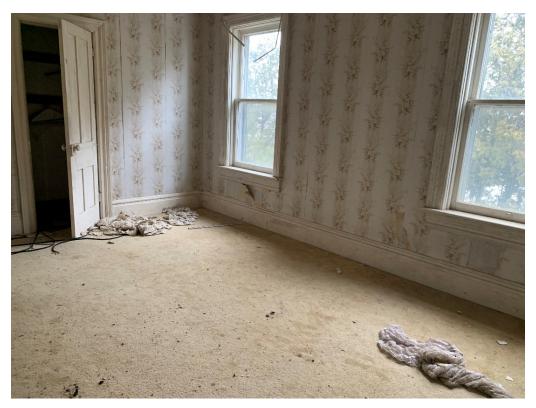
Figure 22: Typical view of upper floor room (CU 2020).

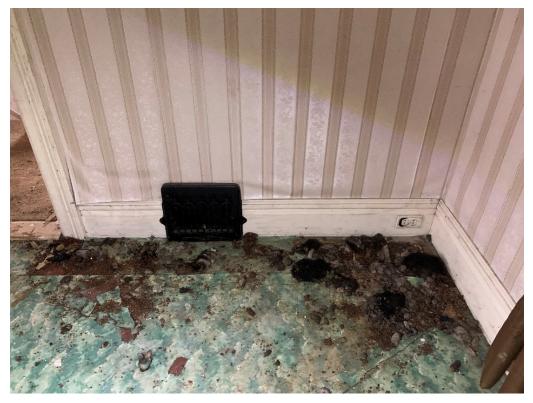
Figure 23: Metal ventilation grate (CU 2020).

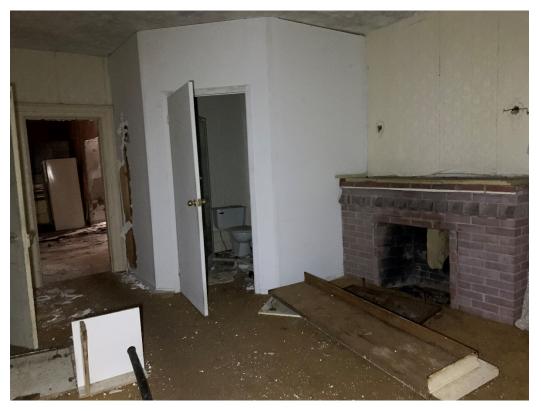
Figure 24: View of first floor, including fireplace (looking west towards kitchen and southern addition) (CU 2020).

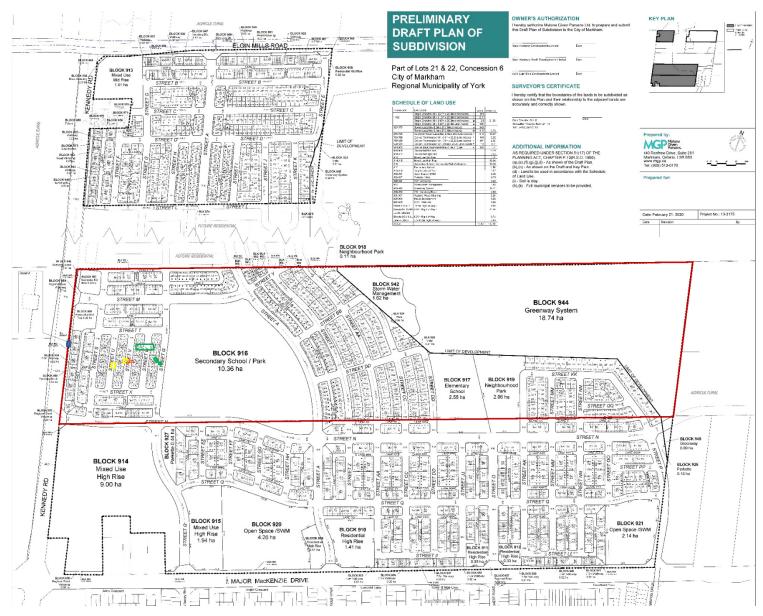
Figure 32: Preliminary draft plan of subdivision with structures from Figure 13 overlaid.

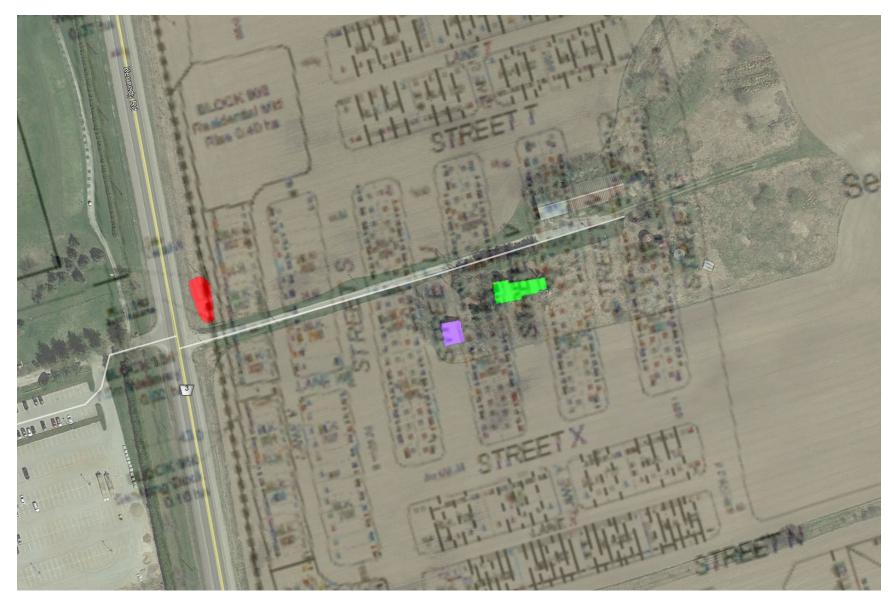
Figure 33: Detail of plan of subdivision over cultural heritage resources (Red: Pingel Cemetery, Purple: J.P. Carr Cottage, Green: Homer Wilson Farmstead).

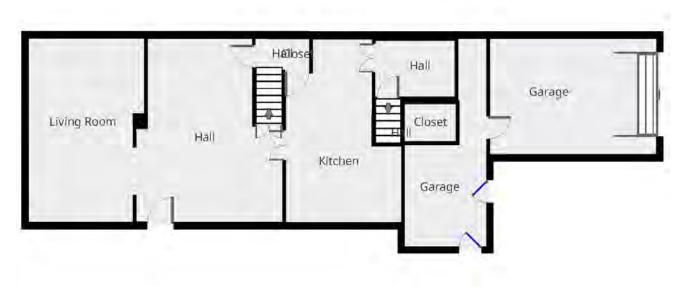
Figure 8: Ground Floor Plan (not to scale)

On the second floor, the three bedrooms towards the west of the structure likely date to the turn of the century construction of the second floor and their configuration would suggest that the current location of the stairs is original to the construction of the second floor (Figure 9).

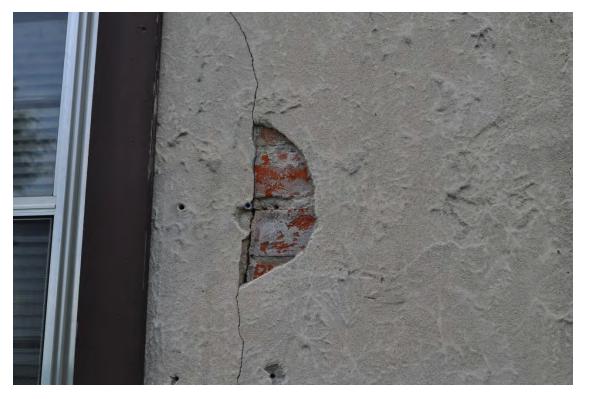
Photo 5: Detail of visible brick structure below cracking stucco

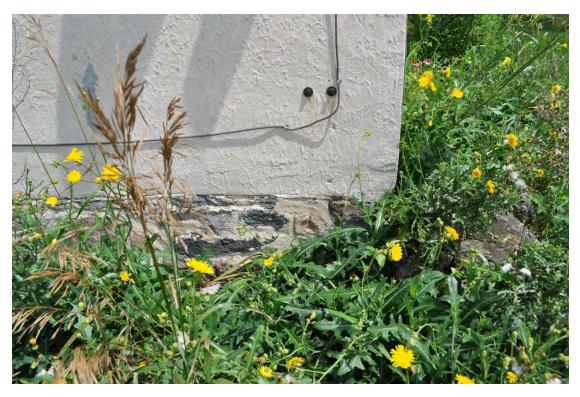
Photo 6: Detail of foundation stones along west elevation

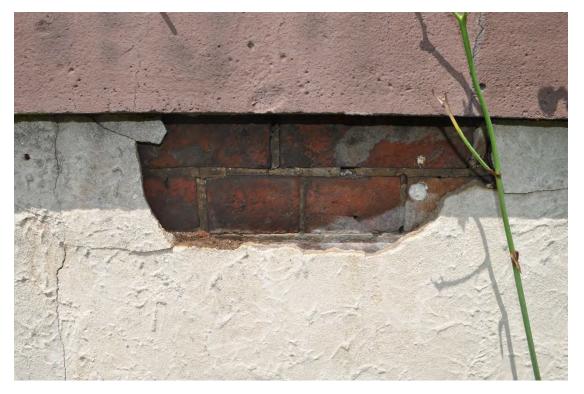
Photo 7: Detail of foundations, near southeast corner of structure

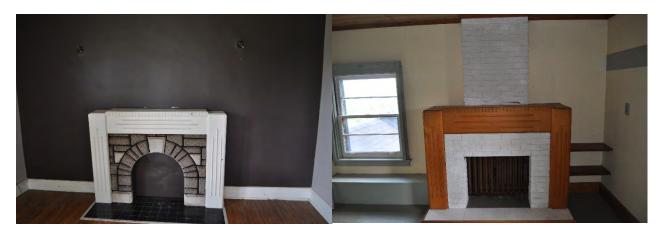
Photo 8: Fireplaces, first floor (left), second floor (right)
