**SUBJECT:** Request for Feedback  
2730 Elgin Mills Road East  
Post Fire Engineering Report

**Property/Building Description:** Christian Heise House, single detached, 1-1/2 storey dwelling constructed c. 1859.

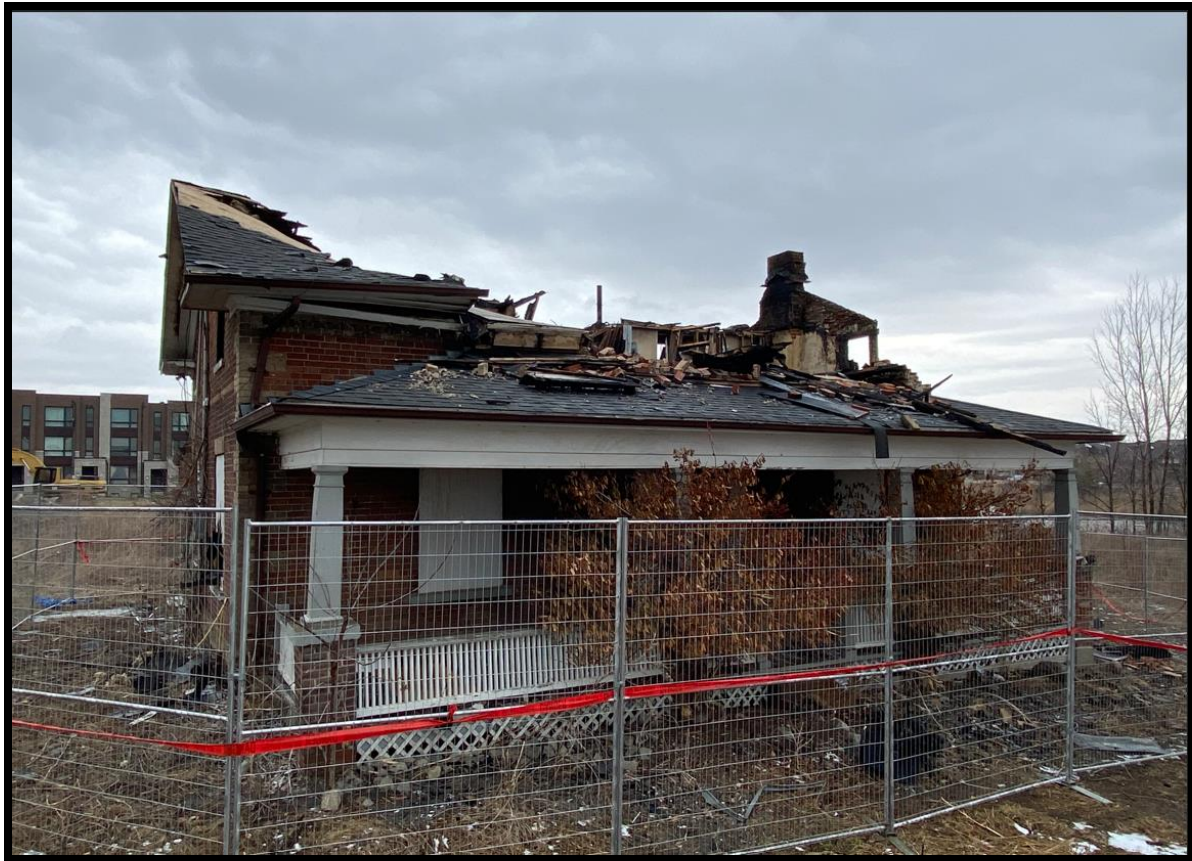
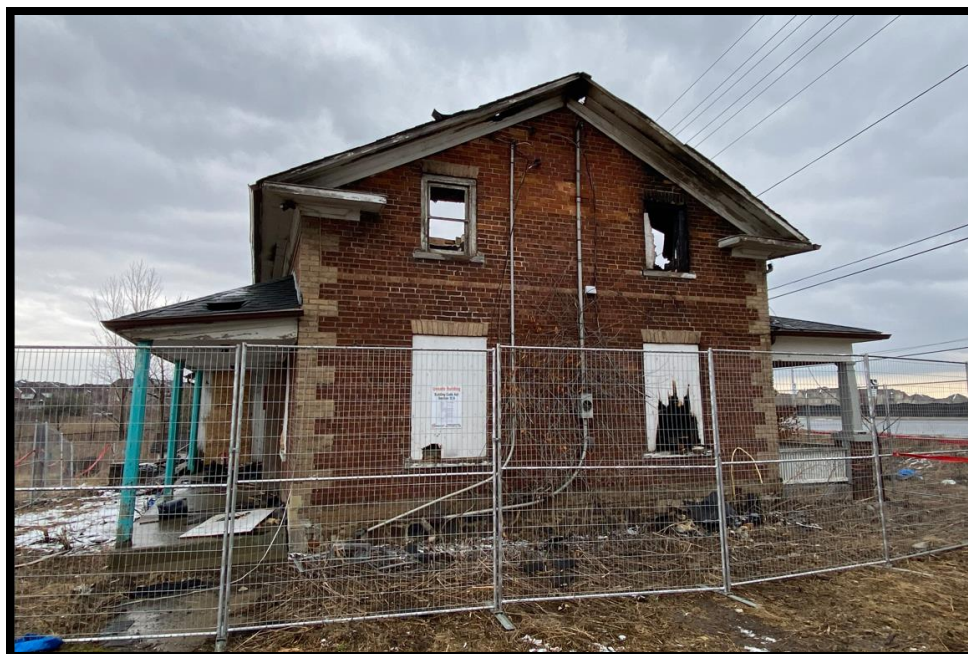
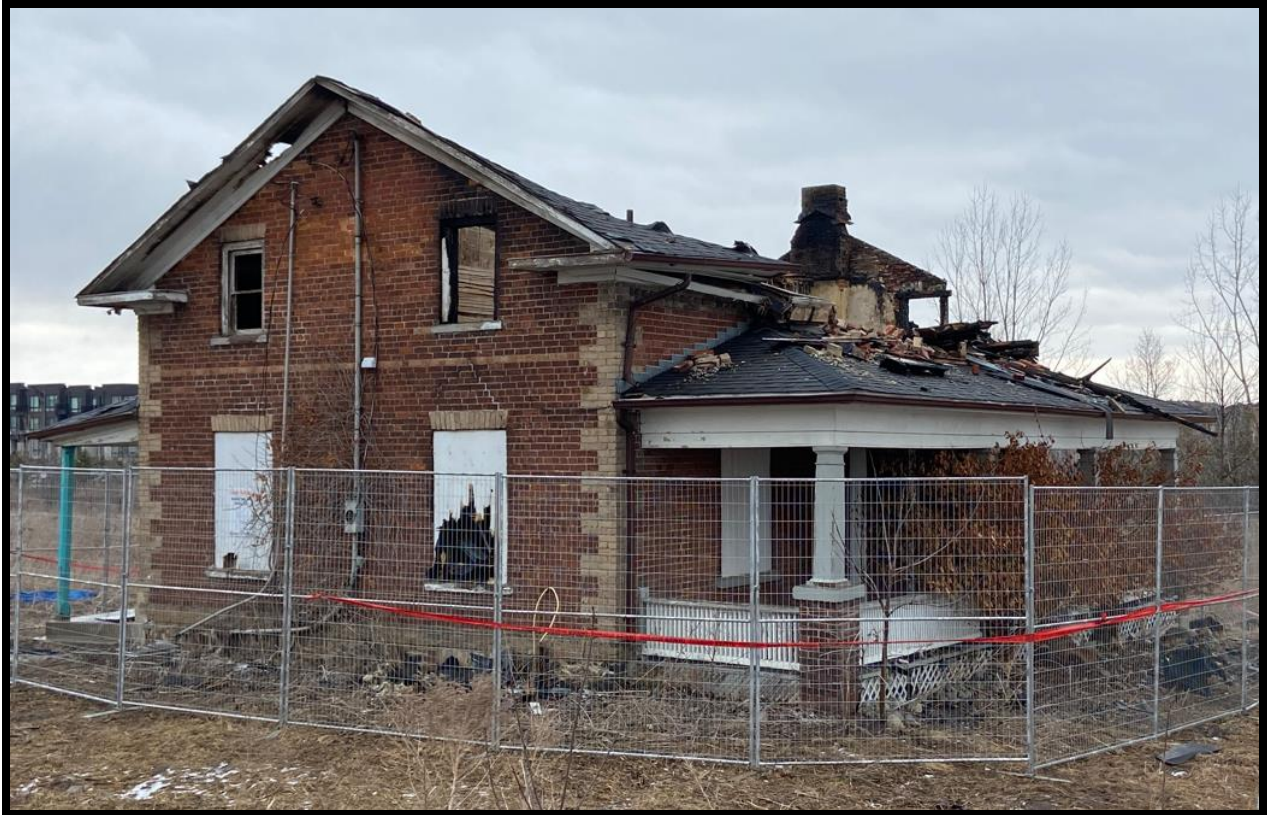
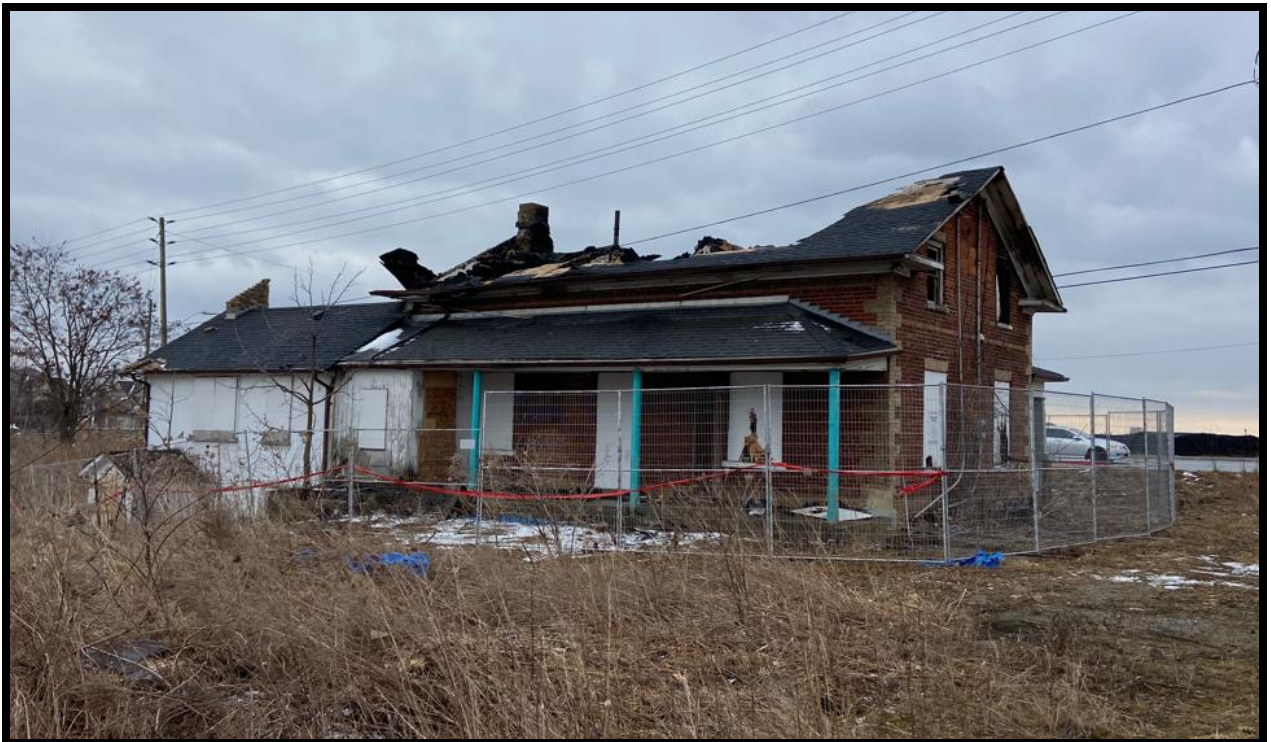
## Post Fire Photographs of the Christian Heise House

- On February 19<sup>th</sup> 2025, a fire caused significant damage to the Christian Heise House including the loss of most of the roof, partial collapse of the east brick gable wall, heat damage to the west gable wall, partial collapse of the second floor adjacent to the west gable wall as well as water damage from the extinguishing of the fire and from the interior being exposed to the winter elements.

- Although reconstruction using salvaged material is in the opinion of the engineer the most effective method of balancing safety concerns with preserving remaining heritage fabric, the engineer also provides the stabilization work required to return the building to a safe condition recommending that any preservation work should proceed with caution while prioritizing the safety of workers.

- THAT from a heritage perspective, Heritage Markham recommends that the owner of the Chrisitan Heise House perform the stabilization measures outlined in the engineer's report, proceeding with the caution and prioritization of worker safety, so that the Christian Heise House can be stabilized, restored to safe condition, and relocated intact as proposed by the Subdivision application.
