MEMORANDUM

SUBJECT: Major Heritage Permit Application
Proposed 2-Storey Rear Addition and Garage
33 Colborne St., Thornhill
HE 25 110515

Property/Building Description: 1-1/2 storey frame house constructed c. 1900

Heritage Status: Designated under Part V of the Ontario Heritage Act and identified as a Class A building or historic buildings that define the historic character of the district

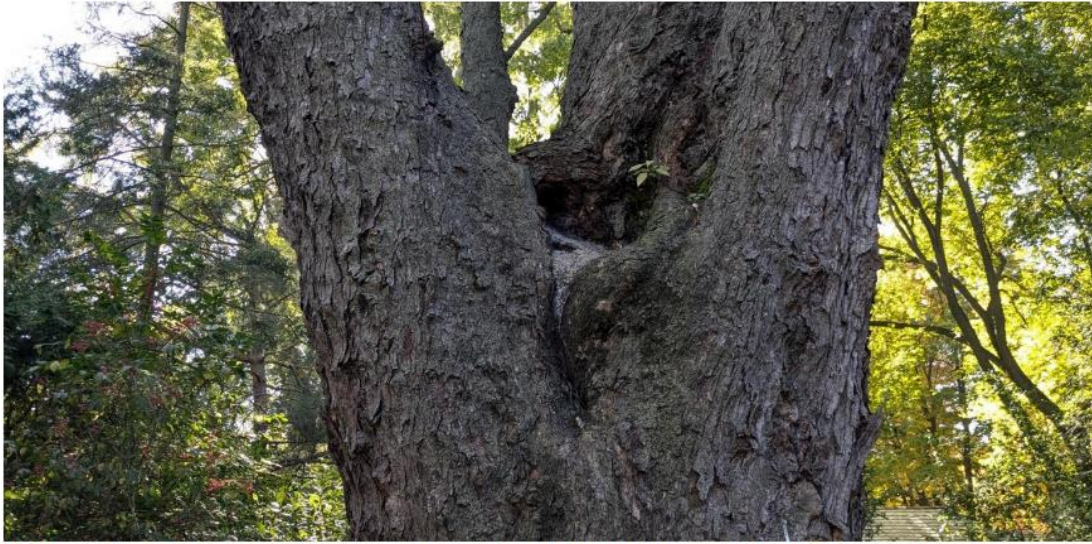
Attachment E - Photographs of Tree 12

Figure 28: Tree 12 is showing advanced rot in the main stem with concrete installed within the stem juncture. This tree is proposed for removal due to construction and poor condition.

- The property is located in the sensitive “core” area of the Thornhill Heritage Conservation District and has several mature trees.
- The application proposes the removal of 5 existing trees due to a combination of the proximity to the proposed addition and poor health, but also proposes replanting 3 native hardwood trees. The most significant tree proposed to be removed is a large Silver Maple tree (Tree 12 that is identified as being in declining health in the attached Tree Assessment and Preservation Plan)

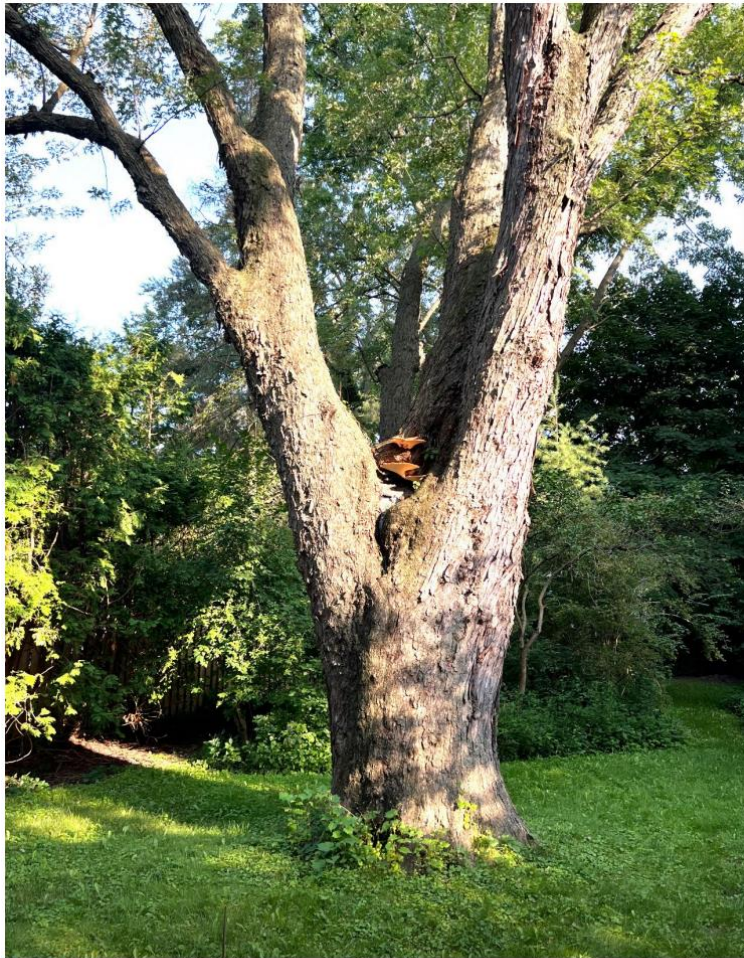
Figure 29: The owner provided pictures of fungal fruiting bodies developing on the main stem of tree 12 in spring 2024.
