Report to: Development Services Committee

SUBJECT: RECOMMENDATION REPORT

Demolition Request for a Fire-Damaged Detached Dwelling within the Thornhill Heritage Conservation District, 16 John St. (Ward 1)
File HE 25 140685

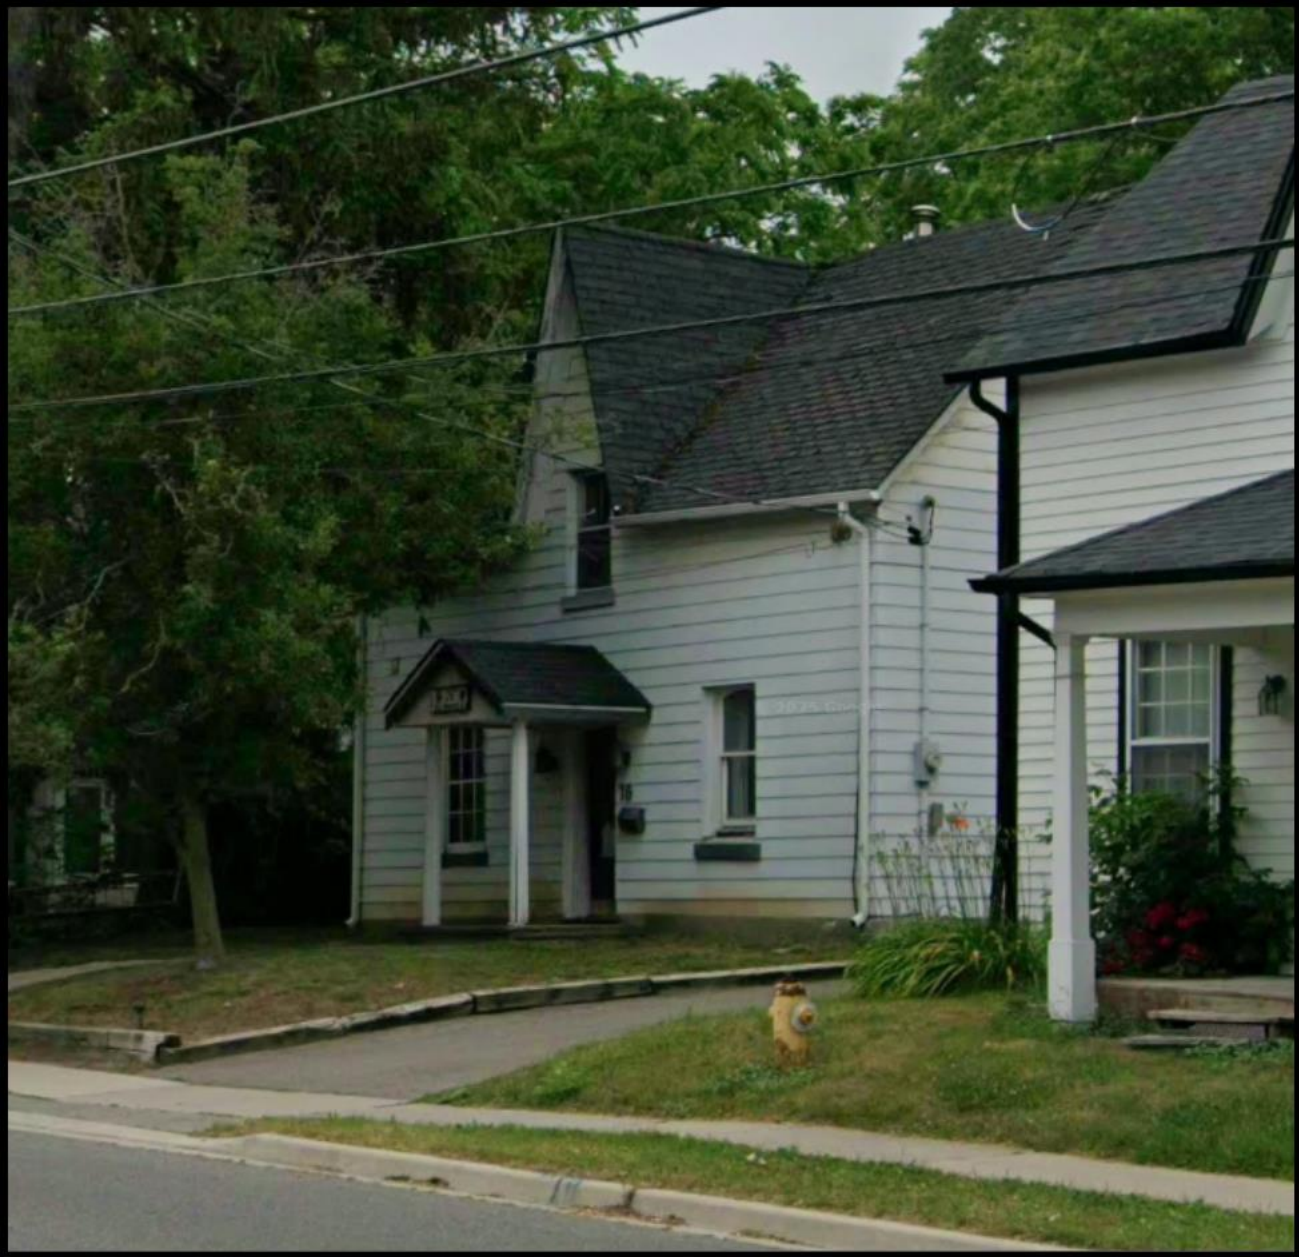
Figure 1: Photograph of the existing heritage dwelling

Google Street View from June 2025

The Subject Property contains a one-and-a-half storey Classic Ontario style heritage dwelling thought to have been constructed in 1879 and relocated from the west side of Yonge Street during an early widening of the street (see Figure 1). Based on the existing granite fieldstone foundation, the building was likely relocated in the late 19th or early 20th century and possibly clad with the existing brick veneer. Figure 2 shows the Subject Property on the north side of John Street, just east of Yonge Street.

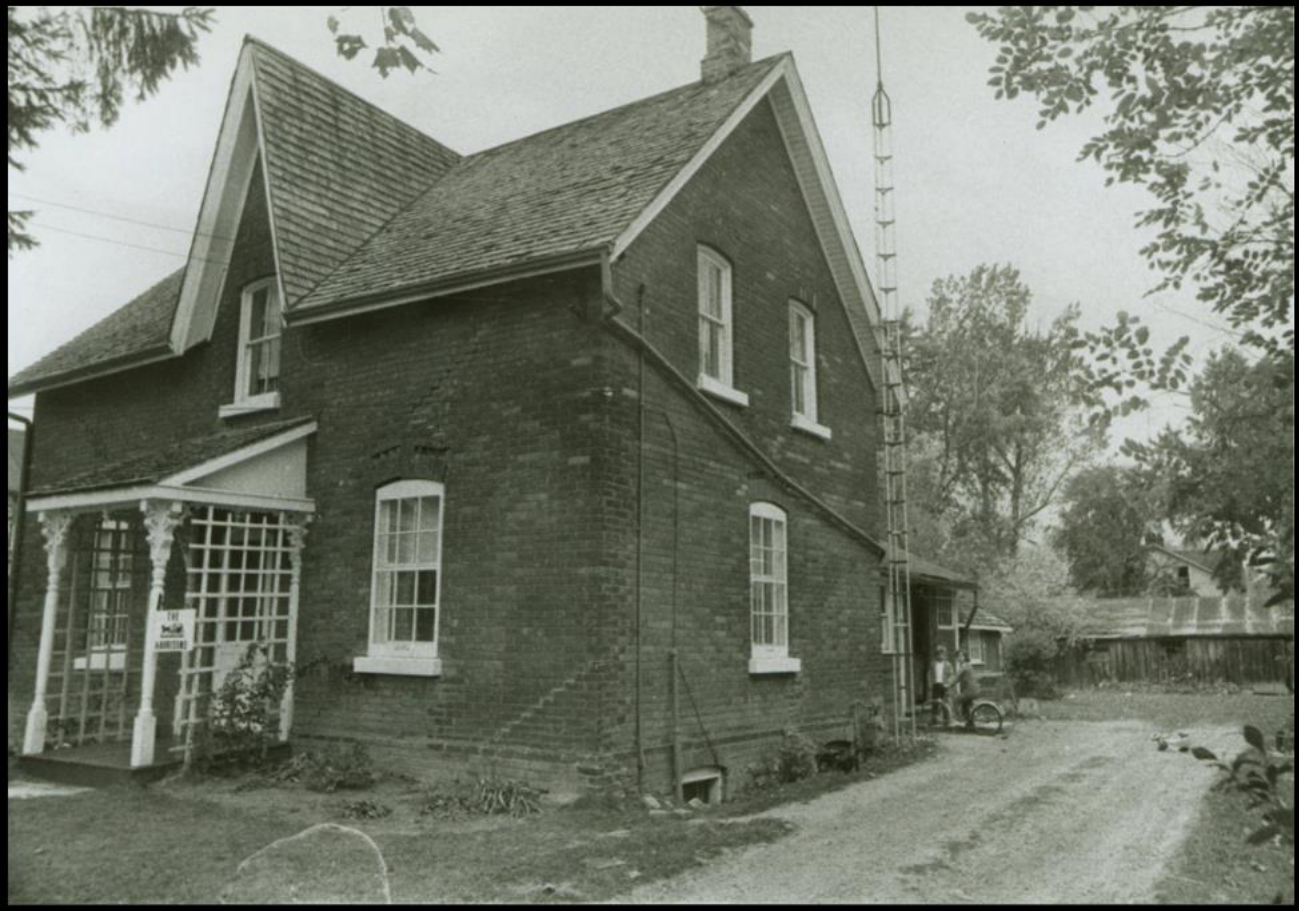
Figure 3: Archival Photograph of the existing heritage dwelling

Archival photograph of 16 John Street Thornhill from the Weaver Collection 1969

It is the opinion of Staff that that Council should only approve the demolition of the historic dwelling on the condition that the owner constructs a historically accurate replica of the existing building, based on details derived from measured drawings and archival photographs of the building (see Figure 3-archival photograph of the building).
