Committee of the Whole
Environmental Services
March 12, 2020

Report of the Commissioner of Environmental Services

2019 Drinking Water Systems Report

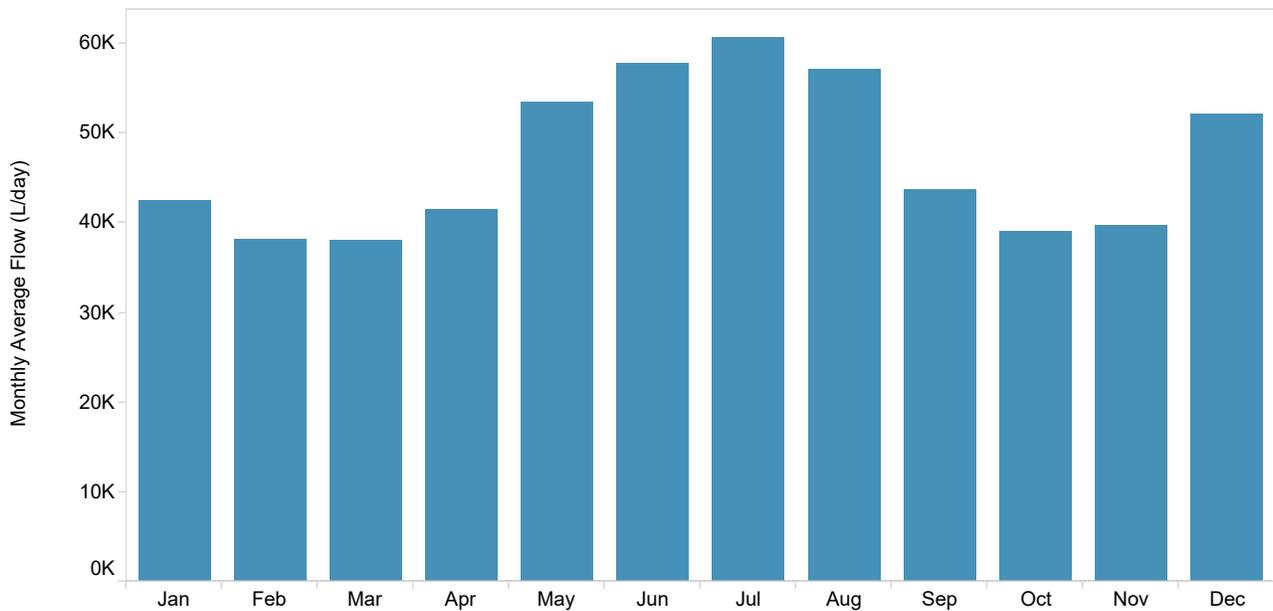
System Monthly Average Flow

The following chart shows the average flow of water produced (treated) in litres per day (L/day) each month in the Ansnorveldt DWS.

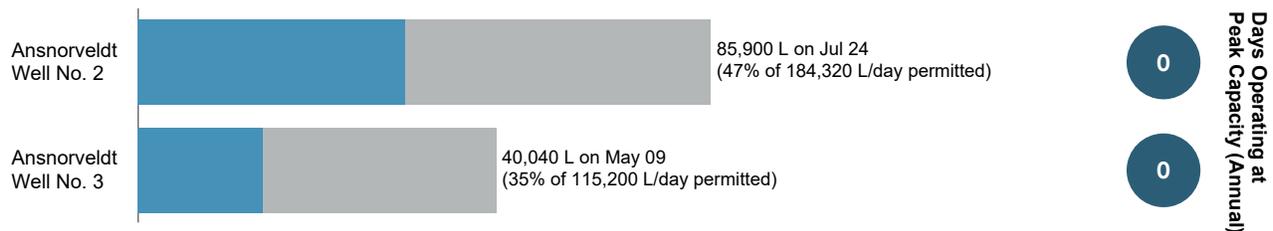
Permitted and Actual Maximum Daily Withdrawal

The following chart shows the maximum volume of water withdrawn in a single day from each water supply facility (blue bar) compared to the maximum withdrawal permitted by the Ministry of the Environment, Conservation and Parks (grey bar). Also shown to the right is the number of days where the water supply facilities were operating at peak capacity (greater than 80% of the permitted withdrawal).

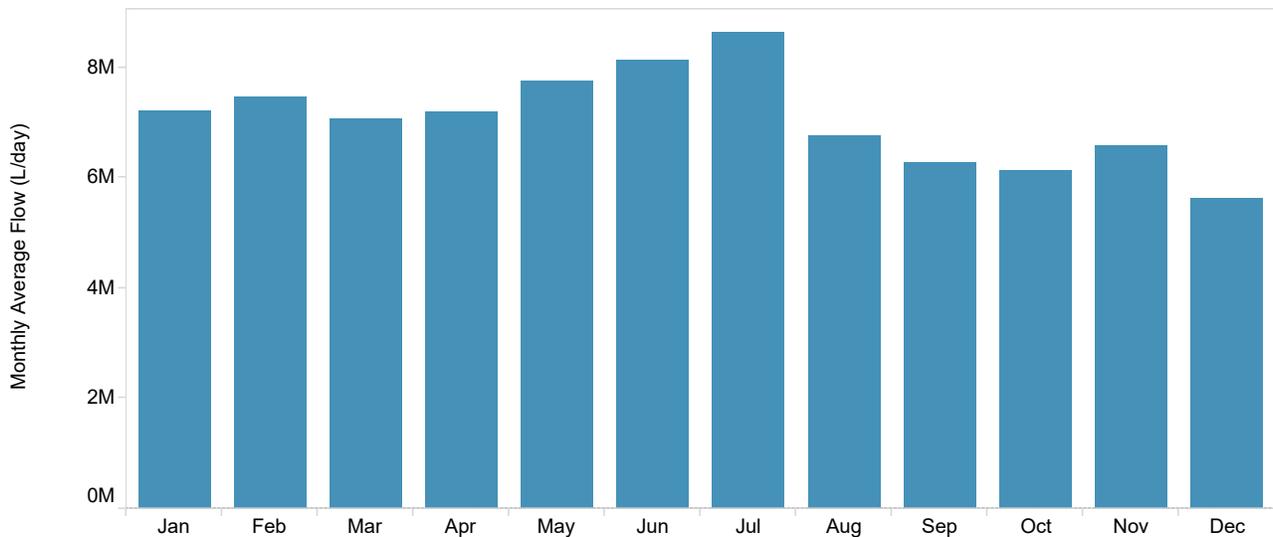
System Monthly Average Flow

The following chart shows the average flow of water withdrawn from wells (but not directed to users) in litres per day (L/day) each month in the Aurora DWS.

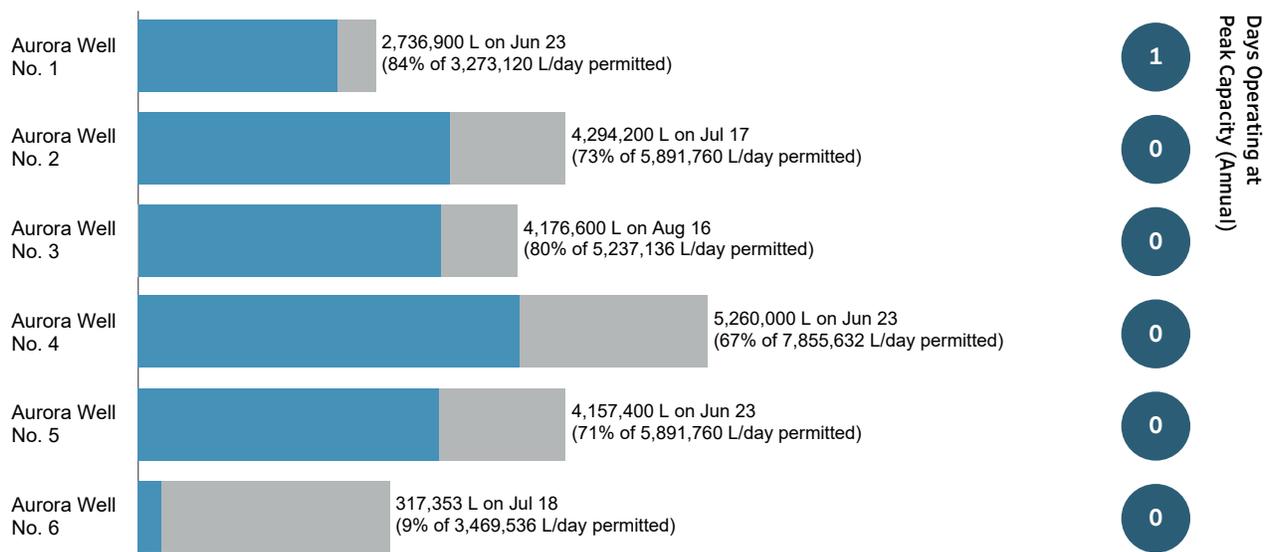
Permitted and Actual Maximum Daily Withdrawal

The following chart shows the maximum volume of water withdrawn in a single day from each water supply facility (blue bar) compared to the maximum withdrawal permitted by the Ministry of the Environment, Conservation and Parks (grey bar). Also shown to the right is the number of days where the water supply facilities were operating at peak capacity (greater than 80% of the permitted withdrawal).

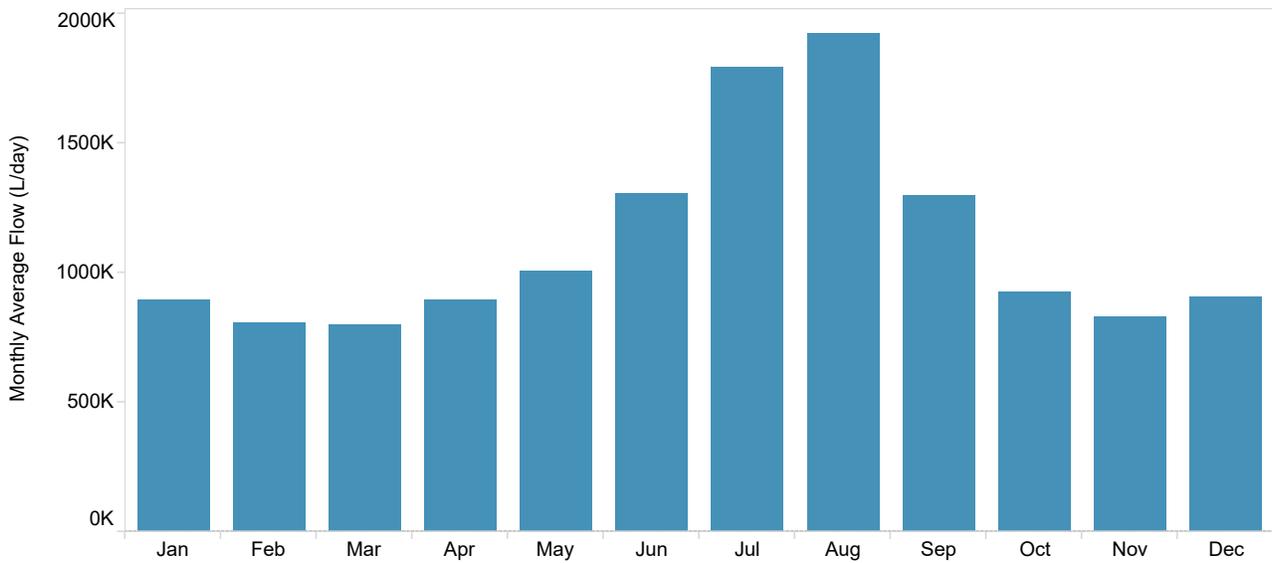
System Monthly Average Flow

The following chart shows the average flow of water produced (treated) in litres per day (L/day) each month in the Ballantrae/Musselman's Lake DWS.

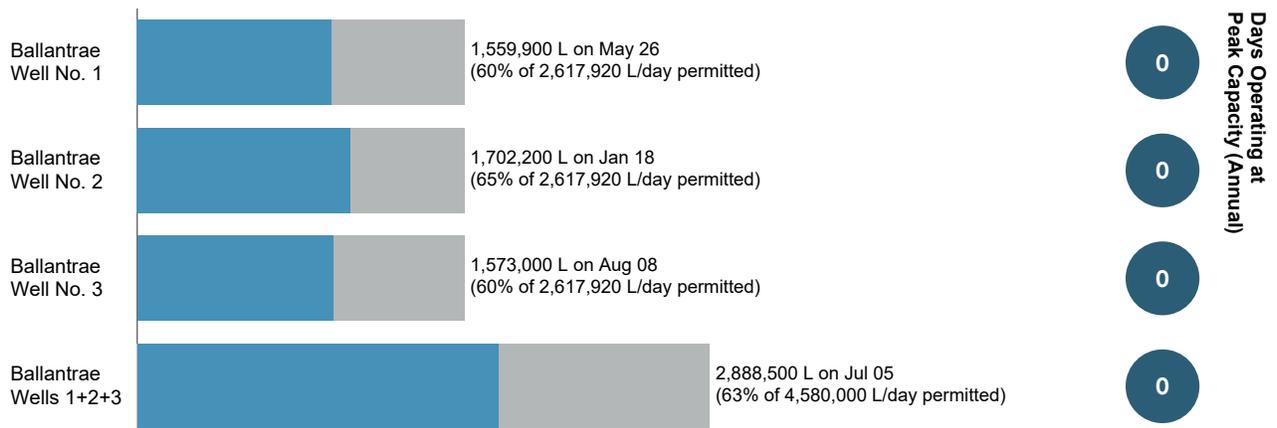
Permitted and Actual Maximum Daily Withdrawal

The following chart shows the maximum volume of water withdrawn in a single day from each water supply facility (blue bar) compared to the maximum withdrawal permitted by the Ministry of the Environment, Conservation and Parks (grey bar). Also shown to the right is the number of days where the water supply facilities were operating at peak capacity (greater than 80% of the permitted withdrawal).

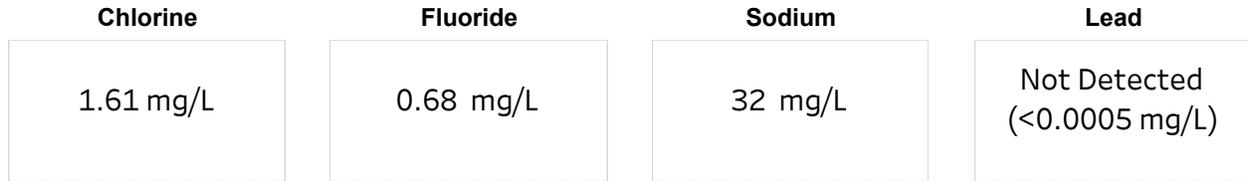
Top Requested Water Quality Parameters

Drinking water is monitored for a wide range of chemical parameters through a combination of continuous monitoring by online analyzers and routine grab samples by operators. The following annual average concentrations in milligrams per litre (mg/L) were reported from treatment and distribution facilities in the Georgina DWS.

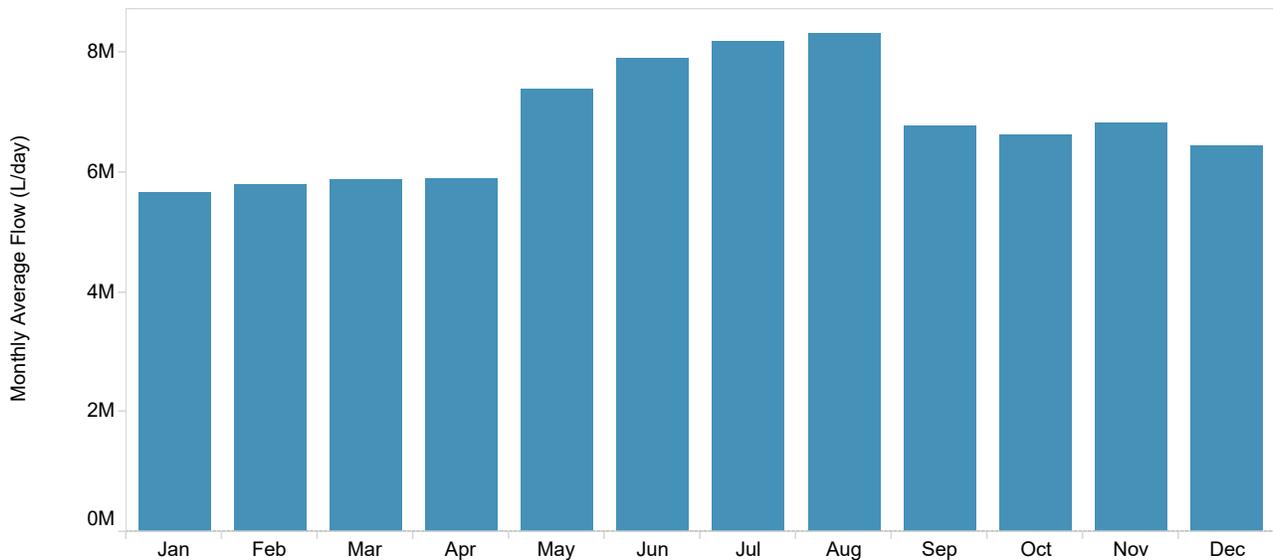
System Monthly Average Flow

The following chart shows the average flow of water produced (treated) in litres per day (L/day) each month in the Georgina DWS.

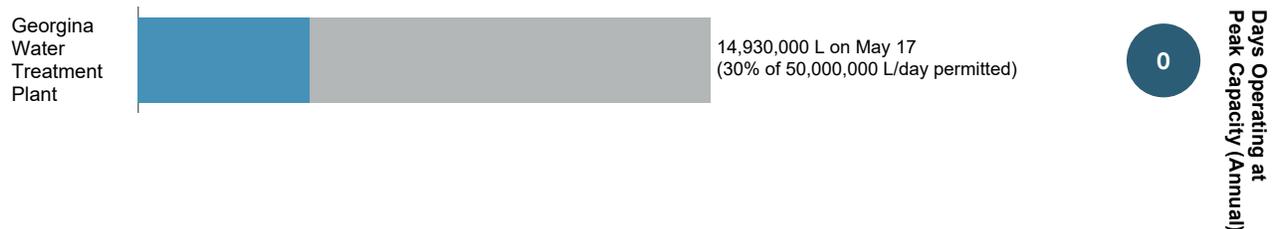
Permitted and Actual Maximum Daily Withdrawal

The following chart shows the maximum volume of water withdrawn in a single day from each water supply facility (blue bar) compared to the maximum withdrawal permitted by the Ministry of the Environment, Conservation and Parks (grey bar). Also shown to the right is the number of days where the water supply facilities were operating at peak capacity (greater than 80% of the permitted withdrawal).

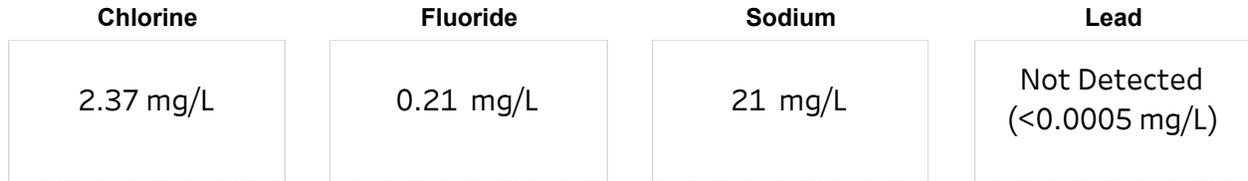
Top Requested Water Quality Parameters

Drinking water is monitored for a wide range of chemical parameters through a combination of continuous monitoring by online analyzers and routine grab samples by operators. The following annual average concentrations in milligrams per litre (mg/L) were reported from treatment and distribution facilities in the Holland Landing DWS.

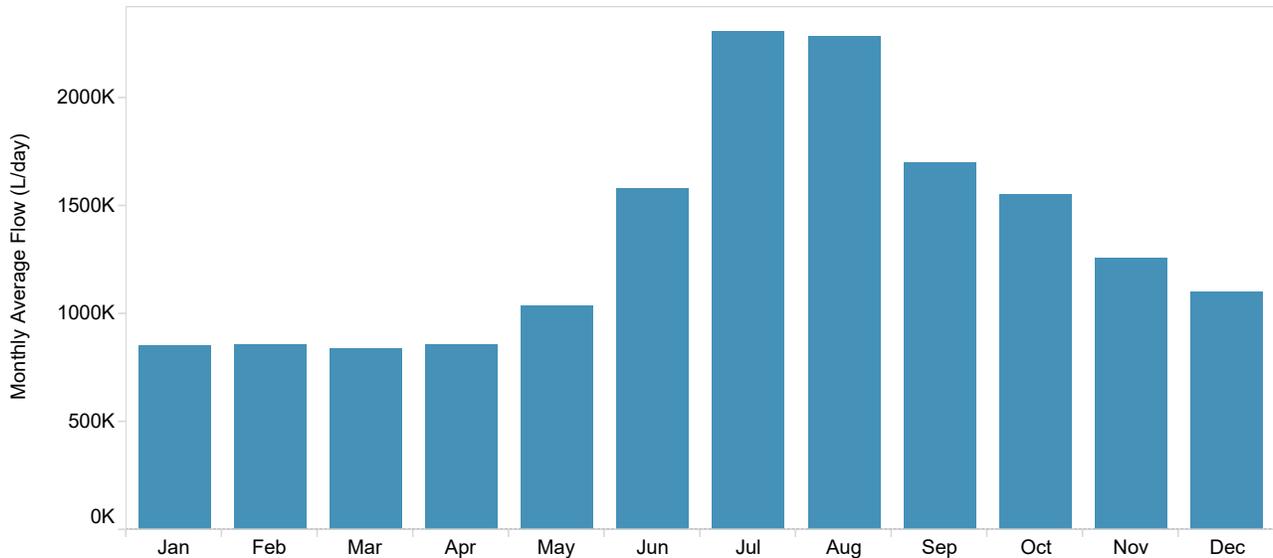
System Monthly Average Flow

The following chart shows the average flow of water produced (treated) in litres per day (L/day) each month in the Holland Landing DWS.

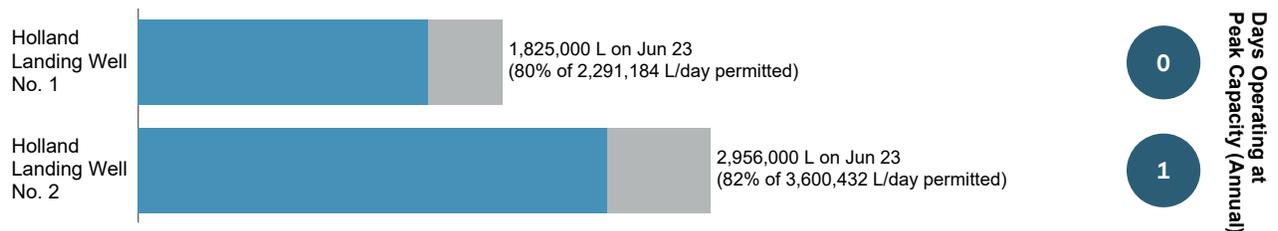
Permitted and Actual Maximum Daily Withdrawal

The following chart shows the maximum volume of water withdrawn in a single day from each water supply facility (blue bar) compared to the maximum withdrawal permitted by the Ministry of the Environment, Conservation and Parks (grey bar). Also shown to the right is the number of days where the water supply facilities were operating at peak capacity (greater than 80% of the permitted withdrawal).

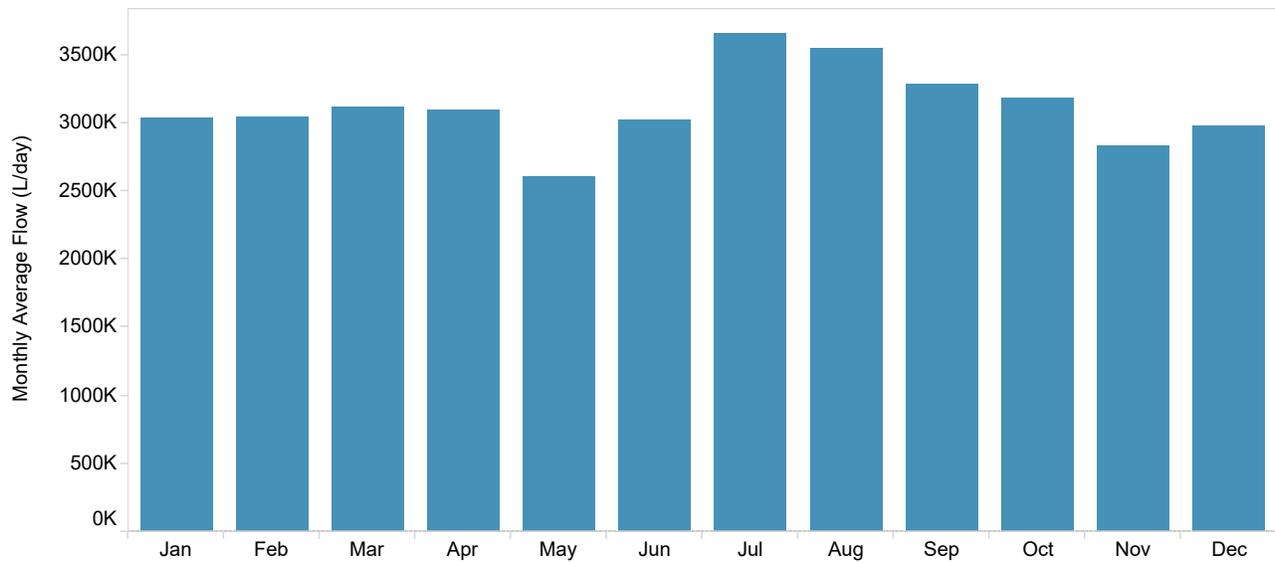
System Monthly Average Flow

The following chart shows the average flow of water produced (treated) in litres per day (L/day) each month in the Keswick DWS.

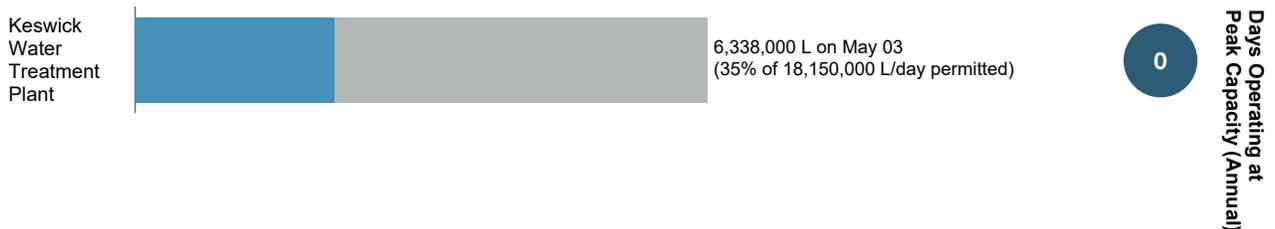
Permitted and Actual Maximum Daily Withdrawal

The following chart shows the maximum volume of water withdrawn in a single day from each water supply facility (blue bar) compared to the maximum withdrawal permitted by the Ministry of the Environment, Conservation and Parks (grey bar). Also shown to the right is the number of days where the water supply facilities were operating at peak capacity (greater than 80% of the permitted withdrawal).

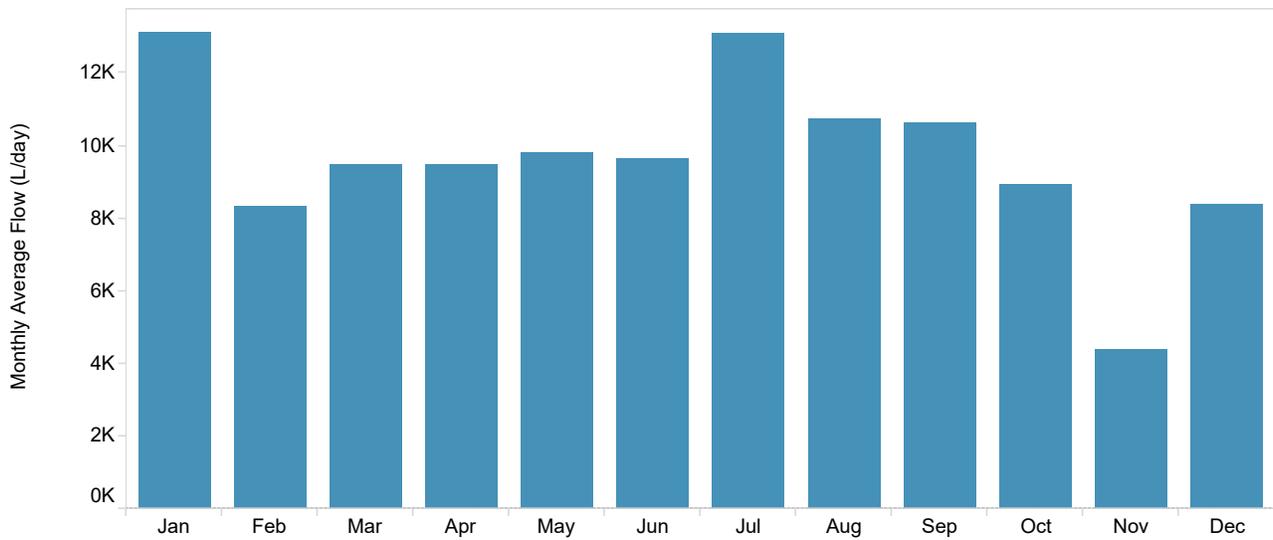
System Monthly Average Flow

The following chart shows the average flow of water withdrawn from wells (but not directed to users) in litres per day (L/day) each month in the King City DWS.

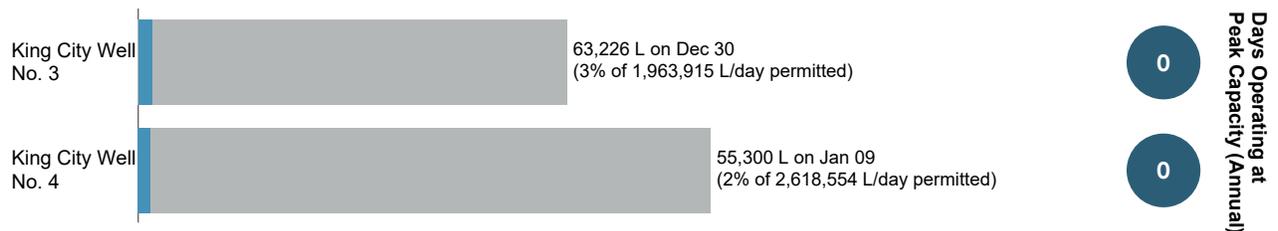
Permitted and Actual Maximum Daily Withdrawal

The following chart shows the maximum volume of water withdrawn in a single day from each water supply facility (blue bar) compared to the maximum withdrawal permitted by the Ministry of the Environment, Conservation and Parks (grey bar). Also shown to the right is the number of days where the water supply facilities were operating at peak capacity (greater than 80% of the permitted withdrawal).

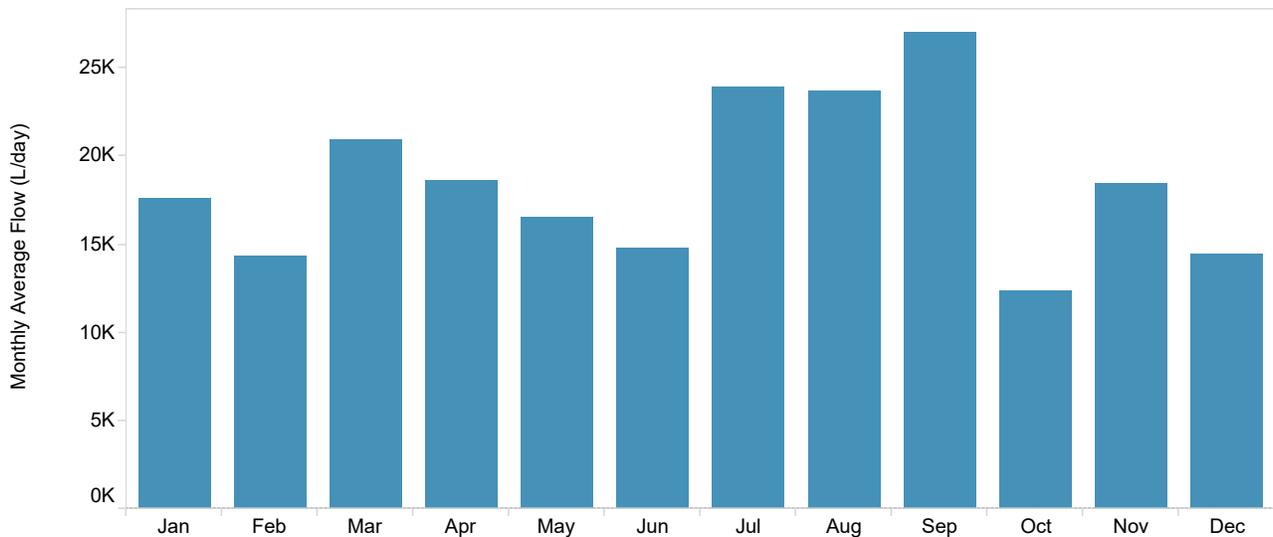
System Monthly Average Flow

The following chart shows the average flow of water withdrawn from wells (but not directed to users) in litres per day (L/day) each month in the Kleinburg DWS.

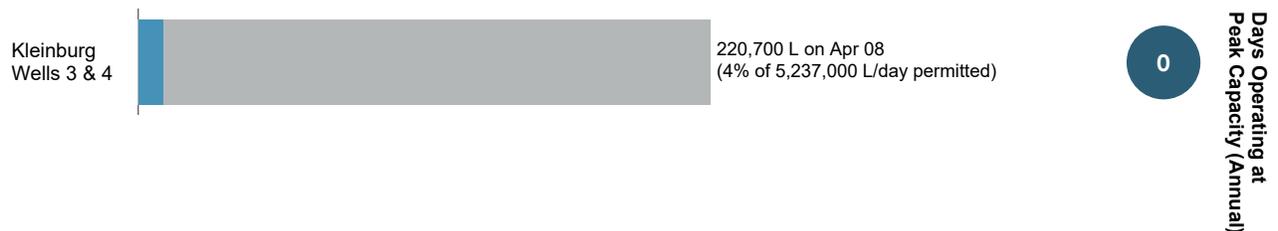
Permitted and Actual Maximum Daily Withdrawal

The following chart shows the maximum volume of water withdrawn in a single day from each water supply facility (blue bar) compared to the maximum withdrawal permitted by the Ministry of the Environment, Conservation and Parks (grey bar). Also shown to the right is the number of days where the water supply facilities were operating at peak capacity (greater than 80% of the permitted withdrawal).

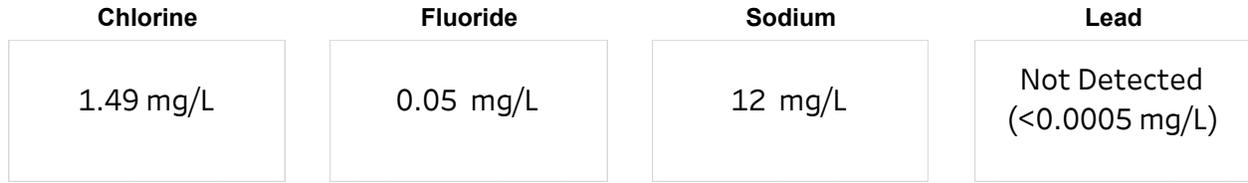
Top Requested Water Quality Parameters

Drinking water is monitored for a wide range of chemical parameters through a combination of continuous monitoring by online analyzers and routine grab samples by operators. The following annual average concentrations in milligrams per litre (mg/L) were reported from treatment and distribution facilities in the Mount Albert DWS.

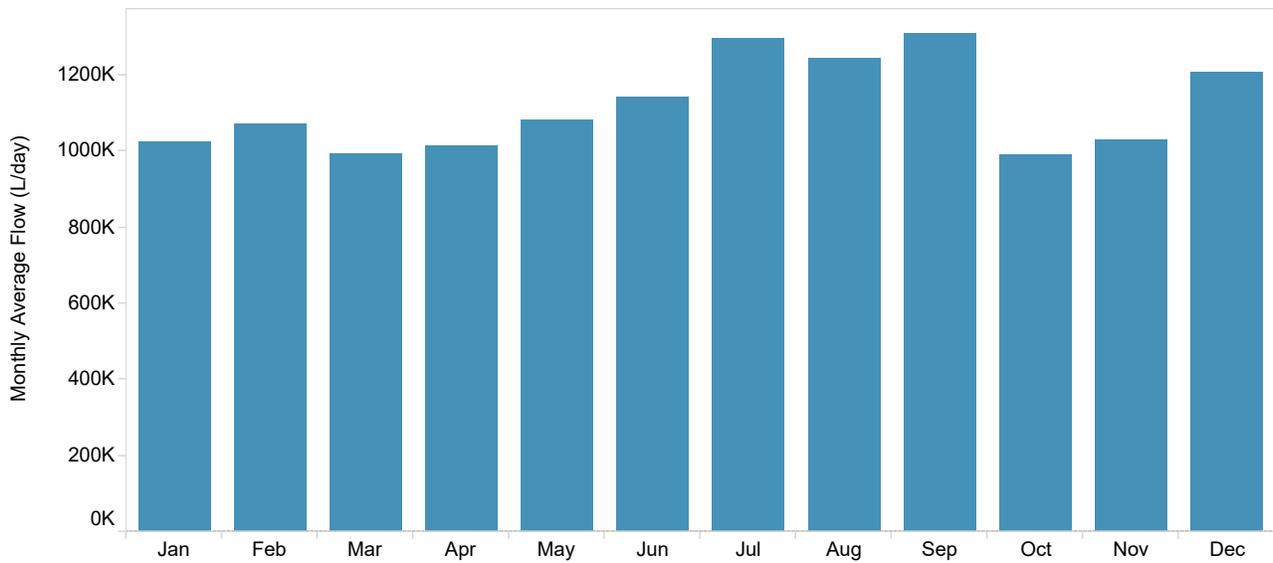
System Monthly Average Flow

The following chart shows the average flow of water produced (treated) in litres per day (L/day) each month in the Mount Albert DWS.

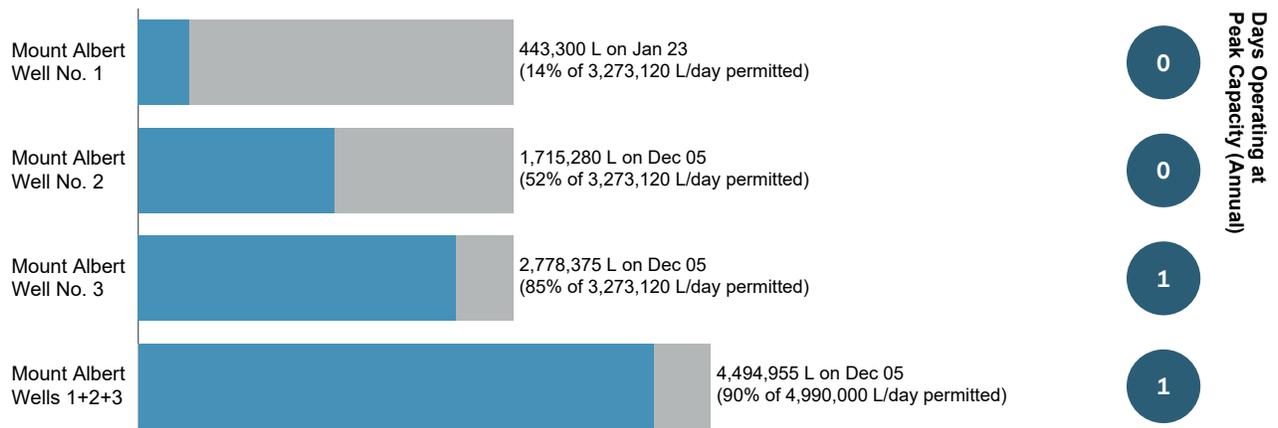
Permitted and Actual Maximum Daily Withdrawal

The following chart shows the maximum volume of water withdrawn in a single day from each water supply facility (blue bar) compared to the maximum withdrawal permitted by the Ministry of the Environment, Conservation and Parks (grey bar). Also shown to the right is the number of days where the water supply facilities were operating at peak capacity (greater than 80% of the permitted withdrawal).

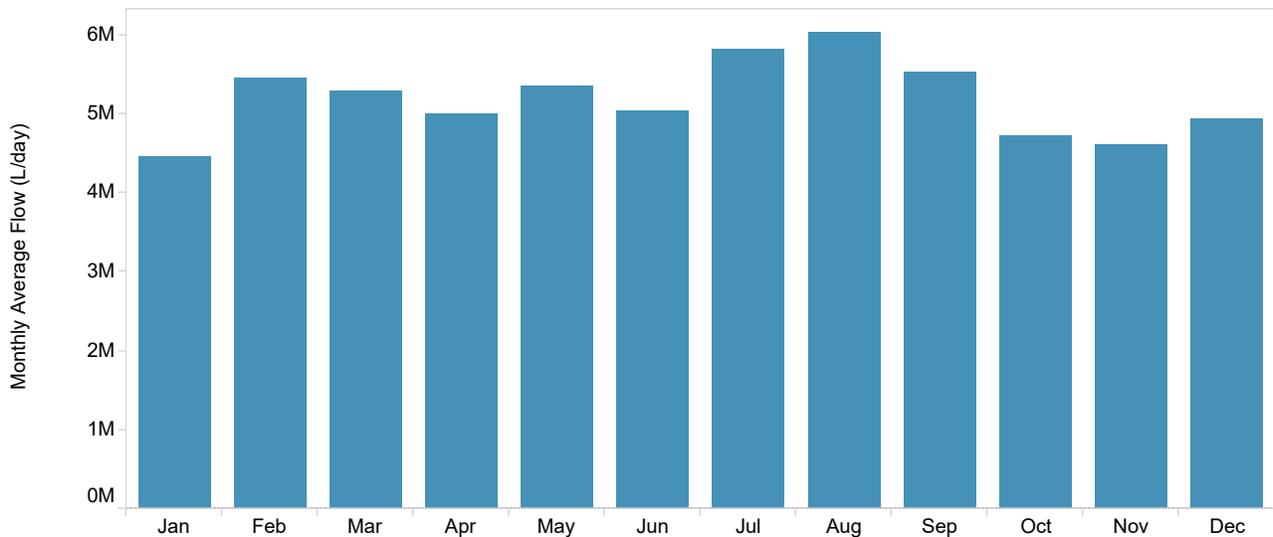
System Monthly Average Flow

The following chart shows the average flow of water withdrawn from wells (but not directed to users) in litres per day (L/day) each month in the Newmarket DWS.

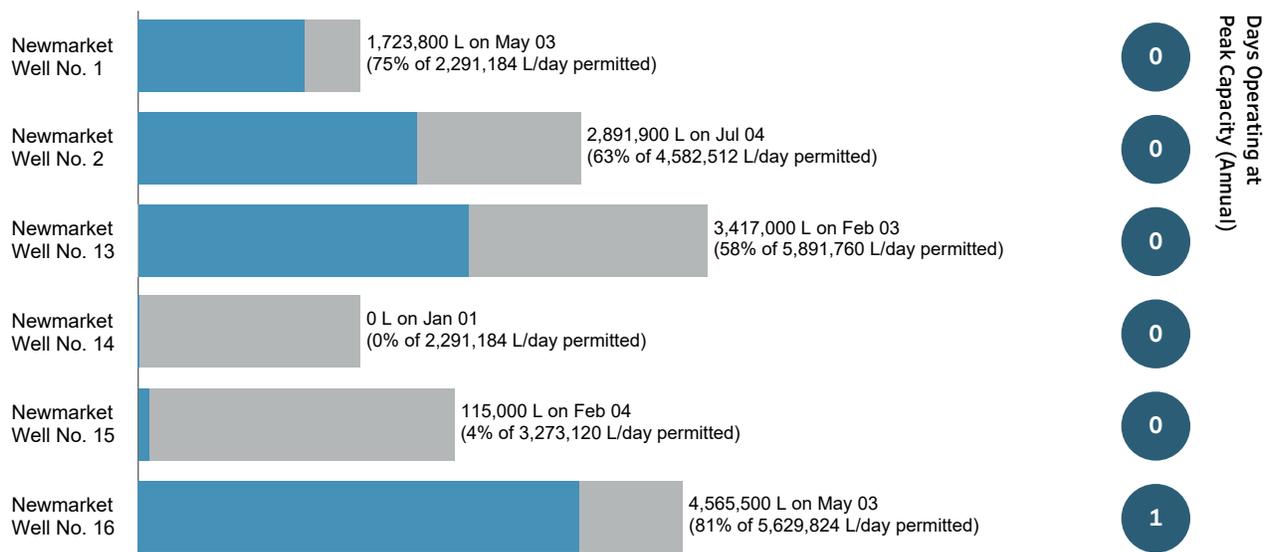
Permitted and Actual Maximum Daily Withdrawal

The following chart shows the maximum volume of water withdrawn in a single day from each water supply facility (blue bar) compared to the maximum withdrawal permitted by the Ministry of the Environment, Conservation and Parks (grey bar). Also shown to the right is the number of days where the water supply facilities were operating at peak capacity (greater than 80% of the permitted withdrawal).

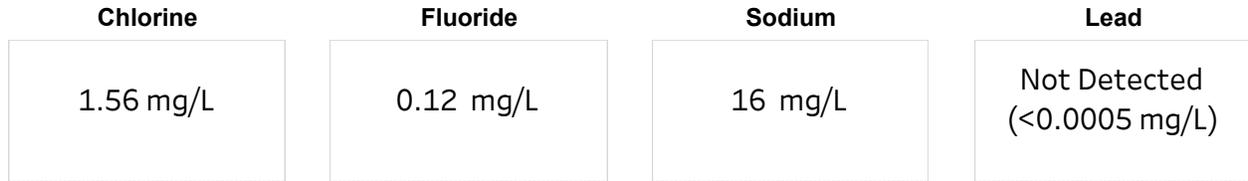
Top Requested Water Quality Parameters

Drinking water is monitored for a wide range of chemical parameters through a combination of continuous monitoring by online analyzers and routine grab samples by operators. The following annual average concentrations in milligrams per litre (mg/L) were reported from treatment and distribution facilities in the Nobleton DWS.

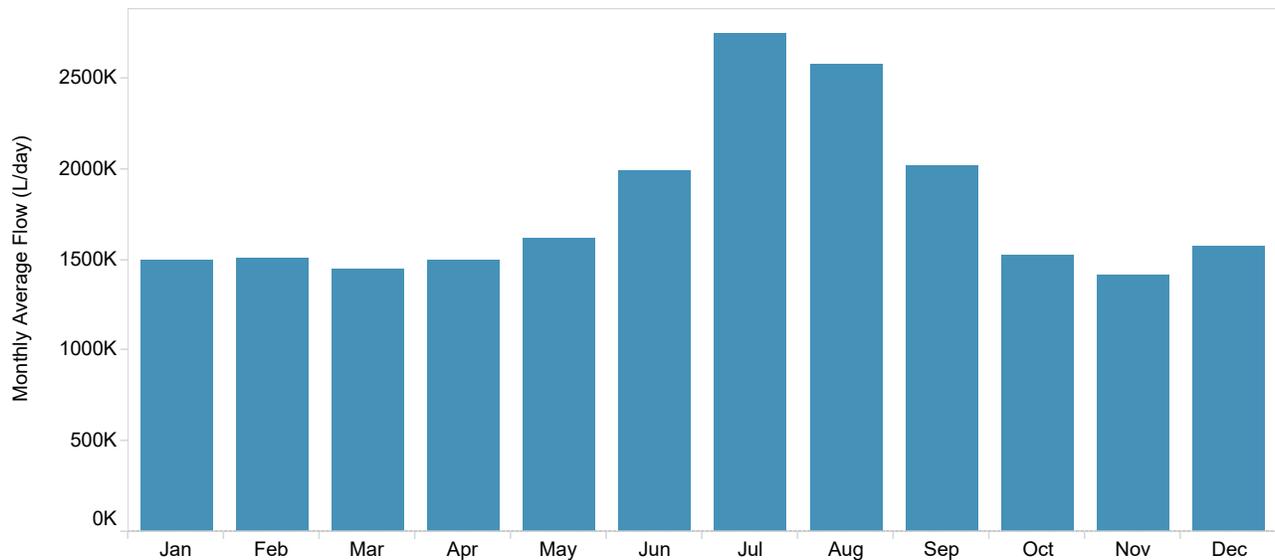
System Monthly Average Flow

The following chart shows the average flow of water produced (treated) in litres per day (L/day) each month in the Nobleton DWS.

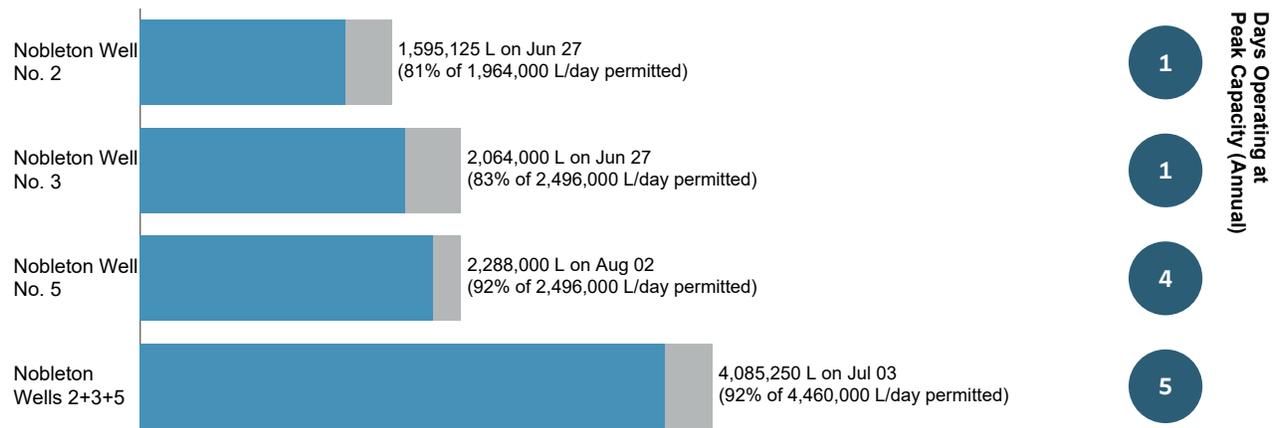
Permitted and Actual Maximum Daily Withdrawal

The following chart shows the maximum volume of water withdrawn in a single day from each water supply facility (blue bar) compared to the maximum withdrawal permitted by the Ministry of the Environment, Conservation and Parks (grey bar). Also shown to the right is the number of days where the water supply facilities were operating at peak capacity (greater than 80% of the permitted withdrawal).

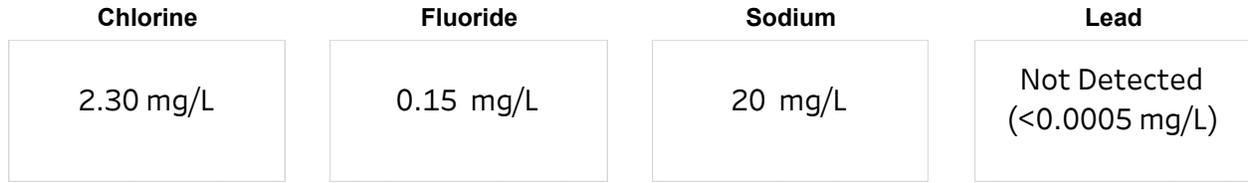
Top Requested Water Quality Parameters

Drinking water is monitored for a wide range of chemical parameters through a combination of continuous monitoring by online analyzers and routine grab samples by operators. The following annual average concentrations in milligrams per litre (mg/L) were reported from treatment and distribution facilities in the Schomberg DWS.

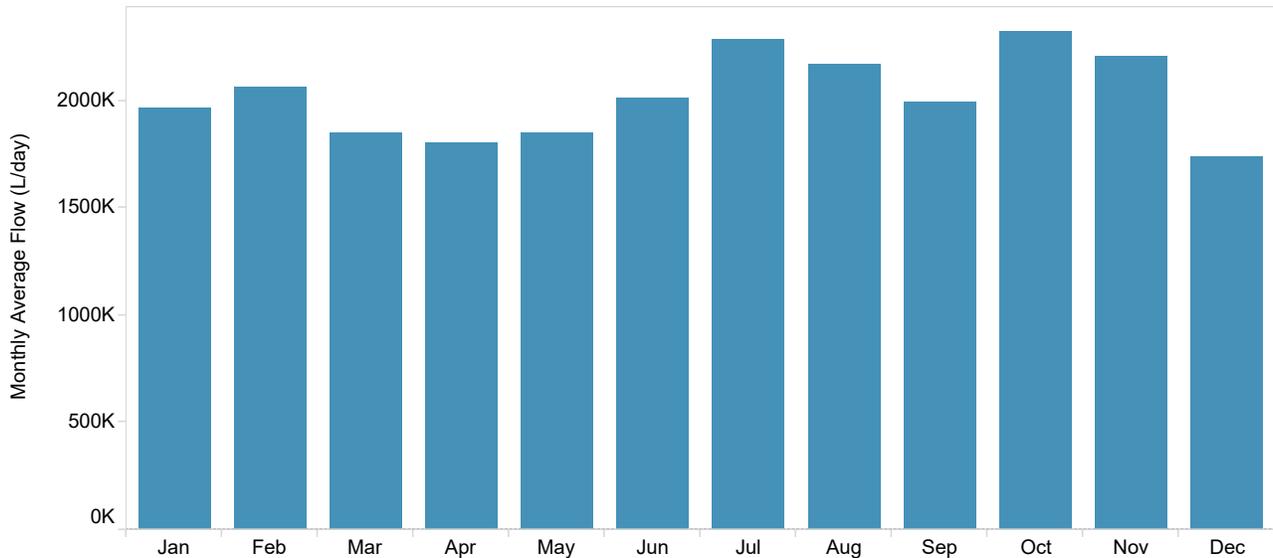
System Monthly Average Flow

The following chart shows the average flow of water produced (treated) in litres per day (L/day) each month in the Schomberg DWS.

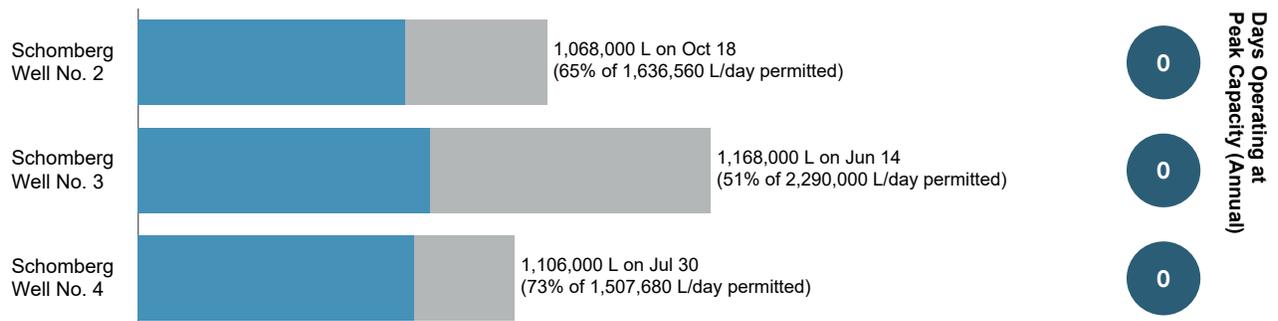
Permitted and Actual Maximum Daily Withdrawal

The following chart shows the maximum volume of water withdrawn in a single day from each water supply facility (blue bar) compared to the maximum withdrawal permitted by the Ministry of the Environment, Conservation and Parks (grey bar). Also shown to the right is the number of days where the water supply facilities were operating at peak capacity (greater than 80% of the permitted withdrawal).

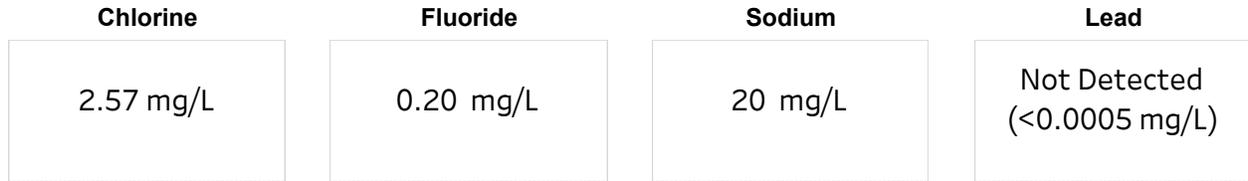
Top Requested Water Quality Parameters

Drinking water is monitored for a wide range of chemical parameters through a combination of continuous monitoring by online analyzers and routine grab samples by operators. The following annual average concentrations in milligrams per litre (mg/L) were reported from treatment and distribution facilities in the Sharon/Queensville DWS.

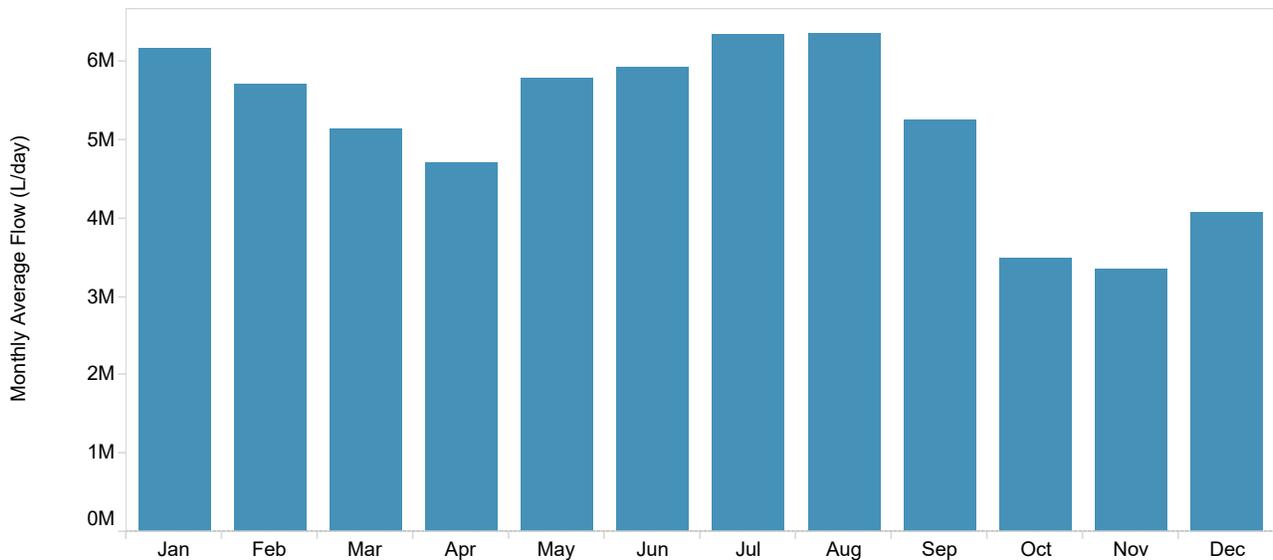
System Monthly Average Flow

The following chart shows the average flow of water produced (treated) in litres per day (L/day) each month in the Sharon/Queensville DWS.

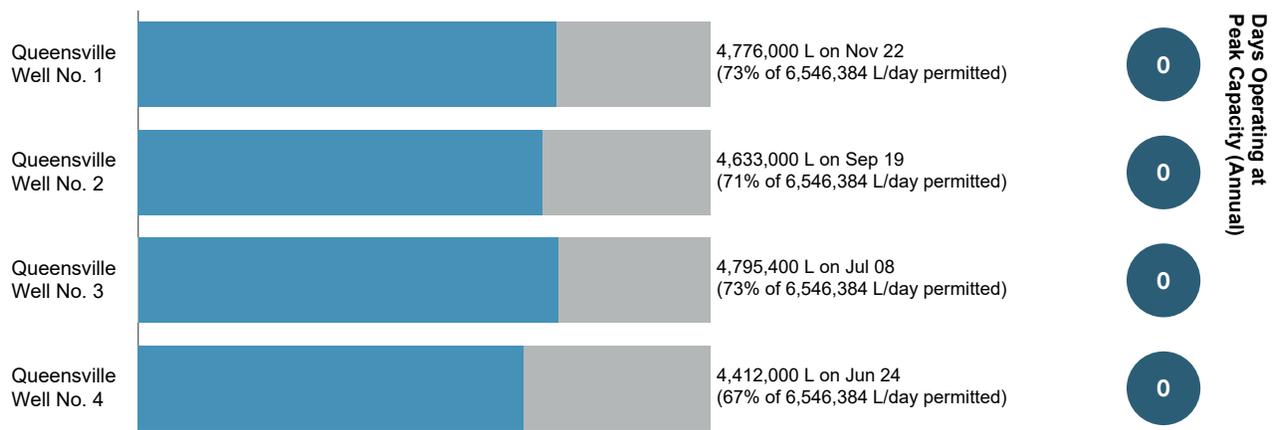
Permitted and Actual Maximum Daily Withdrawal

The following chart shows the maximum volume of water withdrawn in a single day from each water supply facility (blue bar) compared to the maximum withdrawal permitted by the Ministry of the Environment, Conservation and Parks (grey bar). Also shown to the right is the number of days where the water supply facilities were operating at peak capacity (greater than 80% of the permitted withdrawal).

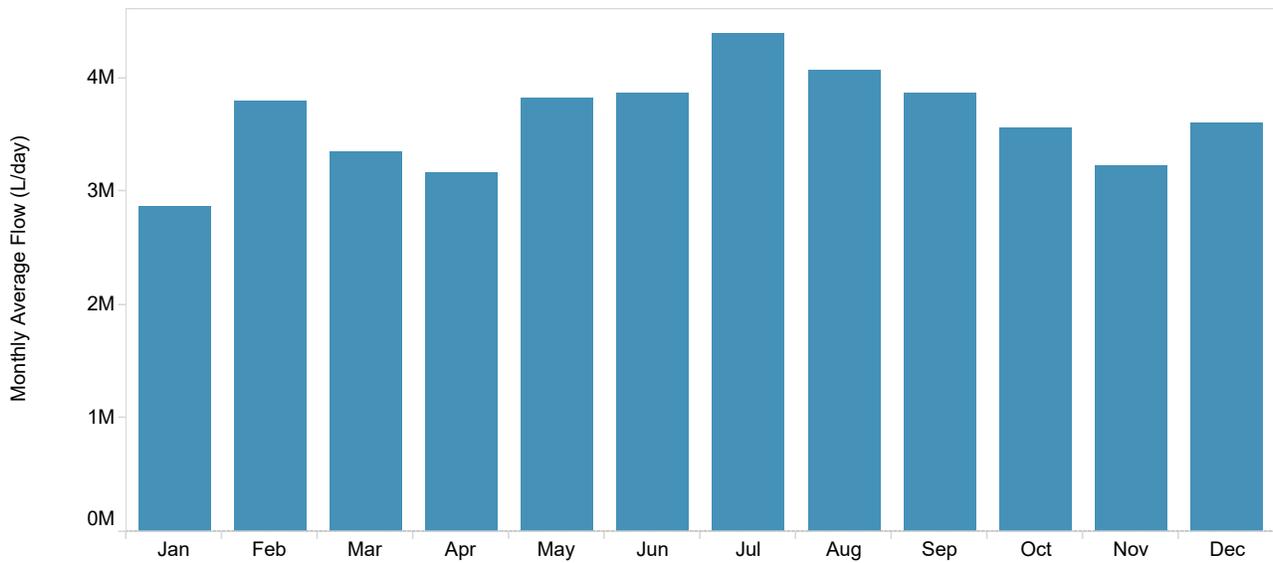
System Monthly Average Flow

The following chart shows the average flow of water produced (treated) in litres per day (L/day) each month in the Stouffville DWS.

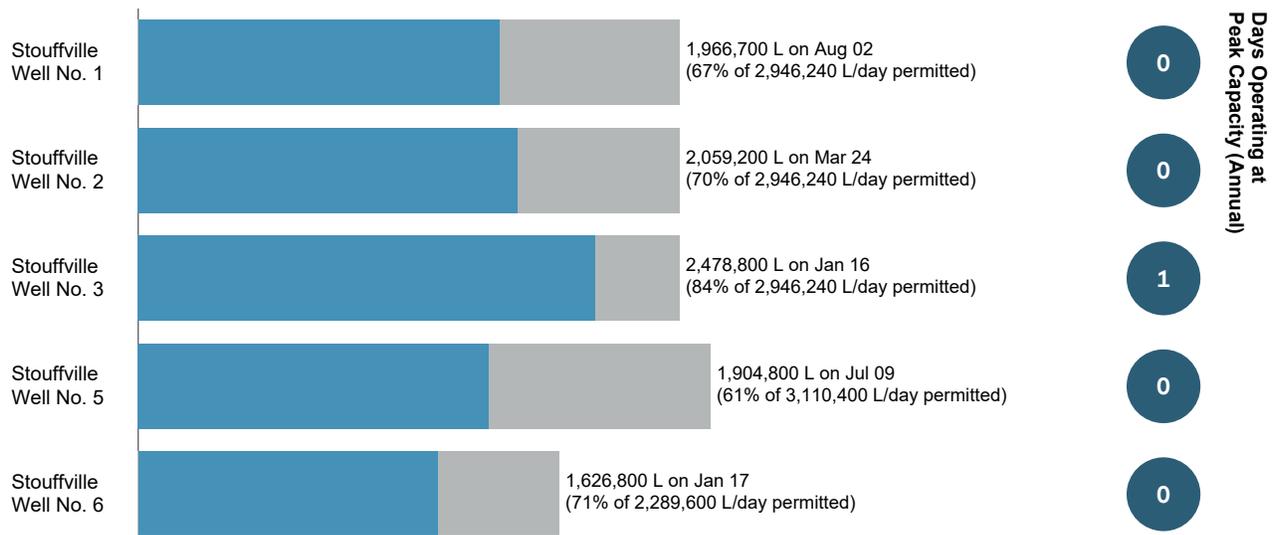
Permitted and Actual Maximum Daily Withdrawal

The following chart shows the maximum volume of water withdrawn in a single day from each water supply facility (blue bar) compared to the maximum withdrawal permitted by the Ministry of the Environment, Conservation and Parks (grey bar). Also shown to the right is the number of days where the water supply facilities were operating at peak capacity (greater than 80% of the permitted withdrawal).

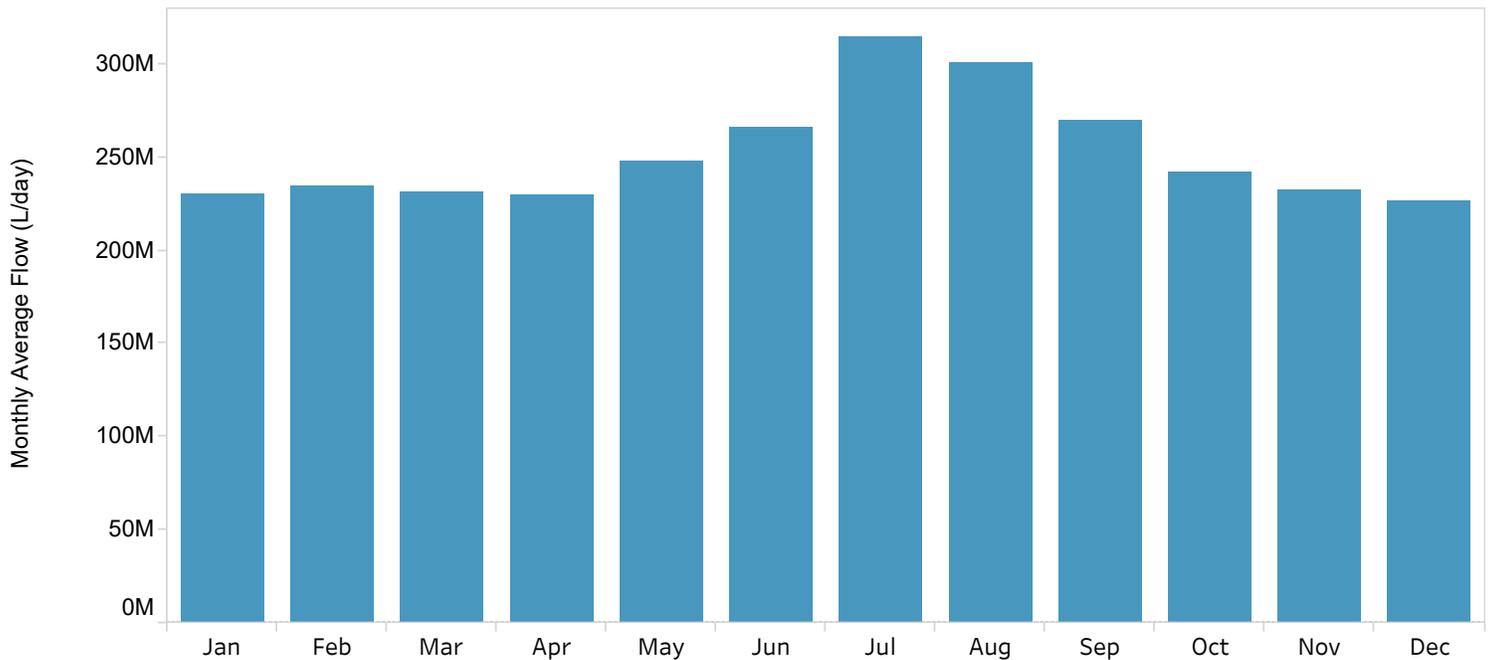
System Monthly Average Flow

The following chart shows the monthly average consumption in million litres per day of purchased Lake Ontario water.

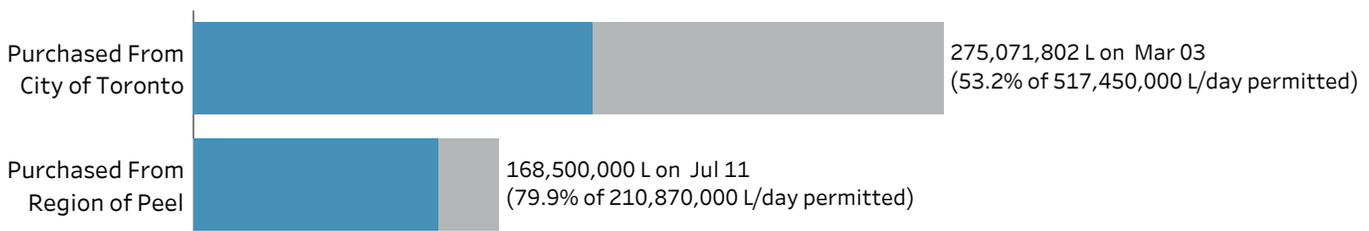
Permitted and Actual Maximum Daily Flow

The City of Toronto and Peel Region supply water to York Region under water supply agreements. The following chart shows the maximum volume of water purchased from each municipality in a single day (blue bar) compared to the maximum flow permitted under the applicable water supply agreement (grey bar).
