MEMORANDUM

SUBJECT: Status of Building from a Cultural Heritage Perspective
12 Wilson Street
Markham Village Heritage Conservation District

Property/Building Description: 1 ½ storey frame building, c. 1875,
Use: Commercial (originally residential)
Heritage Status: Identified as Class A Property in Markham Village Heritage
Conservation District Plan

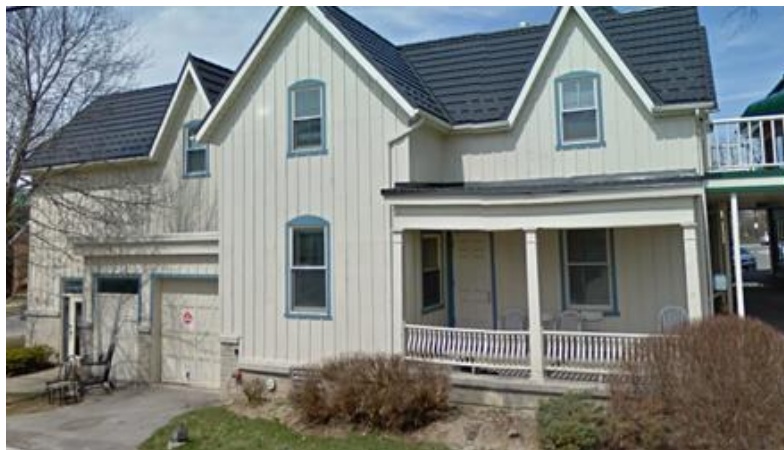
Close up of front of Building

- two existing windows
- existing porch below
- many existing walls (shoen dotted) are removed

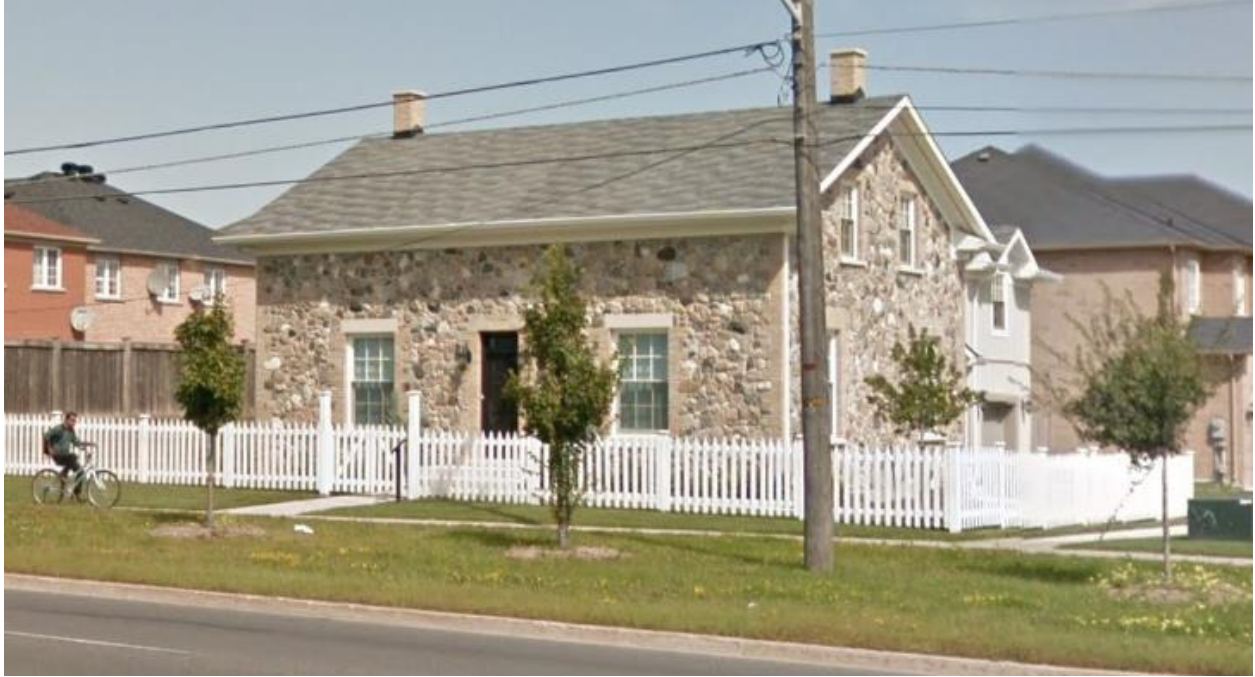
Stone House at 66 Monique Court. Building collapsed during the relocation process. Original stone was re-used.

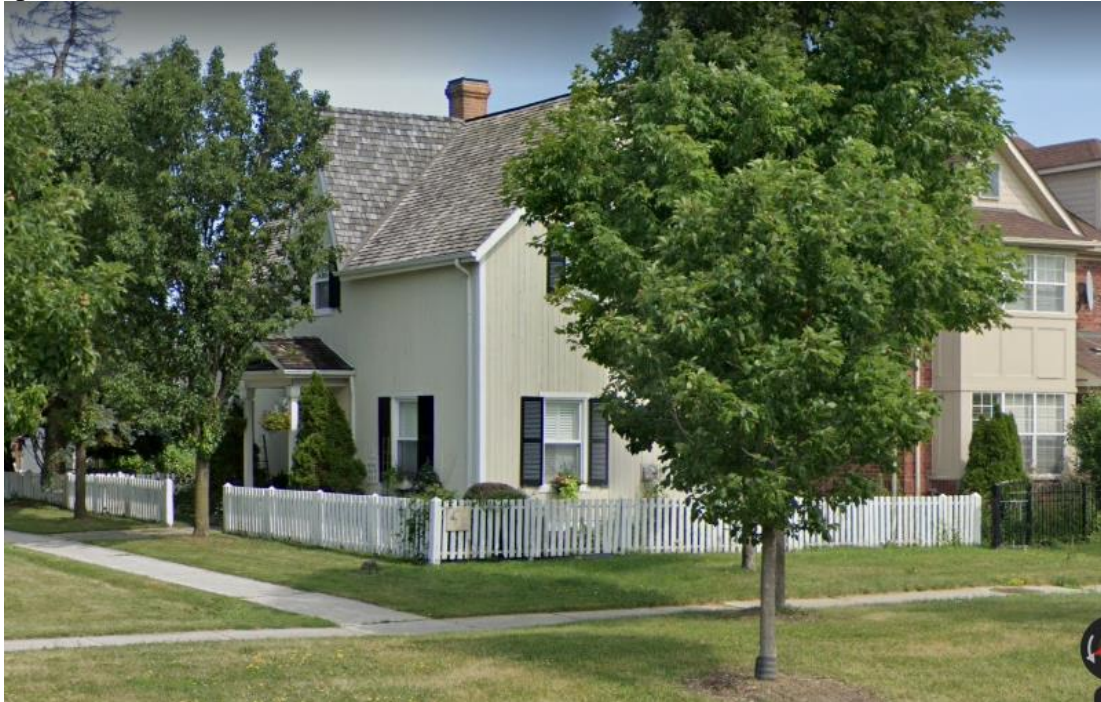
Frame House at 28 Milroy Lane. Building was in a deteriorated state and was re-built to original specifications.
