# John Stickley House

10536 McCowan Road,  
City of Markham, ON

<b>To:</b>	Clay Leibel, Minotar Holdings Inc.
<b>From:</b>	Rachel Redshaw, Heritage Planner, MHBC & Dan Currie, Managing Director of Cultural Heritage, MHBC
<b>Date:</b>	January 31, 2020
<b>File:</b>	1935-B
<b>Subject:</b>	Scoped Cultural Heritage Evaluation Report for 10536 McCowan Road, "The John Stickley House"

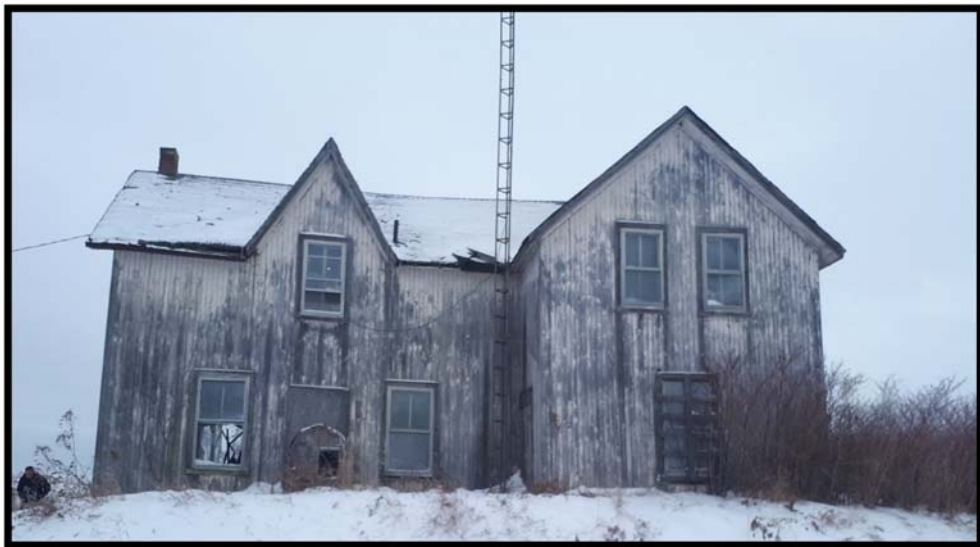
The John Stickley House is a wood frame house constructed in the Gothic Revival style. It has an "L" shaped floor plan which consists of the main house, right wing addition and rear addition. The front façade of the main house displays a modest, unadorned pitched gable. There is a chimney on the end gable on the south gable of the main building and two other chimneys on the right wing additions constructed of red brick. Both the main house and addition have medium-pitched open gabled roofs. Window openings and frames are original; original wooden window frames are heavily rotted although protected from the exterior by storm windows as a result of moisture entering the interior of the house through the exposed roof and elevations.

The house is identified as Gothic Revival due to the pitched gable on the main façade of the house and symmetrical layout of the main facade, however, is not indicative of other key elements of Gothic Revival architecture such as: lancet window openings, decorative fascia or high-pitched roofs. It does not display a high degree of craftsmanship or artistic merit or technical and scientific achievement.

*Figure 1: Photograph of main façade in January, 2020 (MHBC, 2020)*

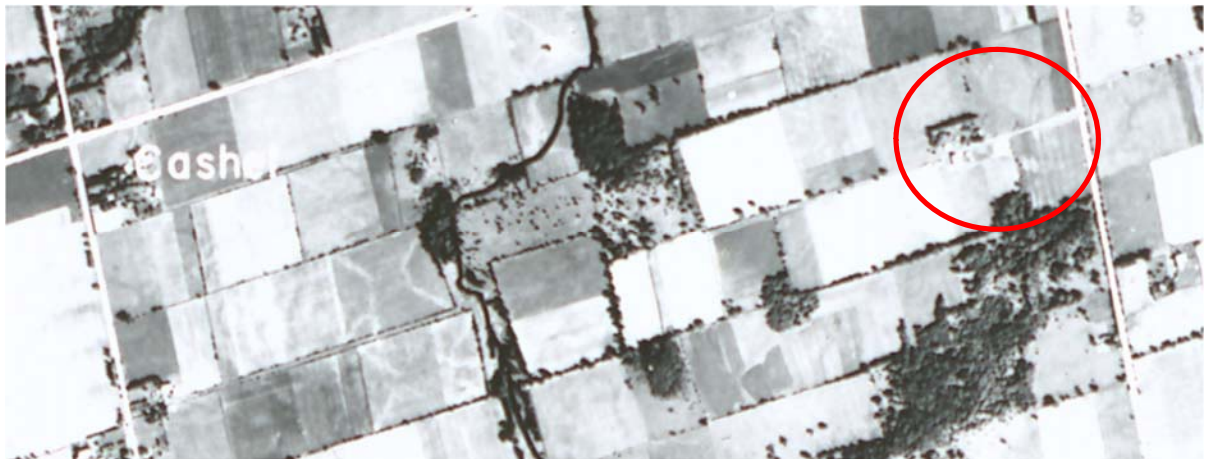
In a 1954 aerial photograph, there was no designed treed boulevard to the house. There appears to have been a designed treed area along the north and west of the immediate land surrounding the homestead which no longer exists.

*Figure 4: 1954 aerial photograph of Markham (Courtesy of the University of Toronto); red circle indicates the subject property.*

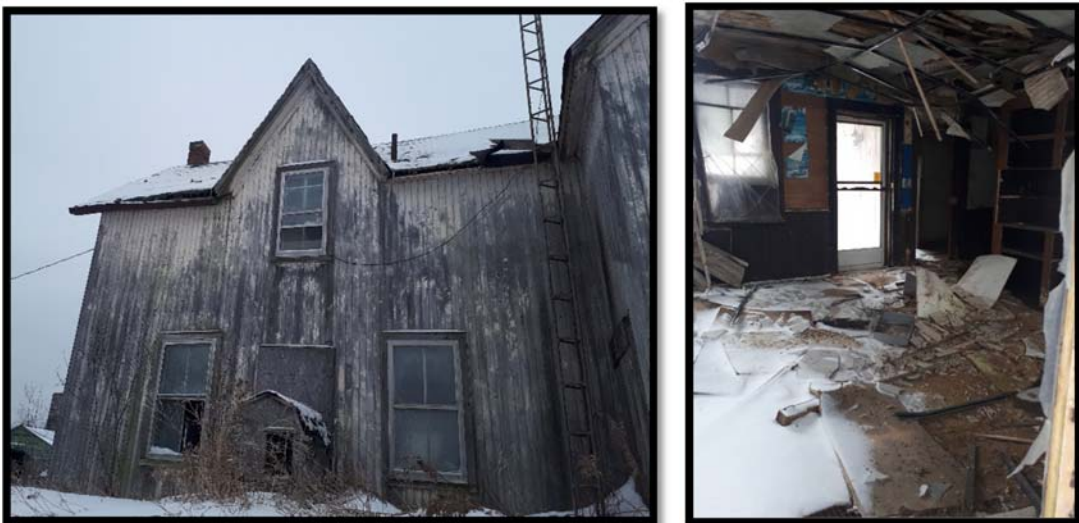
*The framing (perimeter walls, floor partitions, roof) has been completely deteriorated. This house should be demolished, not renovated, as it will pose a danger to the repair crew entering the premises.*

A site visit was completed by MHBC Staff on January 21, 2020. Observations concluded that the building is in poor condition. The interior has been stripped by the former owner including copper piping, ceiling tiles, front door (etc.) and the flooring is unstable. The interior was only seen from an exterior rear door opening as it was unsafe for staff to enter. The exterior wood frame has partially collapsed in areas as well as the roof. The associated chimneys are crumbling. A former rear addition has partially collapsed and has been exposed to the elements. Photographic Documentation is included in this report (see Attachment 3) which demonstrates the degradation of the building in so much that very little of its heritage integrity remains, in addition to its lack of structural integrity.

Figures 2 & 3: (Left) Photograph of main façade in January, 2020 (Right) View of interior from rear exterior door (MHBC, 2020)

It is concluded that the property is modestly representative of the Gothic Revival Style but in its condition, has lost the majority of its heritage integrity. There are 58 properties designated under Part IV of the Ontario Heritage Act on the Markham Register of Property of Cultural Heritage Value or Interest for being excellent examples of the Gothic Revival style and therefore, several excellent examples exist to testify of this architectural style within the community. The property does not have historical/ associative or contextual value. Based on this analysis, it is recommended that the removal of the property from the Markham Register of Property of Cultural Heritage Value or Interest be considered.
