**Friends of  
Swan Lake Park**

# Swan Lake Park and Mount Joy Park

# PATHWAY TO SUSTAINABILITY

June 1, 2020

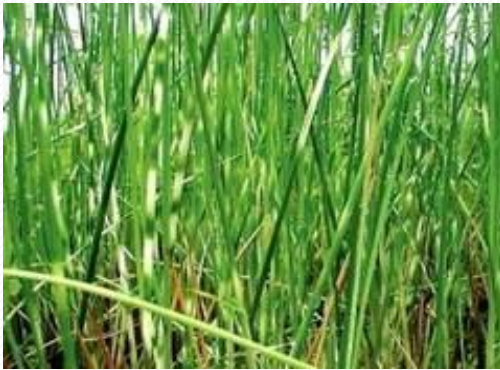
## Drain & Convert to Wetland/ Park

- Partially drain, plant bulrushes, water plants
- Still supports stormwater management needs
- Eliminates geese, cyanobacteria
- One time cost, minimal ongoing costs

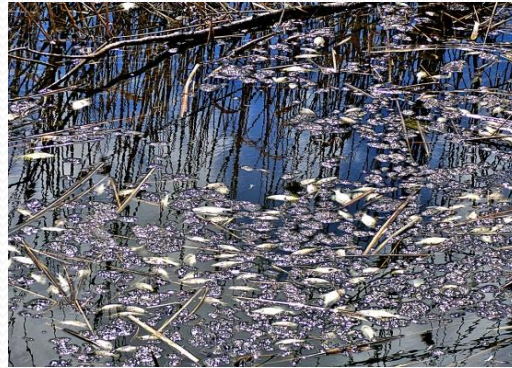
## Just Worry About Containing Bacteria

- Fish kill, March 2012
- Water based plants dying
- Regular algae blooms
- Role is to monitor and manage Cyanobacteria
- Deal with cyanobacteria every 3-5 years

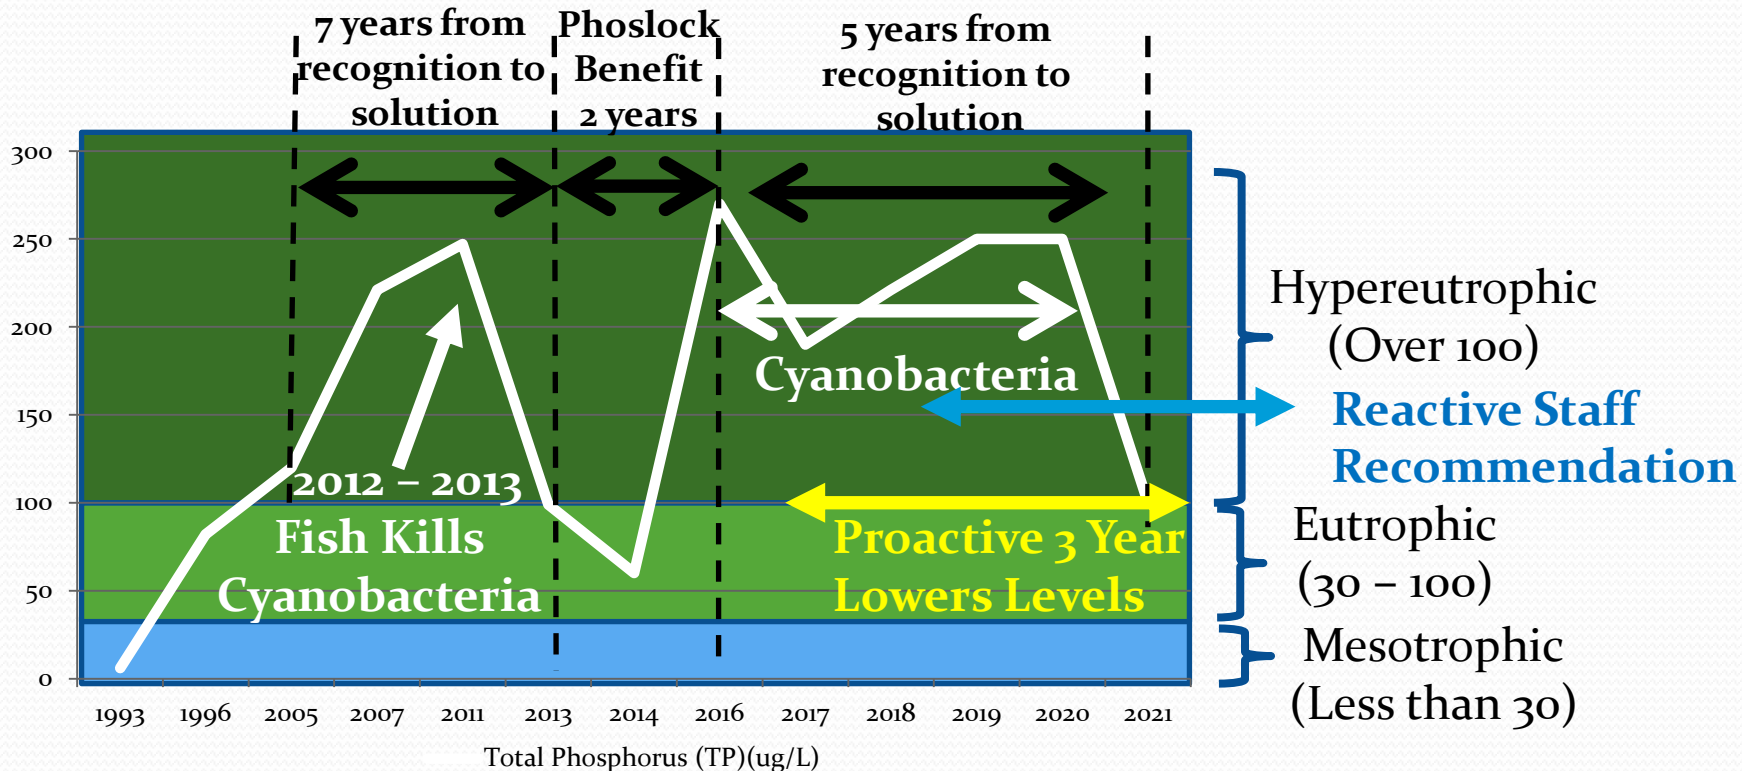
# History of Swan Lake and Phosphorus

- Staff proposal reacts to excessive levels and perpetuates large swings in phosphorus levels as realized after treatment in 2013
- We recommend a proactive 3 year treatment policy – lower phosphorus levels on average and a more stable environment

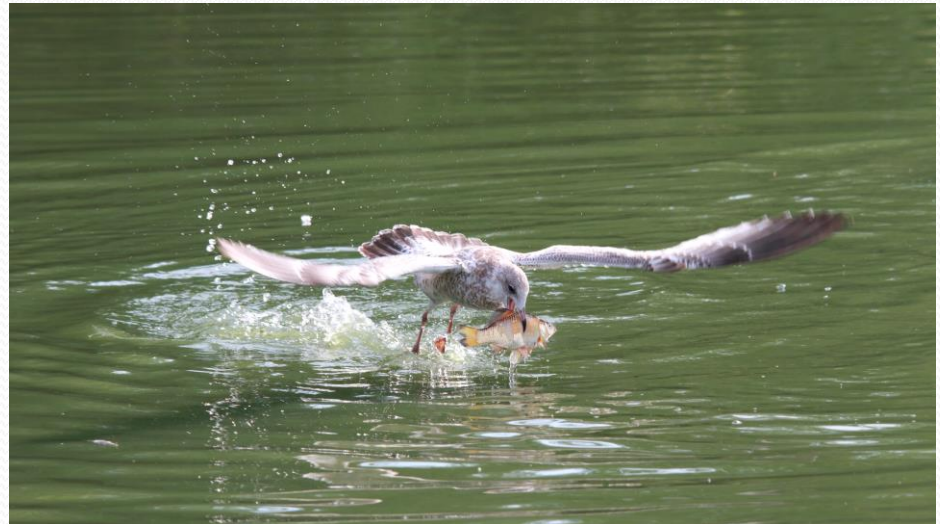
**Note the green murky water that is now the typical look of Swan Lake**

The few remaining fish in the murky green water of Swan Lake are feedstock for a number of birds such as osprey, herons, cormorants and gulls. (Photo courtesy of Don Fowler)

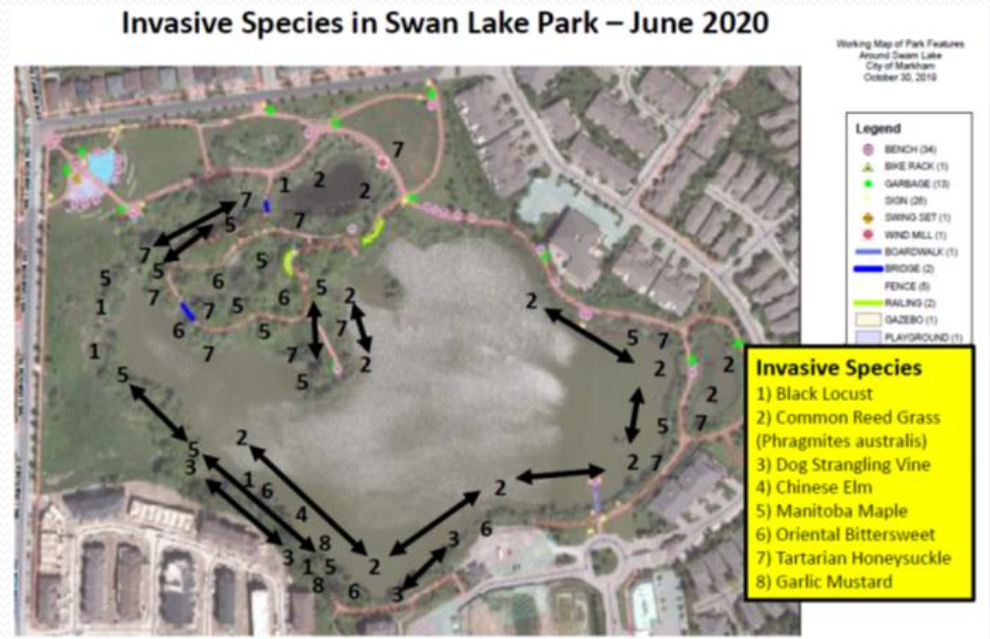
As illustrated in this map, the land based natural areas have been overtaken by invasive plants.

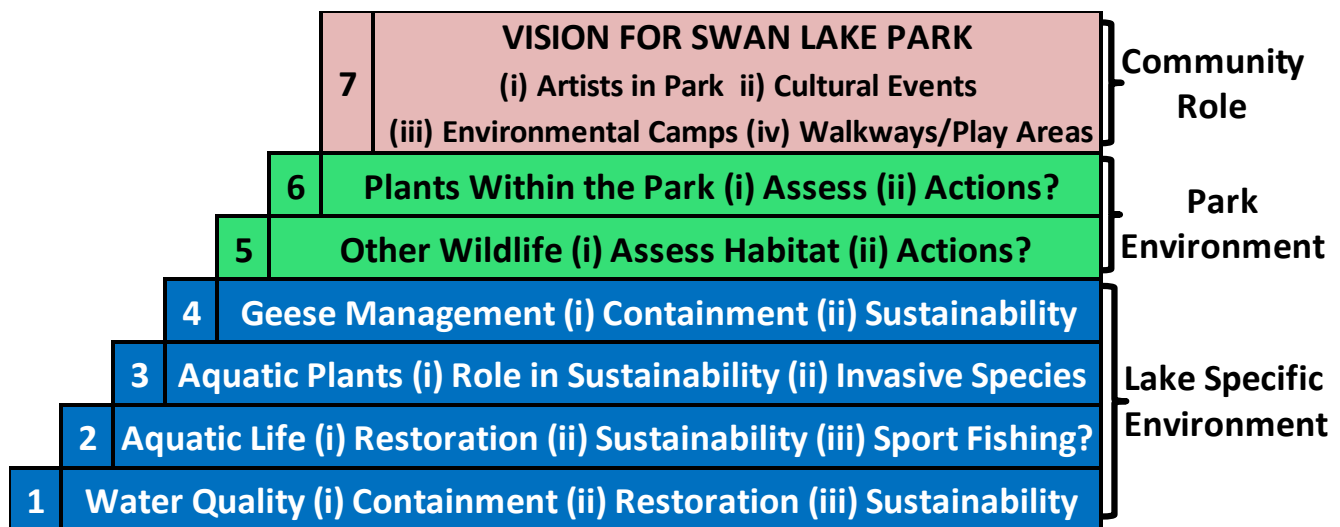
### Interconnected Elements within Swan Lake Park

The environmental elements in the Park are all interconnected and interdependent on each other. Once water quality gets out of balance, aquatic life and aquatic plants are directly impacted while other elements are also negatively affected by the deteriorating aquatic conditions.

We have identified over 80 different species of birds and mammals that inhabit the Park and 7 invasive plant species that are gaining hold. (See Appendix A and B)

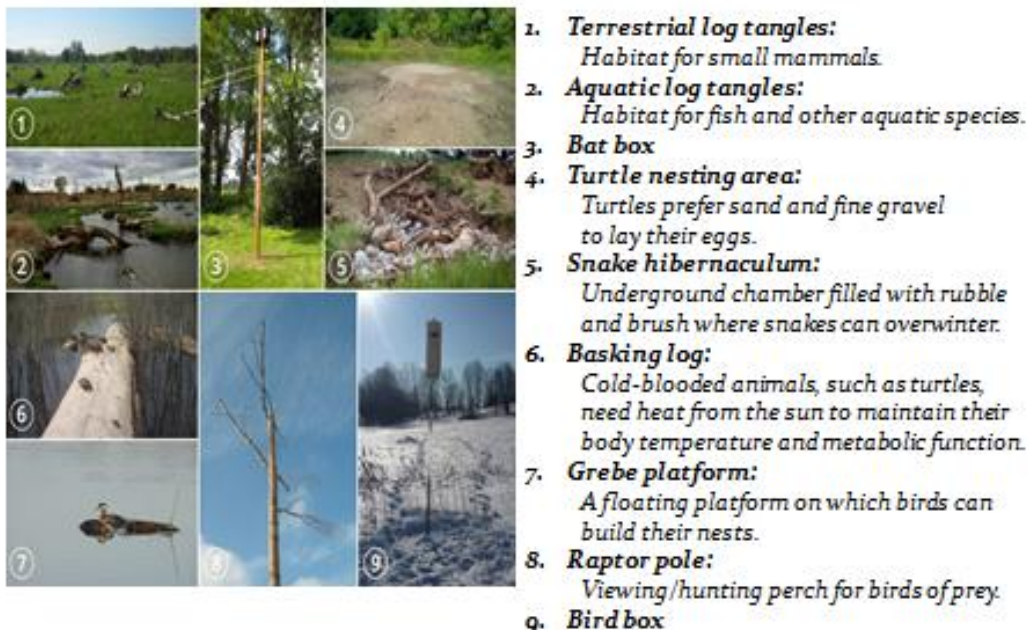
### TRCA: Restoration of Wildlife Habitat

The following chart summarizes some of the approaches the TRCA takes in restoring the habitat. Many of these approaches may be appropriate for Swan Lake and Swan Lake Park

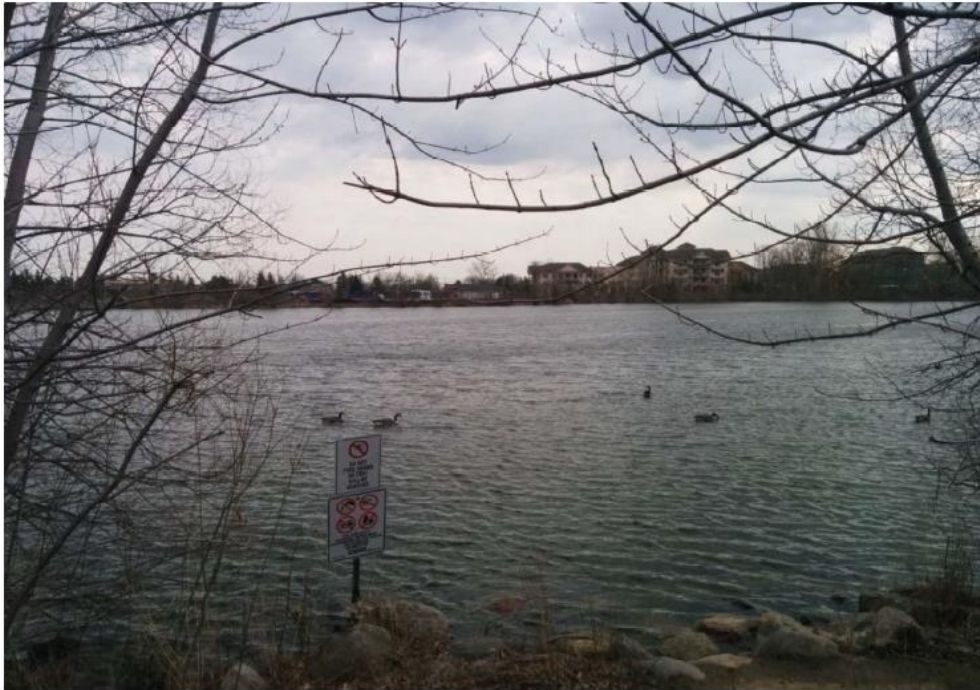
## Appendix D: Swan Lake Water Quality in 2017 (Executive Summary)

## SWAN LAKE WATER QUALITY IN 2017

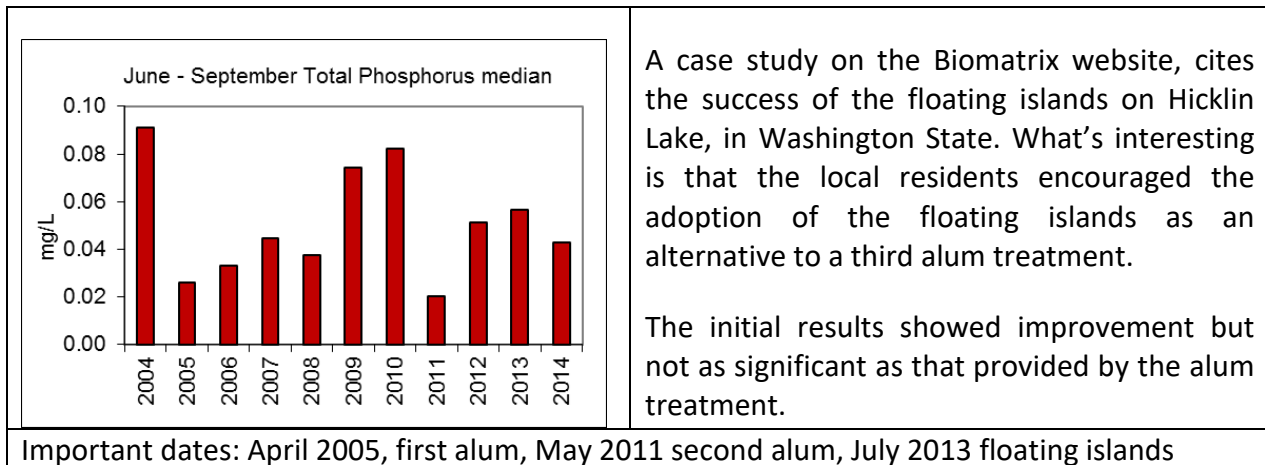
Biomatrix provides floating islands, known as Floating Treatment Wetlands, which are designed to encourage plant growth above and below the waterline. The technology of the Biomatrix floating island was designed to mimic how natural wetlands purify water. A Dynamic Biofilter Media can be added to hang below the island. This feature multiplies the island's efficiency for water purification by creating rich habitat in the root systems for billions of beneficial bacteria.

The use of floating islands may be beneficial in an area like Turtle Inlet (the small bay near the north foot bridge) or in the northern channel in lieu of a traditional bioswale.

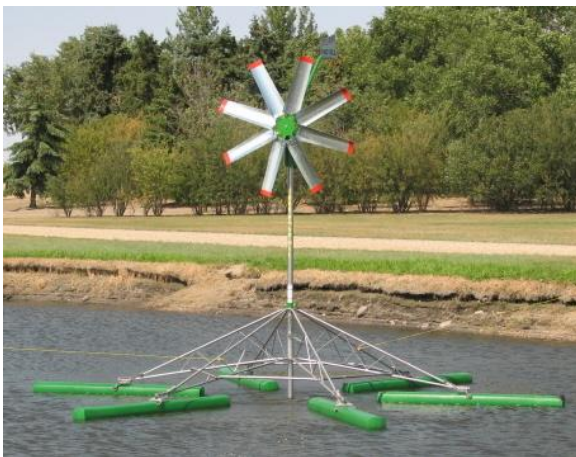
### Solar Bee® Lake Circulators

In essence, it is a floating windmill with a propeller below the water surface.

The circulator has successfully reversed the signs of eutrophication/remediation of surface waters (lakes, ponds, dugouts, etc.) for more than 26 years.

Designed to solve a variety of water quality problems in lakes and reservoirs.

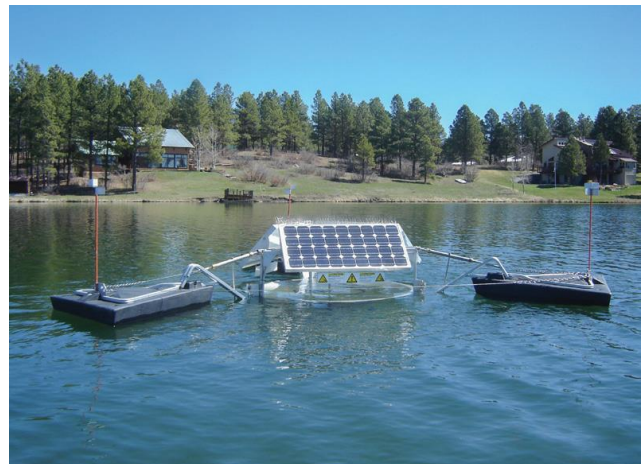
Active lake circulation can prevent and control harmful cyanobacteria (a.k.a. blue-green algae) blooms in the top water above the thermocline or they can be deployed to treat the bottom water below the thermocline.

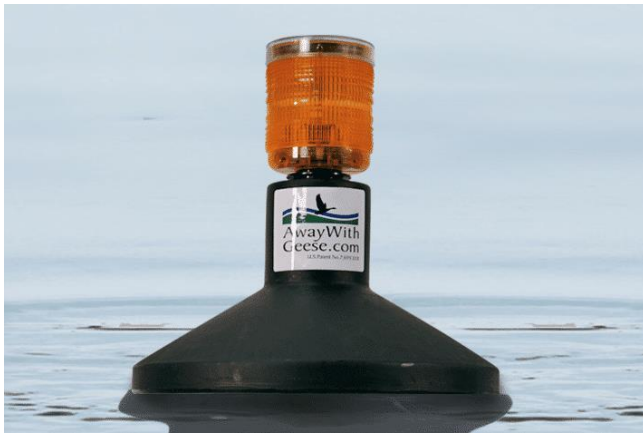
## Strobe Light – Manufactured by Away With Geese

Since the largest volume of migratory geese use the lake in the fall, one tool that may be worth trying – a flashing light that disturbs their sleep and makes them seek a more peaceful setting.

The Water Unit is recommended for use in ponds, lakes, retention areas and any waterway where unwanted geese are a problem. This floating unit features an amber 360-degree solar-powered LED light that flashes every two seconds, from dusk to dawn, year-round.

| Our Perception on Effectiveness of Goose Mangement at Swan Lake | | |
|--|--|---|
| <b>Our Recommendation: Implement Immediately (Under \$10,000)</b><br>1) Hire expert consultant experienced with goose management and relocation programs (\$2,000)<br>2) Purchase 9 Floating Strobe Lights and install immediately (\$6,500) | | |
