## MEMORANDUM

**SUBJECT:** Intention to Designate a Property under Part IV of the Ontario Heritage Act  
Joseph & Leah Pipher Farmhouse and Smokehouse  
33 Dickson Hill Road

<b>SUBJECT:</b>	Intention to Designate a Property under Part IV of the Ontario Heritage Act     Joseph & Leah Pipher Farmhouse and Smokehouse 33 Dickson Hill Road
<b>PREPARED BY:</b>	Peter Wokral, Senior Heritage Planner, ext. 7955
<b>REVIEWED BY:</b>	Regan Hutcheson, Manager of Heritage Planning ext. 2080

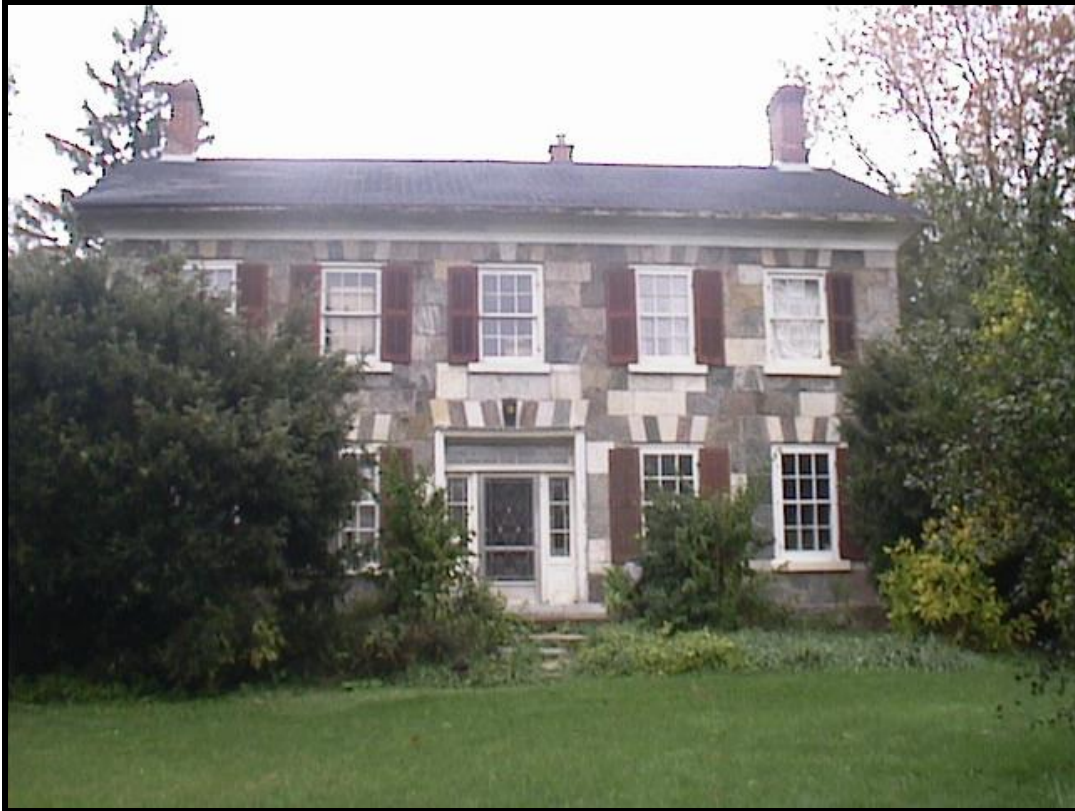
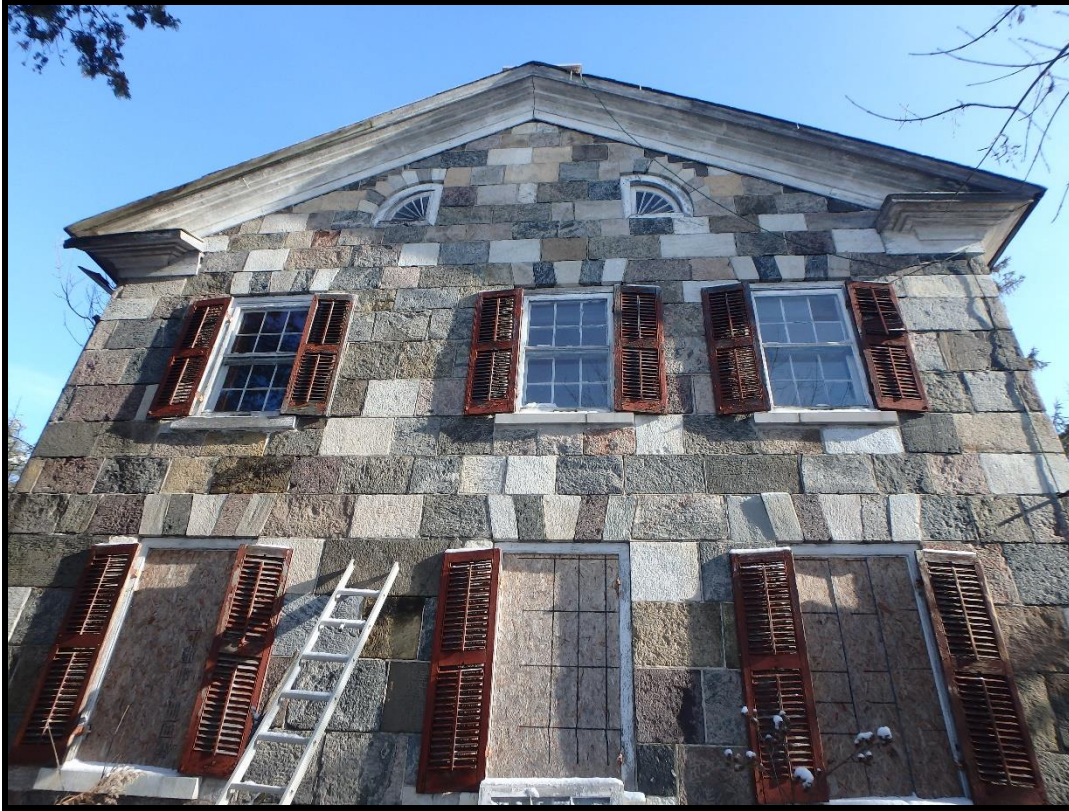
FIGURE 3 – Photographs of the Joseph and Leah Pipher Farmhouse

The Joseph and Leah Pipher Farmhouse is undoubtedly Markham's finest remaining field stone building. It is remarkable for being a full two stories in height, and for the quality of stonework. The house retains almost all of its original exterior and interior features and is a testament to the industry and prosperity of the Pipher family (see Figure 3- Photographs of the Joseph and Leah Pipher farmhouse).

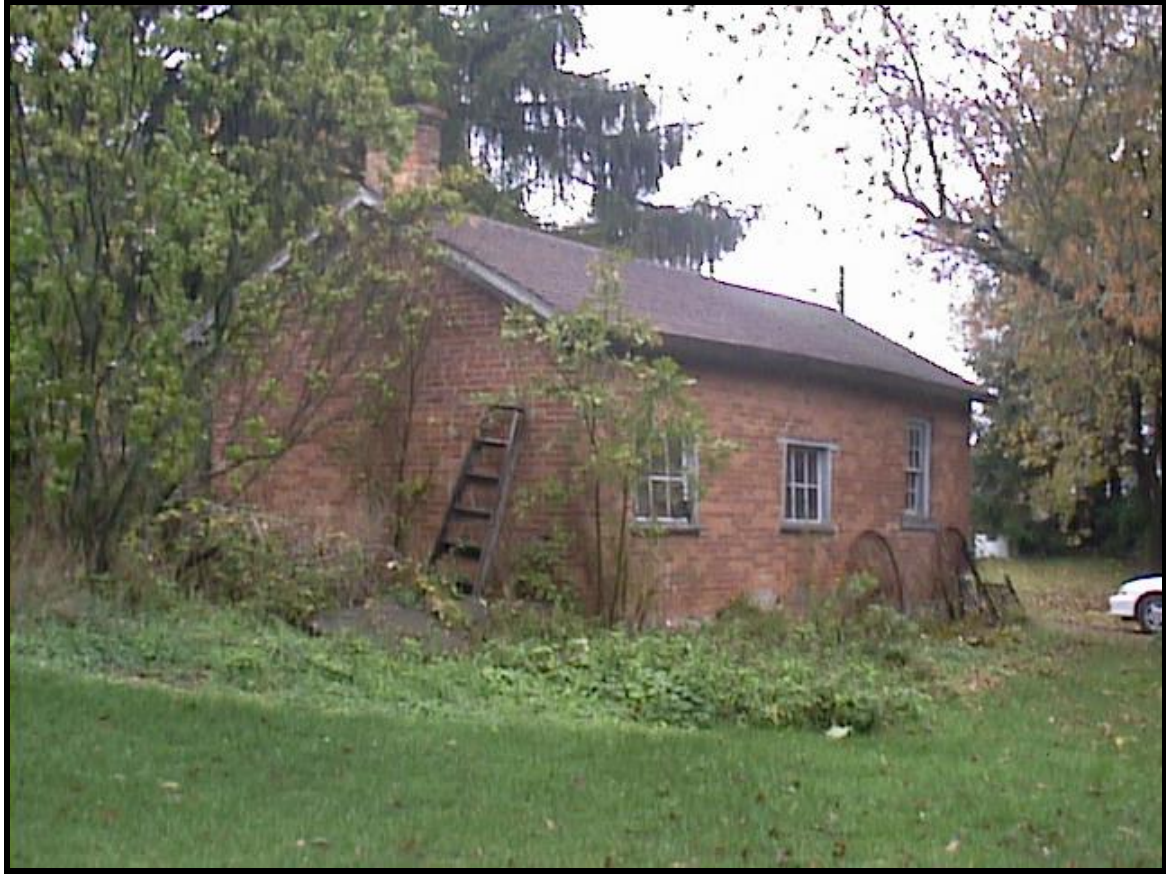
FIGURE 4 – Photograph of the Joseph and Leah Pipher Smokehouse

Based on an archival picture, the smokehouse/summer kitchen located in front and to the side of the main house, was just one of a large complex of buildings that made up the Pipher farm (See Figure 5 – Archival Photograph of the Pipher farmstead). This substantial local clay brick building is a rare surviving example of a specialized farm building that retains most of its original features (See Figure 4 – Photograph of the Joseph and Lean Pipher Smokehouse).

- **Recommended Approach**
  - Retain the smokehouse as an identified heritage attribute in the designation report, but acknowledge through this report, support for the future dismantling and replication of the building elsewhere on the property using salvaged bricks and other components from the structure.

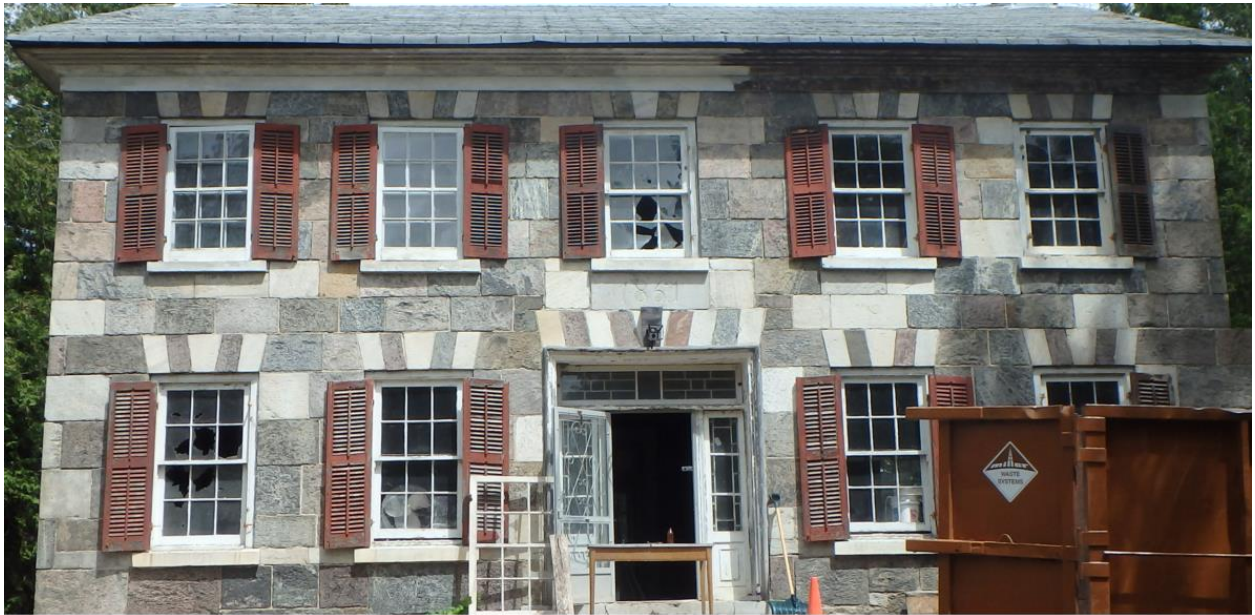
**Front Elevation (showing windows and shutters)**

- **6/6 windows are in reasonably good repair.** Some window panes have been broken.
- **Louvered wood window shutters are mounted with hardware, so they are functional. They have been weathered over time and need repair and painting. Some un-weathered shutters have been stored inside the smokehouse.**

- Retain the existing windows as an identified heritage attribute in the designation report, but acknowledge through this report, that the owner has agreed not to remove any heritage windows upon his taking possession of the property, and that a future site visit by staff with the owner will assess the condition of the windows in a fair and reasonable manner to determine their suitability for retention and if necessary, re-conditioning.
- The objective will be to retain as much of the original material as possible. As per Official Plan policy, protection, maintenance and stabilization of existing cultural heritage attributes and features as opposed to removal or replacement will be the core principle for all conservation projects (Policy 4.5.3.1)

- Retain the existing shutters as an identified heritage attribute in the designation report, but acknowledge through this report, that many shutters appear to be in poor shape and that a future site visit by staff with the owner will assess their condition and authenticity in a fair and reasonable manner.
- If existing shutters are found to be inappropriate and/or beyond reasonable repair, new wooden, louvered shutters should be re-introduced.

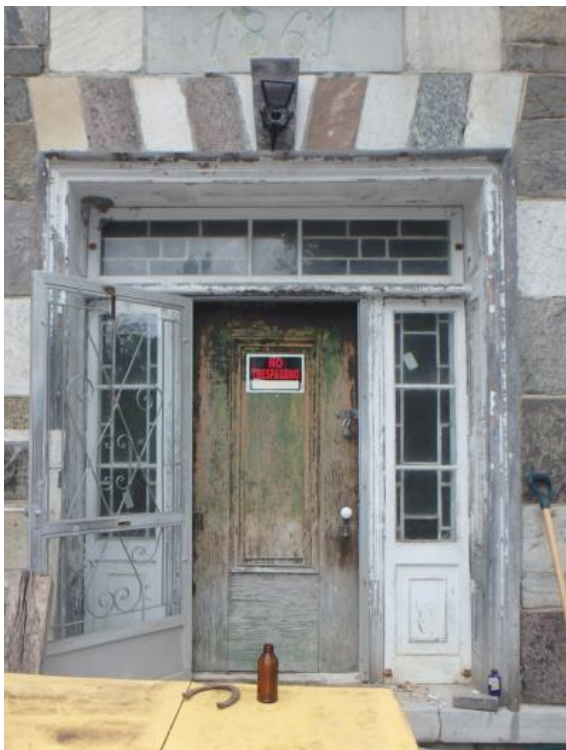
**Front Entry (1861 date stone above door)**

- **Front entry is in reasonably good repair.** The front door is a little weathered. Its large old rim lock still in place.
- Floor has sunk a little to the east of the entry. Maybe due to weakness in support of hallway wall based on structural members viewed in the basement.

- **Recommended Approach**
  - Retain the existing entry door and sidelights as identified heritage attributes in the designation report, but acknowledge through this report, that the owner has agreed not to remove these features upon his taking possession of the property, and that these features will be examined during a future site visit by staff with the owner to assess their condition and ability to be restored, in a fair and reasonable manner.

- The objective will be to retain as much of the original material as possible. As per Official Plan policy, protection, maintenance and stabilization of existing cultural heritage attributes and features as opposed to removal or replacement will be the core principle for all conservation projects (Policy 4.5.3.1)

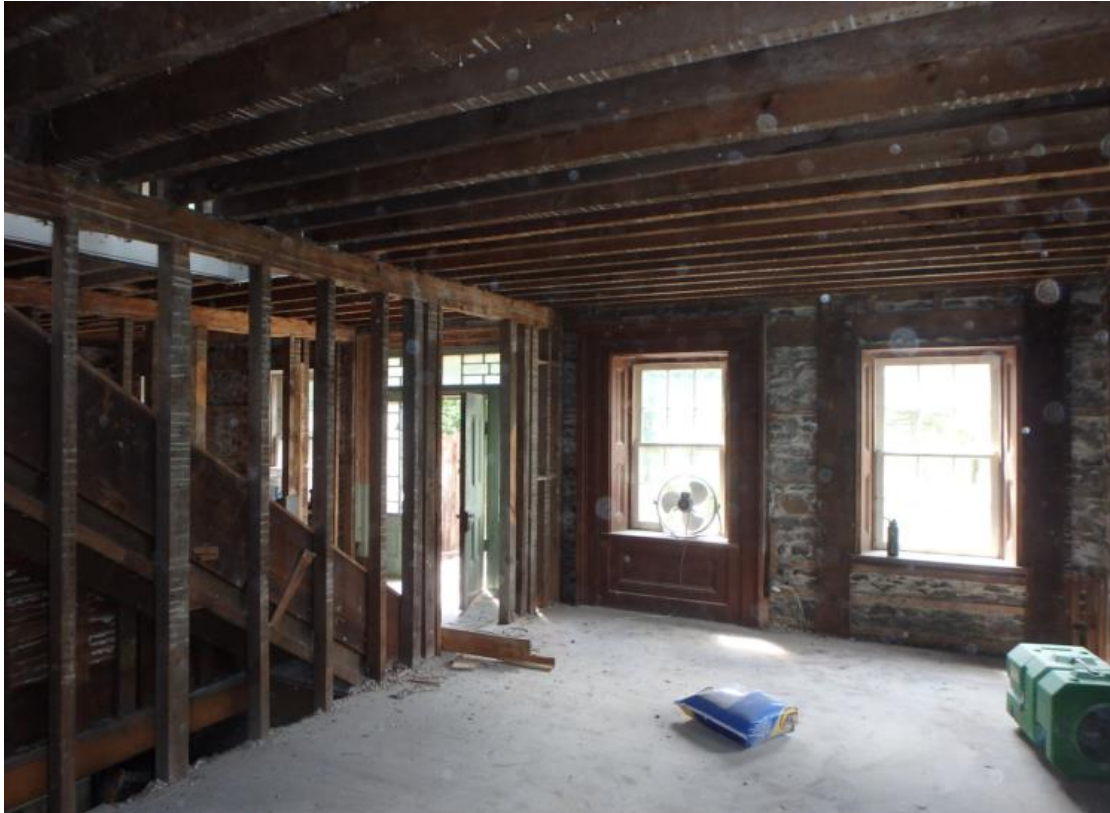
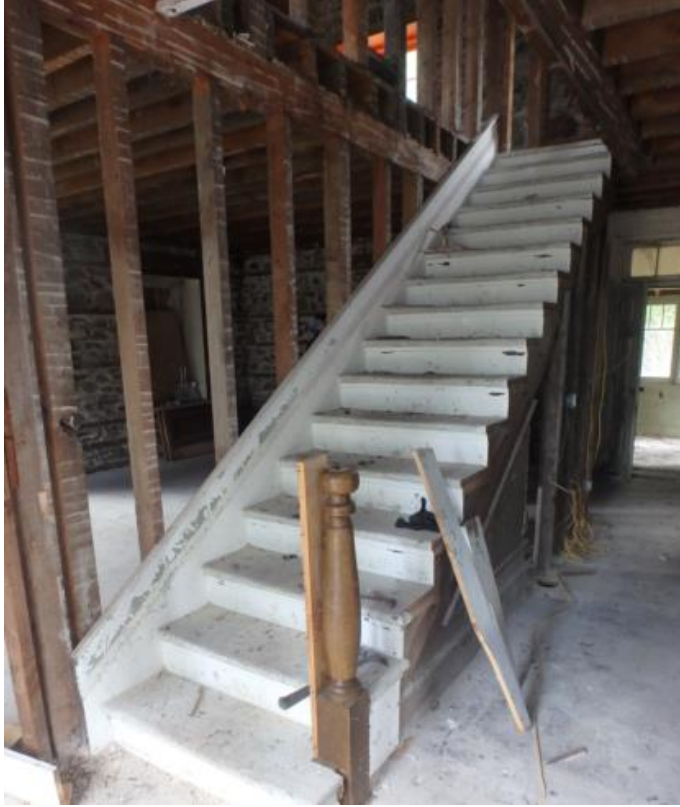
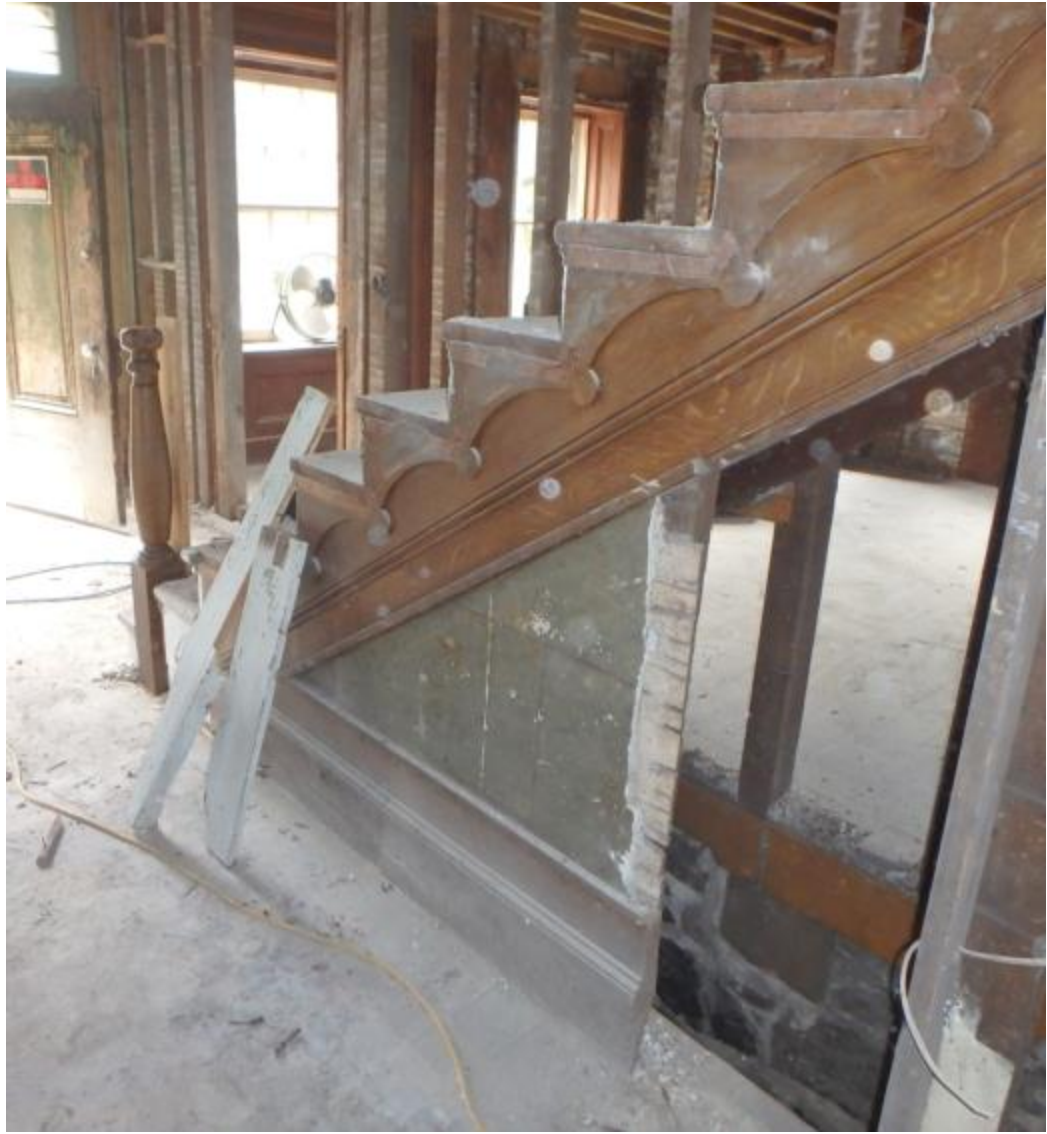
**Interior – all walls back to studs**

- All interior wall materials have been removed- back to wooden studs.
- Stairway is exposed in centre hall. Scrollwork is found on the open stringer. Turned newel post with paint-grained finish was found encased in a boxy 1940s newel post.

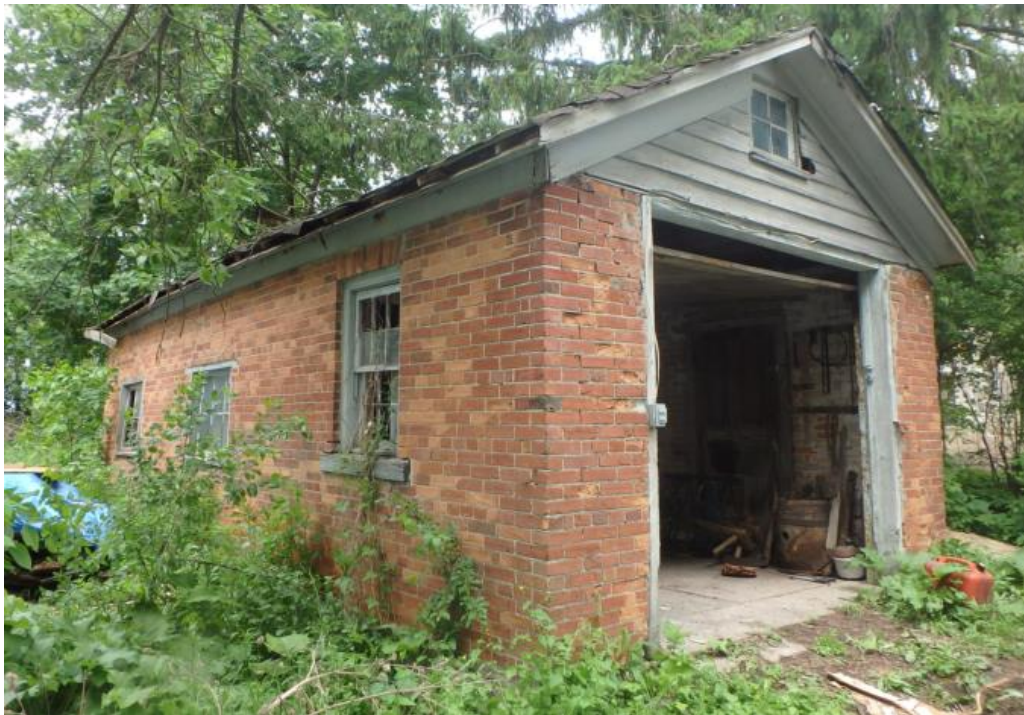
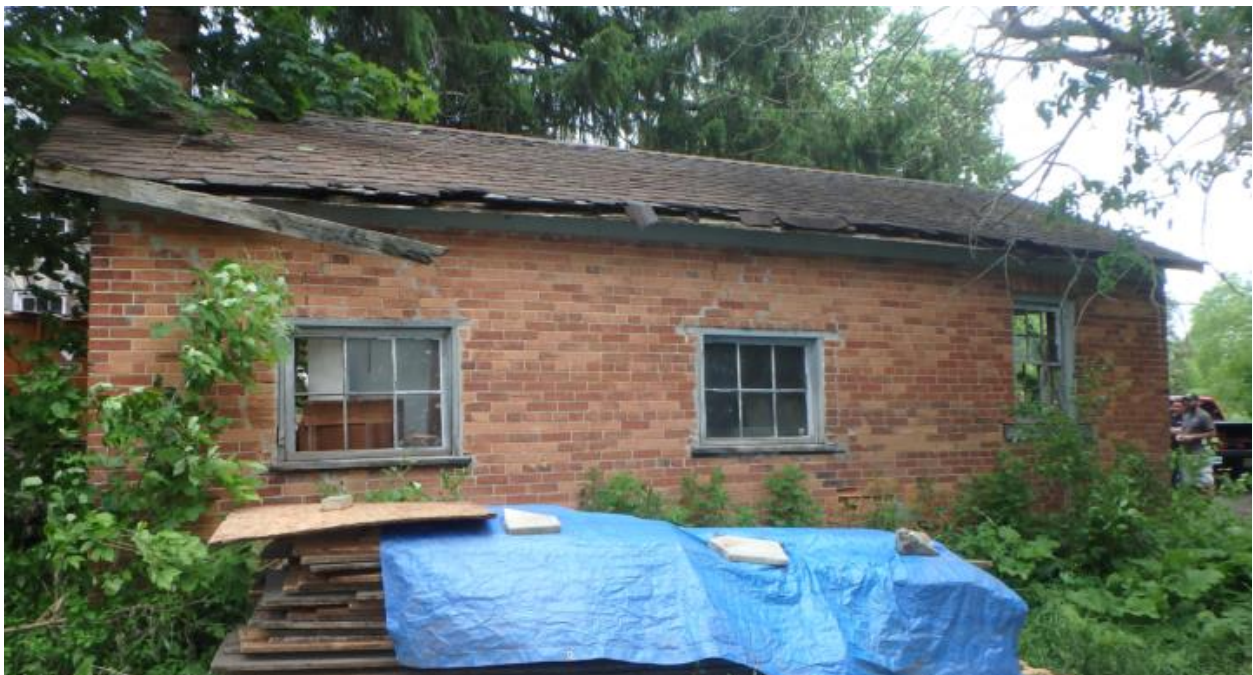
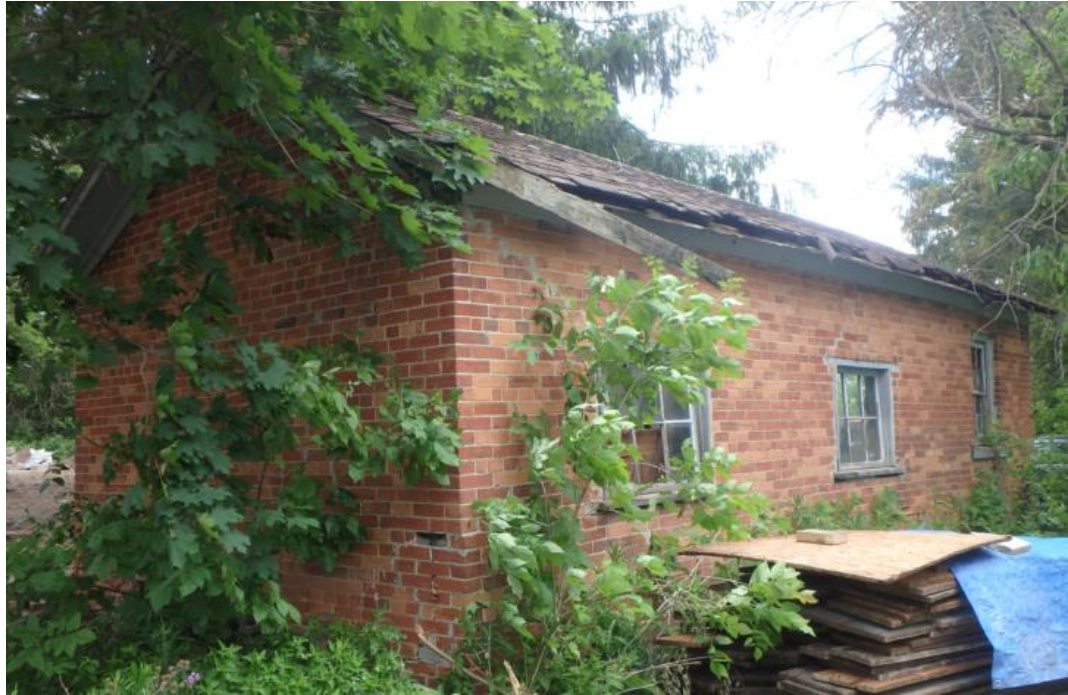
Former Smokehouse – Converted to Garage c. 1920s

- No major structural issues were observed on the brick accessory building.
- The interior was once divided into three sections – walls have been removed but their scars remain visible.
- The main issue with the building is some spalling of brick on the base of the walls, particularly at the west end of the structure.

- The building appears to have been converted to a garage in the 1920s, with a large door introduced where a cooking fireplace and bake oven once may have existed.
- The owner has collected artifacts from the house and other parts of the property, mostly relating to farm use, and is storing them in the building. Stone-working chisels of various sizes and a hammer head, possibly used in the construction of the house in 1861, have been found on the property and are stored in the brick building.
- The owner has no definite plans for the building but stated that it is in an awkward position in front of the house and has condition issues.
