## MEMORANDUM

**SUBJECT: Heritage Permit Application**  
8 David Gohn Circle, Markham Heritage Estates  
The Pingle House  
HE 20 124651

**Property/Building Description:** 1-1/2 storey single detached dwelling constructed c. 1855  
**Use:** Residential  
**Heritage Status:** Designated under Part IV of the Ontario Heritage Act

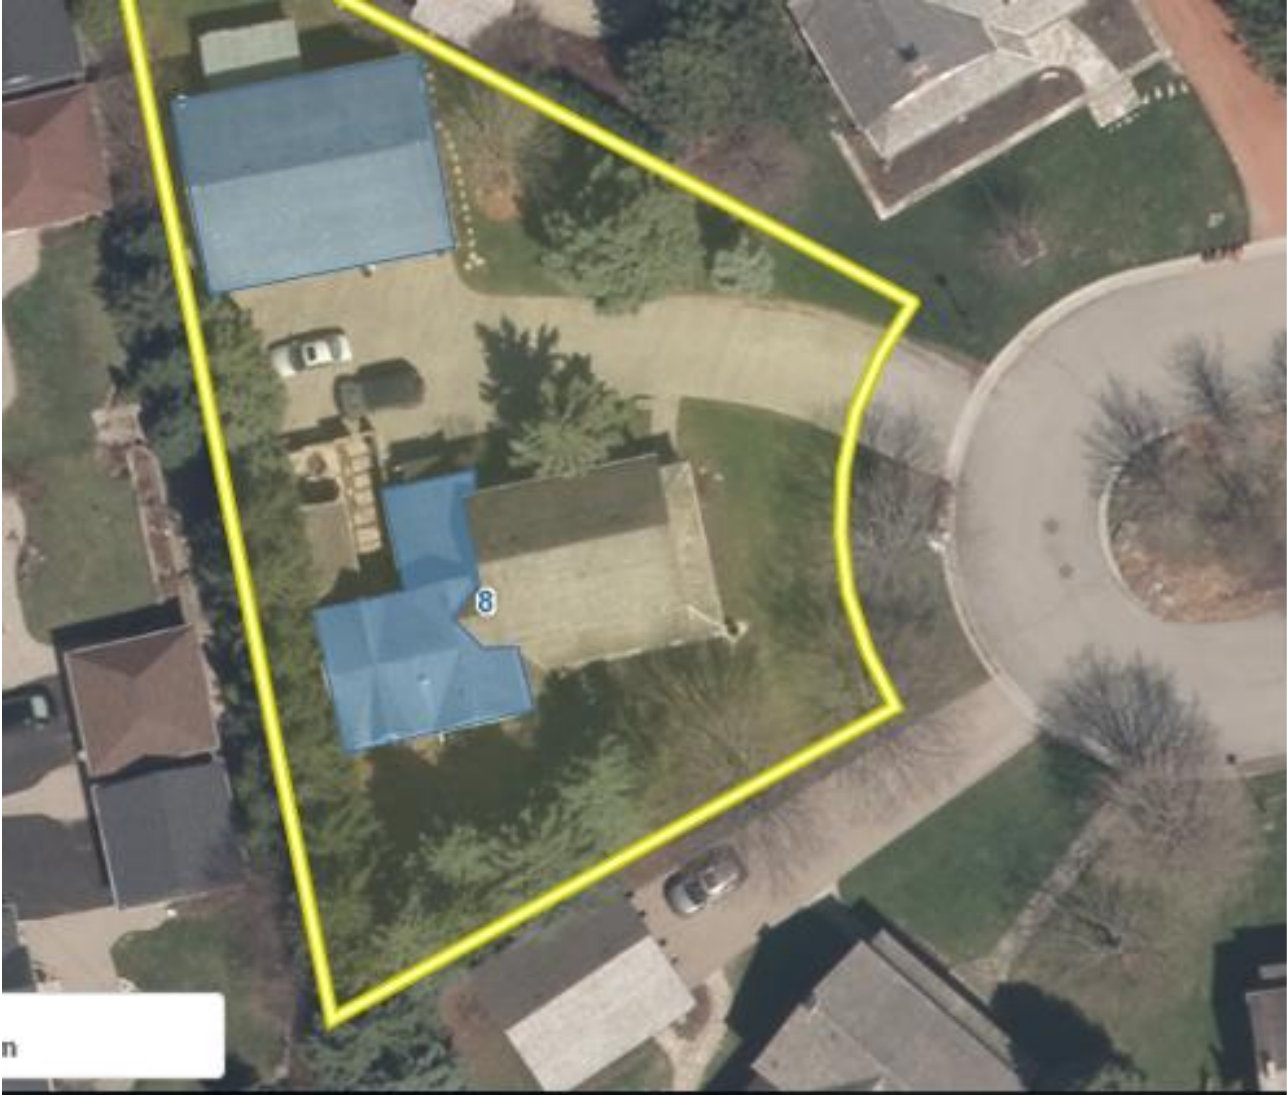
Google Street View Image from 2009 showing visibility of proposed metal roofs in orange colour

- In this particular case at 8 David Gohn Circle, Staff notes that most of the roof of the addition is not readily visible from the public realm of the street, and the portion that is, is generally far enough back to have minimal visual impact;

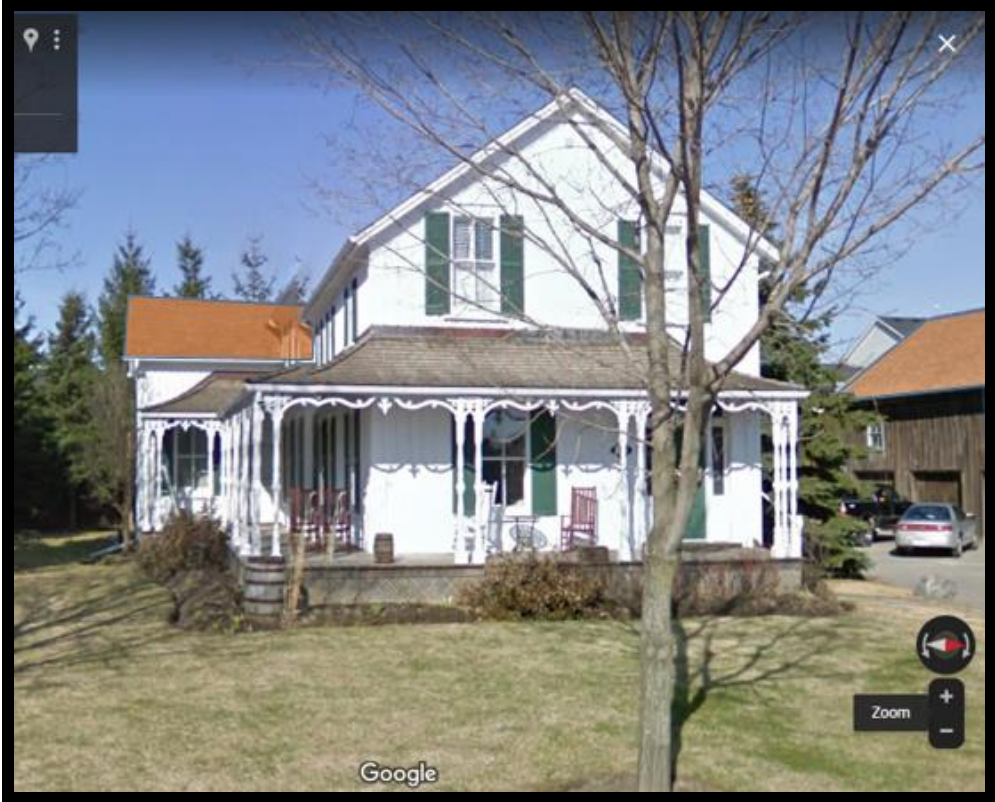
2018 Google Streetscape – mature vegetation provides extensive coverage in summer months

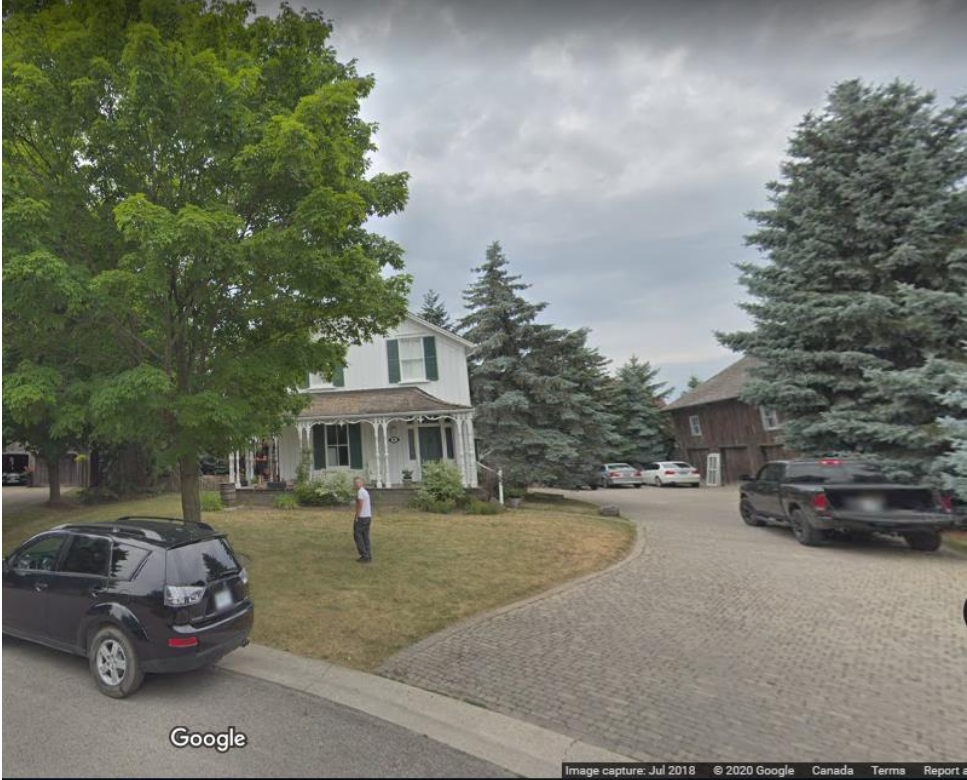
2018 Google Streetscape – mature vegetation provides extensive coverage in summer months

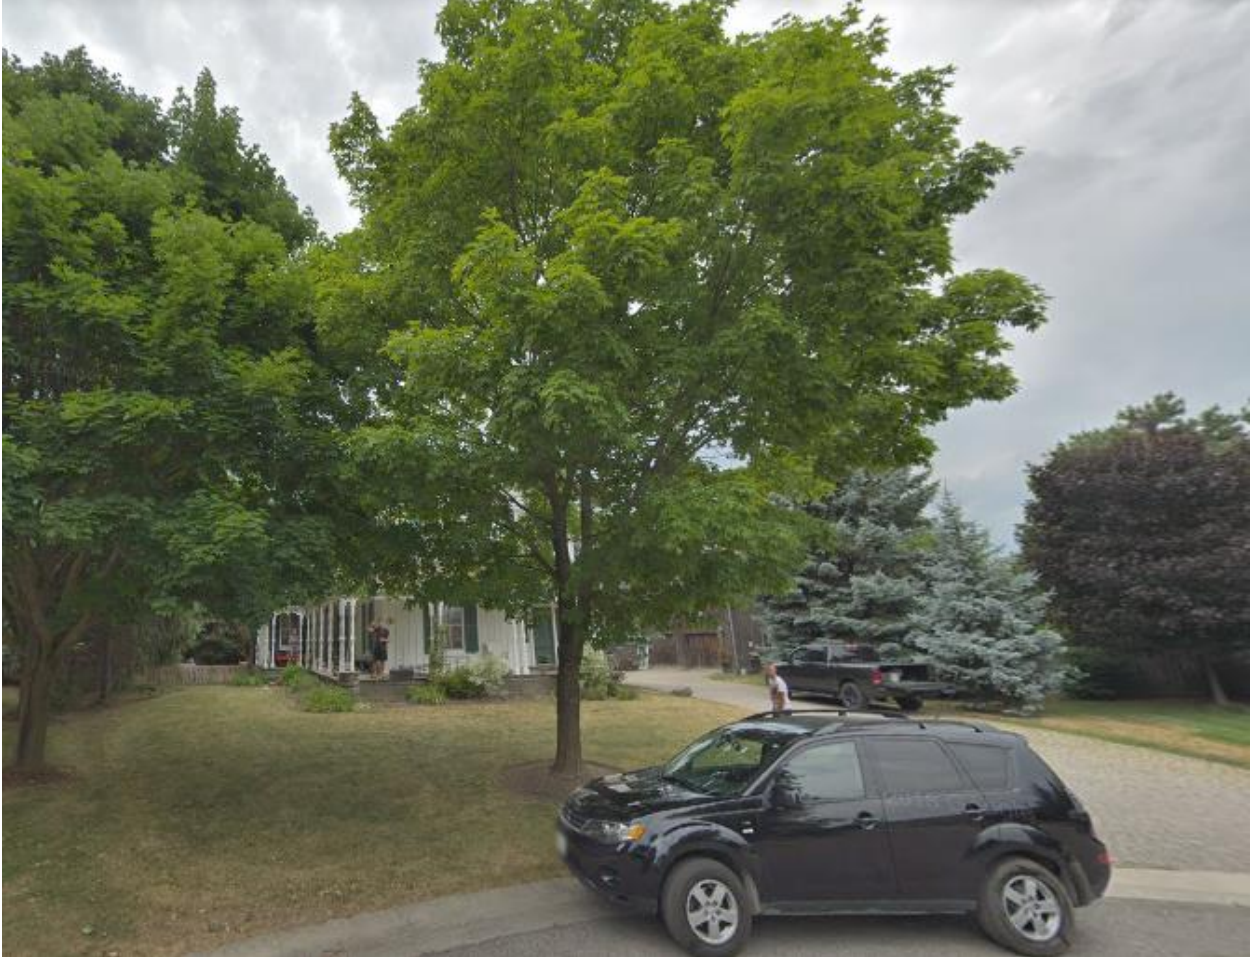
Examples of new metal roofs on outbuildings in Markham Heritage Estates

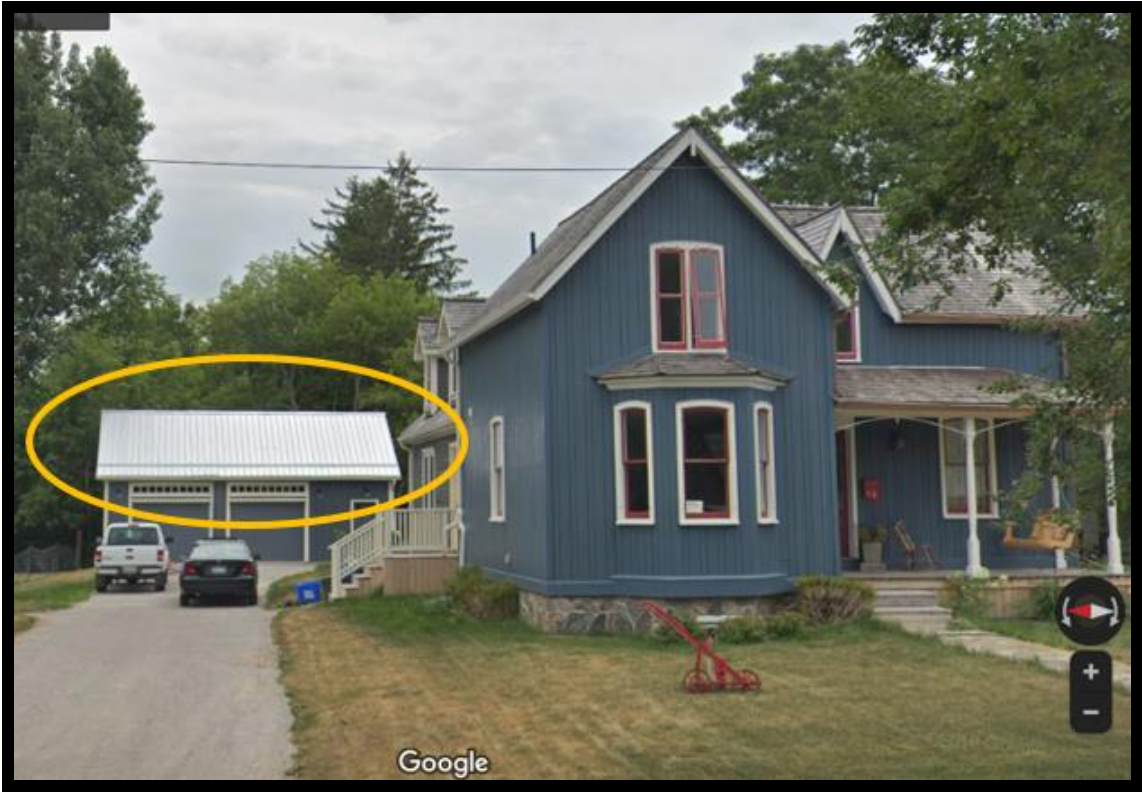
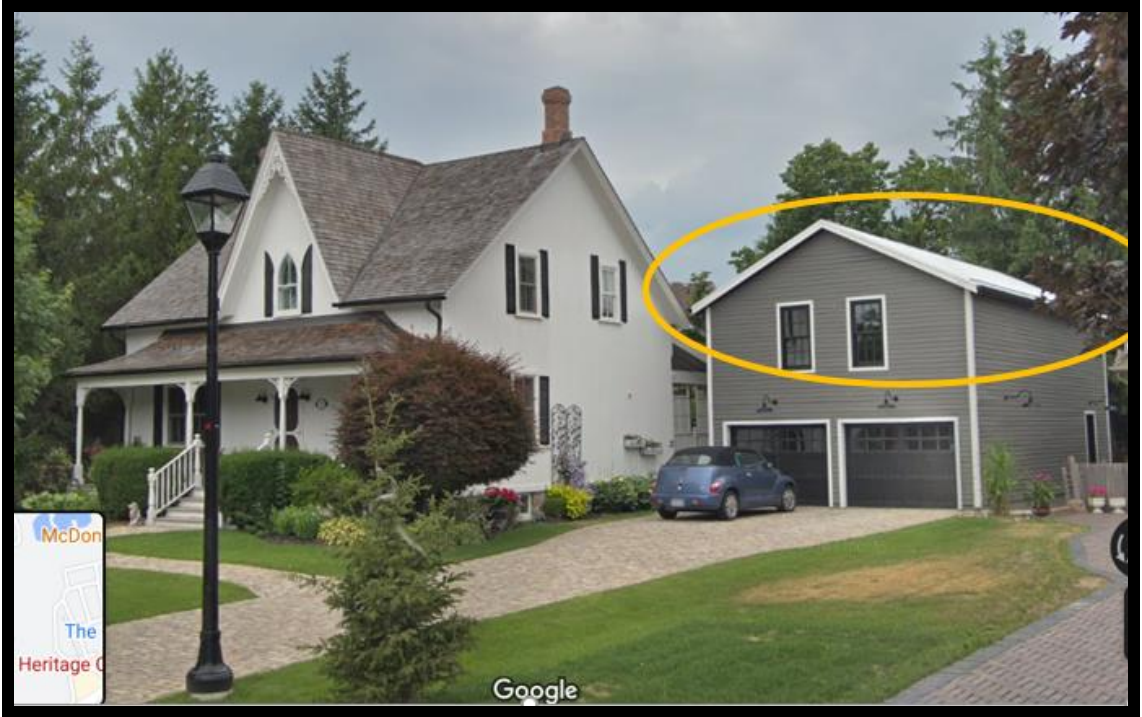
Home at 10 Heritage Corners Lane with salvaged galvanized roofing on new addition

- Although most of the metal roofs found in Heritage Estates are on garage accessory buildings, a salvaged galvanized metal roof was approved for the new rear addition to the house at 10 Heritage Corner's Lane;
