## MEMORANDUM

**SUBJECT:** Heritage Permit Application  
8 David Gohn Circle, Markham Heritage Estates  
The Pingle House  
Request for Metal Roof on Addition to Dwelling  
HE 20 124651

**Property/Building Description:** 1-1/2 storey single detached dwelling constructed c. 1855  
**Use:** Residential  
**Heritage Status:** Designated under Part IV of the Ontario Heritage Act

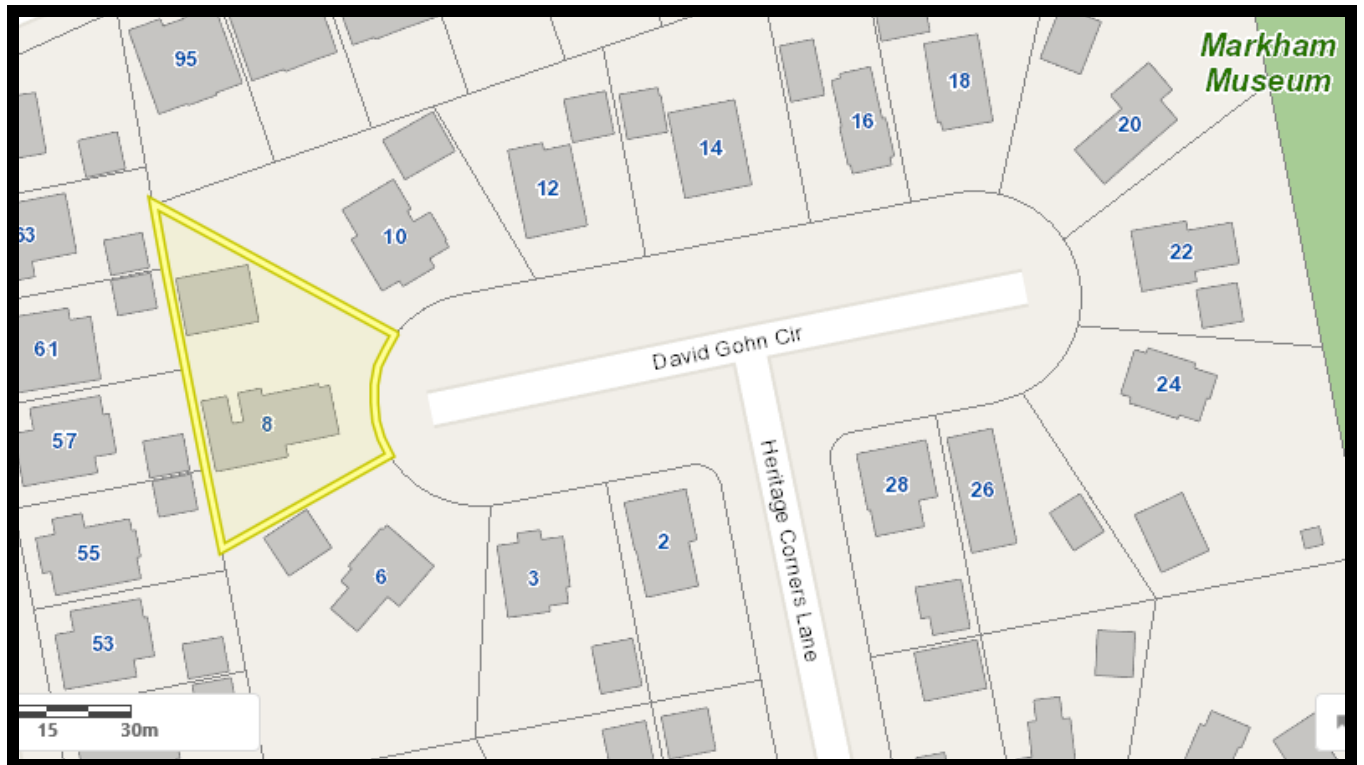
Roof area highlighted in blue is where the applicant wishes to install metal roofing rather than cedar shingles.

- Therefore new illustrations have been provided to show the extent of the metal roof proposed and the visibility from the street/public realm;
- Although cedar shingle roofs were overwhelmingly the most common type of roofing used on 19<sup>th</sup> century homes in Markham, metal roofs were also historically used on out buildings or barns or on farmhouses in the early 20<sup>th</sup> century as a cost effective replacement for cedar shingles.;

- Although cedar shingles are the preferred roofing material for an addition to a dwelling in Heritage Estates, the proposed metal roof on the addition would not appear to be readily visible from the public realm of the street;
