Main Street Unionville Streetscape Master Plan

**Council Meeting
March 8, 2022**

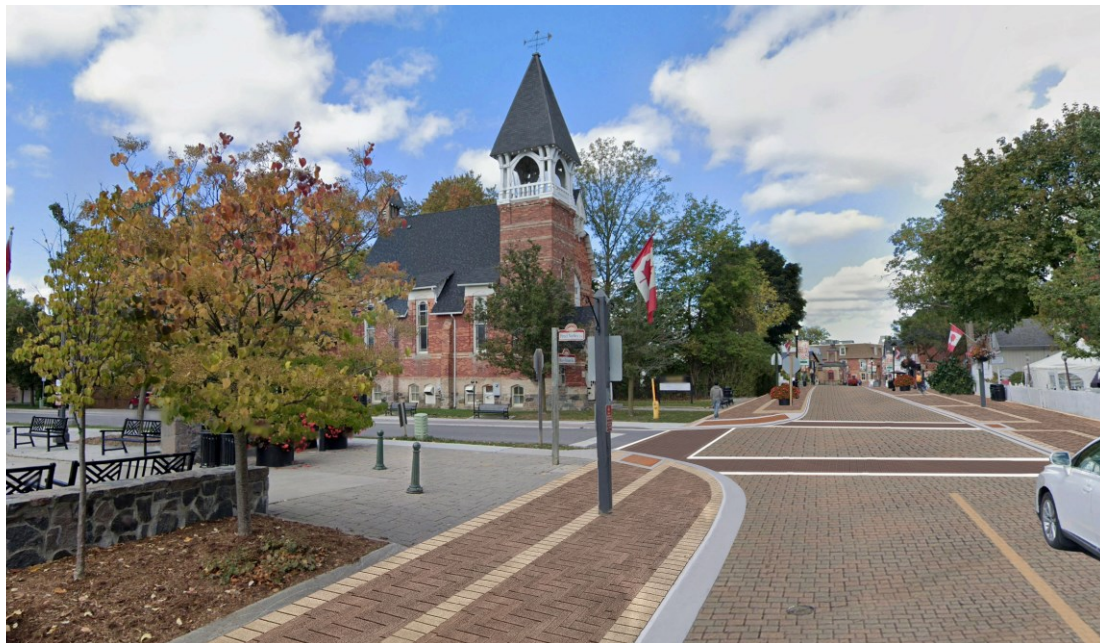
Concept 2 - Cross Section - 2m Sidewalk - Parking East Side

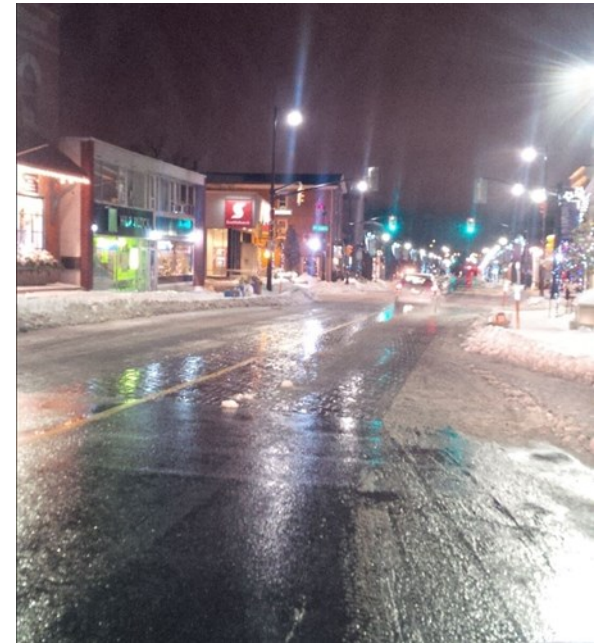
Winter Maintenance

- Specialized snow clearing equipment with shoes or high-density plastic blades will reduce scraping of brick finish.
- Winter salting practices;
 - The use of common rock salt (sodium chloride) as a de-icer is a widespread practice on paver installations. However excessive use of de-icing salts over a long period could cause damage to the pavers;
 - The effectiveness of the salt on melting snow is more effective on asphalt, as the darker asphalt will have greater heat absorption from the sun, increasing snow melt. (-12°C vs -7°C)
- Specialized Sweeper Brooms for street and sidewalk sweepers to remove excess salt and brine.

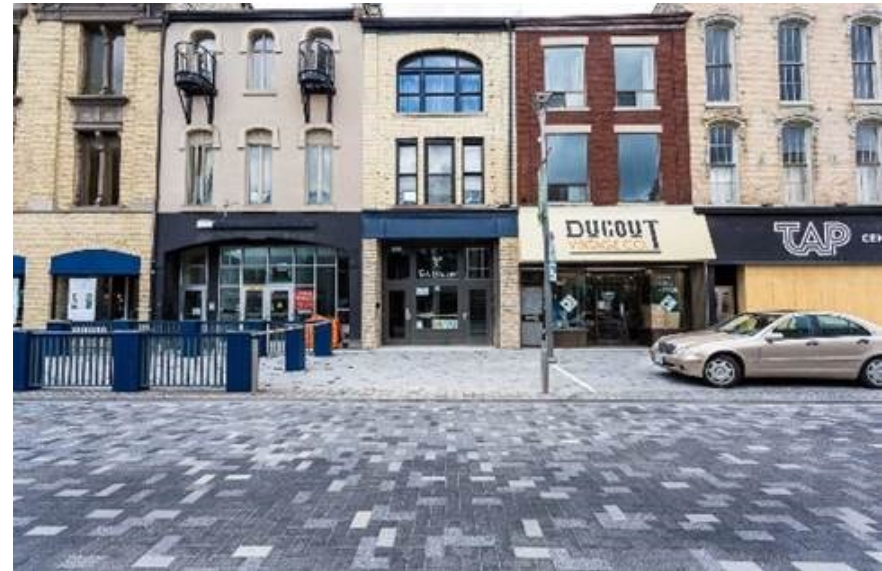
City of London, ON (Dundas St.)

- \$16 Million dollar project to complete London's first "Flex Street" (opened at the end of 2019)
- Features: pavers in roadway encourage lower speeds, extra-wide sidewalks, no curbs. Textured pavers guide people with visual impairments.
- Objective: "A flex street is seamless space that allows for more pedestrian priority and for the area to be closed off for events."
- The design utilized a concrete base across the entire right-of-way width. The warranty period has recently lapsed with no issues to date in regard to the maintenance of the pavers.

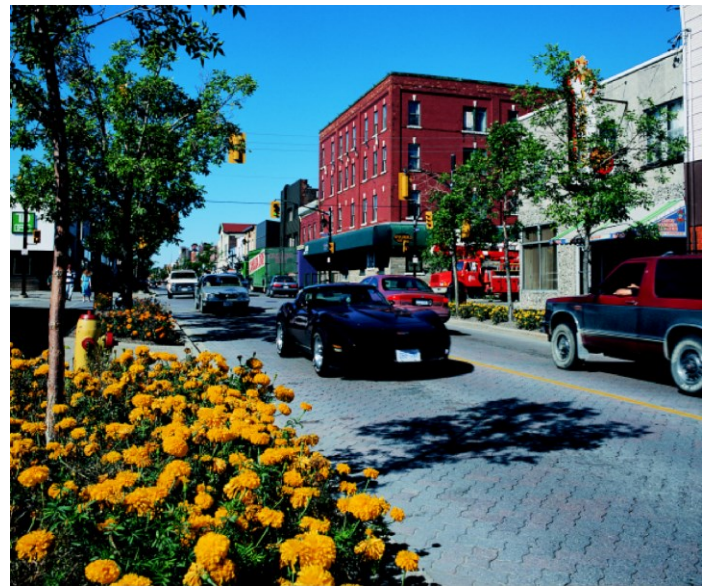
City of North Bay (Main Street)

- A case study prepared by Interlocking Concrete Pavement Institute was completed 20 years after the original installation noted:
 - Little or no deformations or rutting in wheel paths.
 - Little to know degradation of the concrete pavers (less than 1%)
 - 4% of the pavement surveyed had depressions concentrated in an area that had been reinstated after utility repairs.
- City of North Bay is in the process of replacing their interlocking brick that was placed in the 80's on a granular base.
- Even though the City's Main Street has been a successful installation we have been advised of sidewalk concrete paver installation across the City that have prematurely failed due to salt corrosion.

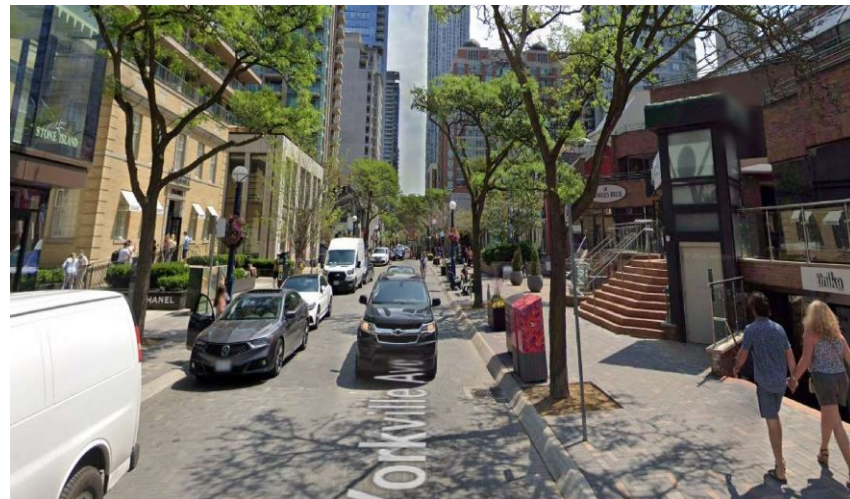
City of Toronto (Yorkville Avenue)

- Streetscape and road rehabilitation project to the revitalization of the streetscape environment from Bay St to Avenue Road (constructed in 2015)
- Features: pavers in roadway encouraging lower speeds and modified concrete curbs.
- The design utilized a concrete base across the entire right-of-way width.

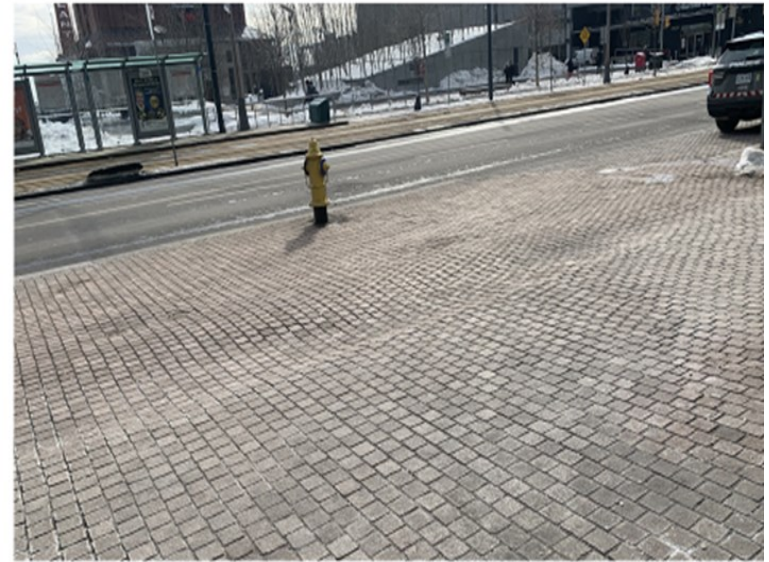
Queens Quay- Blvd Failures

- Streetscape and road rehabilitation project to the revitalization Queens Quay was completed by Waterfront Toronto in 201.)
- The design utilized a concrete base within the blvd of the public right-of-way width.
- Waterfront Toronto recommended the installation of a concrete base on private property, however, some locations may not have agreed to installation of a concrete base resulting in differential settlement.

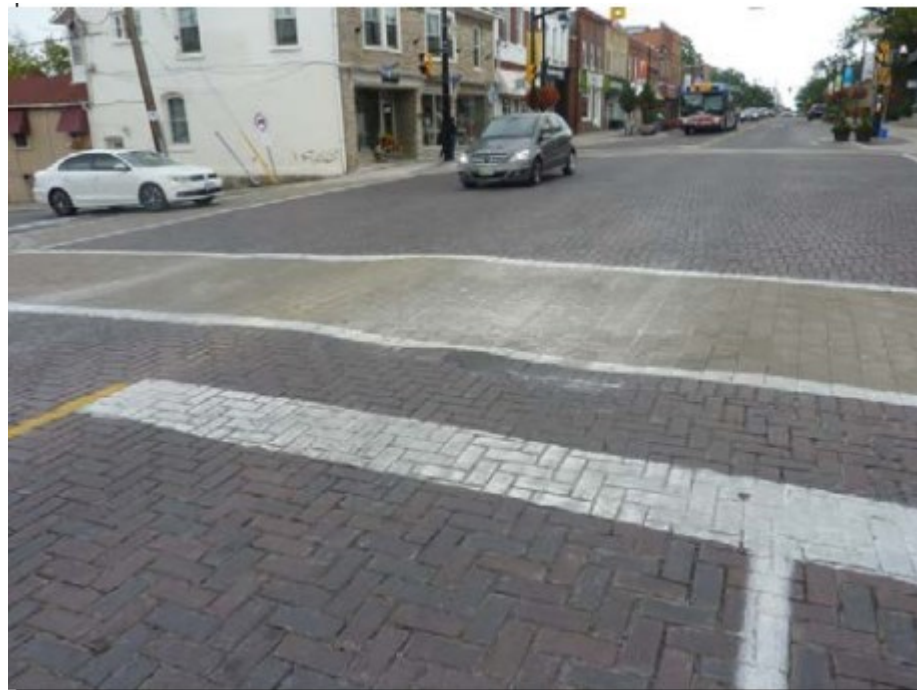
Main St Markham – Road Failures

The major contributor to the failure was the type of bedding layer used between the concrete brick paver and the concrete base. It was determined that:

- the bedding layer used was a soft aggregate and was not suitable for this type of application;
- the thickness of the concrete brick paver (7cm vs 8cm);
- laying pattern;
- lack of edge restraint to hold the concrete brick pavers in place; and
- joint width (spacing) of pavers
