Cultural Heritage Resource **STRATEGY**

City of Markham
North District Employment Lands (MiX)

November 2021 (FINAL)

MacNaughton Hermsen Britton Clarkson Planning Limited (MHBC)

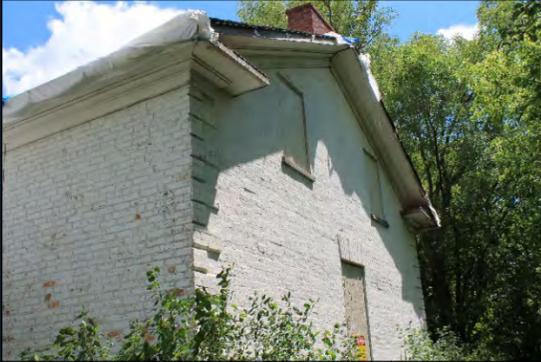
#1	<p style="text-align: center;">2780 19th Avenue (Alfred Read Farmhouse – c.1855)</p>

Listed	City of Markham	Existing building only	Fair	Located outside of business park area.	Yes. Further assessment required as future plans develop.	n/a – outside planned business park area	Retain and integrate with future development, should re-location (as previously approved by Council) not proceed.

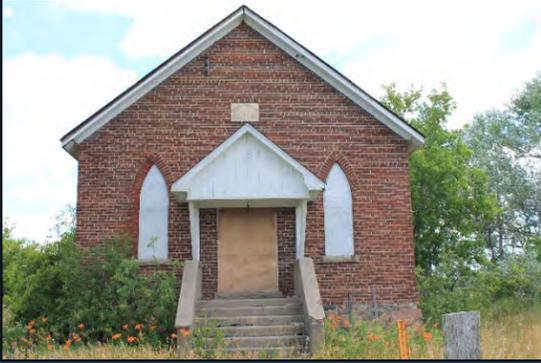
#2	<p style="text-align: center;">3010 19th Avenue (SS #7 – c.1902)</p>

Designated Part IV (2004-215)	Private (Catholic Diocese)	Existing building	Good	Located at periphery of business park area, adjacent to environmental features	<p style="text-align: center;">Good candidate for re-location due to size.</p> <p style="text-align: center;">Little benefit to move because of location at the periphery and near road.</p>	<p style="text-align: center;">Low impact. Small corner parcel at periphery of business park area.</p> <p style="text-align: center;">Building could be adaptively reused for office / commercial / restaurant and integrate with surrounding uses, or be converted to residential with low impact.</p>	Retain in existing location and adaptively re-use

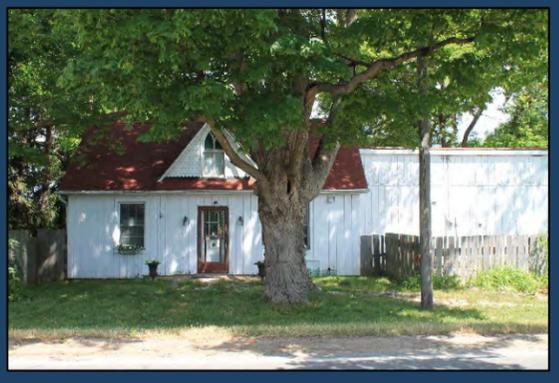
#3	<p>3270 19th Avenue (Doner House – c.1881)</p>

<p>Listed</p>	<p>Private (Flikas)</p>	<p>Existing building.</p>	<p>Good. Building is currently occupied.</p>	<p>Located in close proximity to environmental features (Greenway System).</p>	<p>Little benefit to move because of location – unless required due to road widening</p>	<p>Low impact. Small parcel located near road and environmental features. Building could be adaptively reused for office / commercial / restaurant and integrate with surrounding uses, or continue to be used for residential purposes with relatively low impact.</p>	<p>Retain and continue existing use.</p>

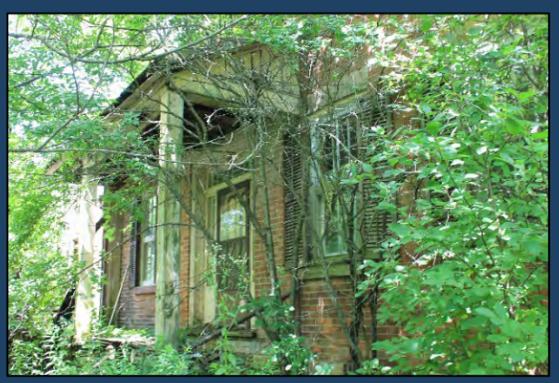
#4	<p>3490 19th Avenue (Gormley Widman House and Barn – c.1855 / c.1902)</p>

<p>Listed</p>	<p>Private (Wideview Farms – Friedman)</p>	<p>Significance relates to built features (house, barns, outbuildings), as well as landscape features. Prominent lane leads towards buildings from road, house situated on rise of land, and layout of collection of buildings appears to remain in original form. Fields are not significant.</p>	<p>Condition of house appears fair-poor but is deteriorating, and some integrity is starting to erode. Repairs required to secure building envelope. Condition of outbuildings appears good overall. General grounds upkeep required in area around house.</p>	<p>Located within/adjacent to environmental features (Greenway System, ORMCP, unevaluated wetland).</p>	<p>No.</p>	<p>Low-medium impact. Buildings located near environmental features but set back from road. House and other buildings could be adaptively reused for a variety of purposes. May be some impact on range of business park uses if house used for residential purposes</p>	<p>Sever house and barn and retain and adaptively re-use</p>

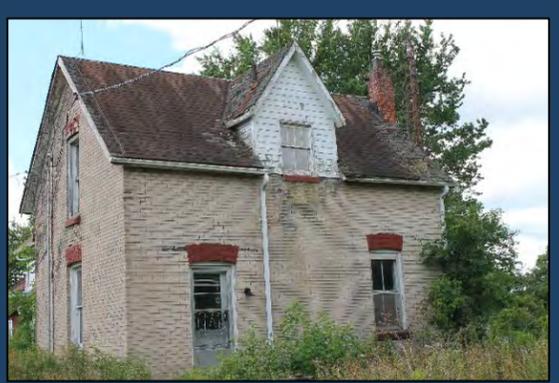
#5	<p>3565 19th Avenue (Lewis-Jarvis House and Barn – c.1870/c.1900)</p>

<p>Listed</p>	<p>City of Markham</p>	<p>Significance relates to the built features (house, barn, outbuildings), as well as landscape features. Tree-lined laneway leads from the road, and the layout of the collection of buildings appears to remain in original form. Fields are not significant.</p>	<p>Condition of house appears to be fair-poor, and some repairs have been identified to secure building envelope. The barn and other outbuildings appear to be fair condition. General grounds upkeep required.</p>	<p>Located near proposed collector road network and adjacent to environmental features (Greenway System, unevaluated wetland).</p>	<p>No</p>	<p>Low-medium impact. Buildings located near environmental features and near road. House and other outbuildings could be adaptively reused for a variety of purposes. May be some impact on range of business park uses if house used for residential purposes</p>	<p>Sever house and main barns (excluding small barn in field) from larger parcel of land. Buildings should be restored, retained and adaptively re-used. Consider relocation or demolition of outlying barn.</p>

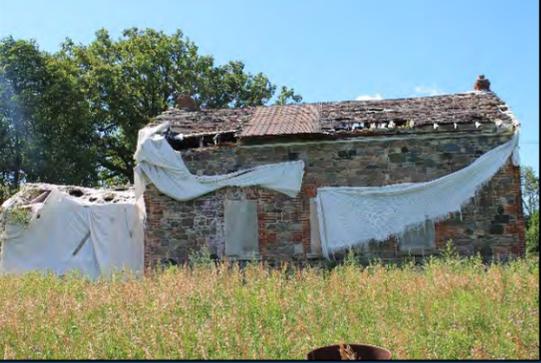
<p>#6</p>	<p>11251 Woodbine Avenue (Hopper House – c.1855)</p>

<p>Listed</p>	<p>Private (Glendower Properties)</p>	<p>Significance relates to built resource and architectural features.</p>	<p>Overall condition of house is poor, although stonework and foundation appear sound. Repairs required to secure building envelope.</p>	<p>Located near floodplain</p>	<p>House is candidate for relocation, however stabilization would be required internally in order to prepare for move.</p>	<p>Medium impact. Building could be adaptively reused for office / commercial / restaurant and integrate with surrounding planned business park uses. Residential use not recommended due to location.</p>	<p>Relocate within development parcel.</p>
<p>#7</p>	<p>11242 Warden Avenue (Summerfeldt-McKay House – c.1835/c.1875)</p>

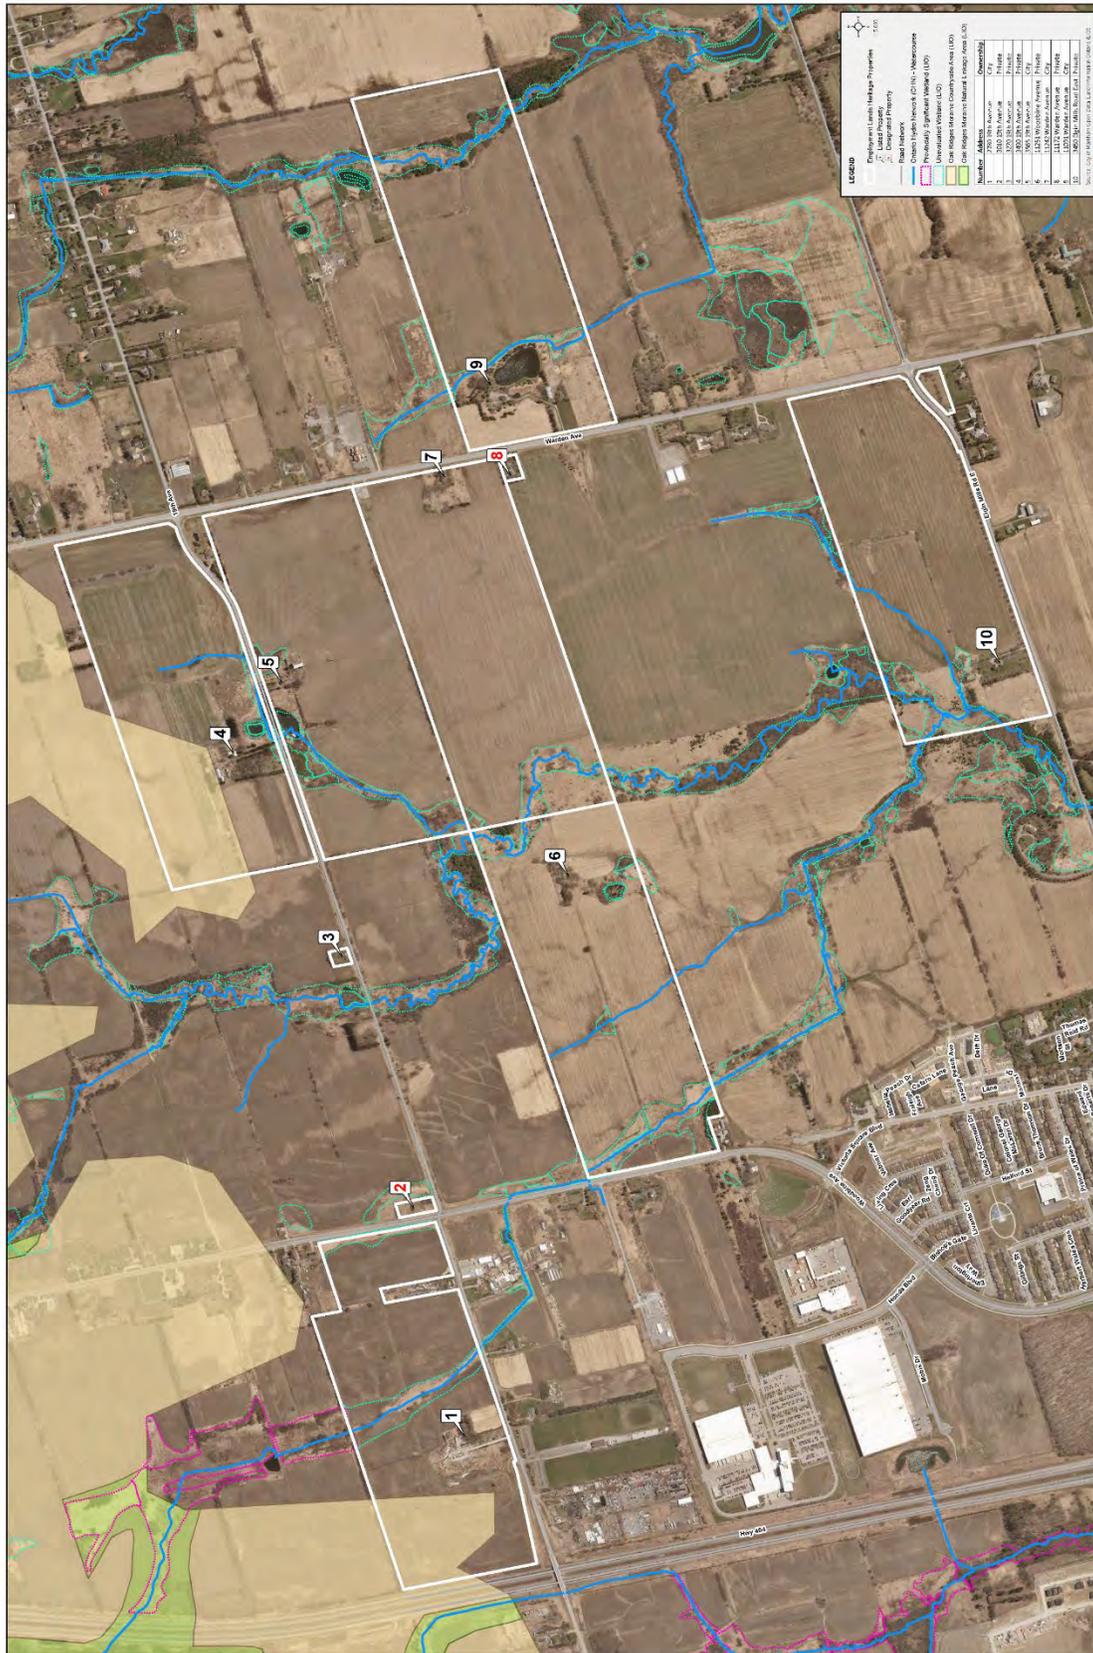
Figure 3: Study Area cultural heritage resources (*source: MHBC*)

A map depicting the resources within the study area is included as **Figure 3** on the following page.

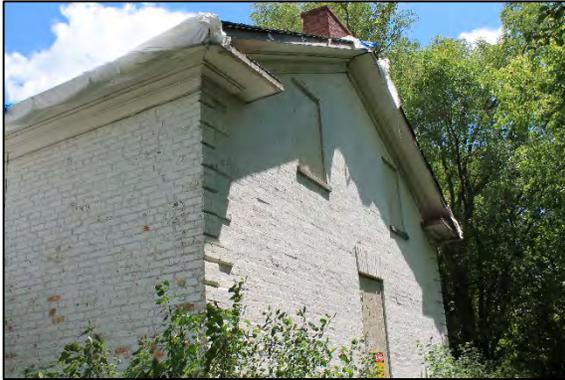
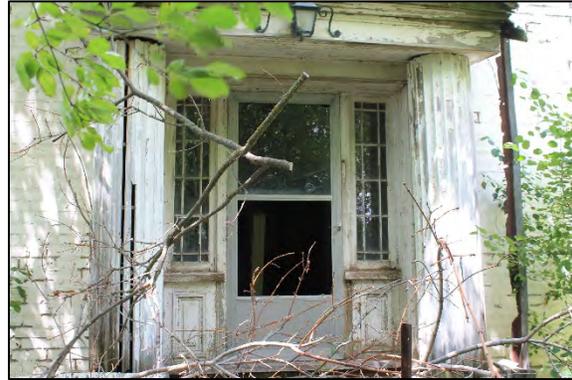
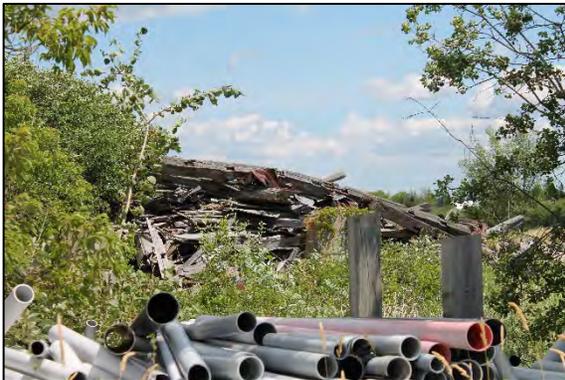
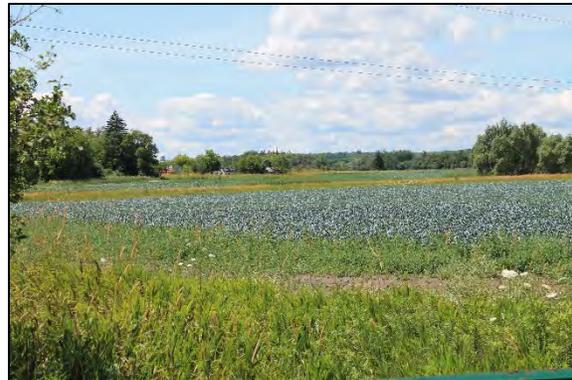
The subject lands contain a vacant farmhouse with a driveway leading to 19th Avenue. The remains of a barn, former driveway and vegetation exist in the yard areas around the house. A stream traverses the property in a north-south direction to the east of the building cluster.

The significance of the property relates to built resource and architectural features. Although some remains of landscape context remain (e.g. overgrown driveway), much of the pattern associated with agricultural past has been altered or removed. The fields are not significant.

Building condition appears fair, but some integrity has been lost. Some repairs are required in order to secure the building envelope, such as re-securing door and window openings and ensuring integrity of the roof.

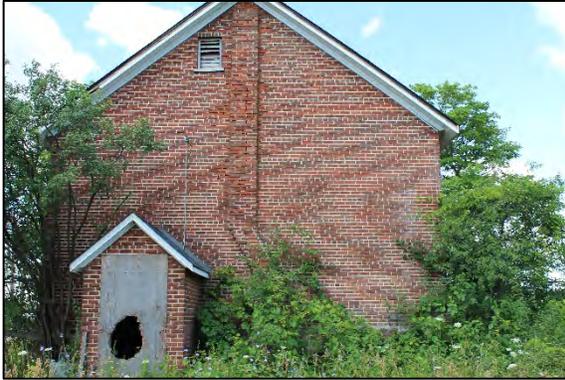
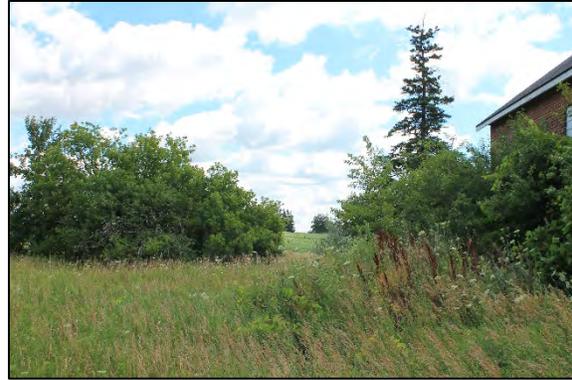
Significance relates to built resource and architectural features present in building. No landscape features were identified in research report or as a result of site visit.

Building condition is good overall and the roof appears to have recently been repaired. Minor repairs needed to secure building envelope, such as re-securing the rear door to prevent further access.

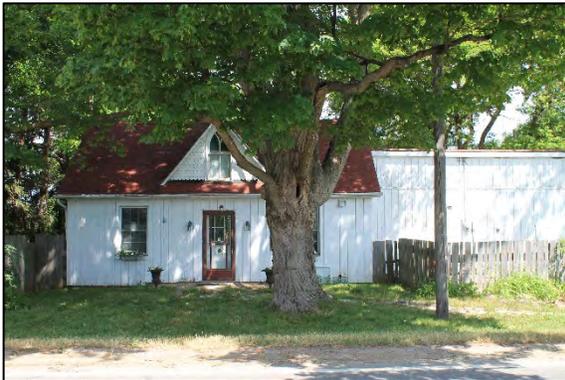
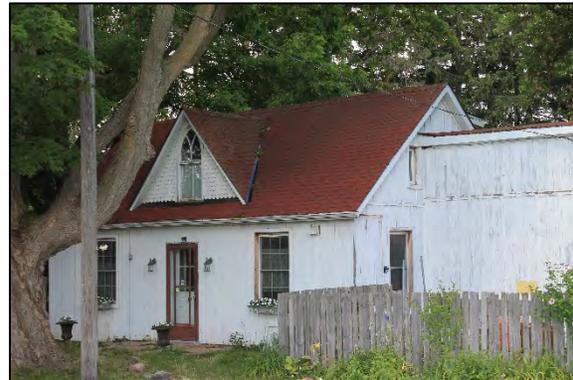
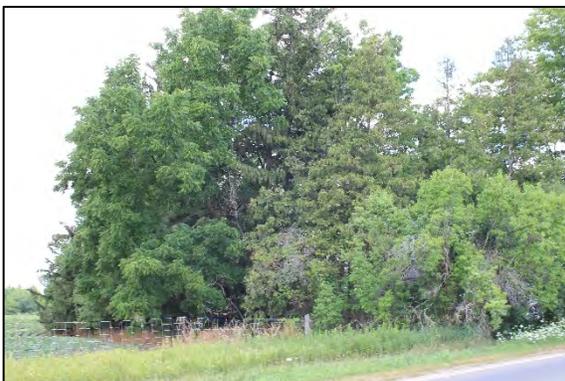
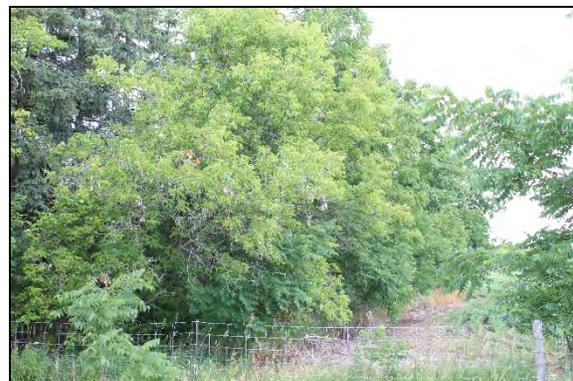
The dwelling on the property is located near the edge of the road allowance for 19th Avenue, with a driveway located to the east of the dwelling. An addition is located on the eastern side of the building. A treeline surrounds the property on three sides and provides a buffer from surrounding land uses. A small outbuilding is located to the north of the dwelling.

Significance relates to built resource and architectural features present in building. No significant landscape features were identified in research report or as a result of site visit.

Building condition appears good overall, although close inspection was not undertaken due to access restrictions. Building appears to be currently occupied.

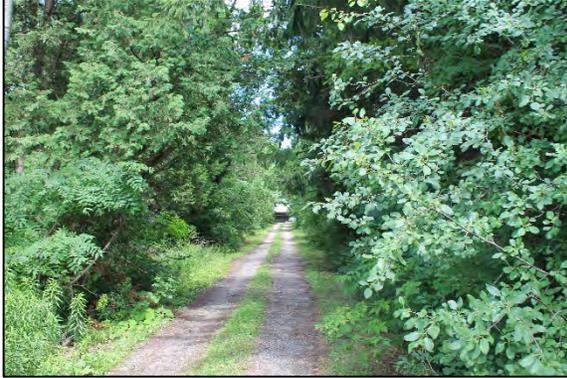
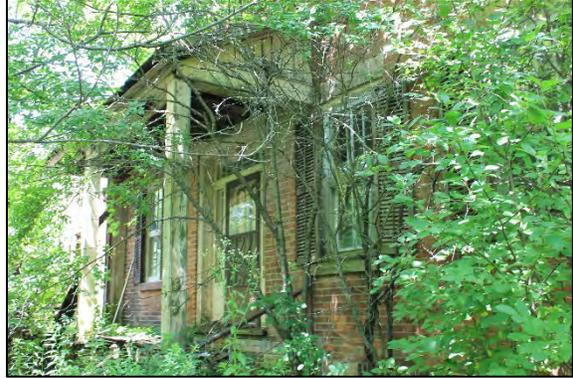
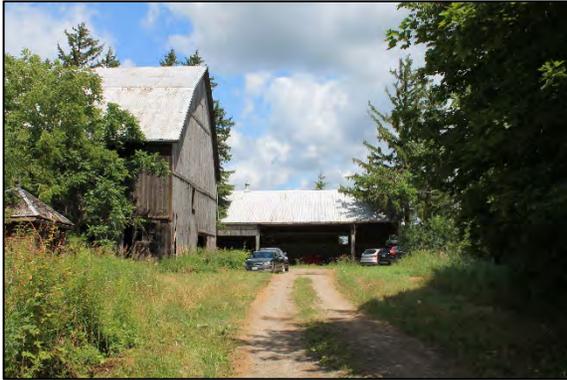
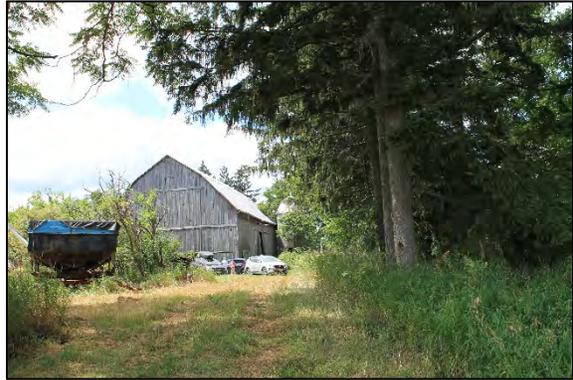
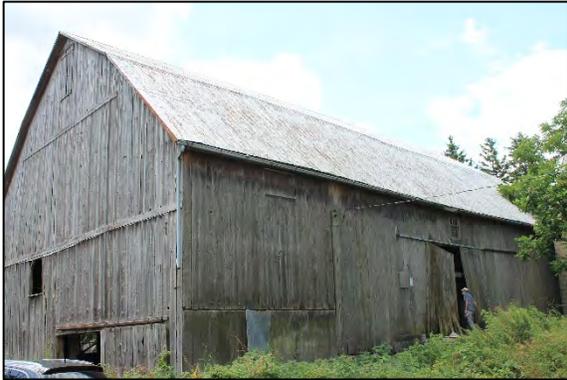
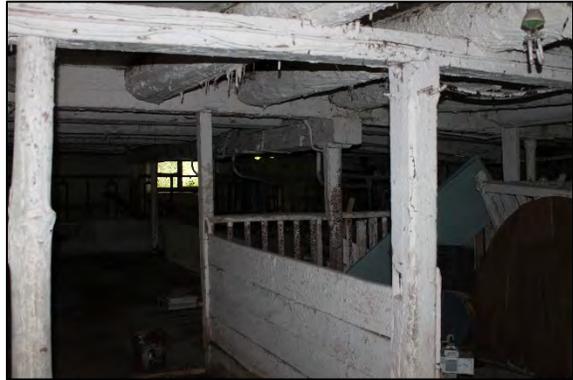
The subject lands contain a vacant farmhouse and collection of agricultural buildings, accessed via a long driveway leading from 19th Avenue. The former yard areas surrounding the home are overgrown and vegetation is growing up around the house. The outbuildings include a barn complex, storage shed, and concrete block silo. The driveway is framed with trees on both sides, and a row of trees shield the northern edge of the building cluster. A small pond is located near 19th Avenue.

Significance relates to built features (house, barns, outbuildings), as well as landscape features. A prominent lane leads towards buildings from road, the house is situated on a rise of land, and the layout of the collection of buildings appears to remain in original form. Fields are not significant and have been altered over the years to suit changing agricultural needs.

Condition of house appears fair-poor but is deteriorating, and some integrity is starting to erode. Some repairs are required in order to secure the building envelope. Condition of outbuildings appears good overall. General grounds upkeep required in area around house.

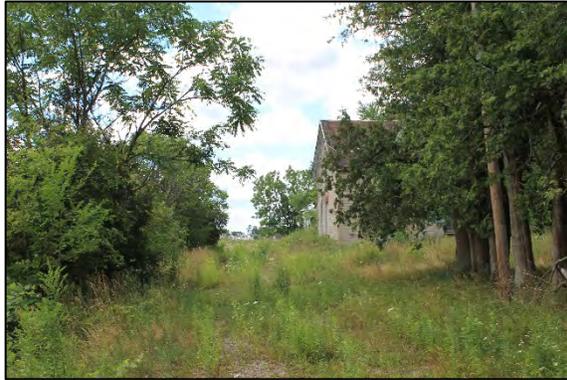
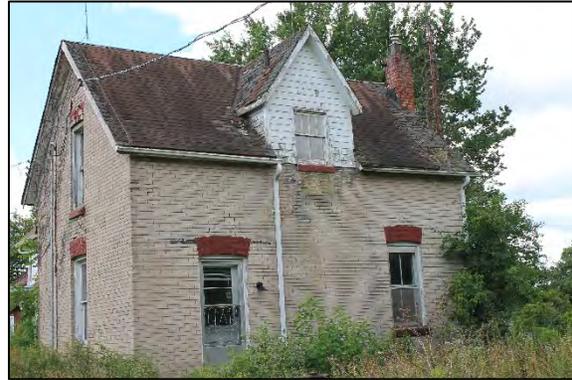
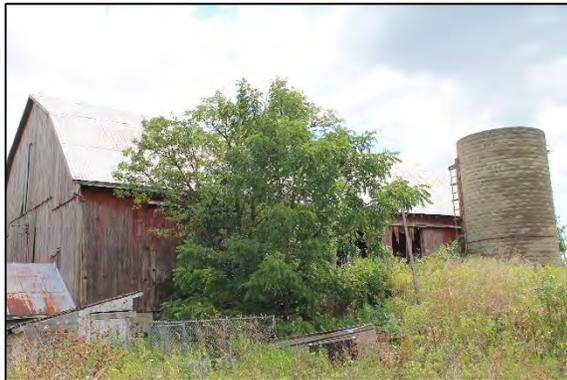
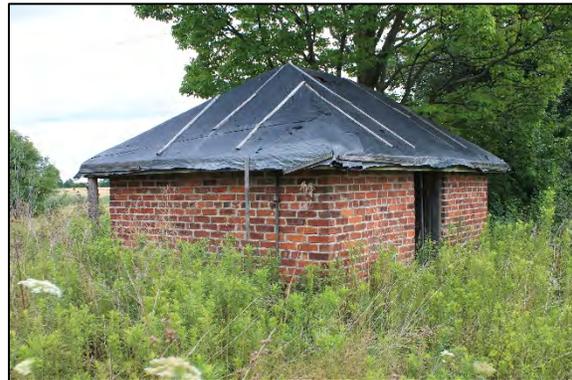
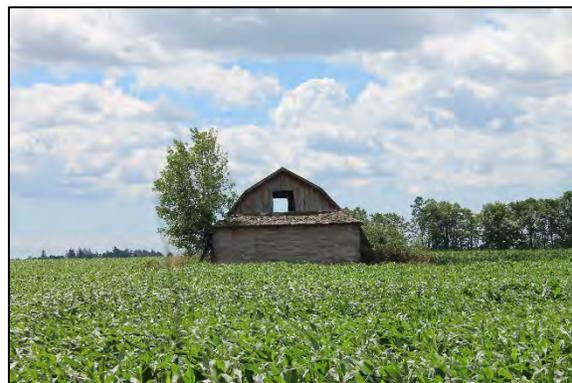
The subject lands contain a vacant farmhouse and collection of agricultural buildings, accessed via a driveway leading from 19th Avenue. The former yard areas surrounding the home and former barnyard areas are overgrown. The outbuildings include two barns and a smaller outbuilding located south of the main building cluster. The driveway is framed with trees on both sides, and a row of trees shields the western edge of the building cluster.

Significance relates to the built features (house, barn, outbuildings), as well as landscape features. A tree-lined laneway leads from the road, and the layout of the

collection of buildings appears to remain in original form. Fields are not significant.

Condition of the house appears to be fair-poor, and some repairs have been identified to secure building envelope. The barn and other outbuildings appear to be fair condition. General grounds upkeep is required.

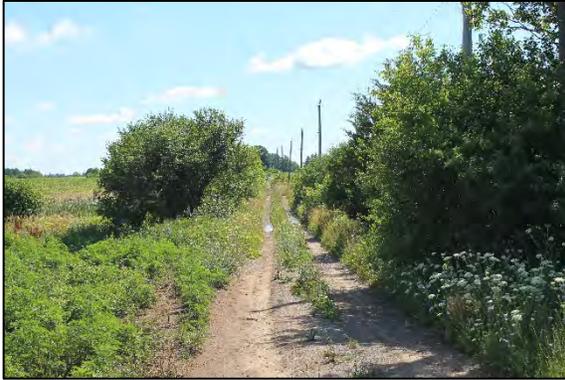
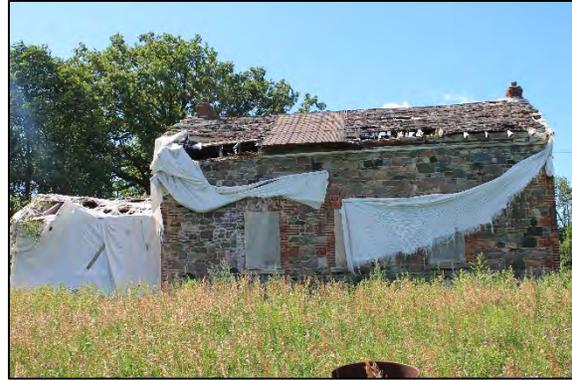
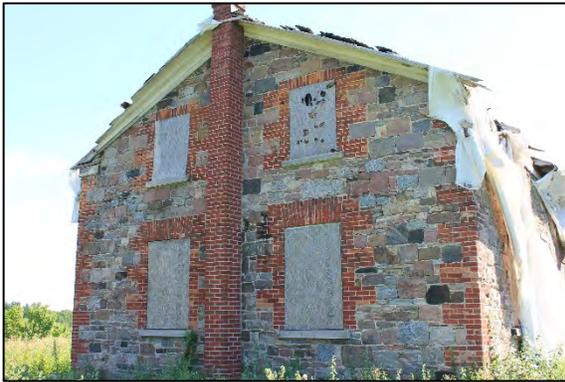
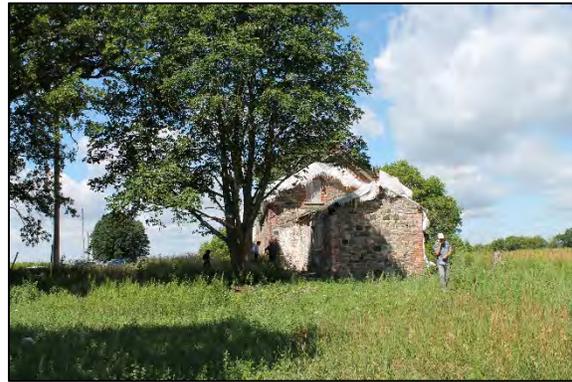
The driveway accessing the dwelling and former farm building cluster leads approximately 800 metres from Woodbine Avenue. The property contains a vacant farmhouse and former barn site. The driveway is framed with vegetation on both sides, and crosses two watercourses as it leads to the dwelling. Some large trees remain around the house and former building areas.

Significance relates to built resource and architectural features. Although some remains of landscape context remain (e.g. overgrown driveway, tree clusters), much of the pattern associated with agricultural past has been altered or removed. The field areas are not significant.

Overall condition of the house is poor, although stonework and building foundation appear sound. Repairs are required to secure building envelope.

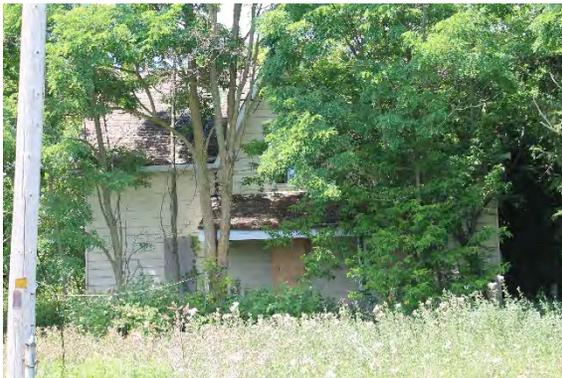
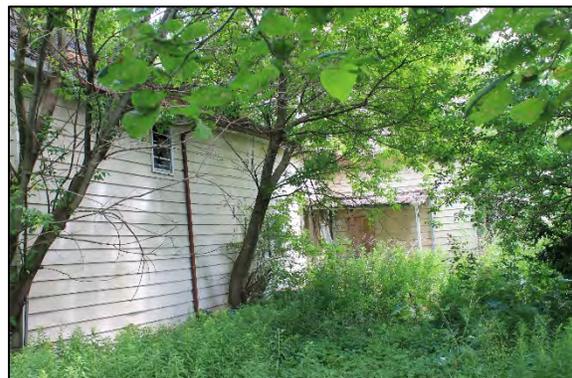
The subject lands contain a vacant farmhouse and a driveway located along the north side of the house. The area of the former farmyard is grassed and there are no remains of the barn complex or other outbuildings.

Significance relates to built resource, construction type (possibly mud-brick based on available historical information), and architectural features. Very little remains of the agricultural past of the property. No landscape features were identified in research report or as a result of site visit. The field areas are not significant.

Condition of house appears to be fair-poor, and some repairs have been identified to secure building envelope. General grounds upkeep is required.

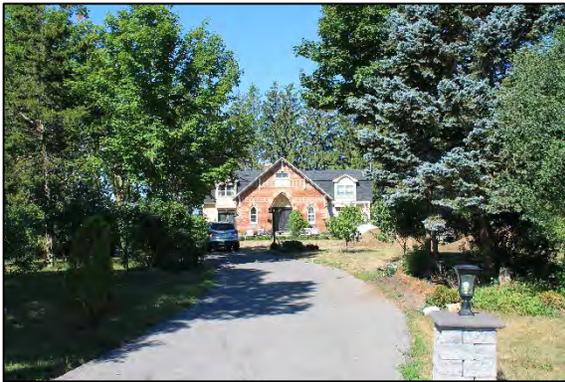
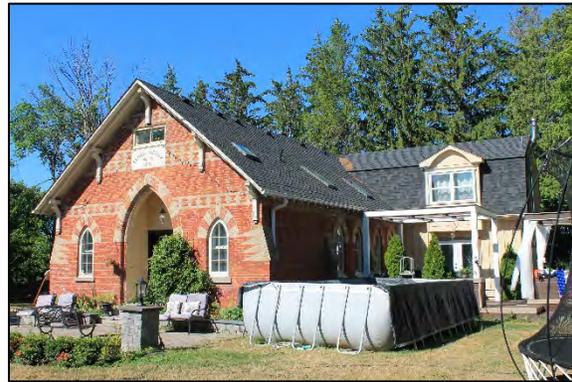
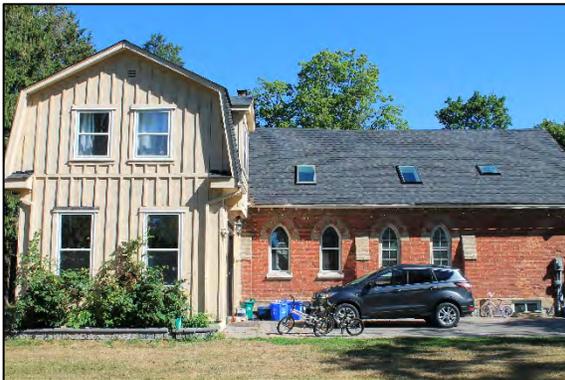
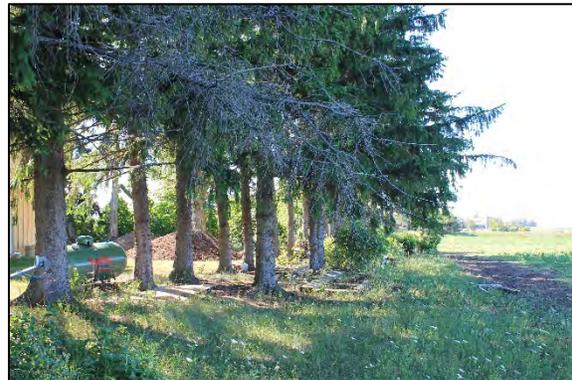
The subject lands contain a former schoolhouse that has been converted into a single-detached residential dwelling. An addition is located to the rear of the dwelling, and leads to deck/patio areas located on the north side of the building. The schoolhouse is accessed via a curved driveway from Warden Avenue, which frames views of the building. The building is surrounded by treelines around each side, and several large trees are located on the property.

Significance relates primarily to built resource, as detailed in designation report. Landscape features consist of a prominent view from Warden Avenue, as well as some notable large trees which are also found in historic photos of the property.

Building condition is very good, with only minor cosmetic repairs identified. The house is currently occupied.

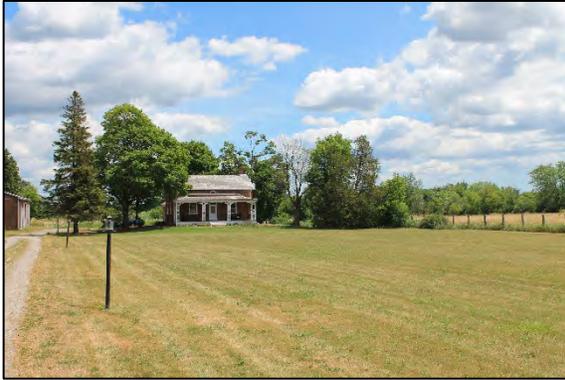
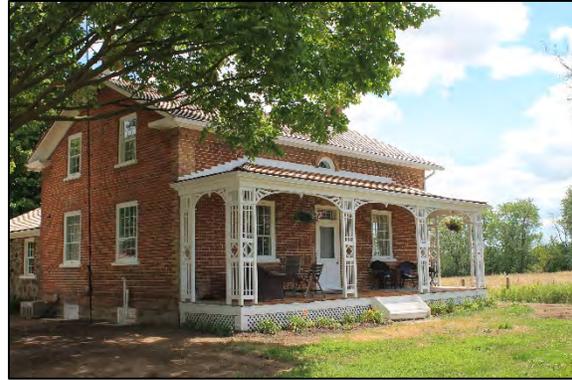
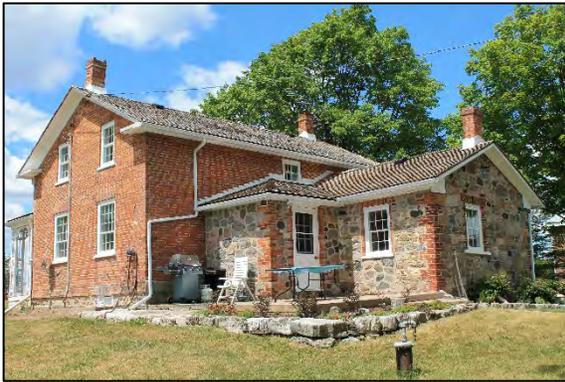
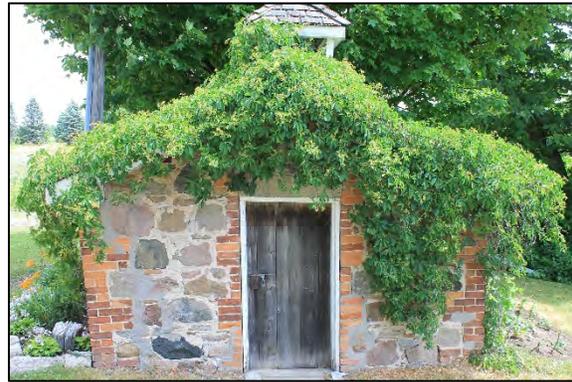
The subject lands contain a house accessed via a long driveway from Warden Avenue, which appears to be in the original location. The property once contained a farm complex, but remains of the agricultural past have been removed. A pond is located on the property, and remains of a second home site are present to the north of the home. Agricultural field pattern has been altered to accommodate changing farming needs.

Significance relates primarily to built resources (house, small outbuilding) and architectural features. Landscape features consist of vegetation groupings near house and prominent views from Warden Avenue. Much of the pattern associated with agricultural past has been altered or removed. Fields are not significant.

Building condition is very good. House is currently occupied.

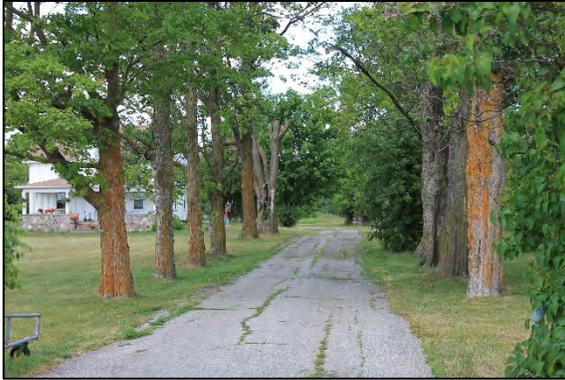
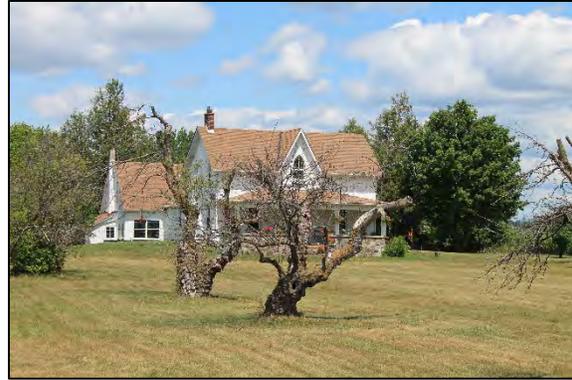
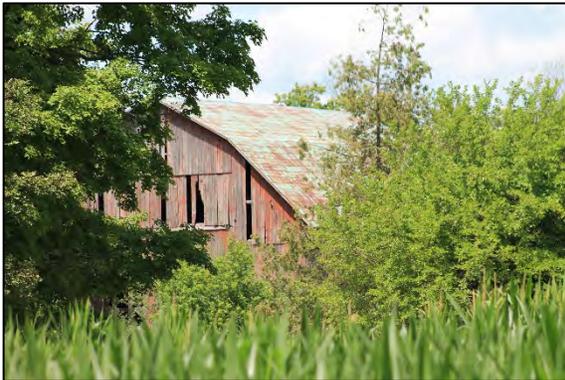
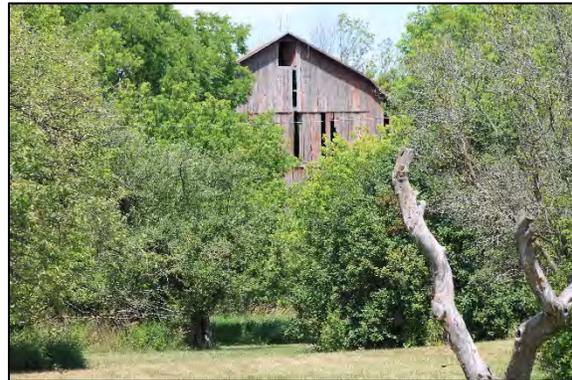
The subject lands contain a former farmhouse and a barn complex, accessed via a long driveway leading from Elgin Mills Road. Remains of an orchard are located in the front yard, generally south and slightly west of the dwelling. A large barn is located to the north of the dwelling. The driveway is framed with trees on both sides, and a row of trees shields the western edge of the building cluster. A stream branches across the property just north of the barn and into the field areas. The field patterns have been altered in order to accommodate changing agricultural needs.

Significance relates to the built features (house, barn), as well as landscape features. A tree-lined laneway leads from the road, orchard remnants remain in front yard, and vegetation groupings are located west and north of house. The layout of the collection of buildings appears to remain in the original form. The field areas are not significant.

Condition of house appears to be good. Outbuildings also appear to be in good condition, although close inspection was not undertaken due to access restrictions.

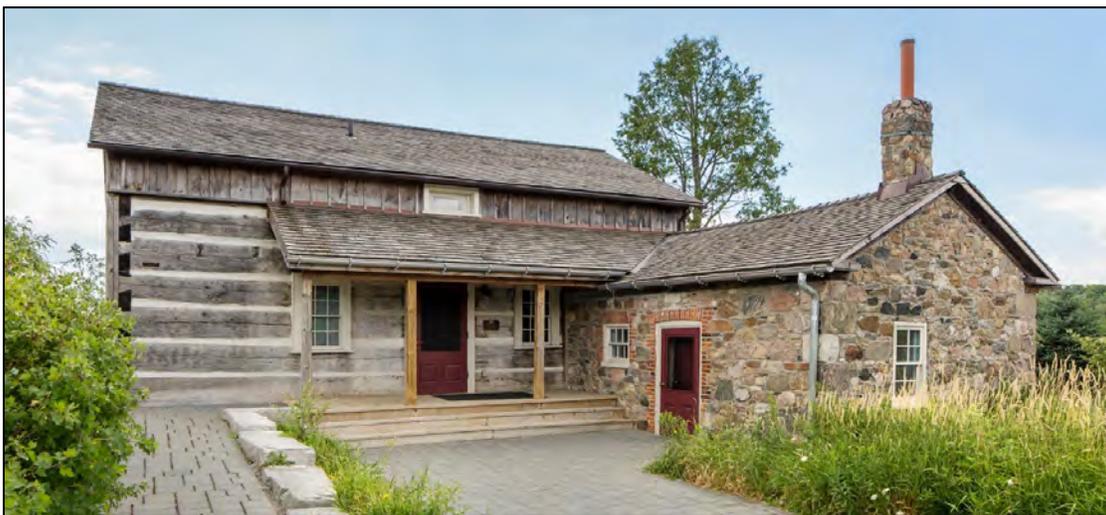
In the same park is the George Forster House, a log structure with stone addition that has been updated to provide community meeting space as well as office space for Town staff. Among other improvements, the George Forster House received a new geothermal heating system and was made accessible at the ground floor.

George Forster House, Phyllis Rawlinson Park (Source: George Robb Architect)

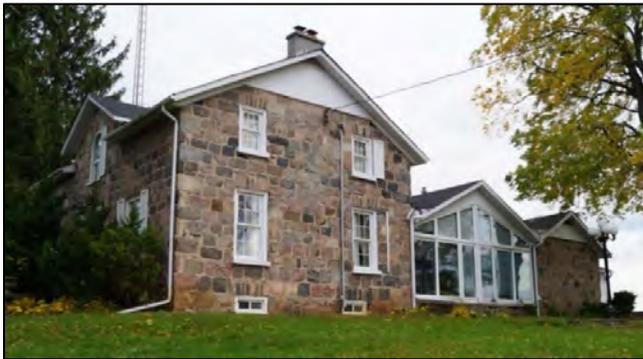
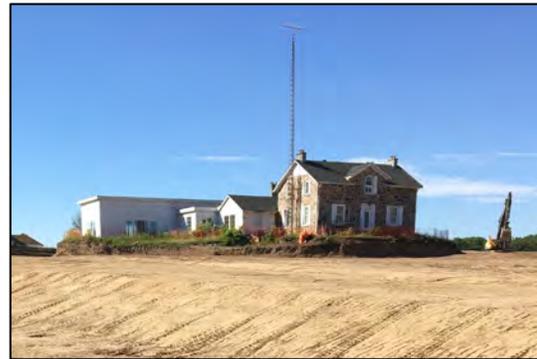
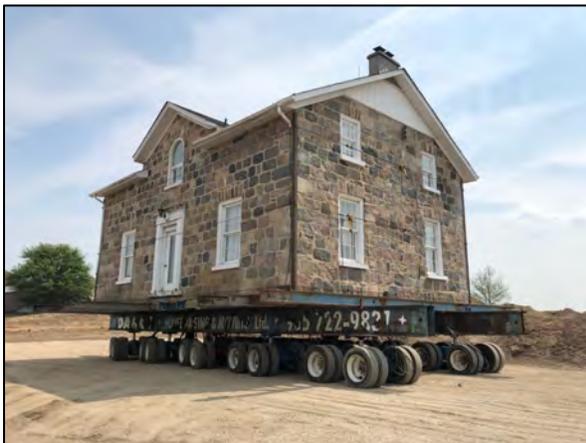
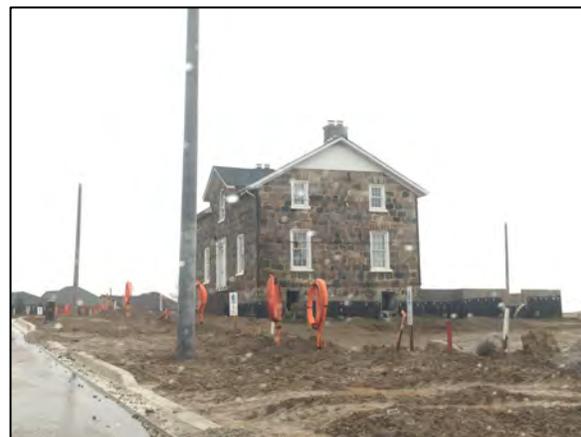
Another strategy is shown in the historic house at 710 Huron Road in Kitchener. This home was on a site slated for development as a subdivision, but was in an awkward location for the new plan, grading and site layout. George Robb Architect was consulted on the stabilization of the structure and on its relocation within the same site, where it is to be restored and added on to for resale as a residence. The building has been moved to the new location, new basement constructed, and construction is underway.

710 Huron Road, Kitchener (source: MHBC and George Robb Architect)

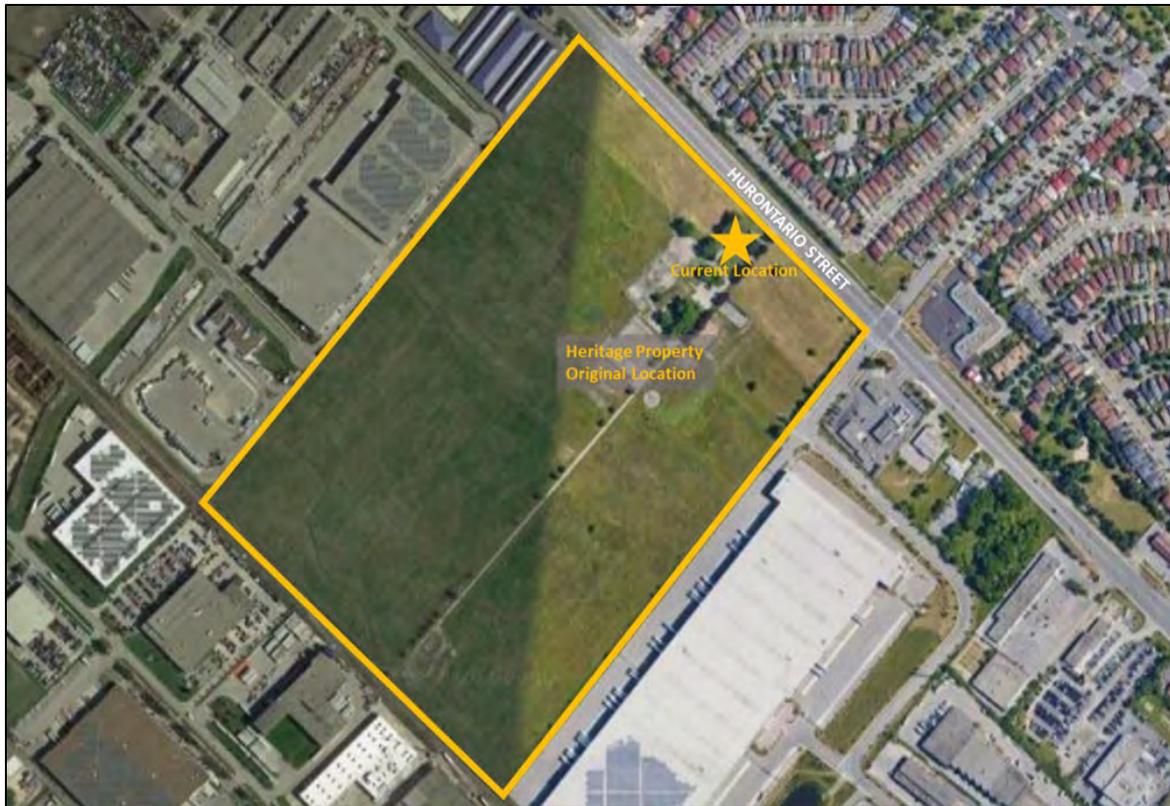
More specifically, **Figure 4** illustrates the relocation of the cultural heritage resource at 10254 Hurontario Street. The property is owned by a private interest who is currently pursuing the development of a major warehouse distribution centre on the site. To accommodate this large-format development, the property owner obtained approval from the City of Brampton to relocate the vacant cultural heritage resource from the center of the property to the northeast corner.

By relocating and restoring the resource, the property owner can now build the warehouse distribution centre and occupy the resource as an accessory office building or lease the space to a commercial tenant. The City of Brampton is supportive of this conservation approach because the resource will no longer be landlocked. It is now directly visible from Hurontario Street and can be accessed by the public. Dependent on whether the property owner can successfully attract a commercial tenant, the resource could become a valuable neighbourhood amenity to the adjacent residential community.

Figure 4: 10254 Hurontario Street, Case Study (Source: urbanMetrics inc.)

Aside from the historic value of preserving a cultural heritage resource in its original place, the extremely high cost of relocation is one of the primary reasons why municipalities encourage conservation in-situ. As demonstrated by the various case studies, relocation of a cultural heritage property within the original lot-lines will cost the property owner over \$100,000, which does not account for the additional costs of constructing the new foundation and footings. More specifically, the relocation cost for 10254 Hurontario Street was more than double the cost of the restoration works.

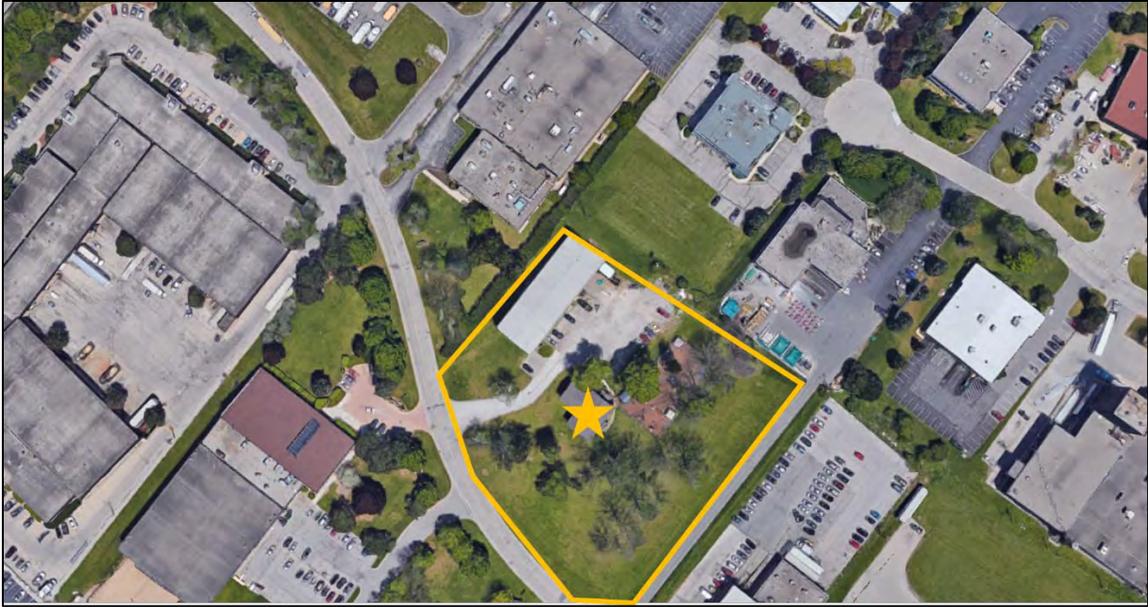
The remaining three case studies found a range of success in retaining the cultural heritage resource in-situ. The most successful example is 955 Century Drive in the City of Burlington (see **Figure 5**), which involved the integration of an old farmhouse into a light industrial business park. The resource was being considered from the very beginning of the planning and development process, and the subdivision was intentionally planned and built in a configuration that allowed to resource to be retain in-situ. The resource was retained on a large property that was able to provide sufficient parking, accessory buildings, and outdoor work/storage areas.

This is a key finding for resources intended to be integrated into an employment area site plan and repurposed for commercial uses. Maintaining a generous lot size for the resource was the key factor in giving the resource flexibility to be adapted to a new use. A commercial tenant will require a prescribed amount of parking outlined in the local zoning by-law, so if the property owners want to attract a tenant, they will need to keep that in consideration when determining the developable lot for industrial buildings. While maintaining a 10-metre buffer is important for the longevity and protection of the resource, it is not enough space to accommodate the parking and circulation requirements of a commercial tenant. This resource is now successfully integrated into the employment area and has been occupied by an animal kennel (pet daycare).

Figure 5: 955 Century Drive, Case Study (Source: urbanMetrics inc.)

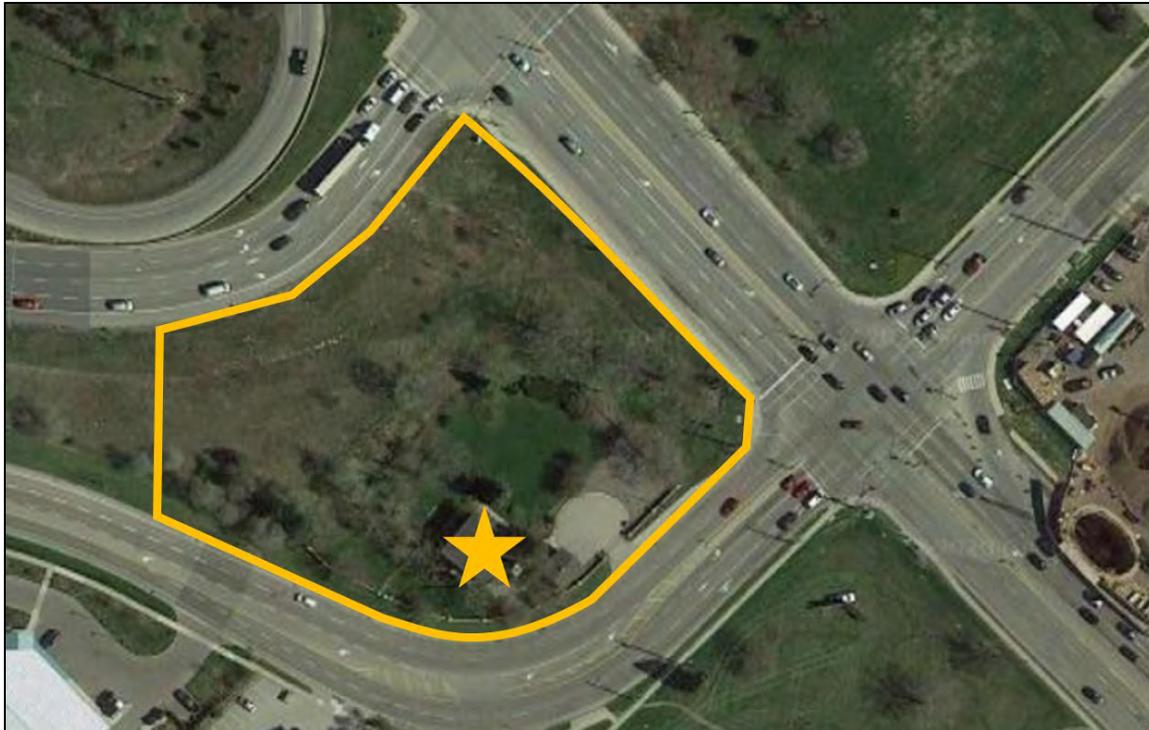
Two planning interventions were used by the City of Burlington in order to encourage the adaptive reuse and leasing of the cultural heritage resource located at 2477 Queensway Drive. The property is subject to a variety of site constraints. The Queen Elizabeth Way (QEW) and Queensway Drive expansions have constrained the property and require significant setbacks; the resource is not visible from the public realm and has limited its potential for adaptive reuse; the property is irregularly shaped and has not opportunity for internal relocation; and the original zoning was very restrictive and did not permit many of the commercial uses that typically occupy heritage properties. The property is illustrated in **Figure 7**.

Figure 7: 2477 Queensway Drive Case Study (Source: urbanMetrics inc.)

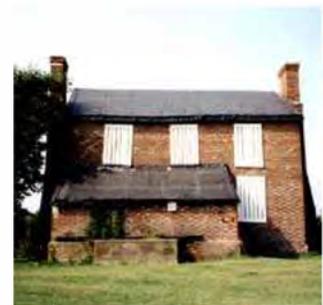
Appropriately mothballed historic building. Photo: NPS files.

When all means of finding a productive use for a historic building have been exhausted or when funds are not currently available to put a deteriorating structure into a useable condition, it may be necessary to close up the building temporarily to protect it from the weather as well as to secure it from vandalism. This process, known as mothballing, can be a necessary and effective means of protecting the building while planning the property's future, or raising money for a preservation, rehabilitation or restoration project. If a vacant property has been declared unsafe by building officials, stabilization and mothballing may be the only way to protect it from demolition.

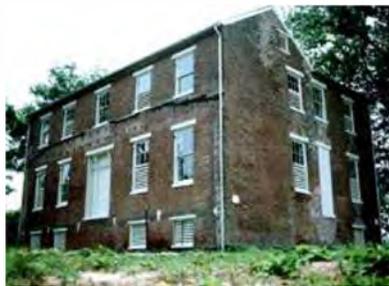
This building has been successfully mothballed for 10 years because the roof and walls were repaired and structurally stabilized, ventilation louvers added, and the property maintained. Photo: NPS files.

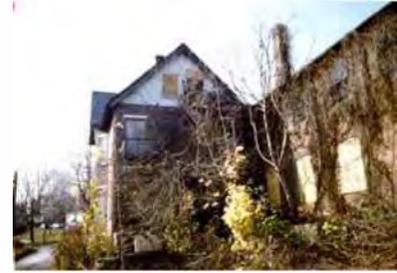
Boarding up without adequate ventilation and maintenance has accelerated deterioration of this property. Photo: NPS files.

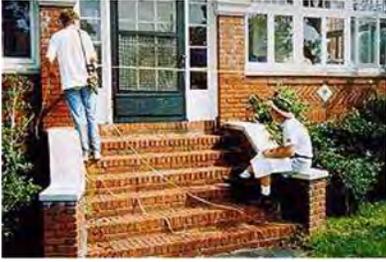
Documenting a building's history and assessing its condition provide information to set priorities for stabilization and repair, prior to mothballing. Photo: NPS files.

A site plan and schematic building floor plans can be used to note important information for use when the building is eventually preserved, restored, or rehabilitated. Each room should be given a number and notations added to the plans regarding the removal of important features to storage or recording physical treatments undertaken as part of the stabilization or repair.

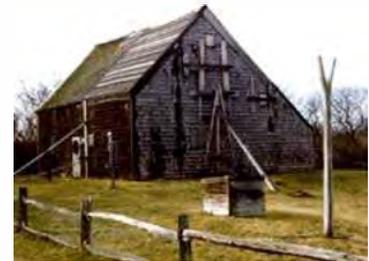
Buildings seriously damaged by storms or deterioration may need to be braced before architectural evaluations can be made. Photo: John Milner Architects. Photo: NPS files

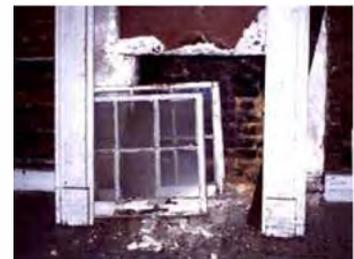
Loose or detached elements should be identified, tagged and stored, preferably on site. Photo: NPS files

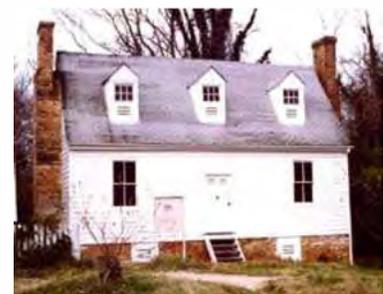
Regrading has protected this masonry foundation wall from excessive damp during its 10-year mothballing. Note the attic and basement vents, temporary stairs, and interpretive sign. Photo: NPS files.

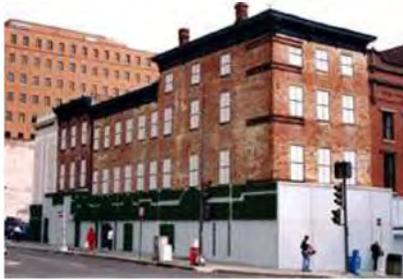
Urban buildings often need additional protection from unwanted entry and graffiti. This commercial building uses painted plywood panels to cover its glass storefronts. The upper windows on the street sides have been painted to resemble 19th century sash. Photo: NPS files.

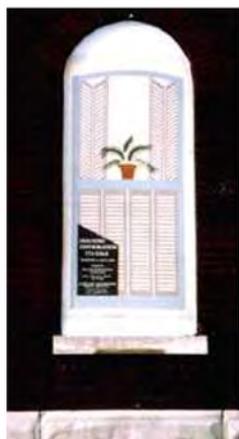
This painted trompe l'oeil scene on plywood panels is a neighborhood-friendly device. Photo: NPS files.

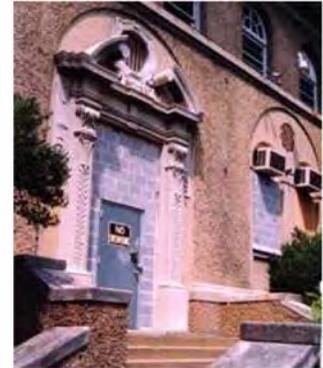
The first floor openings of this historic building have been filled with cinder blocks and the doors, window sash, and frames removed for safe keeping. The security metal door features heavy duty locks. Photo: NPS files.

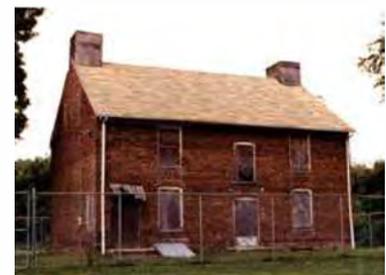
A view showing the exterior of the Brearley House, New Jersey, in its mothballed condition. Photo: Michael Mills, Ford Farewell Mills Gatsch, Architects.

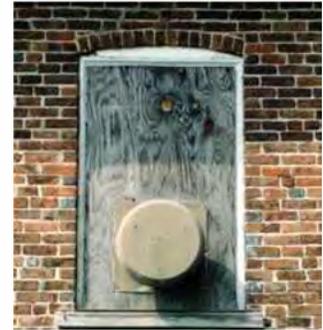
This exhaust fan has tamper-proof housing. Photo: Michael Mills, Ford Farewell Mills Gatsch, Architects.
