Cultural Heritage Resource **STRATEGY**

City of Markham
North District Employment Lands (MiX)

November 2021 (FINAL)

MacNaughton Hermsen Britton Clarkson Planning Limited (MHBC)

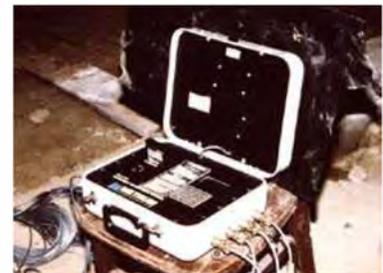
Portable monitors are used to record temperature and humidity conditions in historic buildings during mothballing. Photo: NPS files.
