## MEMORANDUM

**SUBJECT:** Major Heritage Permit - Restoration Plan for the Graham-Hallman House  
5474 19<sup>th</sup> Avenue, Markham  
HE 23 150152

**Property/Building Description:** 2 storey mid-19<sup>th</sup> century Regency style stone farmhouse  
**Use:** Residential  
**Heritage Status:** Designated under Part IV of the Ontario Heritage Act

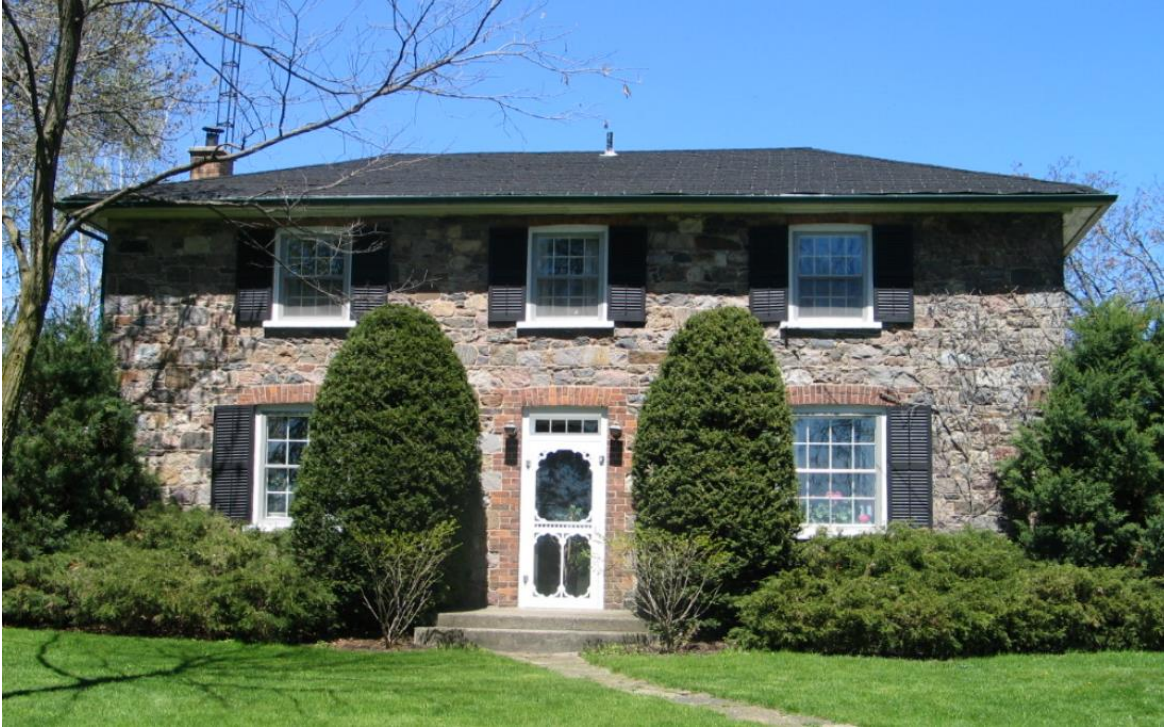
Attachment B- Photograph of Graham-Hallman House Prior to installation of metal roof 2004

- Although the existing metal roof is not historically appropriate, staff have no objection to it remaining in place for its natural lifespan and that it be replaced with a more appropriate roof when a new roof is needed in the future. Staff's position is based on the high cost of installing a metal roof, the existing roof being in good condition, and because the shallow slope of the roof does not make the roofing highly visible. Also, the alternative would be an asphalt shingle roof in an appropriate colour (the City has never

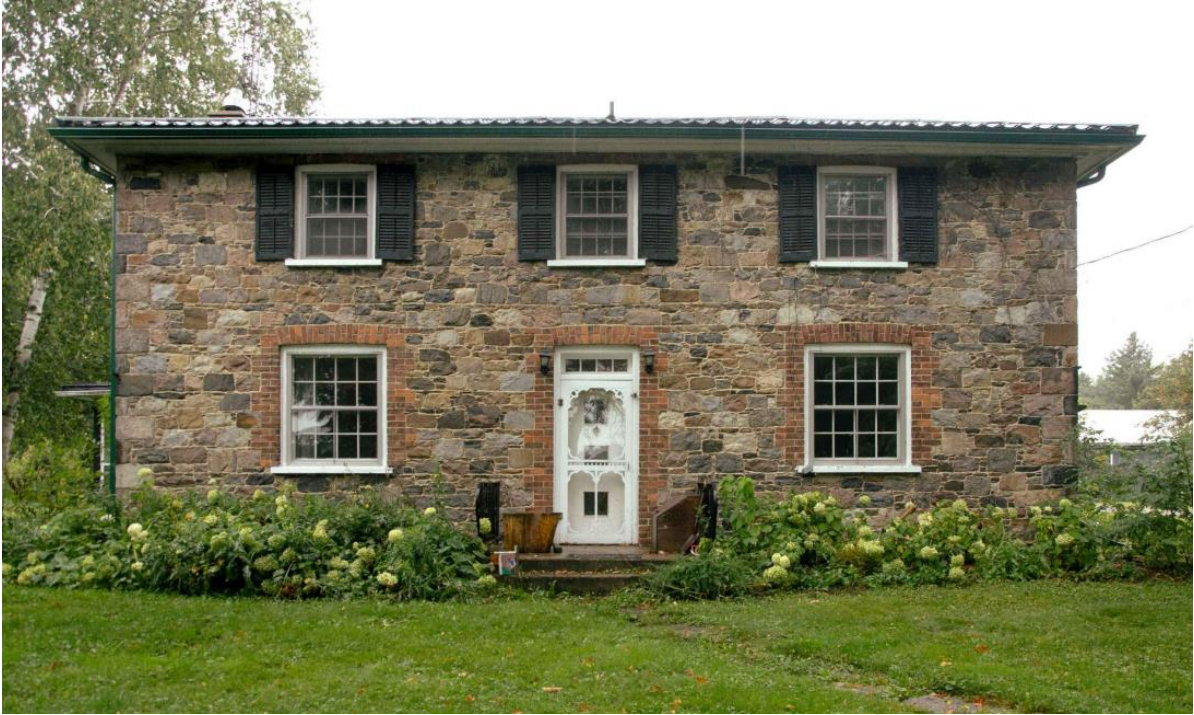
Photograph of Graham-Hallman House from summer of 2023

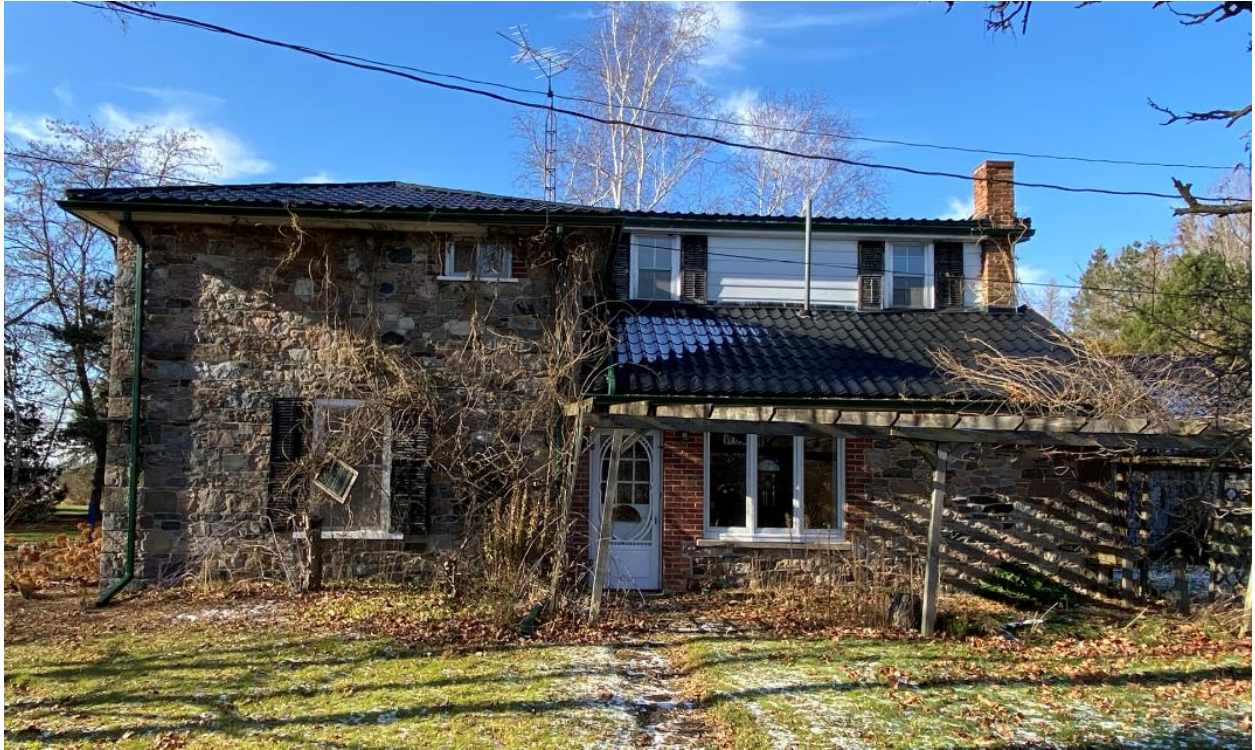
Photograph of East side of Graham Hallman House November 2023

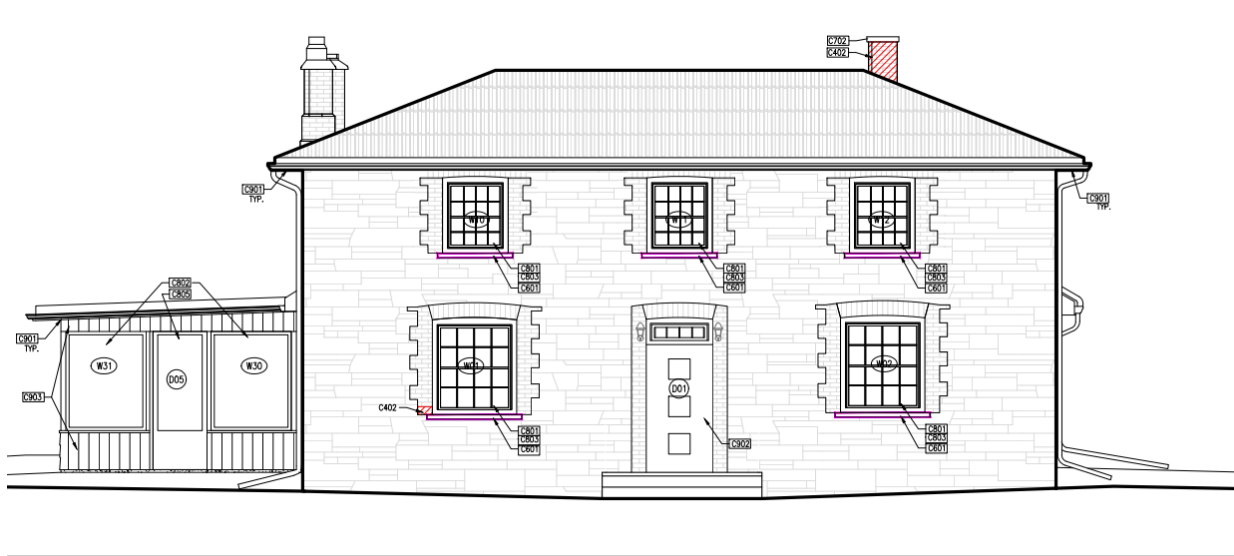
## South Elevation

South Elevation 1 AH404

- The restoration of this heritage house is part of the larger residential development of the property;
- The restoration plan proposes the removal of later claddings of a late 19<sup>th</sup> century addition to the house, new windows for non-heritage 20<sup>th</sup> century additions, and retention and restoration of character defining features of the original 1850's stone house and is supportable from a heritage perspective;
- However, the restoration plan does not propose the removal and replacement of a modern metal roof designed to resemble clay tiles that was installed sometime after 2004 prior to the building being designated under Part IV of the Ontario Heritage Act.

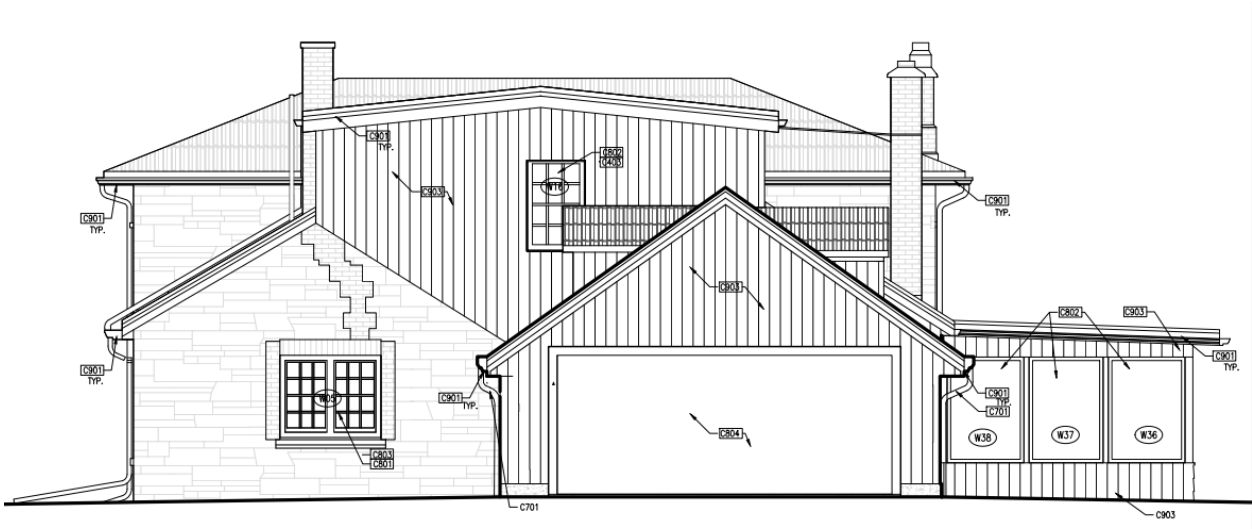
North Elevation 1

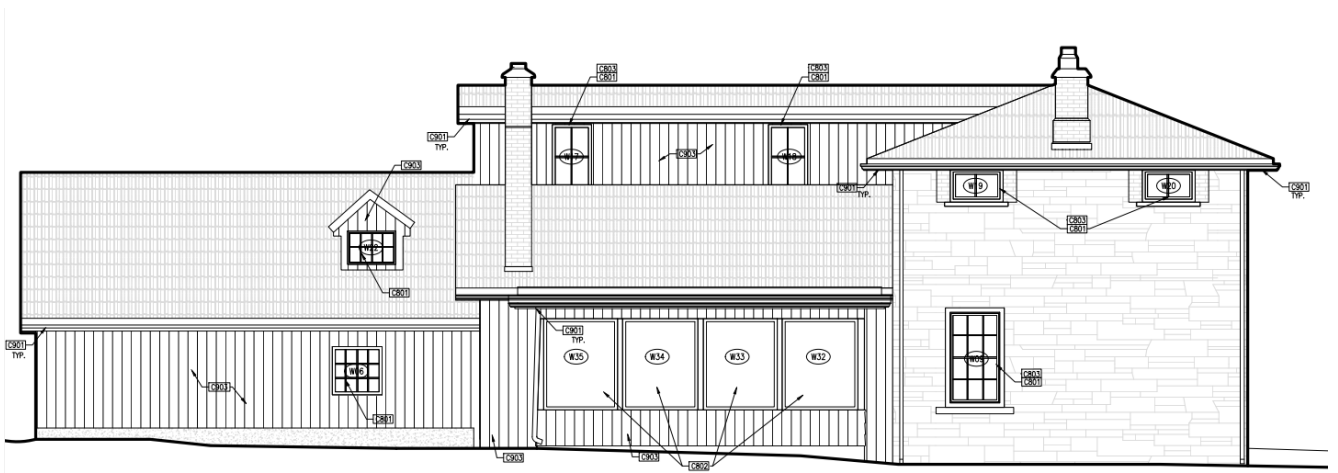
West Elevation

West Elev
