MEMORANDUM

SUBJECT: **Minor Heritage Permit Application**
53 John Street, Thornhill
Unauthorized Installation of a Metal Roof

Property/Building Description: Two-storey detached dwelling constructed in c.1962 as per MPAC records

Heritage Status: 53 John Street is designated under Part V of the *Ontario Heritage Act* as part of the Thornhill Heritage Conservation District (the “THCD”).

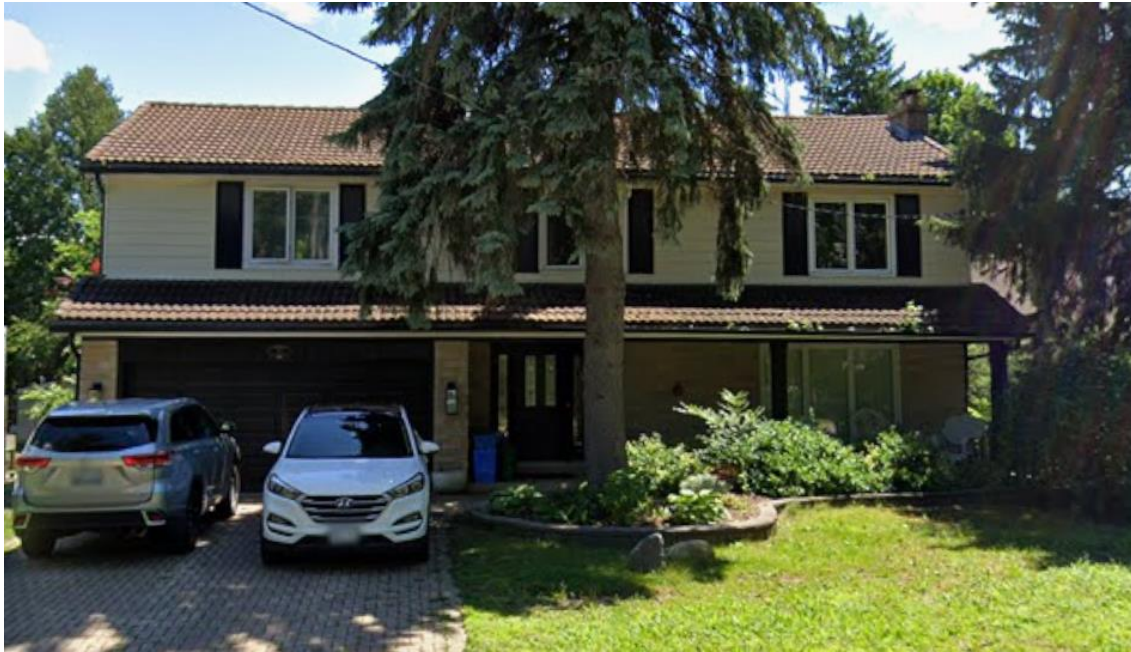
Primary (north) elevation of 53 John Street prior to the installation of metal roofing (Source: Google c.2024)

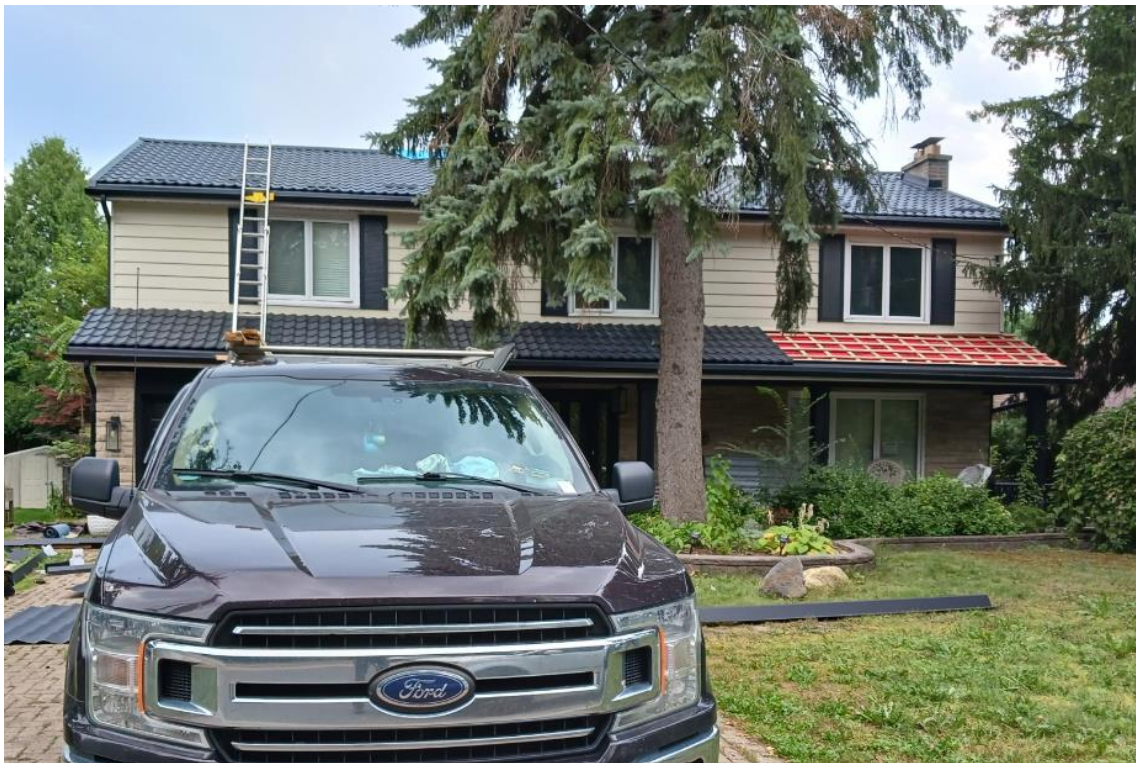
- The Subject Property is located on the south side of John Street between Marie Court to the west and Paul Street to the east;
- The black metal roof, which replaced what appears to be a terracotta roof, generally mimics its appearance albeit in a darker colour (refer to Appendix ‘B’);
- Based on conversations with Heritage Section staff (“Staff”), it appears that the Property owner was unaware of the requirement for Heritage Permit as it was their understanding that their property didn’t have heritage status;
- The Property owner has been advised by Staff that submission of a Minor Heritage Permit application is required for the new roofing material along with any future exterior alterations to their dwelling.

Primary (north) elevation of 146 John Street showing the recently installed roofing material (Source: City of Markham c.2024)

- Notwithstanding direction within the THCD Plan concerning appropriate roofing material for dwellings within the District, Staff do not recommend removal of the newly installed roofing material as it has been installed on a property with minimal heritage significance within the THCD. The properties immediately abutting the Subject Property are also of minimal heritage significance;

- While not ideal, the material is not sufficiently obtrusive to warrant removal (at considerable expense to the Property owner). As such, it is the opinion of Staff that the alteration does not have an adverse impact on the heritage character of the District given the building it was applied to;
