Proposal to Council:

Stay of Demolition & Approval of Stabilization and Relocation Plan for Munshaw House

Submitted by:
Barry Nelson

Date: Monday, March 24, 2025

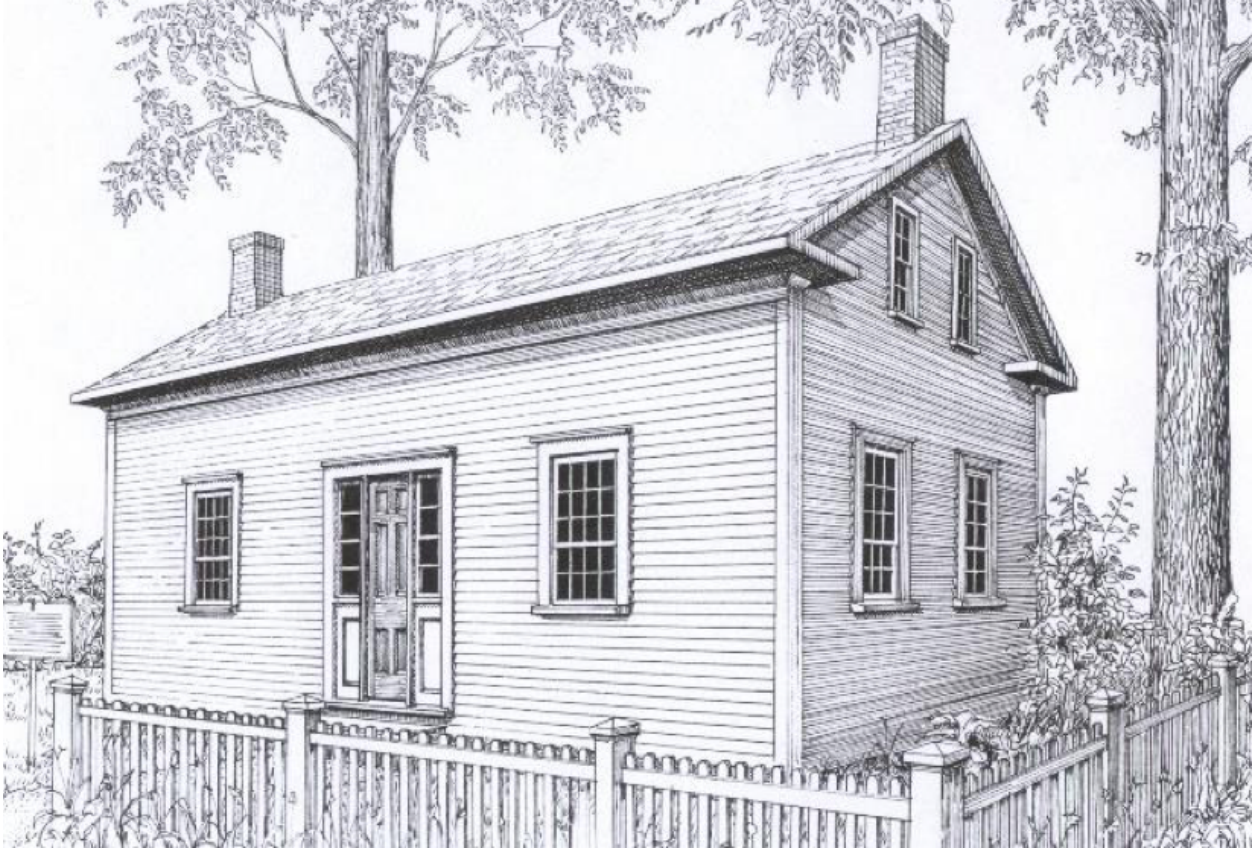
Addendum "B" -

- **Damaged and unsupported dormers** will be carefully removed.
- The **roof structure will be remediated and resurfaced**, using original internal materials where feasible, and supplemented by reinforcement as needed.
- The **roofline will be adapted to reflect the 1800s-era architectural form**, as shown in the attached Drawing Addendum “B”.
