Report to: Development Services Committee

SUBJECT: Multi-use Pathway ("MUP") Update

Attachment 'A' – Phase 1 MUP Construction Photos

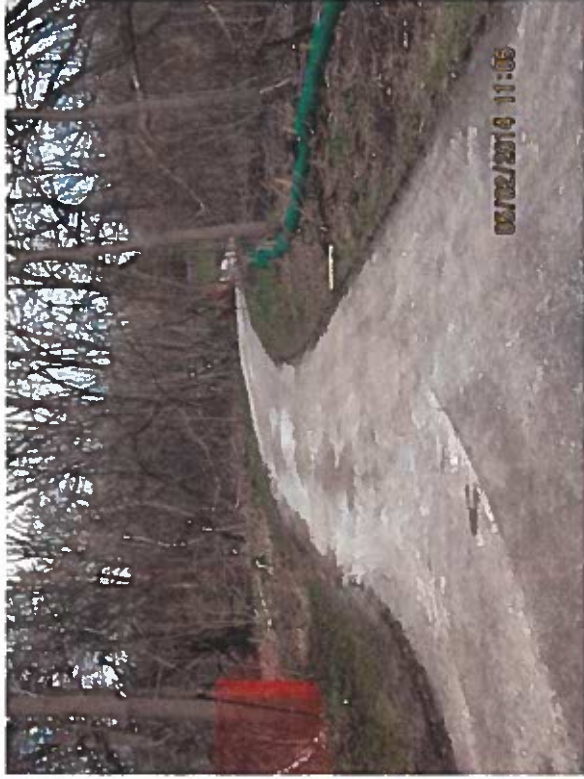
Looking North to Carlton Road (limestone)

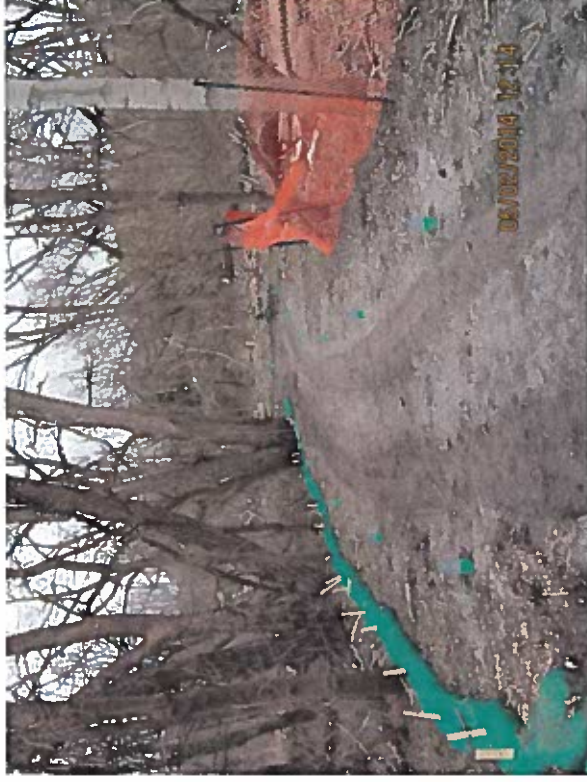
North of Victoria Avenue – Helical Piles Installation for Boardwalk

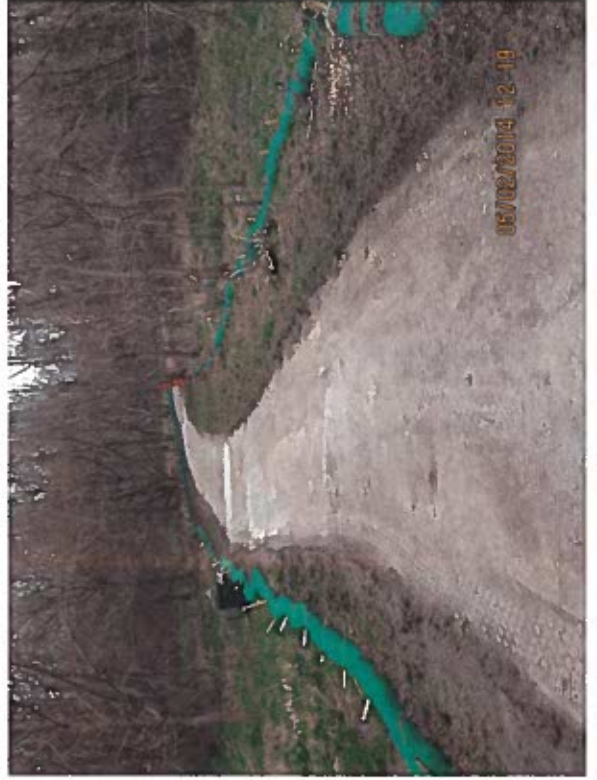
North of Victoria Avenue (limestone)

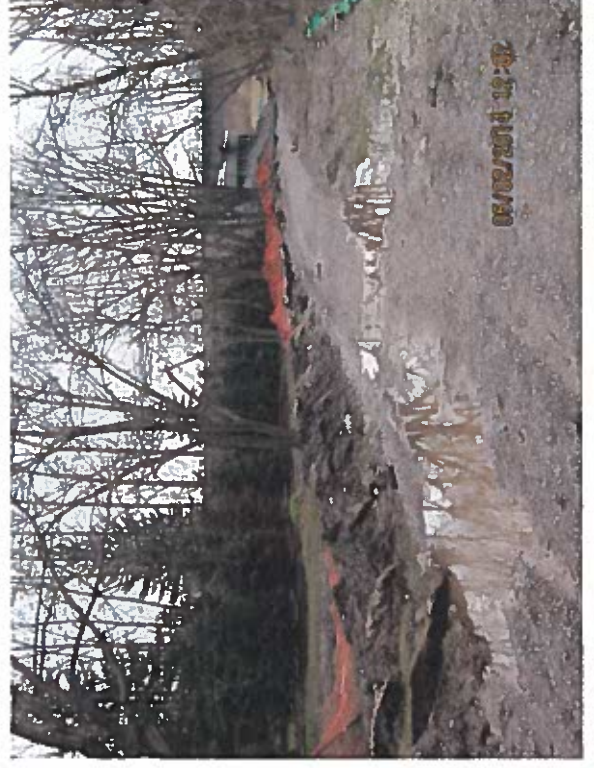
Looking south Victoria Avenue to Railway Crossing (limestone)

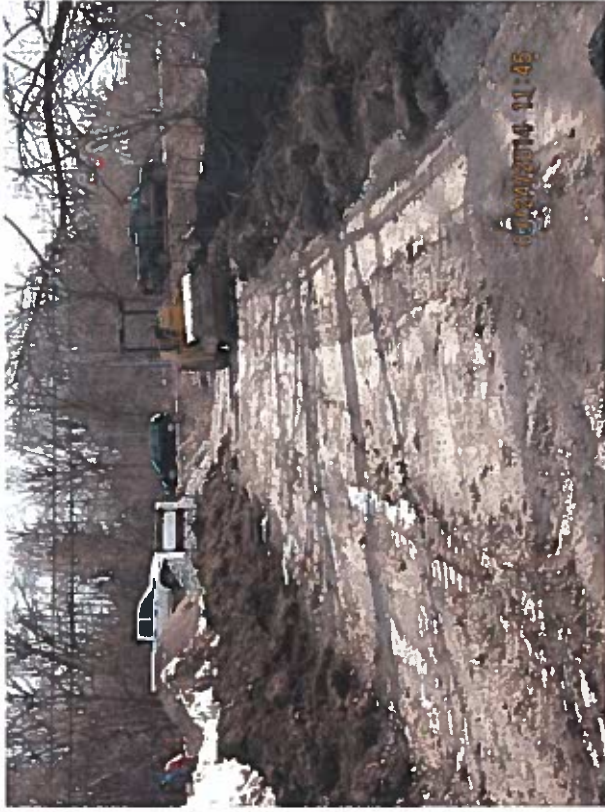
West of McCowan Road (limestone)

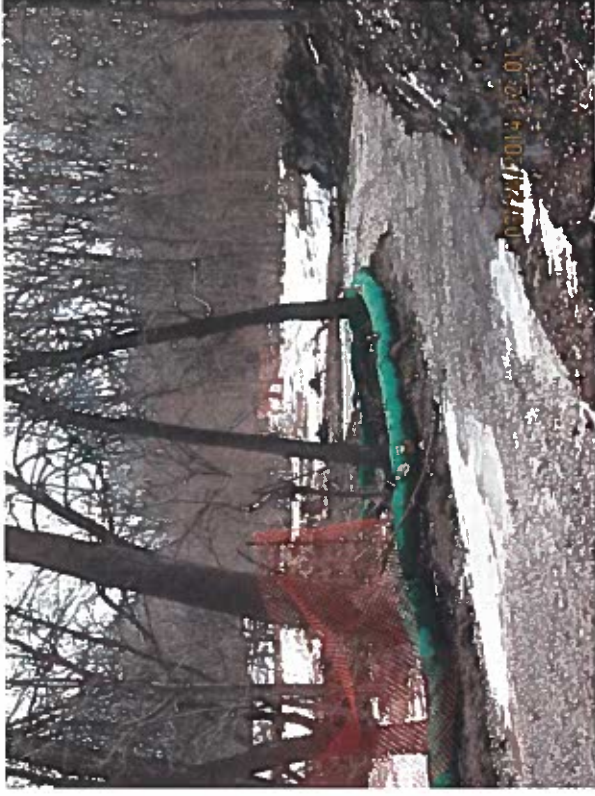
At Annina Crescent (limestone)

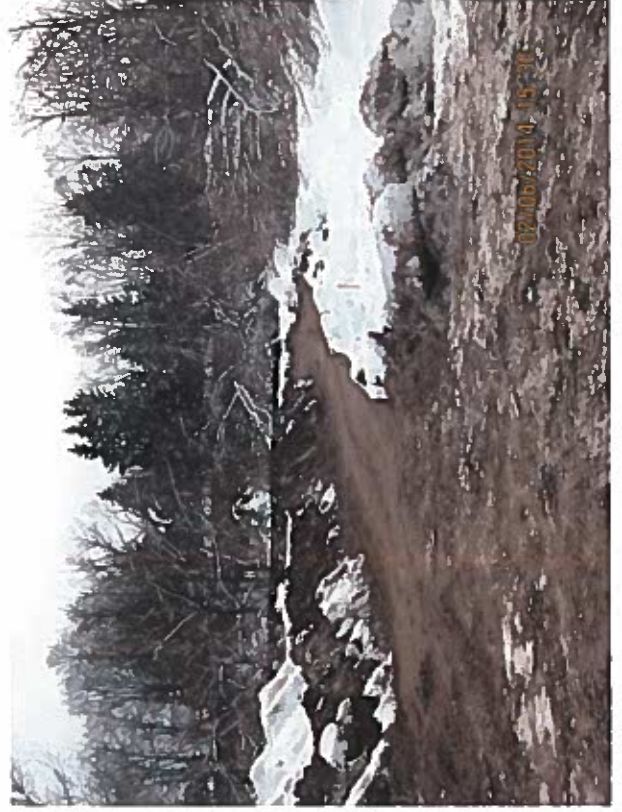
South of Hwy 7 in the Valleyland (limestone)

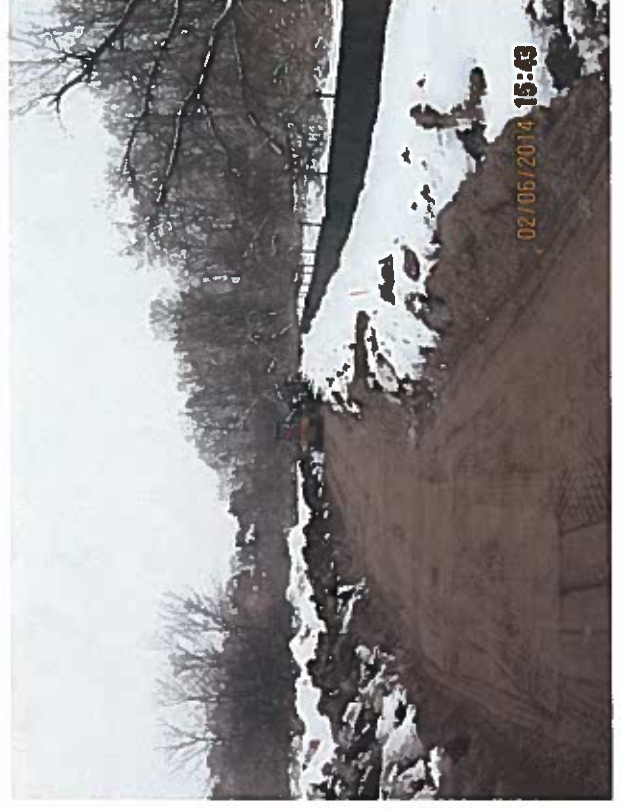
South of Hwy 7 in the Valleyland (limestone)

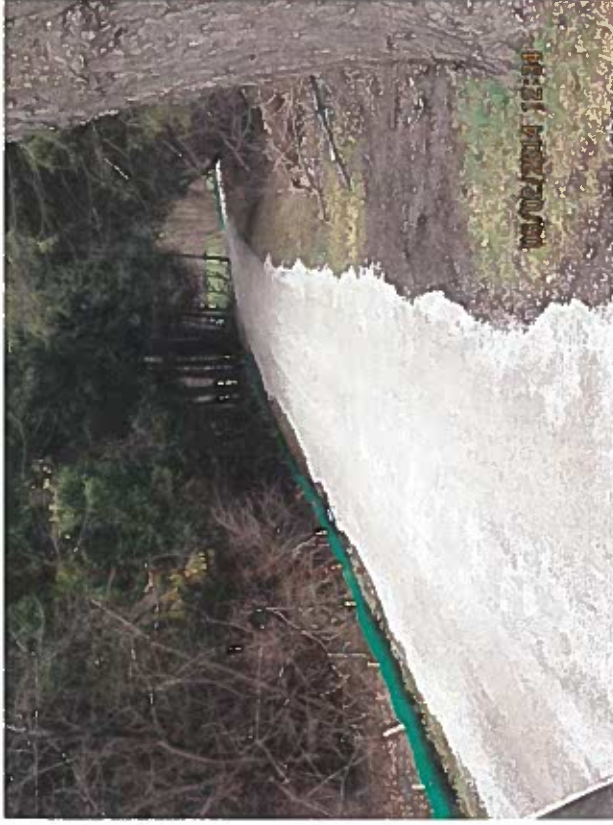
East of McCowan Road (limestone)

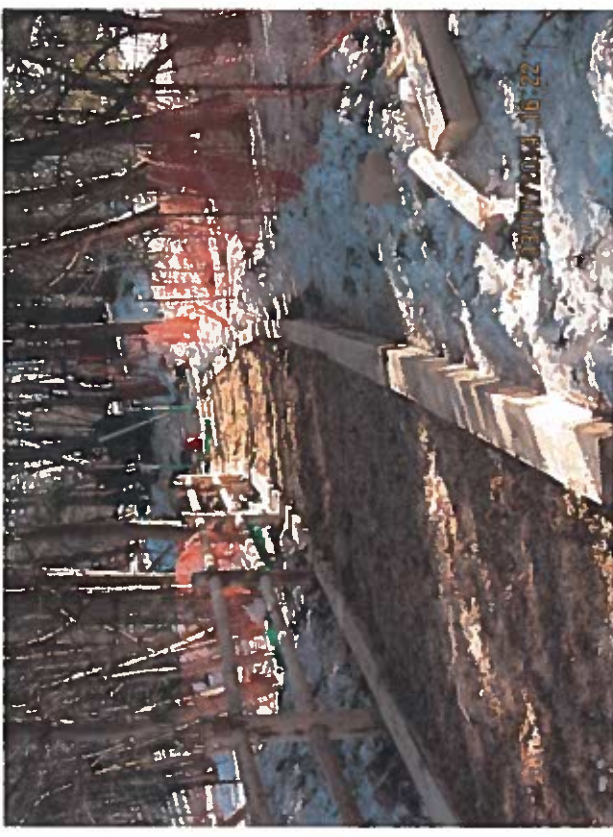
Milne Conservation Park – South of Drakefield Road (woodchips)

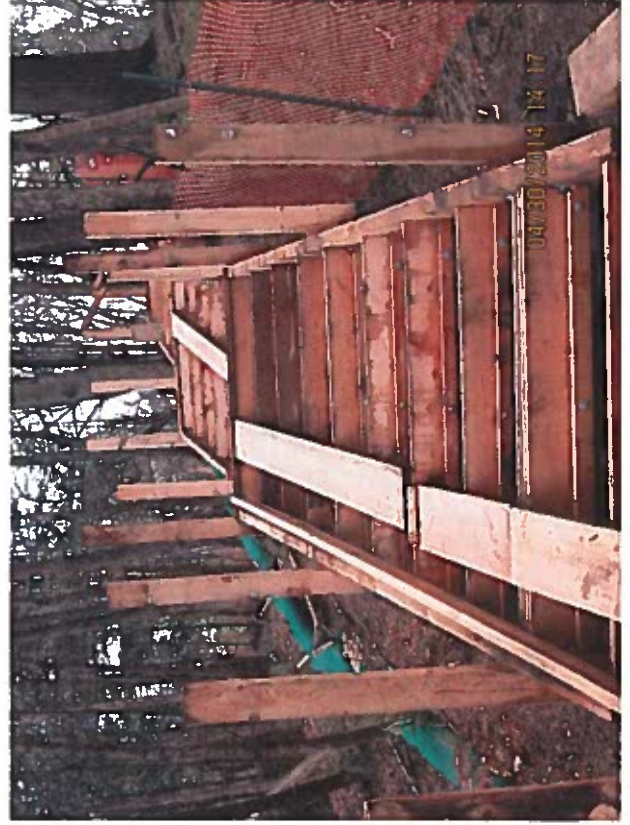
Milne Conservation Park – South of Drakefield (Boardwalk)

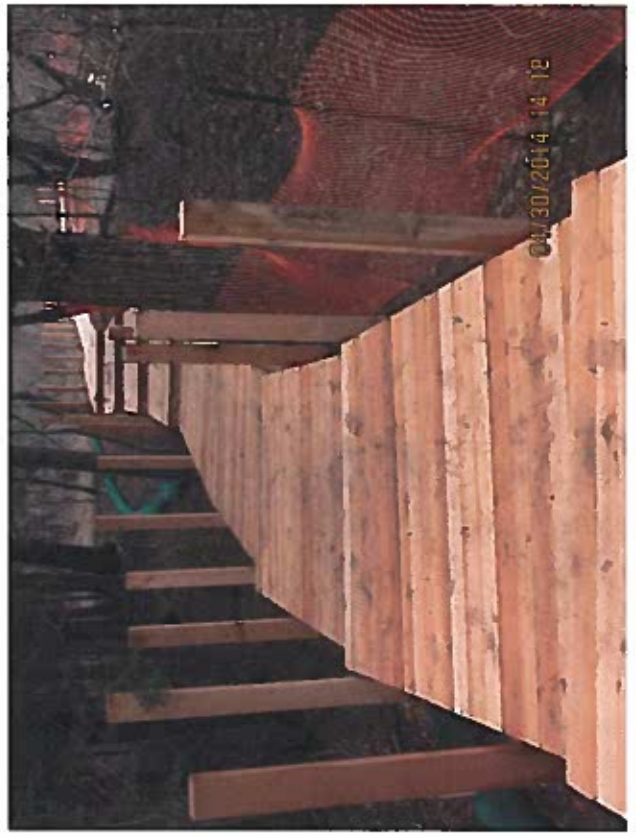
Milne Conservation Park (Boardwalk)

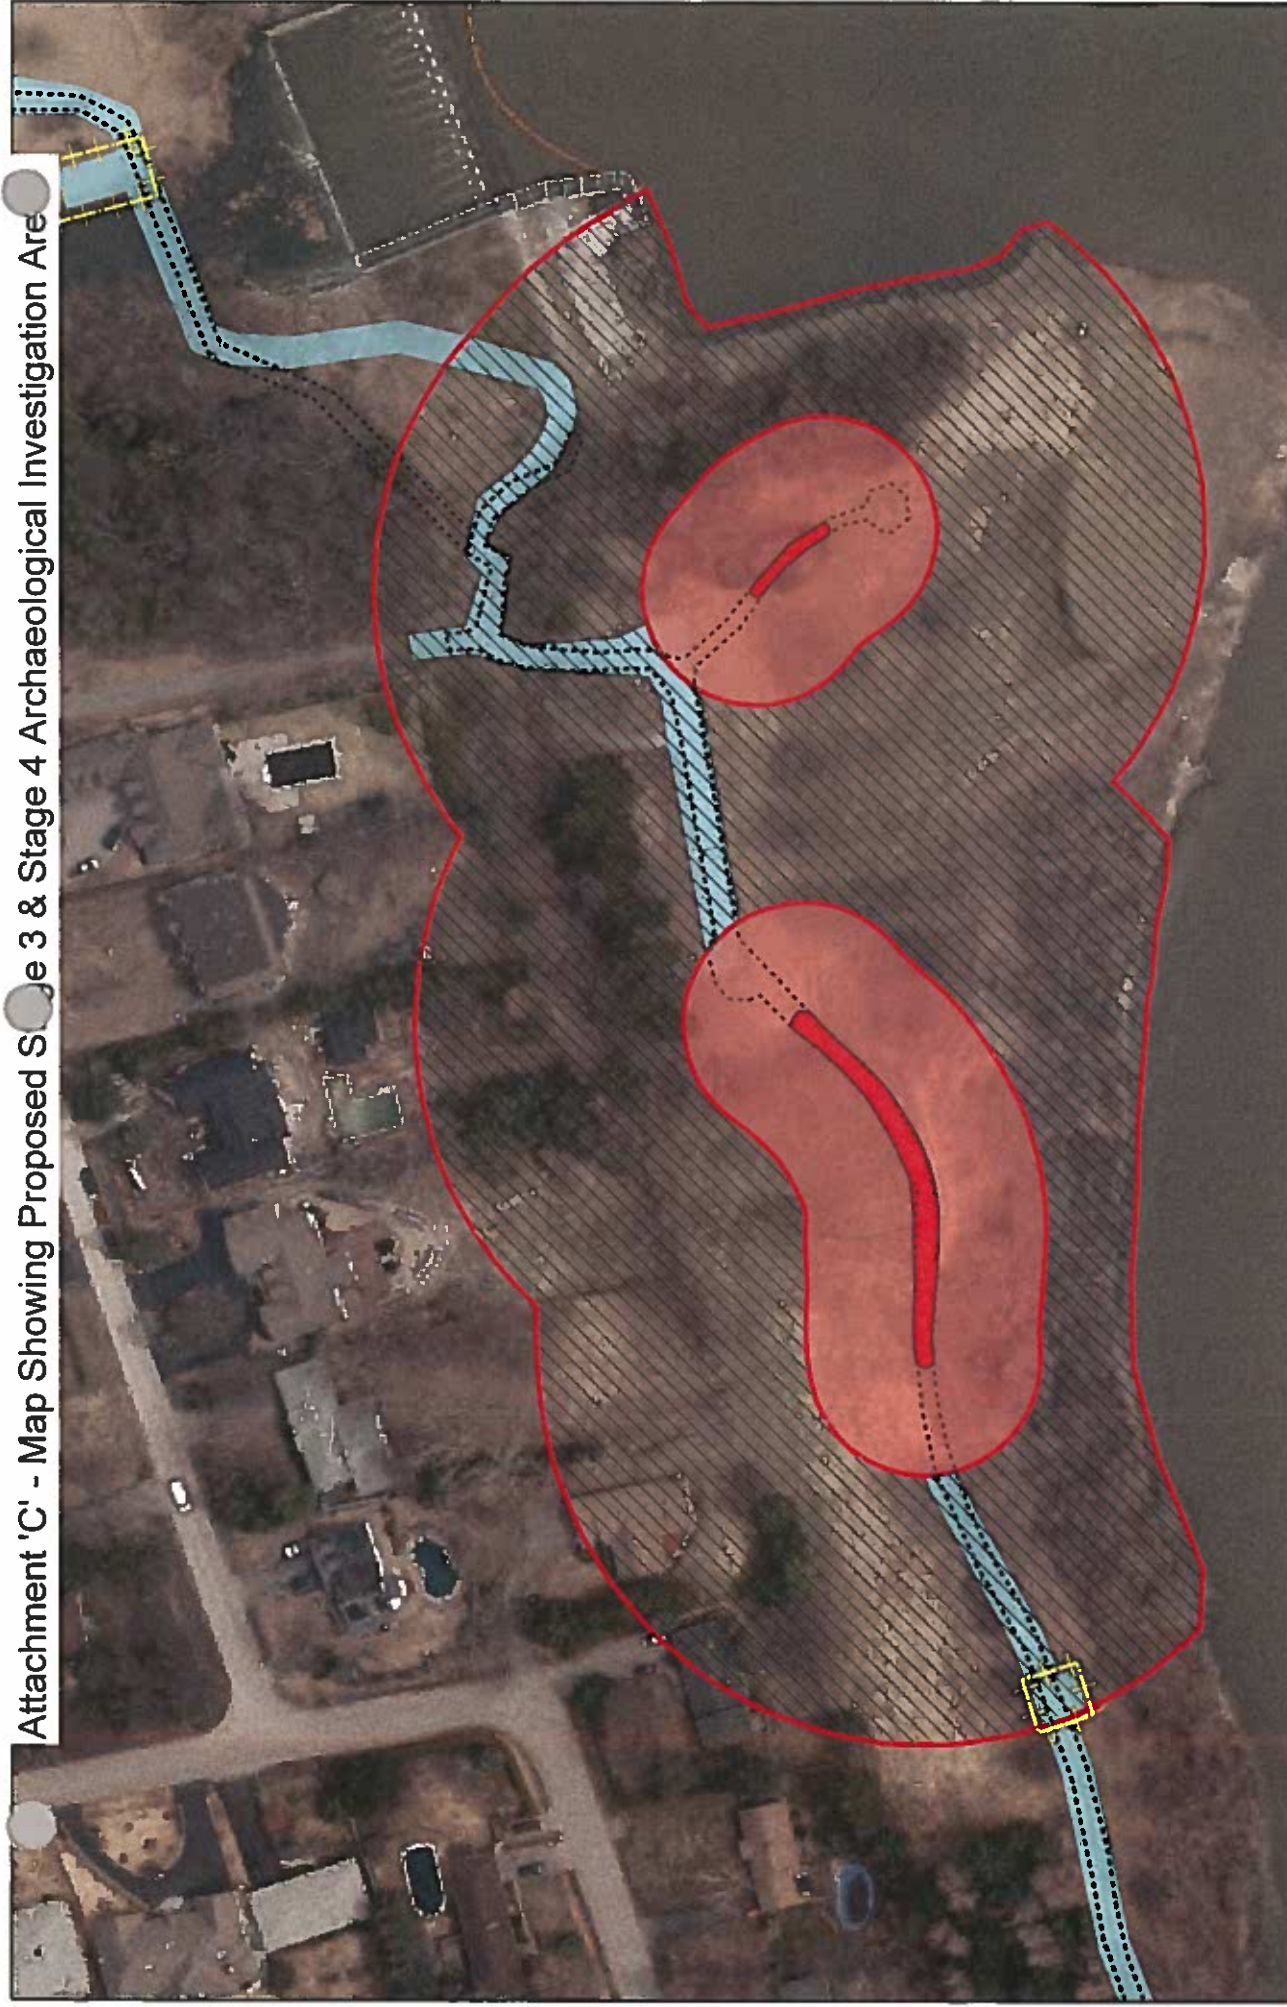
Attachment 'C' - Map Showing Proposed Stage 3 & Stage 4 Archaeological Investigation Areas

- Proposed Location of Trails
- Areas Assessed and Clear of Archaeological Concern
- Areas of Archaeological Concern that were Assessed and Cleared

- Site Boundary
- Stage 3/4 Assessment Required
- 50 Meter Monitoring Zone

An allowance of \$20,352.00 inclusive of HST was initially included as part of Schollen's archaeological investigation for Phases 1-3. The archaeological investigation work within TRCA owned and regulated land, including the Milne Conservation Dam, is being conducted by TRCA archaeology staff. During the initial assessment and investigation in the Milne area, artifacts were encountered in 4 locations. Two locations were cleared of any further concern. The other 2 locations are in the open area west of the Milne Conservation Dam (Attachment 'C'). TRCA's investigation indicates that these 2 sites likely represent the remains of separate buildings (one outbuilding and one house) from a single 19th century homestead.

According to TRCA, the site will require a final Stage 4 archaeological assessment. Stage 4 assessment include the following:

The excavation will take place along the footprint of the proposed trail where artifacts were located during previous assessments, including a five meter buffer on each side of the proposed trail. Once the Stage 4 field work is completed, the TRCA archaeology unit will produce a Stage 4 Excavation Report which will be submitted to the Ministry of Tourism and Culture for acceptance to the Ministry's register. In addition, further archaeological investigation (Stage 1 and Stage 2 Assessment) is being conducted between the Milne Dam and Markham Road. However, the requirement for additional investigation (Stage 3 and Stage 4) will not be known until the initial assessment work is completed. Therefore, additional budget may also be required if artifacts are found during the assessment. Staff will request funding in 2015 for this requirement.
