TOWN OF MARKHAM WATERCOURSE EROSION RESTORATION IMPLEMENTATION PLAN

April 4, 2006

TOWN OF MARKHAM
EROSION RESTORATION
IMPLEMENTATION PLAN

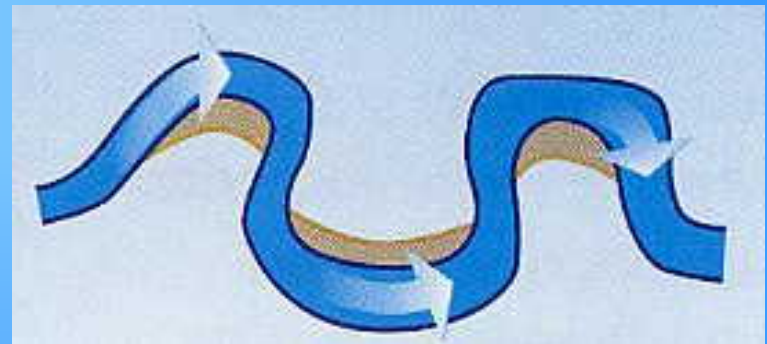
MIGRATION:

- Movement of channel on floodplain

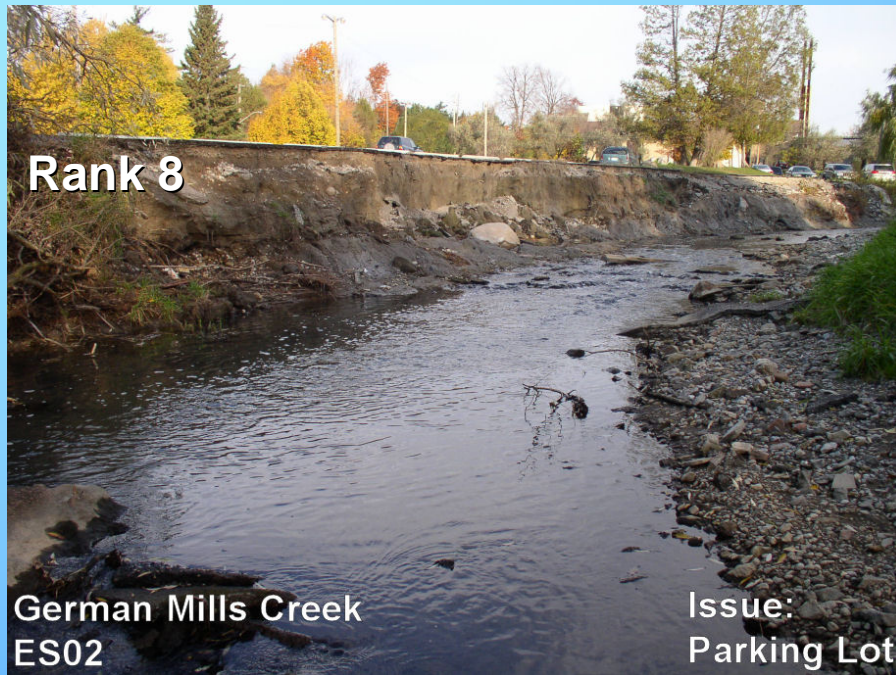
Restoration Concepts - Example Site

- Associated costs
- \$100,000

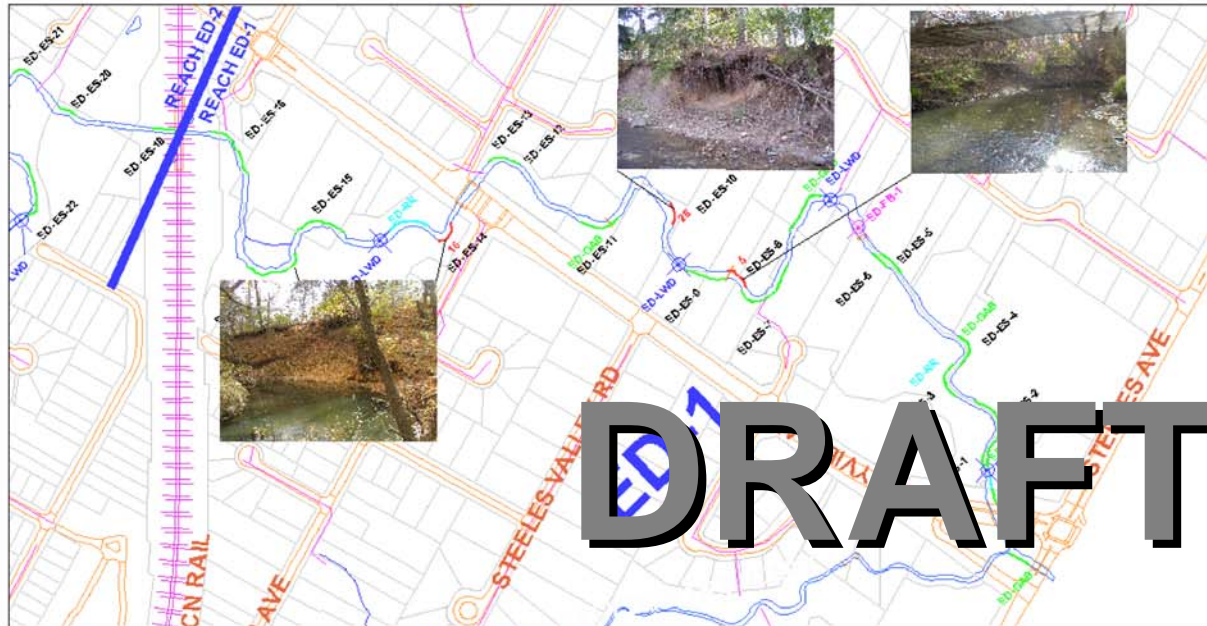
REACH: ED-1 FIGURE: 3

Example concept – to be updated with actual top 30 site

East Don River
Steeles and Bayview area

- VALLEY WALL CONTACTS
- SLOPE TOE PROTECTION
- ESTABLISH VEGETATION ON SLOPE
- ALLOW FOR NATURAL MIGRATION AND WIDENING TENDENCIES

- BANK EROSION
- ENHANCE VEGETATION AT GREST OF BANK
- TOE PROTECTION
- RE-ORIENT THALWEG
- ENHANCE AQUATIC HABITAT
- REPLACE GABIONS WITH SOFTER TECHNIQUE WHERE POSSIBLE
- MONITOR EXISTING EROSION SITES
- ALLOW FOR NATURAL MIGRATION AND WIDENING TENDENCIES
