POMONA MILLS CREEK EROSION RESTORATION AND HABITAT ENHANCEMENT STUDY

Alternative 2 - Selective Works

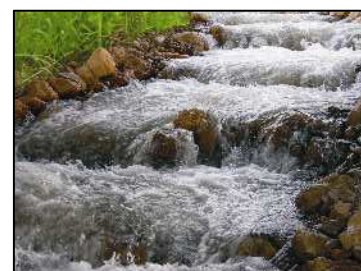
PROPOSED STEP-POOL

Step-pool Channel:
Channel restoration and improved fish passage locally where weirs are removed
