**HERITAGE BUILDING CONDITION SURVEY  
WILLIAM CLARRY HOUSE  
9900 MARKHAM ROAD  
MARKHAM, ONTARIO**

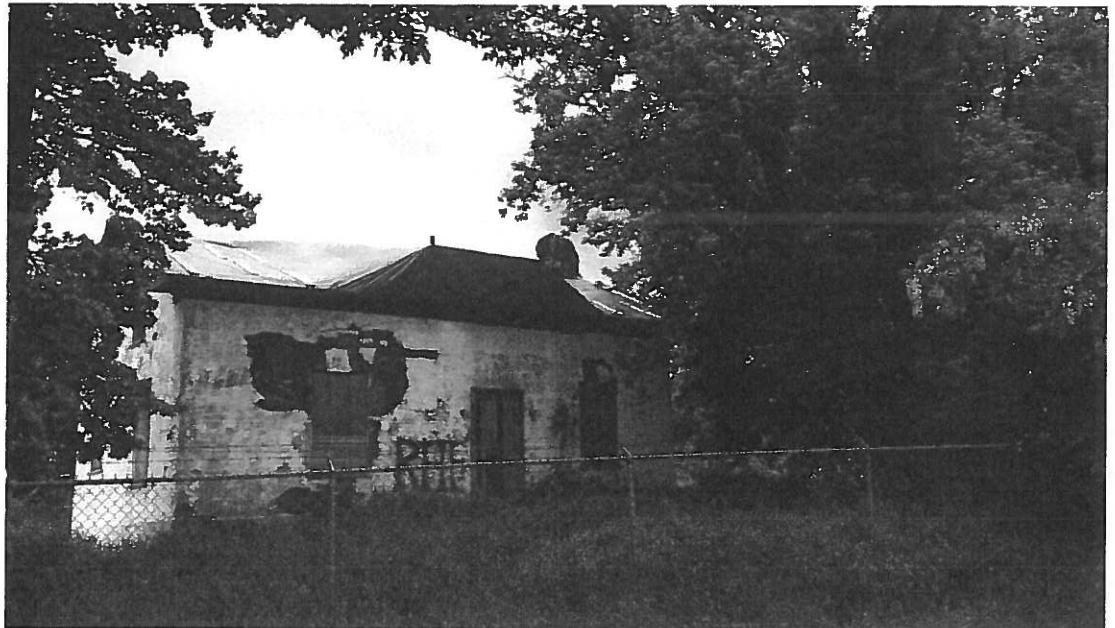
- Typical old stone and rubble foundation. Not sound (subject to shifting with freeze –thaw conditions).
- ZERO structural integrity.
- Moisture able to enter with use of this material. No waterproofing or damp proofing.

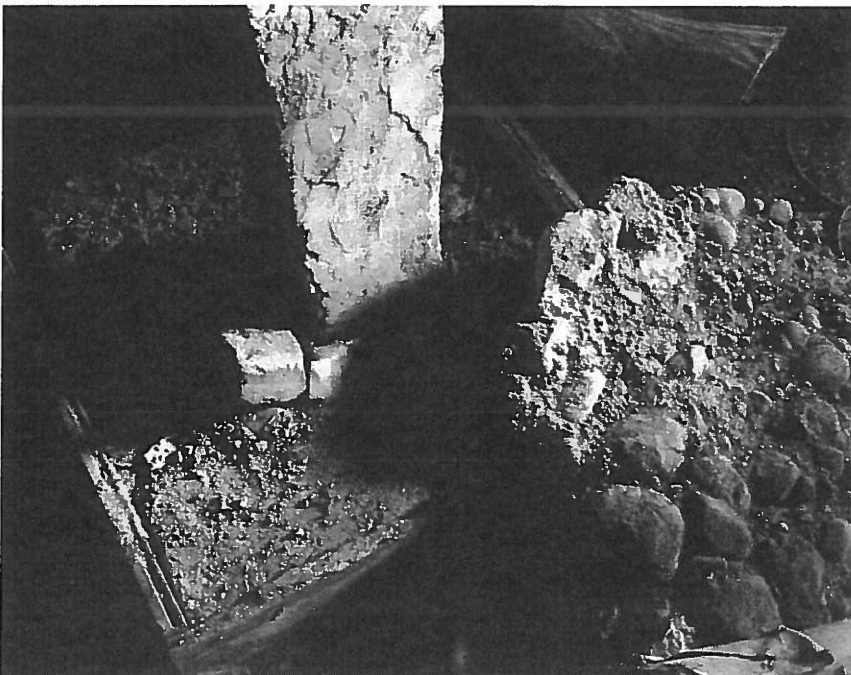
- To the left: Existing foundations are broken, overstressed and failing. This dwelling must be shored immediately.

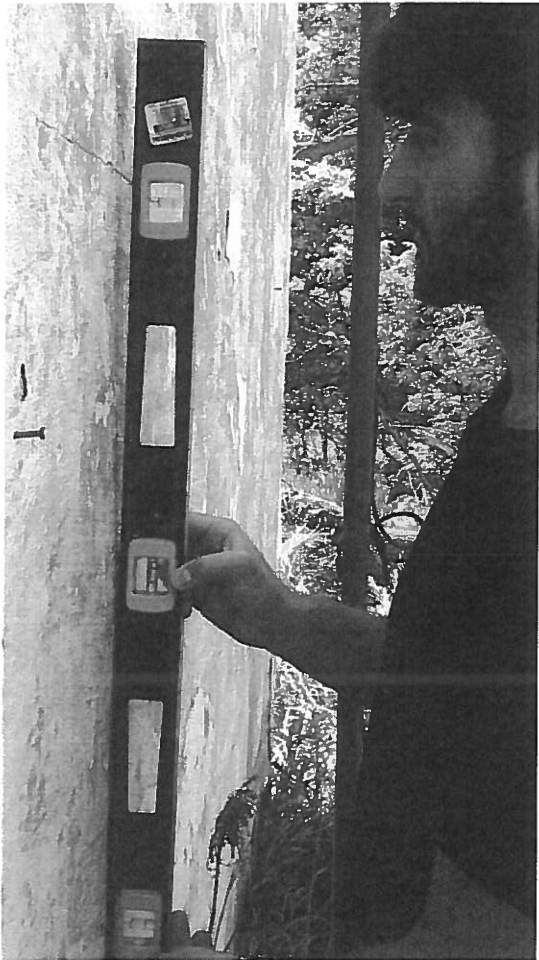
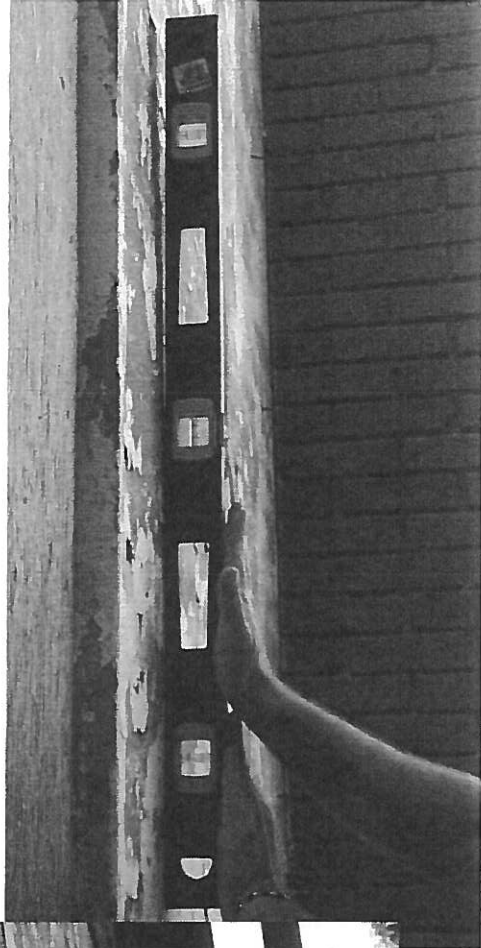
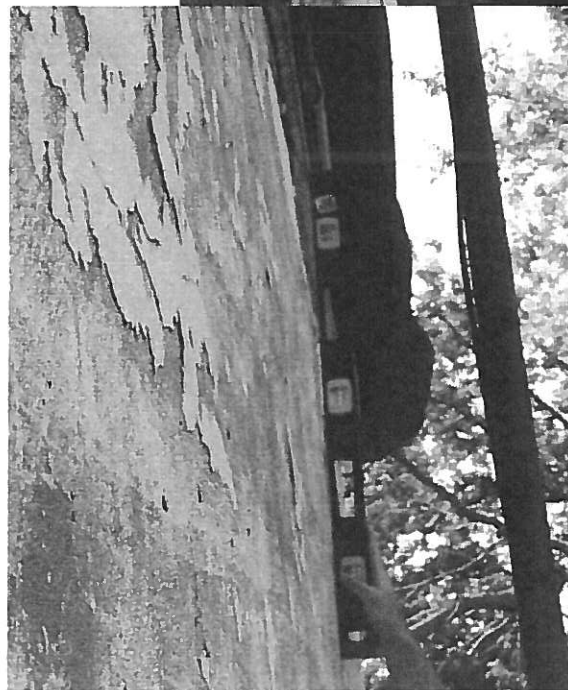
- Exterior walls are out of plum resulting in significant eccentric loading that cannot be supported by the vertical members.

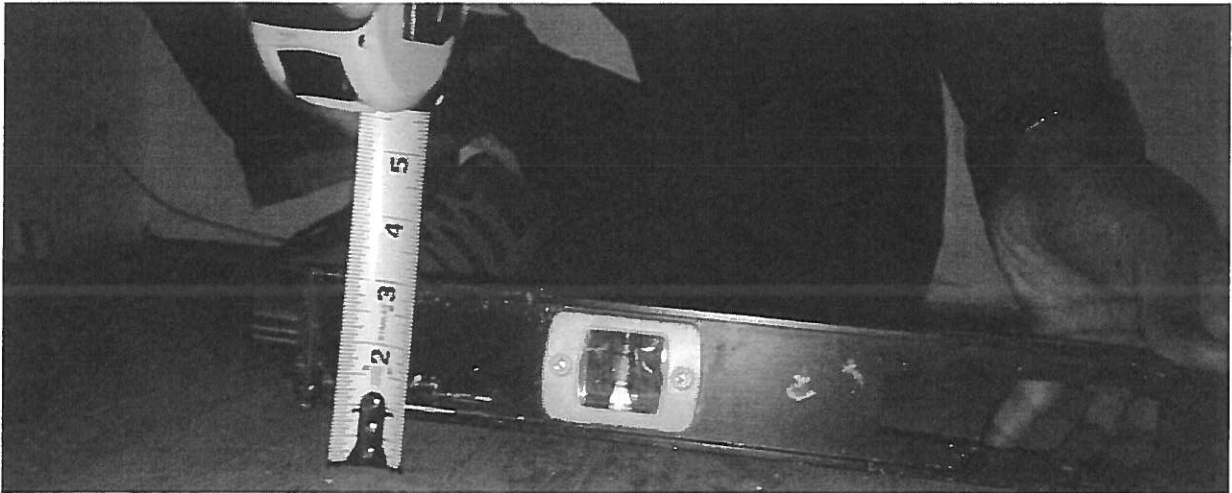
- Floor is out of level beyond what is acceptable by code.
