## MEMORANDUM

**TO:** Heritage Markham Committee

**FROM:** Regan Hutcheson, Manager-Heritage Planning

**SUBJECT:** Request for Feedback  
Proposed Demolitions – 2023  
Rouge National Urban Park

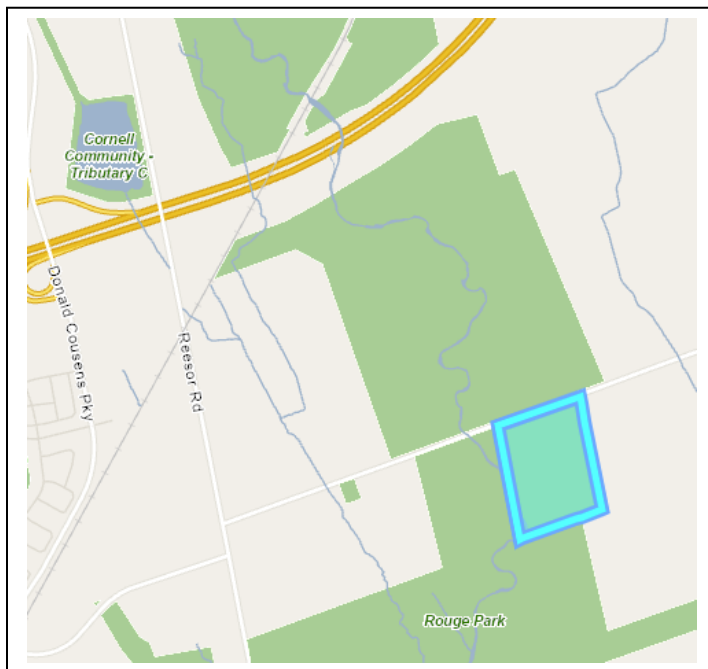
Photo No. 14: East elevation

<b>Address</b>	<b>7933 14<sup>th</sup> Avenue</b>
<b>Heritage Status</b>	Part IV Designation
<b>Location of Building</b>	Close to 14 <sup>th</sup> Ave Overgrown Conditions Adjacent to a parking lot/trail
<b>Historical</b>	<ul style="list-style-type: none"> <li>• James Dimma House, c.1840</li> <li>• Property sold to James Dimma in 1843</li> <li>• 1851 Census- Dimma's in a 1 ½ storey log building</li> <li>• Was a cooperage on the property in 1851 (barrels)</li> <li>• Dimma family came from Scotland- immigrated in 1835</li> <li>• Scottish Presbyterians organized the Zion Church- James was a church elder</li> <li>• Property became Willowdale farm</li> <li>• Building appears to be two structures put together</li> <li>• Early construction techniques</li> </ul>
<b>Physical Condition</b>	<p><b>WSP Condition Rating:</b> D2-Structurally Compromised</p> <p><b>WSP Comments:</b></p> <ul style="list-style-type: none"> <li>- The building structure is compromised and the envelope is severely deteriorated, posing health and safety risks upon entry. With appropriate safety precautions, immediate abatement activities can be completed, before recommended deconstruction.</li> <li>- The building is vacant and has not been inhabited for an unknown period of time.</li> <li>- The building foundations are unstable, and the structure is leaning towards the west at the north wing. The stone foundation walls are cracked and show movement at the northwest and southwest corners and at the joint between the brick chimney and the stone wall. Some exterior repairs have been made, but these are inadequate and have re-cracked due to ongoing movement. Slope and foundation stabilization would be required, in addition to foundation wall and superstructure repairs.</li> <li>- The front porch at the north side is also leaning to the west along with the rest of the structure, and several posts (which support the roof) are hanging freely (i.e., not supported from below). The porch guards are also inadequately supported. Structural repairs would be required.</li> <li>- At the second floor, there is a gap between the stairwell and the east room. The east room slopes down to the east slightly. Structural repairs would be required.</li> <li>- The south wing is also leaning towards the south. The kitchen ground floor is sloped downwards, and is soft underfoot. The crawlspace below is inaccessible, so the extent of deterioration was not confirmed. There is a small hole in the ground floor near the bathroom. In addition to flooring replacements, structural repairs would be required.</li> <li>- Interior finishes are substantially deteriorated and the building is heavily mould-contaminated. Major abatement and full renewal of all finishes would be required.</li> <li>- The stucco cladding is deteriorated. There are cracks throughout, missing sections (typically at the bottom and at corners), peeling finish, and graffiti throughout. Restoration would require abatement/removal and replacement.</li> <li>- All of the windows are boarded up and some are broken; all</li> </ul>

<p>would require replacement.</p> <ul style="list-style-type: none"> <li>- The top of the brick chimney is deteriorated and a clay chimney insert is at an angle. There are loose bricks on the roof.</li> <li>- The furnace and oil tank are missing. The ductwork is corroded and mould-contaminated, and missing in some locations. The domestic hot water tank is very old (likely several generations). A new tank would need to be installed, as well as new water treatment/filtration systems and distribution piping.</li> <li>- The hydro service is disconnected at the service drop and there is no meter.</li> <li>- These would need to be reinstated. The electrical breaker panel could be salvaged/re-used, but the distribution wiring would also require replacement.</li> </ul>
<b>Other Info</b>	City of Markham invested in this property when owned by TRCA- used money provided to City through Southeast Collector project to install new roof

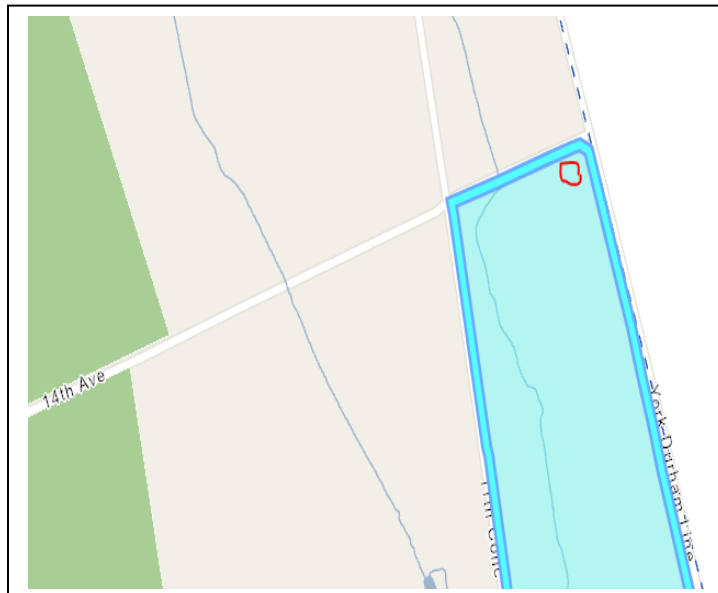
Photo No. 1: North and West Elevations

<b>Address</b>	<b>8331 14<sup>th</sup> Avenue</b>
<b>Heritage Status</b>	Listed on Register
<b>Location of Building</b>	Close to 14 <sup>th</sup> Ave/corner lot at York Durham Line Overgrown Conditions
<b>Historical</b>	<ul style="list-style-type: none"> <li>• David Badgerow House, c. 1840</li> <li>• 1851 lists Badgerow and family in a 1 ½ storey log home on this property</li> <li>• 1861 Census – 1 storey log</li> <li>• Badgerow are the only settlers of French origin know to have settled in Markham Township (arrived in early 1800s)</li> <li>• Active in first Markham Baptist Church</li> </ul>
<b>Physical Condition</b>	<p><b>WSP Condition Rating:</b> D2-Structurally Compromised</p> <p><b>WSP Comments:</b></p> <ul style="list-style-type: none"> <li>- vinyl siding appears to <b>be installed over the original wood siding</b>. Windows are vinyl framed units with insulating glass units.</li> <li>- The building <b>structure is compromised</b> and <b>portions of the envelope are severely deteriorated</b>, posing health and safety risks upon entry. With appropriate safety precautions, immediate abatement activities can be completed, before recommended deconstruction.</li> <li>- The windows and doors are <b>currently boarded</b> up except for one access door located on the north elevation. The building appears to have been <b>vacant for at least the past 5 years</b>, but possibly more.</li> <li>- The <b>roofing is in poor condition</b> and a tarp has been installed (several years ago) to mitigate ongoing leakage, which does <b>not appear to have proven effective</b>. There is a <b>hole in the roof above the second floor bathroom</b>. We note <b>extensive wood rot of the roof and wall framing members at this location</b> and the floor framing below was also noted to be soft underfoot, likely due to prolonged exposure in this area. There is also evidence of <b>leakage at the northwest second floor bedroom</b>. The roof and wall framing members in this area are also soft and water stained from ongoing leakage. We expect structural repairs would be required at these areas and likely other areas that are covered by the finishes and show similar <b>heavy water staining</b>.</li> <li>- The <b>interior finishes are substantially deteriorated</b> and the building <b>likely contains designated substances</b>. Major abatement and full renewal of all finishes is required.</li> <li>- Within the basements, there are numerous additional supports installed at the mid-spans and other locations to <b>address sagging floor joists</b>. These supports are installed without proper foundations and lateral restraint.</li> <li>- The mechanical and electrical systems are not operational and have likely been in this state for some time. <b>Complete renewal of the mechanical and electrical equipment would be required</b>. This would include, but not limited to, replacement of furnace, oil tank and portions of the distribution ductwork, domestic hot water tank heater and distribution piping, the main electrical panel, and likely most of the associated wiring as a large portion of the wiring is of an older vintage.</li> <li>- The <b>vinyl cladding and windows are generally in fair condition</b> with no major concerns noted. We suspect the cladding and windows are about 15 years old. However, the <b>underlying wall structure is locally compromised</b> and we expect at least partial replacement of the cladding would be required in order to properly address structural deterioration.</li> </ul>

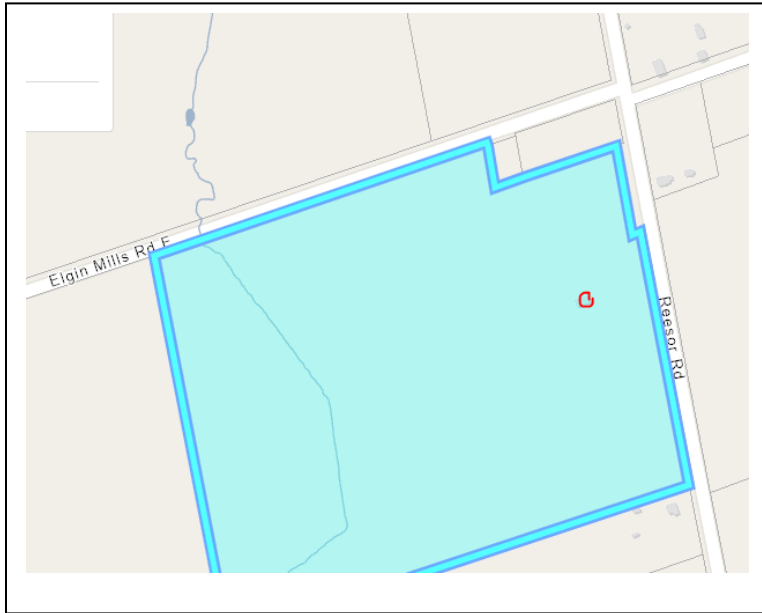
Photo No. 1: South elevation

<b>Address</b>	<b>10676 Reesor Rd</b>
<b>Heritage Status</b>	Part IV Designation
<b>Location of Building</b>	Fair Distance from Road Overgrown Conditions
<b>Historical</b>	<ul style="list-style-type: none"> <li>• Adam Betz House, c. 1871</li> <li>• 1 ½ storey frame near crossroads of Elgin Mills and Reesor (Mongolia)</li> <li>• Classic Ontario Farmhouse</li> <li>• German immigrant who was a farmer</li> <li>• Descendants owned the property until 1955</li> <li>• Remnant of the Markham's agricultural community</li> </ul>
<b>Physical Condition</b>	<p><b>WSP Condition Rating:</b> D2-Structurally Compromised</p> <p><b>WSPComments:</b></p> <ul style="list-style-type: none"> <li>- Exterior walls are clad with vinyl siding, which is clad over Insulbrick (similar to asphalt shingles with a stamped brick pattern) over the original wood tongue-and-groove.</li> <li>- The building structure is compromised and the envelope is severely deteriorated, posing health and safety risks upon entry. With appropriate safety precautions including items noted below, immediate abatement activities can be completed, before recommended deconstruction.</li> <li>- The building is in an advanced state of deterioration.</li> <li>- Foundation walls are mortared field stone; they are generally free of major deterioration or displacement;</li> <li>- Joists are largely intact, but considerable wetness in subflooring; there may be sections of weakened subflooring due to many years of being covered by wet insulation and plaster;</li> <li>- Basement joists and subflooring are generally intact;</li> <li>- Wood cover on the exterior basement/cellar steps is rotted and unsafe;</li> <li>- Studs and sheathing in the south wall in the west extension, at the south porch, are substantially rotted due to exposure to water over the long term;</li> <li>- Porch roof structure has partially collapsed; the extension roof rafters remain in place but there are large holes in the sheathing;</li> <li>- Main east portion stud walls appear to be mostly intact on the ground floor as there is no evidence of leakage through walls and windows;</li> <li>- Main roof rafters and sheathing have not failed; since there are holes in the west slope of the main roof, leakage has been occurring down the southwest side of the 2nd floor - we made exploratory openings in the finishes in this area and found limited rot in one stud and top plate but no extensive framing damage;</li> <li>- Did not enter the attic.</li> <li>-The structure can be made safe enough for workers to carry out hazardous materials remediation</li> </ul>

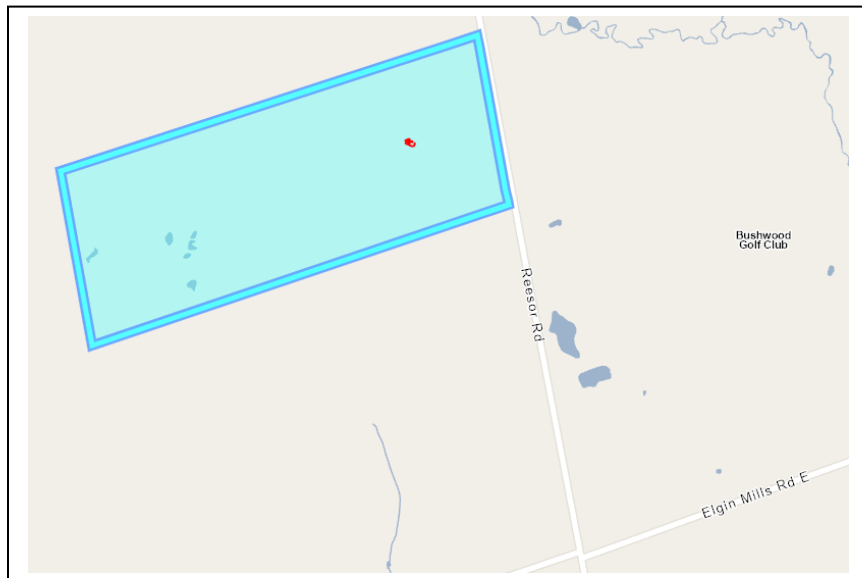
Photo No. 1: East Elevation

<b>Address</b>	<b>11122 Reesor Rd</b>
<b>Heritage Status</b>	Part IV Designation
<b>Location of Building</b>	Fair Distance from Road Overgrown Conditions
<b>Historical</b>	<ul style="list-style-type: none"> <li>• Noble Tenant Farmer's House, c. 1840</li> <li>• Originally a Crown reserve lot</li> <li>• American Ambrose Noble purchase in 1840 who lived in Mount Joy and operated a tannery (in 1851, the property was occupied by John Smith)</li> <li>• Appears he rented this house to others</li> <li>• Modestly scaled frame house- Georgian tradition - front veranda c. early 20<sup>th</sup> C</li> <li>• One storey kitchen wing that may be the earliest part of the building</li> <li>• Part of the Mongolia hamlet community/remnant of agricultural history</li> <li>• Barn is associated with the house</li> </ul>
<b>Physical Condition</b>	<p><b>WSP Condition Rating:</b> D3- Structurally Unsafe/ D2 Structurally Compromised (Main House)</p> <p><b>WSP Comments:</b></p> <ul style="list-style-type: none"> <li>- Exterior walls are clad in vinyl siding over the original wood siding. Windows and doors are boarded up but consist of original wood sliders with outer metal storm windows.</li> <li>- The building is partially collapsed and unfit to enter. It poses an imminent health and safety risk upon entry and within the immediate surrounding. Entry to the north addition for investigation, rehabilitation or abatement is not feasible in its current condition. Demolition is recommended.</li> </ul> <p>However, the original house should be classified as a D2 – Structurally Compromised. The building structure is compromised and the envelope is severely deteriorated, posing health and safety risks upon entry. With appropriate safety precautions, immediate abatement activities can be completed, before recommended deconstruction.</p> <ul style="list-style-type: none"> <li>- The floor of the west addition has collapsed, likely due to prolonged exposure to moisture. Visible from the basement, the central beam supporting the floor joists in this area has failed. The roof has a large hole and is also partially collapsed. THIS AREA SHOULD NOT BE ENTERED.</li> <li>- The structure of the original (two storey east portion) house is compromised due to continued poor performance of the roofing. Wood rot was noted at framing members in multiple locations.</li> <li>- The cladding system is in very poor condition and is no longer providing an acceptable barrier to the elements. There are areas of the cladding that are partially detached and at risk of falling.</li> <li>- In order to safely complete abatement activities at the main house level, the following is required: <ul style="list-style-type: none"> <li>- provide means of safely accessing the house; the structure of the front porch is compromised and will need to be re-enforced to allow multiple workers from entering and exiting the house.</li> <li>- clear excessive amount of debris from rooms and floors so that workers can safely perform duties. This will also allow for closer inspection of flooring in some areas.</li> </ul> </li> </ul>

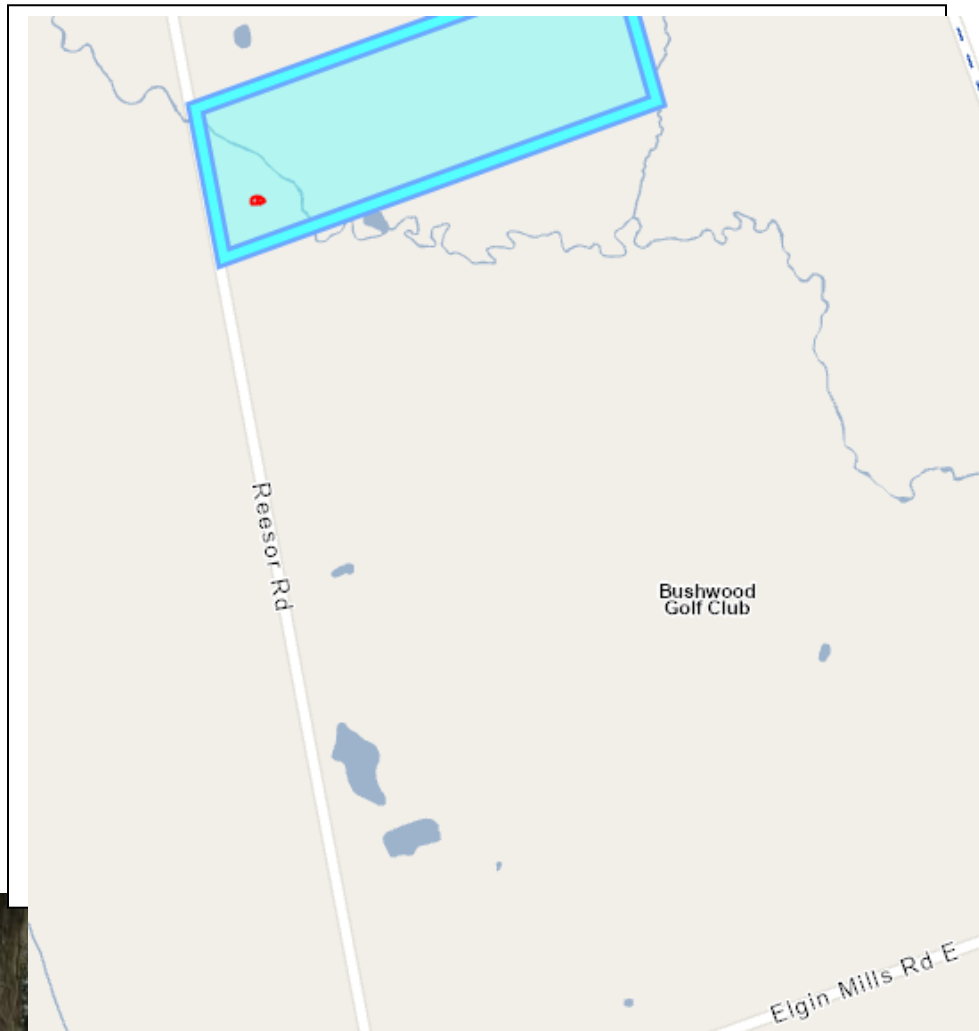
Photo No. 1: Southwest view

<b>Address</b>	<b>11223 Reesor Rd</b>
<b>Heritage Status</b>	Part IV Designation
<b>Location of Building</b>	Short Distance from the Road Overgrown Conditions
<b>Historical</b>	<ul style="list-style-type: none"> <li>• James Collins House, c.1850</li> <li>• 1 ½ storey frame dwelling</li> <li>• Typical example of modest tradesman house</li> <li>• Vernacular Georgian Tradition</li> <li>• Collins was an Irish immigrant who purchase the land in 1849</li> <li>• Carpenter by trade and likely built this house</li> <li>• Sold to the Vanzant family holdings in 1865</li> <li>• Part of hamlet of Mongolia; remnant of the agricultural community</li> </ul>
<b>Physical Condition</b>	<p><b>PC Condition Rating:</b> D3- Structurally Unsafe</p> <p><b>Comments:</b></p> <ul style="list-style-type: none"> <li>- The building is wood and timber-framed on stone foundation walls. The exterior walls are clad in vinyl siding which has been installed over preexisting cladding systems including Insulbrick and original wood siding. Windows and doors are boarded up but consist of vinyl-framed windows with IGUs and wood doors.</li> <li>- There is significant structural deterioration</li> <li>- Roof structure of the addition has partially collapsed;</li> <li>- Large opening in the roof over the addition, damaged/cracked wood framing throughout, and wood rot at ground floor framing where water exposure is evident;</li> <li>- Significant heaving of the concrete slab-on-grade and cracking throughout in the basement; and</li> <li>- East foundation wall of the original building is leaning and there is mortar deterioration and missing stones in the west foundation wall.</li> <li>- Based on the extent of structural deterioration, we confirm that the building be demolished. Based on the condition of the roof structure and basement/foundation structure, we do not believe the building is structurally safe to perform abatement activities prior to demolition.</li> </ul>

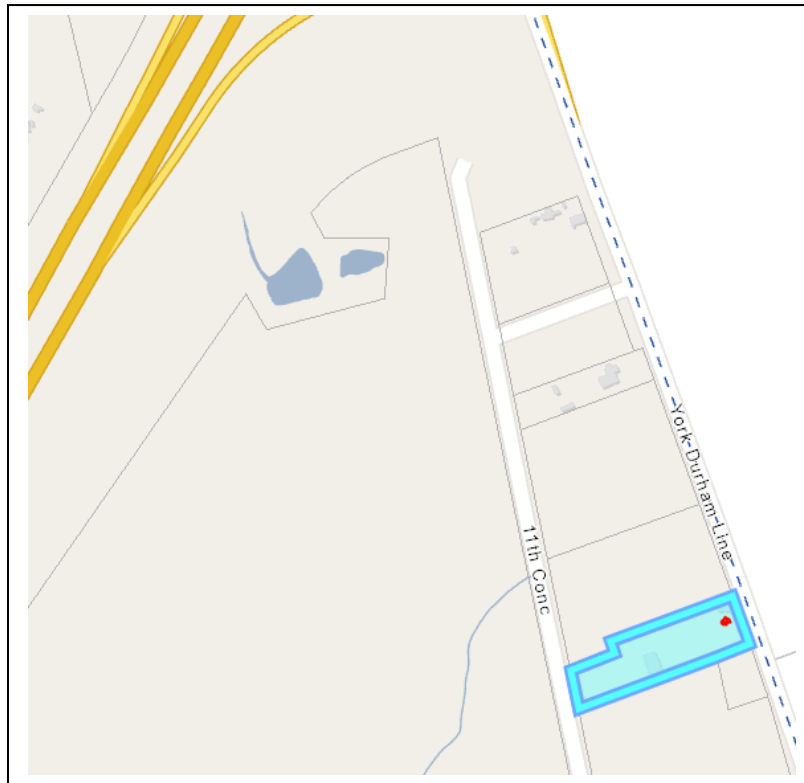
Photo No. 1: South Elevation

<b>Address</b>	<b>8200 York Durham Line</b>
<b>Heritage Status</b>	Listed on the Register
<b>Location of Building</b>	Close to the Road, boundary with Pickering Overgrown Conditions
<b>Historical</b>	<ul style="list-style-type: none"> <li>• William Boyd House, c. 1890</li> <li>• Gothic Revival design</li> <li>• Located in former crossroad community of Bedford (at 5<sup>th</sup> line in Pickering)</li> <li>• Boyd operated a general store and post office in Bedford during the early 1880s</li> </ul>
<b>Physical Condition</b>	<p><b>WSP Condition Rating:</b> D2-Structurally Compromised</p> <p><b>WSP Comments:</b></p> <p>. The above-grade structure is wood-framed. The original house has stone and mortar foundation walls and the addition has some cast-in-place concrete foundation walls. There are supplemental steel beams and steel posts to support the original main floor structure at the east side.</p> <p>- The exterior walls are wood-framed and clad with vinyl siding. The vinyl siding appears to be installed over the original wood siding. Windows are a combination of vinyl framed units with insulating glass units and single-glazed and wood-framed.</p> <p>- The building structure is compromised and portions of the envelope are severely deteriorated, posing health and safety risks upon entry. With appropriate safety precautions, immediate abatement activities can be completed, before recommended deconstruction.</p> <p>- The building is currently vacant and windows and doors are boarded up. It appears that the house has been vacant for about 10 years but this could not be confirmed.</p> <p>-The basement appears to have been subject to (likely repeated) flooding events.</p> <p>- The structure is generally adequate for abatement activities, however, we note a number of structural concerns including the following:</p> <ul style="list-style-type: none"> <li>- extensive water damage at the the west addition due to large openings in the roof and prolonged exposure to the elements of the underlying wood structure;</li> <li>- corroded bases of the supplemental steel posts at the basement level;</li> <li>- localized floor joists that are water damaged at the perimeter foundation walls;</li> <li>- missing treads and weakened staircase leading to the basement;</li> <li>- the porches at the south side are generally in poor and unsafe condition and require full rebuilding; we assume minor/temporary reinforcements can be completed prior to abatement activities.</li> <li>- localized erosion of mortar within stone foundation walls, likely due to prolonged moisture exposure and freeze-thaw cycles.</li> </ul> <p>- In advance of abatement activities, we recommend a general contractor make local reinforcements as required to ensure safety for workers.</p> <p>- This applies primarily to entrance steps and basement steps and some joists.</p> <p>- The roofing is in poor condition and a tarp was installed (several years ago) to mitigate ongoing leakage. The tarp has since deteriorated and is absent. There are holes in the roof of the addition and evidence of ongoing leakage in other areas of the house</p> <p>.-The vinyl siding is generally intact but aged and has a stained appearance. - Windows are old and wood-framed with outer storm windows and will require</p>

<p>replacement due to a large number of broken units.</p> <ul style="list-style-type: none"> <li>- The interior finishes are substantially deteriorated and the building likely contains designated substances. Major abatement and full renewal of all finishes would be required.</li> <li>- The mechanical and electrical systems are not operational and have likely been in this state for some time. The electrical supply to the building is disconnected and the oil tank is no longer present. Complete renewal of the mechanical and electrical equipment would be required. This would include, but not limited to, replacement of the furnace, oil tank and portions of the distribution ductwork, domestic hot water tank heater and filtration/sterilization equipment and distribution piping, the main electrical panel, and likely most of the associated wiring as a large portion of the wiring is of an older vintage</li> </ul>

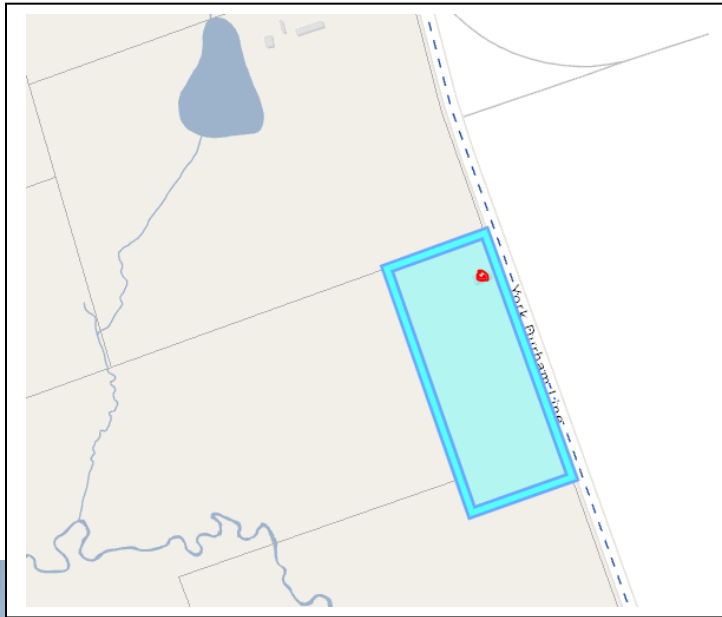
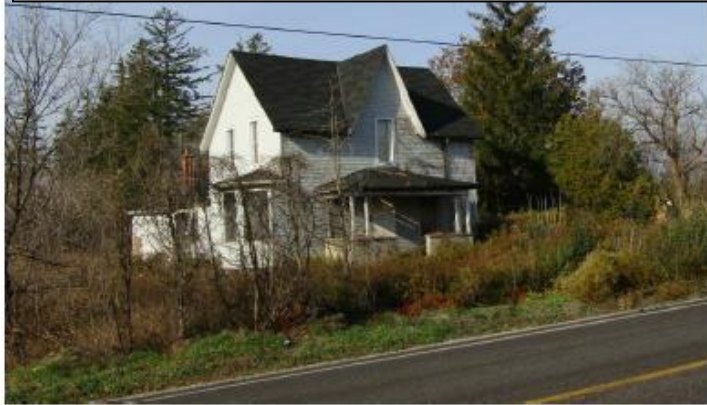
Photo No. 3: East and south elevations

<b>Address</b>	<b>11190 York Durham Line</b>
<b>Heritage Status</b>	Part IV Designation
<b>Location of Building</b>	Close to Road Overgrown Conditions
<b>Historical</b>	<ul style="list-style-type: none"> <li>• John Boyles House, c 1870</li> <li>• 1 ½ storey frame dwelling, Classic Ontario farmhouse</li> <li>• Has canted bay windows on the north and south gable ends</li> <li>• One storey kitchen wind</li> <li>• Boyles was an American of German origin – purchased the property in 1839</li> <li>• Boyles was a labourer, sawyer and farmer</li> <li>• Appears to be his retirement home after his son took over the family farm</li> <li>• Remnant of agricultural community/ Mongolia/ retirement theme</li> </ul>
<b>Physical Condition</b>	<p><b>WSP Condition Rating:</b> D3- Structurally Unsafe</p> <p><b>WSP Comments:</b></p> <ul style="list-style-type: none"> <li>- The house has been abandoned for an unknown period of time. Most window and doors are boarded up.</li> <li>- Where accessible to view (addition), the house is founded on concrete block foundation walls.</li> <li>- The above grade structure is wood-framed.</li> <li>- The exterior walls are clad with horizontally-oriented vinyl siding. Where the siding is missing on the original portion of the house, the siding is installed over faux brick asphalt shingle. Where accessible to view, the windows are in wood frames. However, the second-floor windows are vertical sliders in either aluminum or vinyl frames.</li> <li>- The overall building condition is classified as D3 - Structurally Unsafe. The building is partially collapsed and unfit to enter. It poses an imminent health and safety risk upon entry and within the immediate surrounding. Entry for investigation, rehabilitation or abatement is not feasible in its current condition. Demolition is recommended.</li> </ul> <p>There are several severe conditions that warrant this building as structurally unsafe. These are as follows:</p> <ul style="list-style-type: none"> <li>- The entirety of the ground-floor structure has collapsed; this leaves the main floor inaccessible and the structure above vulnerable to collapse.</li> <li>- There are holes in the roof that have led to moisture damage to the roof wood decking, rafters and interior finishes.</li> <li>- The east canopy roof also has a hole in it that has led to moisture damage to the wood decking (and possibly the wood rafters) and the wood soffit.</li> <li>- We could not enter the house to confirm the condition of the electrical breaker panel and furnace, but these are likely in a state of disrepair given the overall condition of the house. We could not confirm the location of the septic system</li> </ul>
