MEMORANDUM

TO: Heritage Markham Committee

FROM: Regan Hutcheson, Manager-Heritage Planning

SUBJECT: REQUEST FOR FEEDBACK – SITE VISIT
PROPOSED DEMOLITIONS – 2023
ROUGE NATIONAL URBAN PARK

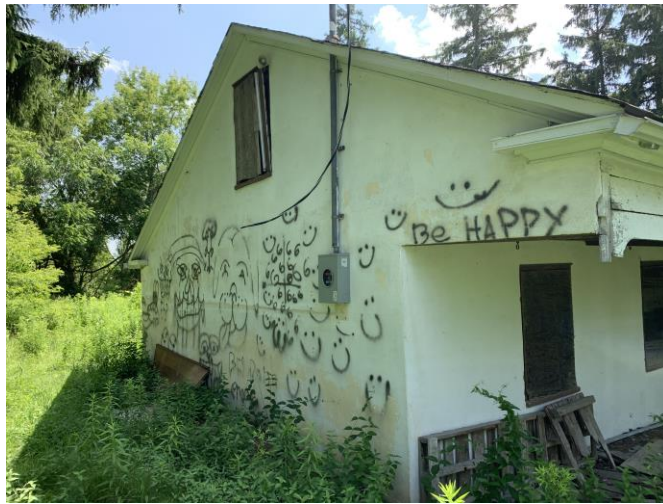
East Elevation, July 4, 2023 (RH) returned eaves

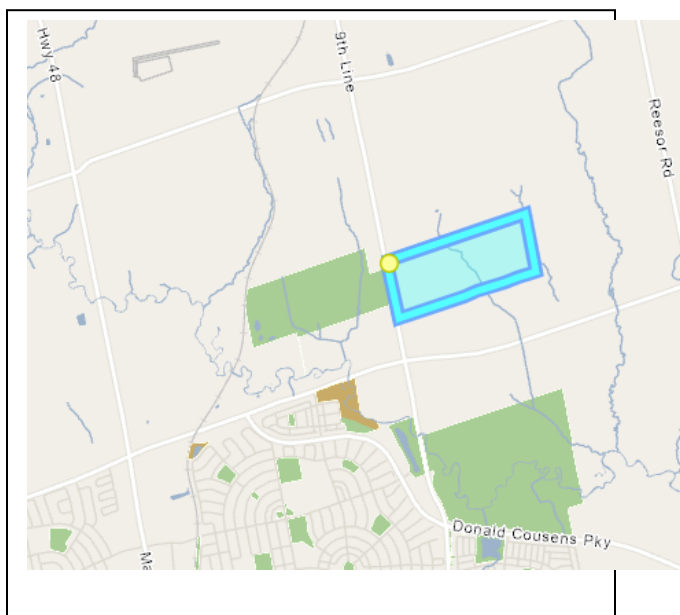
Address	10295 Ninth Line
Heritage Status	Part IV Designation
Location of Building	Close to Ninth Line Overgrown Conditions
Historical	<ul style="list-style-type: none"> • James Brison Johnson House, c. 1915 • Noteworthy frame version of an American Foursquare • First owner was a farmer- lived here until 1967 • May have replaced an earlier house • Remnant of the agricultural community
Physical Condition	<p>WSP Condition Rating: D2-Structurally Compromised</p> <p>WSP Comments:</p> <ul style="list-style-type: none"> - Walls are horizontally-oriented vinyl siding, estimated to have been installed in the past 10-20 years. Windows are modern (likely similar vintage to the siding) double-glazing in vinyl frames. - The building structure is compromised and the envelope is severely deteriorated, posing health and safety risks upon entry. - The building is vacant and has not been inhabited for an unknown period of time. - Interior finishes are substantially deteriorated and the building is heavily mould-contaminated. Major abatement and full renewal of all finishes would be required. - A portion of the addition at the east side has a collapsed roof at the junction between the main house and the addition, and about 9' (2.7m) at the east side. Major repairs and rebuilding would be required. The east porch (below the collapsed areas) is also in an advanced state of deterioration. - About half of the concrete slab-on-grade in the basement is heaved and cracked. Replacement would be required. There is an interior concrete foundation wall that is deteriorated and requires replacement (repair is not likely possible as the concrete is weak). - There are holes in the roof, as seen from the attic and the asphalt shingles are old. Full re-roofing, some local wood plank replacements, and finish repairs would be required. - Where seen from grade, the brick chimney is deteriorated. - The furnace is old and corroded. The oil tank is missing. Making the system functional would require chimney repairs (see above), possible relining, replacing the furnace, providing a new oil tank, and extensive improvements/remediation/replacement of the ductwork. - The well head and septic bed were not located. If these have not been maintained, new systems may need to be installed. The domestic hot water tank is very old (likely several generations). A new tank would need to be installed, as well as new water treatment/filtration systems and distribution piping. - The hydro service is disconnected at the service drop and there is no meter. These would need to be reinstated. The main electric breaker panel are old and corroded would require replacement. The distribution wiring would also require replacement

Photo No. 1: South elevation west side

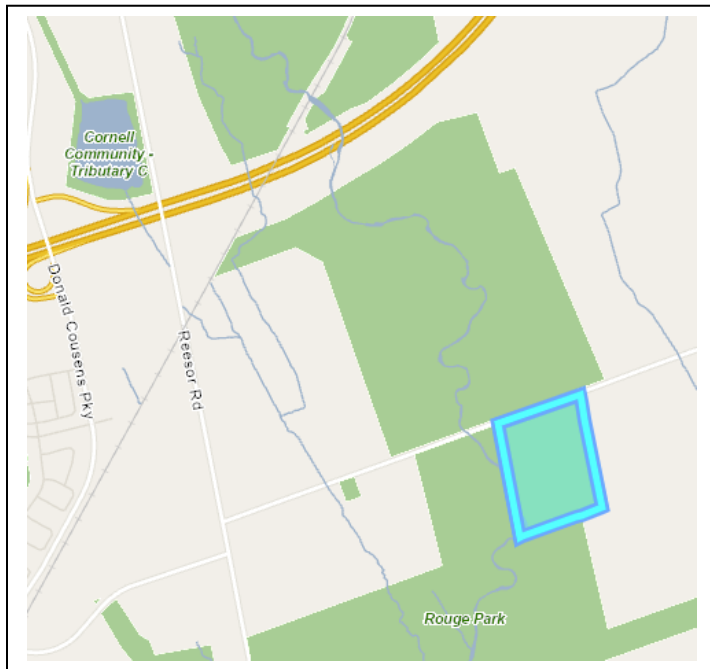
Address	7933 14th Avenue
Heritage Status	Part IV Designation
Location of Building	Close to 14 th Ave Overgrown Conditions Adjacent to a parking lot/trail
Historical	<ul style="list-style-type: none"> • James Dimma House, c.1840 • Property sold to James Dimma in 1843 • 1851 Census- Dimma's in a 1 ½ storey log building • Was a cooperage on the property in 1851 (barrels) • Dimma family came from Scotland- immigrated in 1835 • Scottish Presbyterians organized the Zion Church- James was a church elder • Property became Willowdale farm • Building appears to be two structures put together • Early construction techniques
Physical Condition	<p>WSP Condition Rating: D2-Structurally Compromised</p> <p>WSP Comments:</p> <ul style="list-style-type: none"> - The building structure is compromised and the envelope is severely deteriorated, posing health and safety risks upon entry. With appropriate safety precautions, immediate abatement activities can be completed, before recommended deconstruction. - The building is vacant and has not been inhabited for an unknown period of time. - The building foundations are unstable, and the structure is leaning towards the west at the north wing. The stone foundation walls are cracked and show movement at the northwest and southwest corners and at the joint between the brick chimney and the stone wall. Some exterior repairs have been made, but these are inadequate and have re-cracked due to ongoing movement. Slope and foundation stabilization would be required, in addition to foundation wall and superstructure repairs. - The front porch at the north side is also leaning to the west along with the rest of the structure, and several posts (which support the roof) are hanging freely (i.e., not supported from below). The porch guards are also inadequately supported. Structural repairs would be required. - At the second floor, there is a gap between the stairwell and the east room. The east room slopes down to the east slightly. Structural repairs would be required. - The south wing is also leaning towards the south. The kitchen ground floor is sloped downwards, and is soft underfoot. The crawlspace below is inaccessible, so the extent of deterioration was not confirmed. There is a small hole in the ground floor near the bathroom. In addition to flooring replacements, structural repairs would be required. - Interior finishes are substantially deteriorated and the building is heavily mould-contaminated. Major abatement and full renewal of all finishes would be required. - The stucco cladding is deteriorated. There are cracks throughout, missing sections (typically at the bottom and at corners), peeling finish, and graffiti throughout. Restoration would require abatement/removal and replacement. - All of the windows are boarded up and some are broken; all

<p>would require replacement.</p> <ul style="list-style-type: none"> - The top of the brick chimney is deteriorated and a clay chimney insert is at an angle. There are loose bricks on the roof. - The furnace and oil tank are missing. The ductwork is corroded and mould-contaminated, and missing in some locations. The domestic hot water tank is very old (likely several generations). A new tank would need to be installed, as well as new water treatment/filtration systems and distribution piping. - The hydro service is disconnected at the service drop and there is no meter. - These would need to be reinstated. The electrical breaker panel could be salvaged/re-used, but the distribution wiring would also require replacement.
Other Info	City of Markham invested in this property when owned by TRCA- used money provided to City through Southeast Collector project to install new roof
Photos

Photo No. 14: East elevation

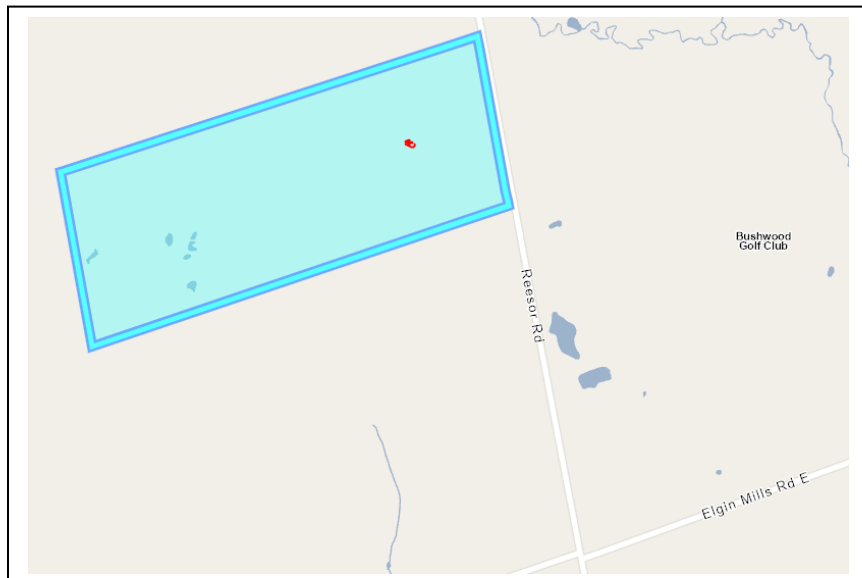
Address	11122 Reesor Rd
Heritage Status	Part IV Designation
Location of Building	Fair Distance from Road Overgrown Conditions
Historical	<ul style="list-style-type: none"> • Noble Tenant Farmer's House, c. 1840 • Originally a Crown reserve lot • American Ambrose Noble purchase in 1840 who lived in Mount Joy and operated a tannery (in 1851, the property was occupied by John Smith) • Appears he rented this house to others • Modestly scaled frame house- Georgian tradition - front veranda c. early 20th C • One storey kitchen wing that may be the earliest part of the building • Part of the Mongolia hamlet community/remnant of agricultural history • Barn is associated with the house
Physical Condition	<p>WSP Condition Rating: D3- Structurally Unsafe/ D2 Structurally Compromised (Main House)</p> <p>WSP Comments:</p> <ul style="list-style-type: none"> - Exterior walls are clad in vinyl siding over the original wood siding. Windows and doors are boarded up but consist of original wood sliders with outer metal storm windows. - The building is partially collapsed and unfit to enter. It poses an imminent health and safety risk upon entry and within the immediate surrounding. Entry to the north addition for investigation, rehabilitation or abatement is not feasible in its current condition. Demolition is recommended. However, the original house should be classified as a D2 – Structurally Compromised. The building structure is compromised and the envelope is severely deteriorated, posing health and safety risks upon entry. With appropriate safety precautions, immediate abatement activities can be completed, before recommended deconstruction. - The floor of the west addition has collapsed, likely due to prolonged exposure to moisture. Visible from the basement, the central beam supporting the floor joists in this area has failed. The roof has a large hole and is also partially collapsed. THIS AREA SHOULD NOT BE ENTERED. - The structure of the original (two storey east portion) house is compromised due to continued poor performance of the roofing. Wood rot was noted at framing members in multiple locations. - The cladding system is in very poor condition and is no longer providing an acceptable barrier to the elements. There are areas of the cladding that are partially detached and at risk of falling. - In order to safely complete abatement activities at the main house level, the following is required: <ul style="list-style-type: none"> - provide means of safely accessing the house; the structure of the front porch is compromised and will need to be re-enforced to allow multiple workers from entering and exiting the house. - clear excessive amount of debris from rooms and floors so that workers can safely perform duties. This will also allow for closer inspection of flooring in some areas.

Photo No. 1: East Elevation
