RE: Robb House Restoration, 66 Monique Court, Town of Markham

Re: Independent Engineering Inspection of Damage to a Relocated

Current Site Address: 66 Monique Court (formally 7205 Markham Road)

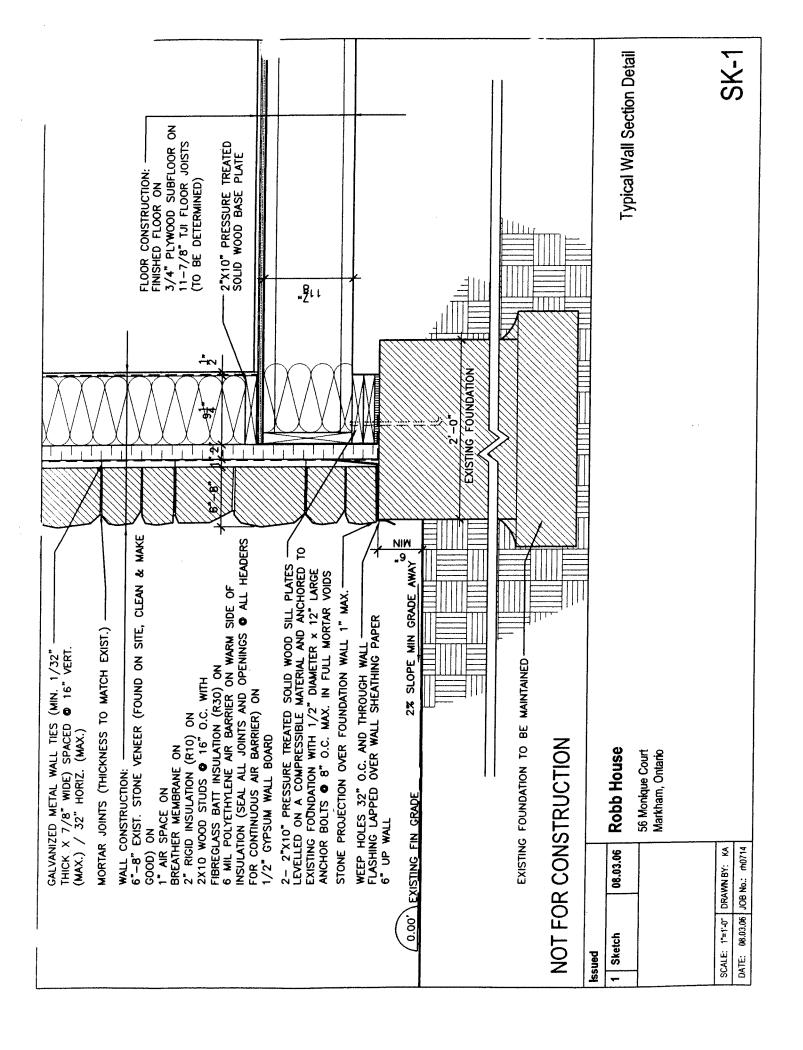
## ROBB HOUSE - RE-CONSTRUCTION MARCH 2008

- 1. Take physical dimension of all elevations establishing location of all windows, doors and heights
- 2. Remove front cut stone lintels particularly the date engraved one
- 3. Salvage as many sill as possible
- 4. Remove exterior stone walls
- 5. Separate the exterior faced stone from the interior back-up rubble, creating a supply
- 6. Create a supply pile of larger interior rubble stone for possible use
- Remove fireplace mantels if possible
- 8. Remove the balance of the old structures
- 9. Rebuild house using 2x10 studs, exterior insulation and 2x12 joists
- 10. Frame roof to original pitch having regard for original photos available
- 11. Provide fieldstone veneer
- 12. All windows to be of wood single hung construction
- 13. All trim to be of wood construction
- 14. Shingled roof
