Report to: Development Services Committee

SUBJECT:	Eligibility of the Alfred Read House for relocation to Markham Heritage Estates 2780 19 th Avenue, Ward 2
PREPARED BY:	Peter Wokral, Heritage Planner, ext. 7955
REVIEWED BY:	Regan Hutcheson, Manager of Heritage Planning ext. 2080

PROPERTY CONDITION ASSESSMENT

2780 19th Avenue,
Markham, ON

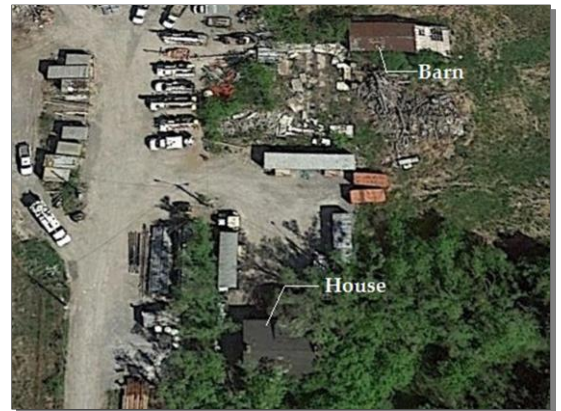
The Farm House is known as Alfred Read Farmhouse and is listed on the Markham Register of Properties of Cultural Heritage Value or Interest. It was constructed in 2 distinct sections.

The south section is 1½ storeys in height with a basement level and is formed by solid masonry (in Flemish and Common bond patterns) that is supported by fieldstone foundation walls. The roof of this section is gabled and is covered by conventional 3-tab asphalt shingles. Rainwater from the roof is collected in gutters installed along the eaves and the water is directed to ground level by downpipes. Window units are single glazed with wood frames.

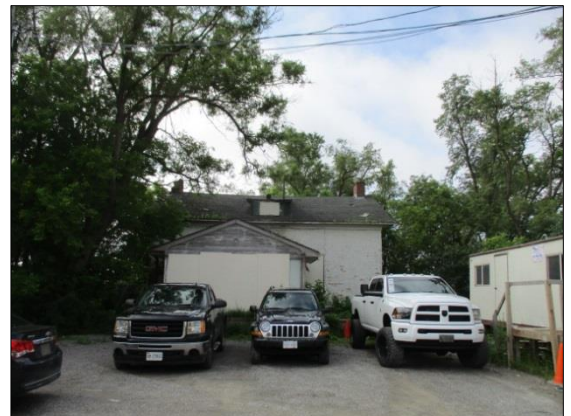
The north addition is 1 storey in height and appears to be located above a crawl space. The north addition appears to be more recent construction than the south section. The north addition is formed by wood framing that appears to be supported on concrete masonry foundation walls. The exterior walls are covered with wood siding. The roof is covered by conventional 3-tab asphalt shingles. Rainwater from the roof is collected in gutters installed along the eaves and the water is directed to ground level by downpipes. Window units are single glazed with wood frames.

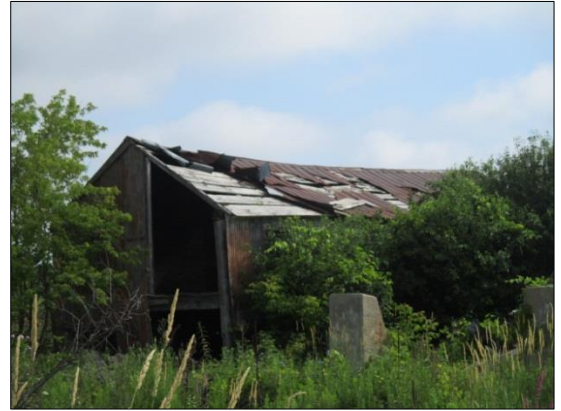
The Storage Barn is constructed using heavy timber construction that is supported by poured concrete foundation walls. The ground floor of the building is formed by a poured concrete slab-on-ground. The exterior walls are covered with corrugated metal panels installed over wood planks. The sloped roof is covered with corrugated metal roof panels.
