MEMORANDUM

Re:	Main Street Unionville Commercial Core Streetscape Master Plan Study – Follow up items
Date:	March 3, 2022
Prepared by:	Alain Cachola, Senior Manager, Infrastructure and Capital Works, Ext. 2711 Regan Hutcheson, Manager, Heritage, Ext. 2080
From:	Frank Clarizio, Director, Engineering, Ext. 7507
To:	Mayor and Members of Council

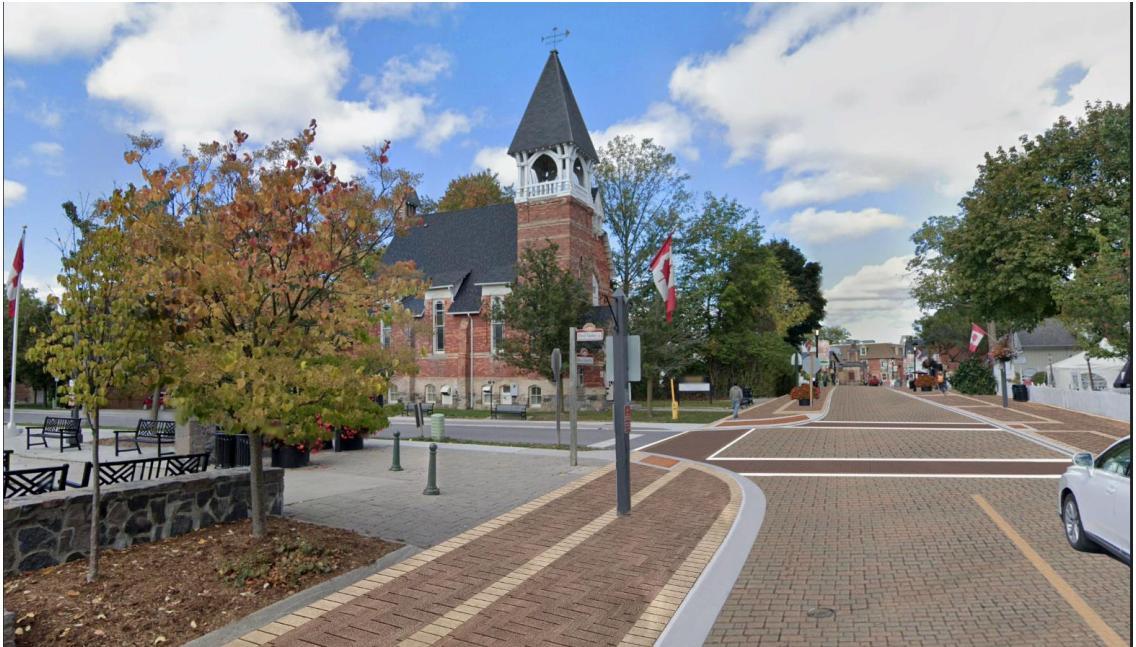
The artist rendition below, as illustrated in Figure 1, reflects the Streetscape Treatment Option #3A features. Note that the brick colours are preliminary only and will be subject to change based on the scheduled stakeholder consultation.

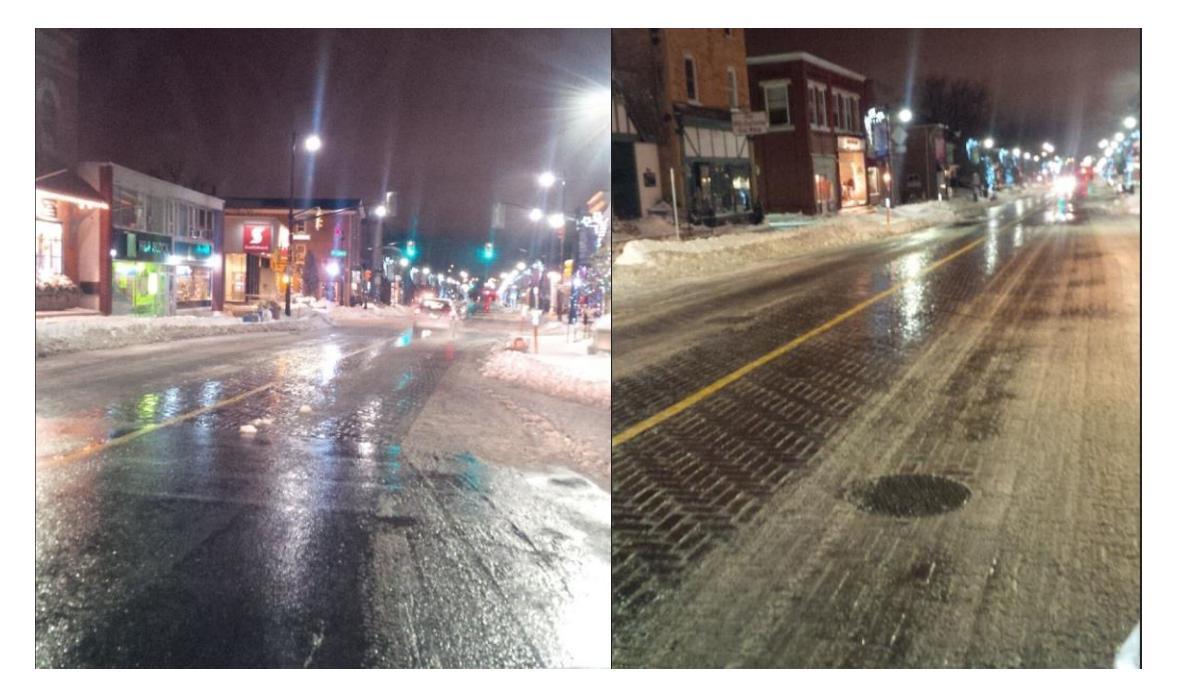
Figure 2 – Main Street Markham Salt Effectiveness for Asphalt and Paver

It should be noted that Markham staff encountered a number of winter events in the past on Main Street Markham, as seen below in Figure 2, which required a number of repeated de-icing applications to meet required maintenance standards. The repeated applications increased winter maintenance costs related to material and labour resources.

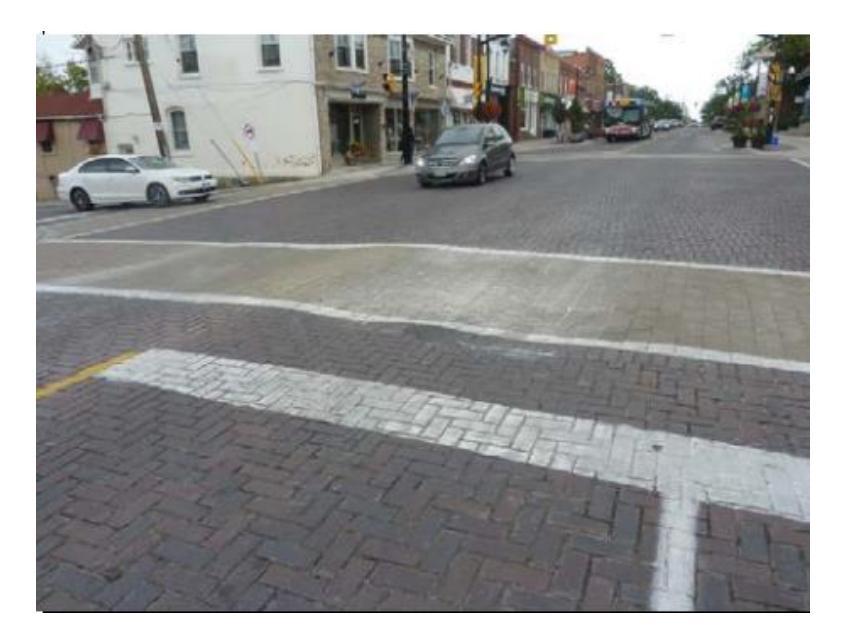
Figure 4. - Main Street Markham

Based on an investigative consultant report, the result of the failures on the Main Street Markham are a combination on a number of issues. The major contributor to the failure was the type of bedding layer used between the concrete brick paver and the concrete base. It was determined that:

- the bedding layer used was a soft aggregate and was not suitable for this type of application;
- the thickness of the concrete brick paver was 7cm (vs 8cm);
- laying pattern (used square brick at crossing which is not recommended);
- lack of edge restraint to hold the concrete brick pavers in place; and
- joint width (spacing) of pavers.

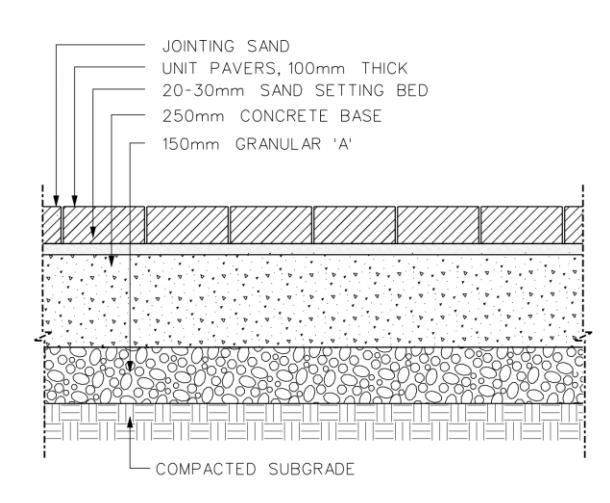
Figure 5- Unit Pavers on a Concrete Base

The use of a concrete base is usually dependent on the loading that the road is designed to support and the quality of the subbase underneath the concrete pavers. The concrete base allows for the loads that are imparted to the pavers to be spread over a greater area of the supporting granular material reducing the likelihood of deformation of the area being loaded. Figure 5. below, illustrates a typical paver design using a concrete base.
