Report to: Development Services Committee

Meeting Date: May 25, 2020

SUBJECT: **Recommendation Report**
Demolition Permit Application for a Building Listed on the
Markham Register of Property of Cultural Heritage Value or
Interest,
Summerfeldt-Stickley House
10536 McCowan Road, Ward 6
File No. 20 110958 DP

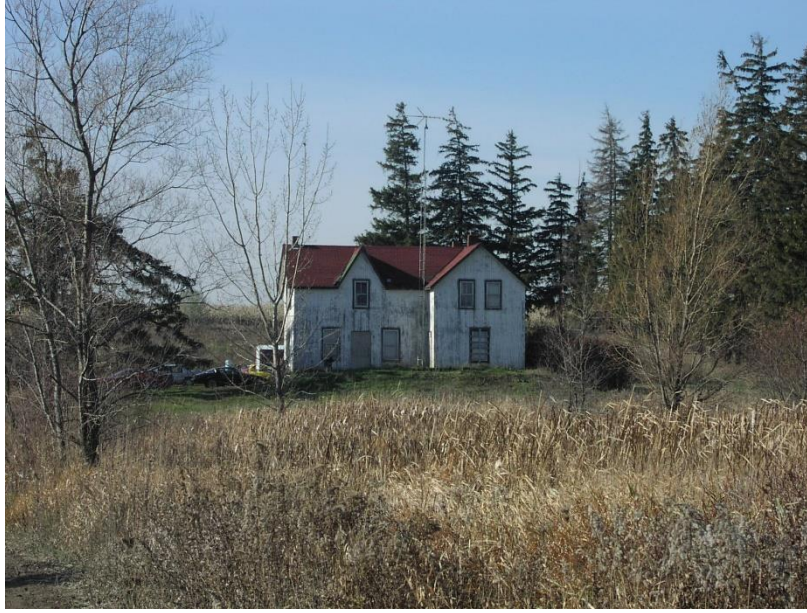
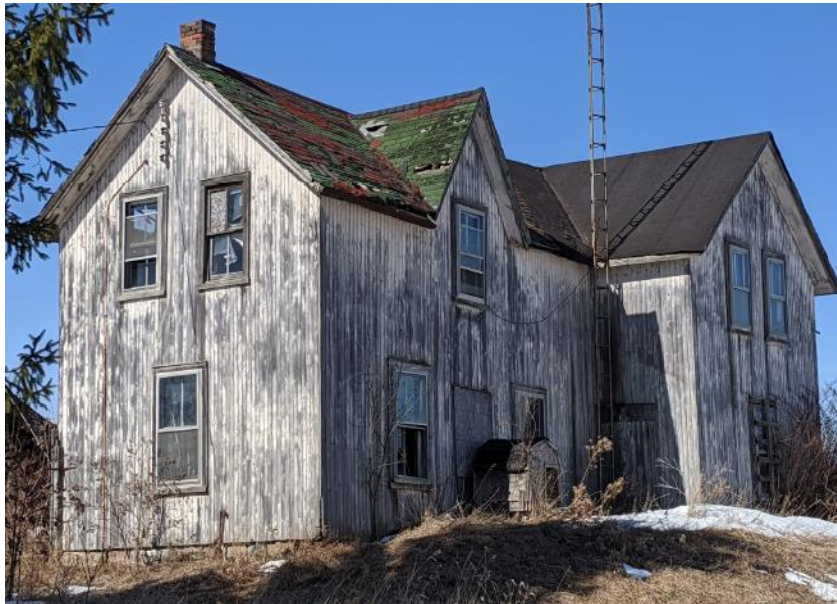
FIGURE 2
BUILDING PHOTOGRAPHS

Summerfeldt-Stickley House in 2000 and 2020

TACOMA Engineering Photograph

The report by TACOMA Engineers, which reviewed an earlier report by Zaretsky Consulting Engineers Inc., concludes that the building is beyond the point of restoration due to structural issues and would be unsafe for workers to enter to undertake either shoring or repairs. The report states that the level of replacement of existing material would be such that little would remain of the original heritage building if restoration was to be undertaken.

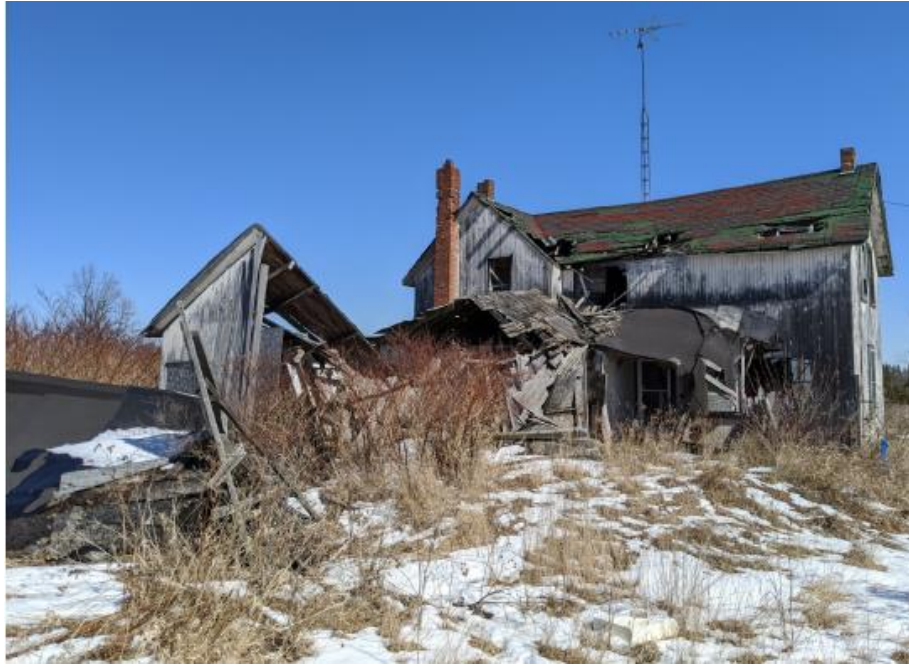
Rear of Summerfeldt-Stickley House, 2020

TACOMA Engineers Photograph
