## MEMORANDUM

**Re:** Partial Removal of Modern Construction on a Property Designated under Part IV of the Ontario Heritage Act, 11172 Warden Ave., The Clayton Schoolhouse

## APPENDIX A: Photographs of Clayton Schoolhouse after Fire

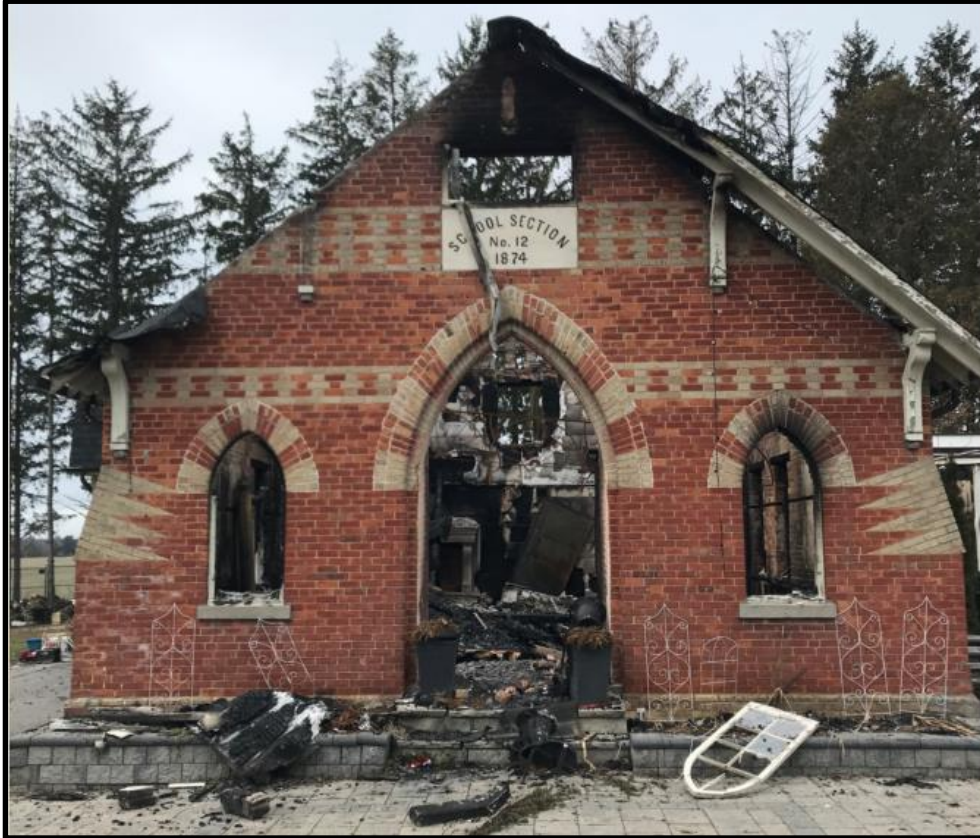
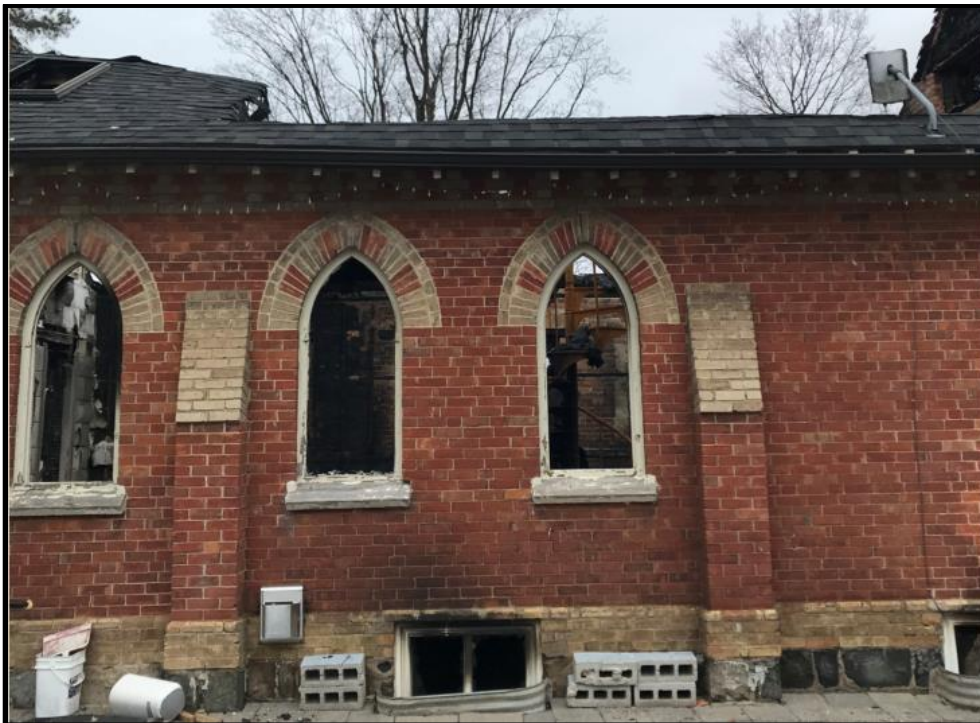
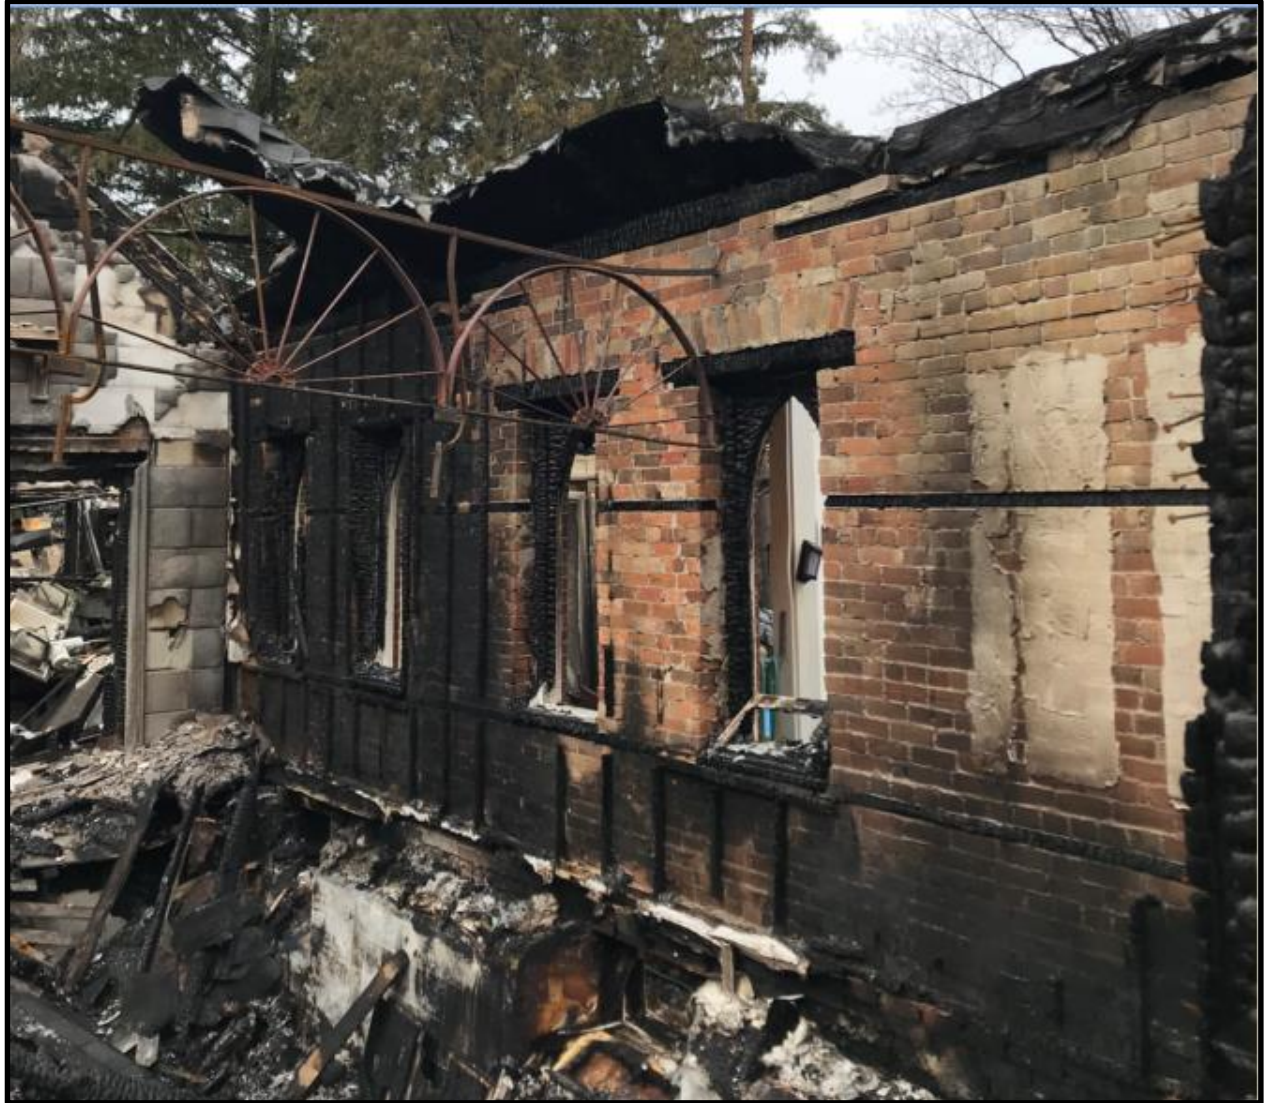
On December 25, 2022, a fire occurred at 11172 Warden Avenue affecting the former Clayton Schoolhouse, which has been converted to a dwelling unit and was designated under Part IV of the *Ontario Heritage Act* in 1982. No one was injured in the fire, but it severely damaged a modern two-storey frame rear addition to the historic building and a deck. The fire also

destroyed almost all of the wooden portions of the historic schoolhouse, but left the foundation and multi-wythe solid brick walls intact (See Appendix A).

Based on the findings of two separate reports prepared by structural engineers in the days immediately following the fire, the brick walls appeared to have escaped any serious damage and were structurally sound and stable. The reports recommended that the gable walls be temporarily braced. Heritage Staff and Heritage Markham have no objection to the removal of what remains of the non-heritage portions of the building, but that everything possible be done to preserve the remaining historic masonry structure so that the heritage component can be restored (See Appendix C).

As the remaining historic brick structure is exposed to the elements and requires temporary bracing to make it safe, it is important that Council provides its approval for the removal of the non-heritage portions of the property so that a more thorough examination of the structural integrity of the historic masonry can be safely conducted, and allow an investigation into the probable cause of the fire.

Therefore, Heritage staff recommends that Council support the removal of the non-historic portions of the former Clayton Schoolhouse and that the remaining historic brick structure be protected from the elements and temporarily stabilized to prevent any further damage to the structure, so that it may be restored to its original appearance.

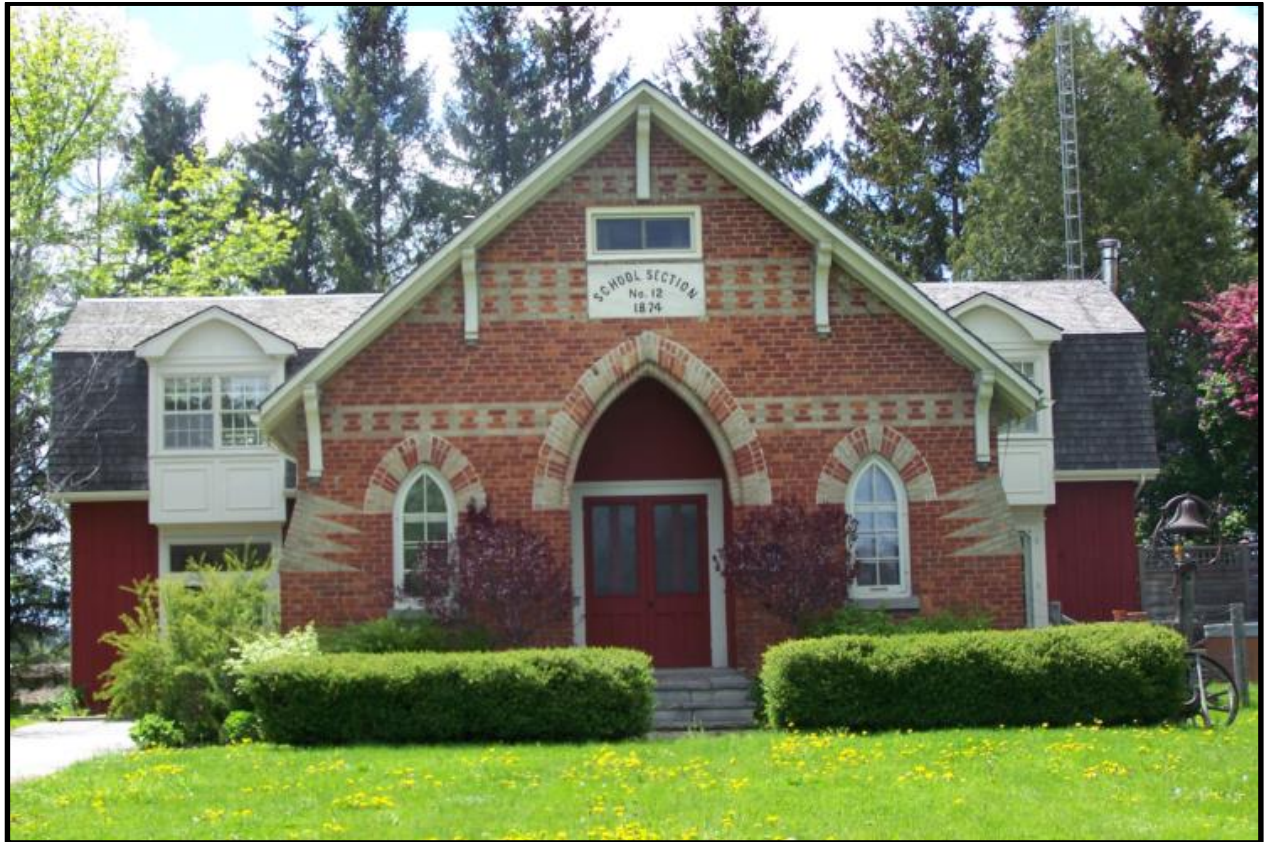
**APPENDIX B: Photograph of Clayton Schoolhouse and Designation By-Law**

The Clayton Schoolhouse is rectangular in plan, a single storey in height, and sheltered by a medium pitch gable roof. Red bricks laid in a stretcher bond indicate a brick veneer over a timber frame. White bricks are used to create decorative patterning, which lends to the building a distinctive appearance. Fieldstones have been split, squared, and laid in courses for the foundation.

The schoolhouse is oriented with gable ends on an east-west axis. The principal elevation is in the east gable end facing Warden Avenue. This elevation has a central door, recessed in an umbrage, flanked by two windows, symmetrically placed.

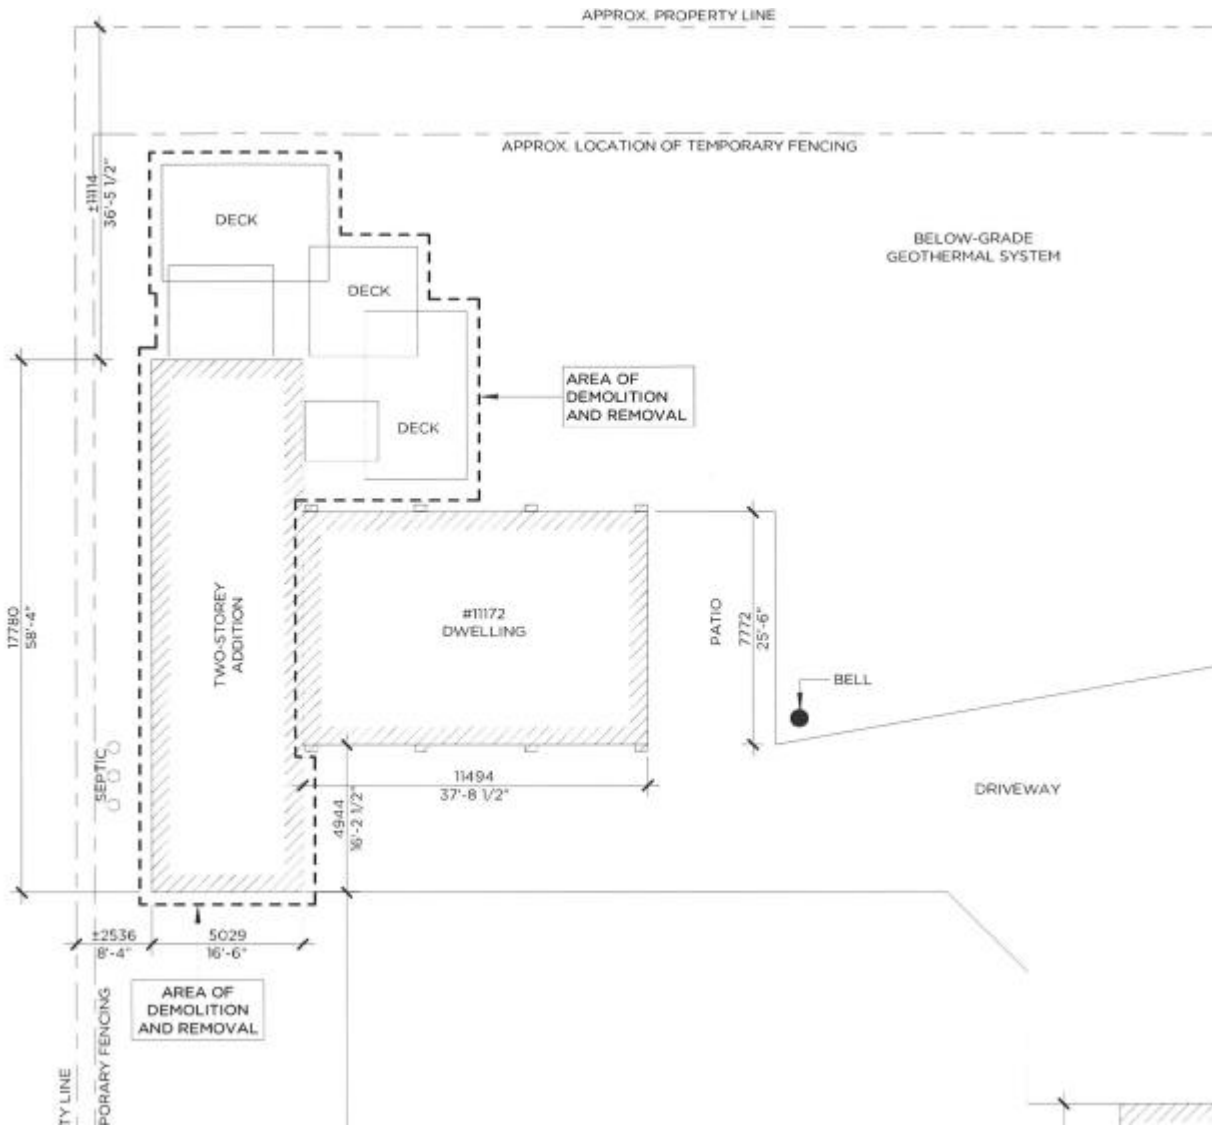
## APPENDIX D: Plan showing Proposed Scoped Demolition of Non-Heritage Portions of Clayton Schoolhouse

The City received a Building Permit application for the demolition of what remains of the non-heritage portions of the building, but not the historic masonry structure (See Appendix D). Section 34(1) of the *Ontario Heritage Act* states that an owner is required to obtain a permit from the municipality to:

AND THAT Heritage Markham has no objection to the demolition of what remains of the modern two storey rear addition or the deck located on the north side of the schoolhouse.
