Archibald Fenwick House

c.1845

North Half Lot 25, Concession 6
4551 Elgin Mills Road

ADDITIONAL PHOTOS OF THE FENWICK HOUSE

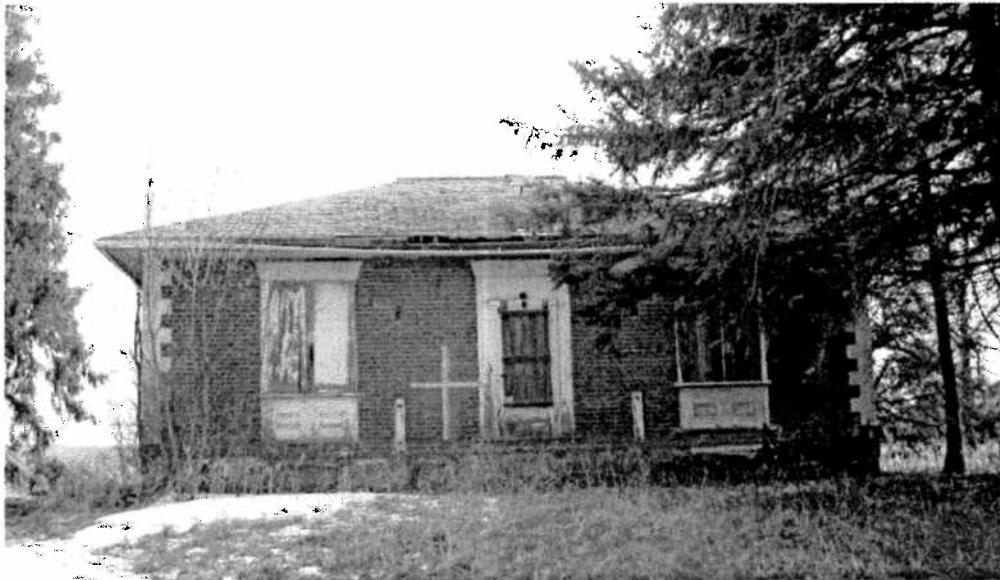
The Archibald Fenwick House is a one and a half story brick building with a simple rectangular plan. It rests on a raised fieldstone foundation that may have housed a basement kitchen. A one storey frame kitchen wing/woodshed, a later addition, extends from the north half of the east (rear) wall. The house is boarded up so detailed descriptions of doors and windows is limited at this time.

The house has a three-bay front with a centre doorcase flanked by tall, wide windows that were originally French doors. The lower, panelled portion of the French doors remain, in a fixed position, while the glazed upper portion has been replaced with windows of a more recent date. The doorcase has narrow sidelights and a transom light, but these have been boarded over for some time, so their original glazing pattern is not visible. Evidence on the front wall indicates the former presence of a bellcast-roofed, full-width verandah.

The brickwork of the front wall is laid in Flemish bond, while the remainder is in common bond. There are white brick quoins and cut limestone splayed lintels over the front and side door and window openings. At the rear of the house, the door and window openings have splayed brick arches.

The house has a low-pitched hip roof with a wide overhang and a narrow, moulded wood cornice. No historic chimneys remain. On the rear slope is a tiny, gable-roofed dormer window providing the only natural light for a room within the attic.

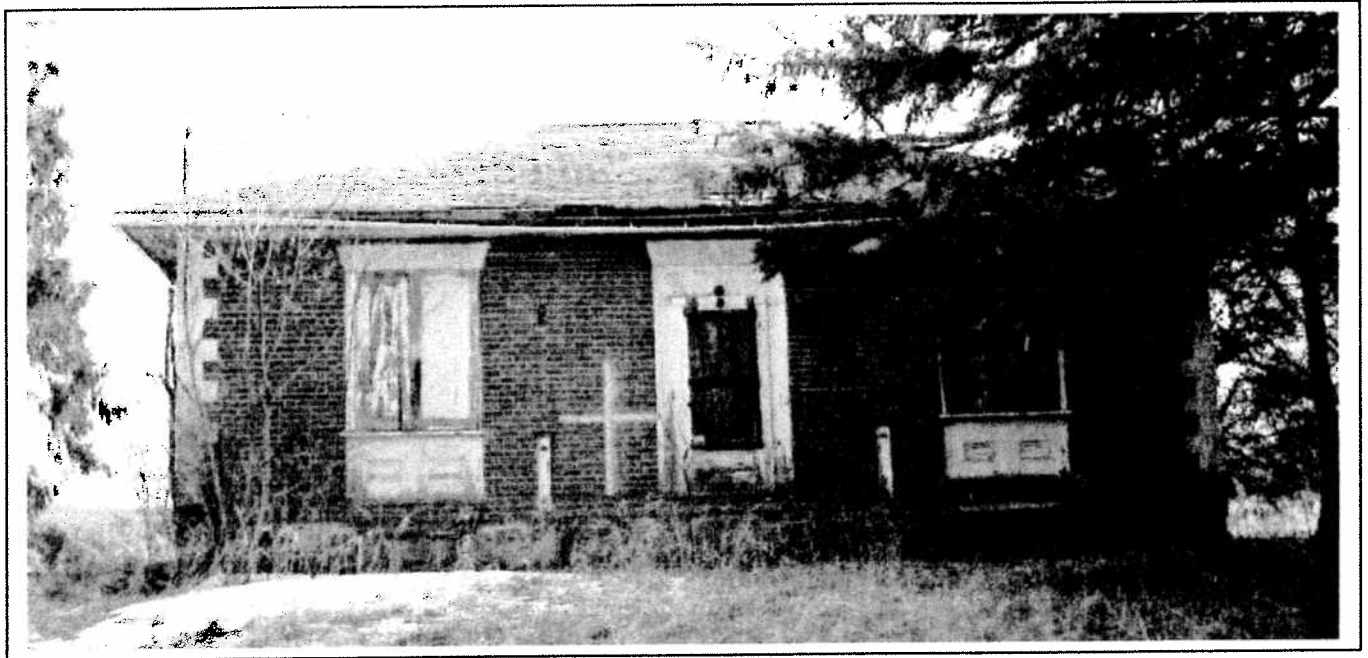
Photograph:

Style Description: A 1 storey brick regency cottage with a 3 bay façade. The house has a medium pitched roof, with contrasting quoins. The house likely originally had French doors on the main facade

Status: Vacant – for at least 15 to 20 years
Listed on the Heritage Inventory

The house is relatively close to the road and could succumb to vandalism.

1. That the owner of the property be requested to repair the structure and either tenant the building or secure it, fence around it and post a sign on the property indicating that the building is to be preserved;
2. That if a compatible use is planned for that general site area, that the subject house be retained and suitably reused;
3. That in the event that all options for on-site preservation are reasonably exhausted, and given that the subject house is largely intact, represents one of the best examples of the Regency Cottage Style, in the Town of Markham, and is located in an area which is not likely to be subject for pressure for development for at least 10 years, that the Archibald Fenwick House could be considered to be appropriate for relocation to the Heritage Subdivision.
4. The building should be designated under Part IV of the Ontario Heritage Act.
